Inspection Photos
Location Name: GE 30-02
Location ID: 422359

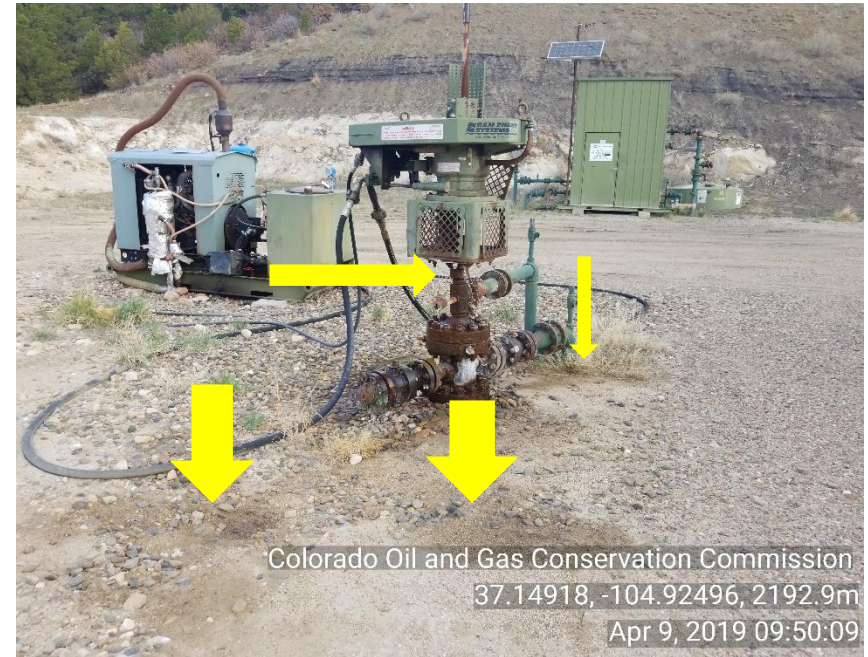
Photo 2 WH. Stained soil around well head. Packing on WH leaking at time of inspection.

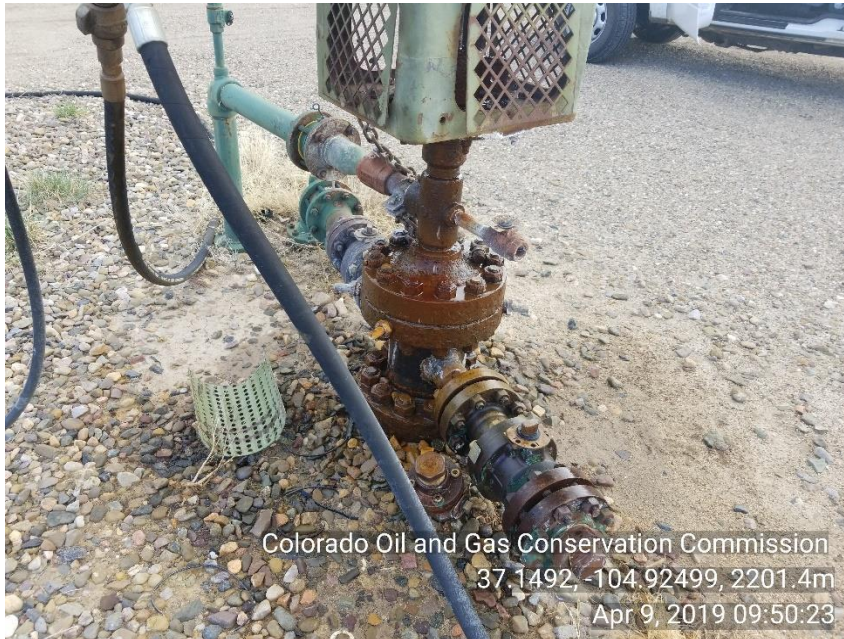
Photo 3 Stained soil around WH and packing leaking on well head.

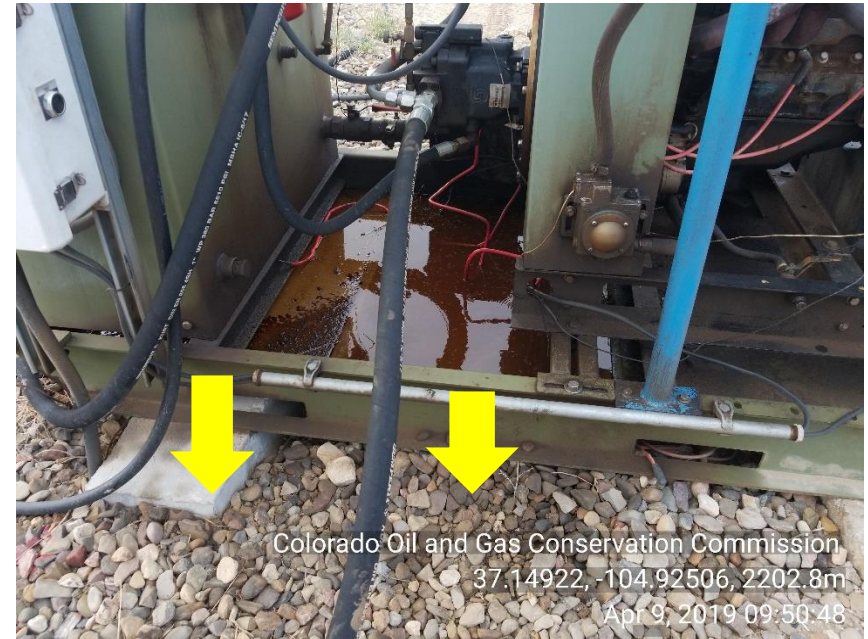
Photo 4 WH. Stained soil around Hyd skid

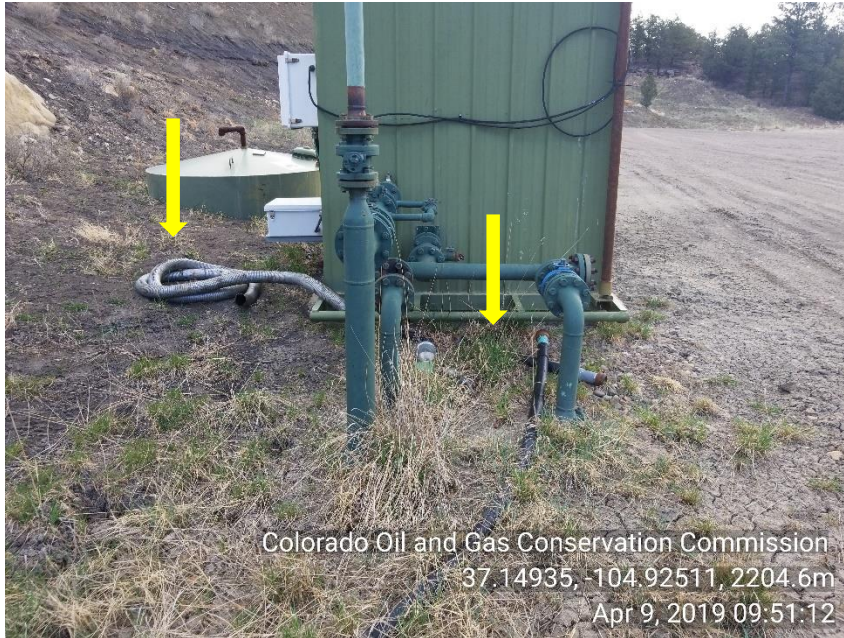
Photo 5 Unused equipment: 2" poly, 2" parts buried in dirt and exhaust hose.
