Inspection Photos
Location Name: SGU-64S96W 23 SW SW Pad
Location ID: #335680
Inspection Date: May 30, 2019

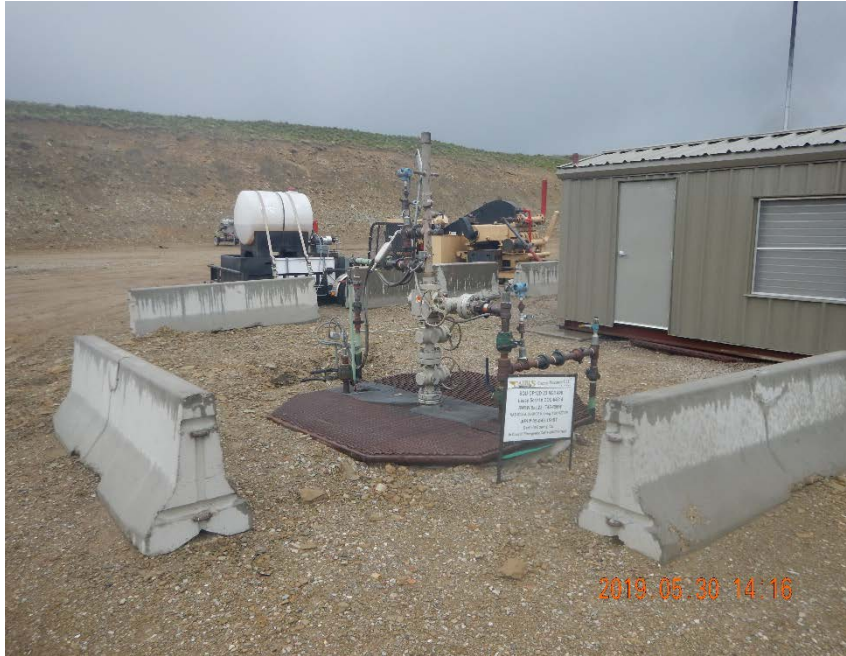
Photo #1 – Well sign located at well head.

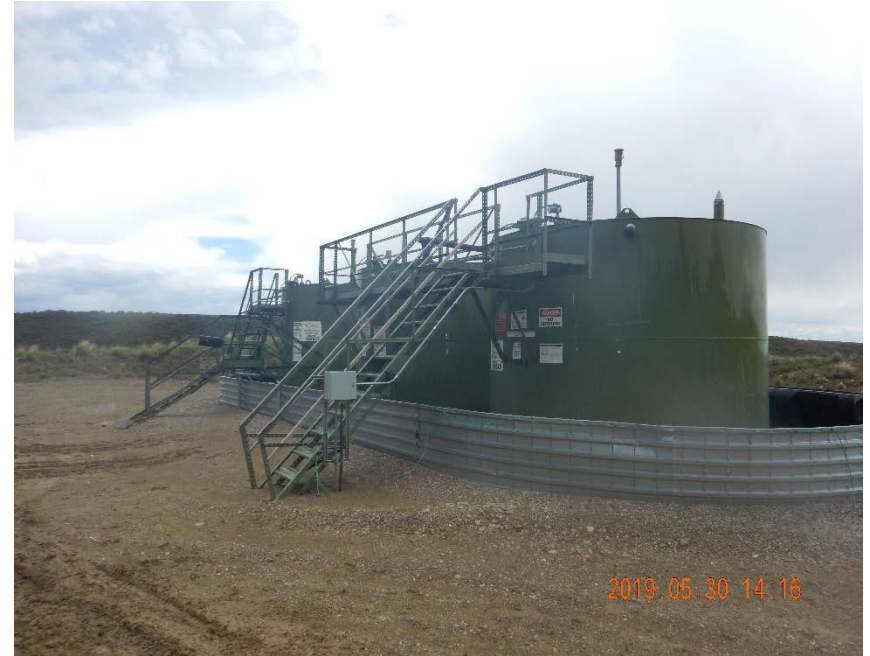
Photo #2 – View of tank battery from southeast.

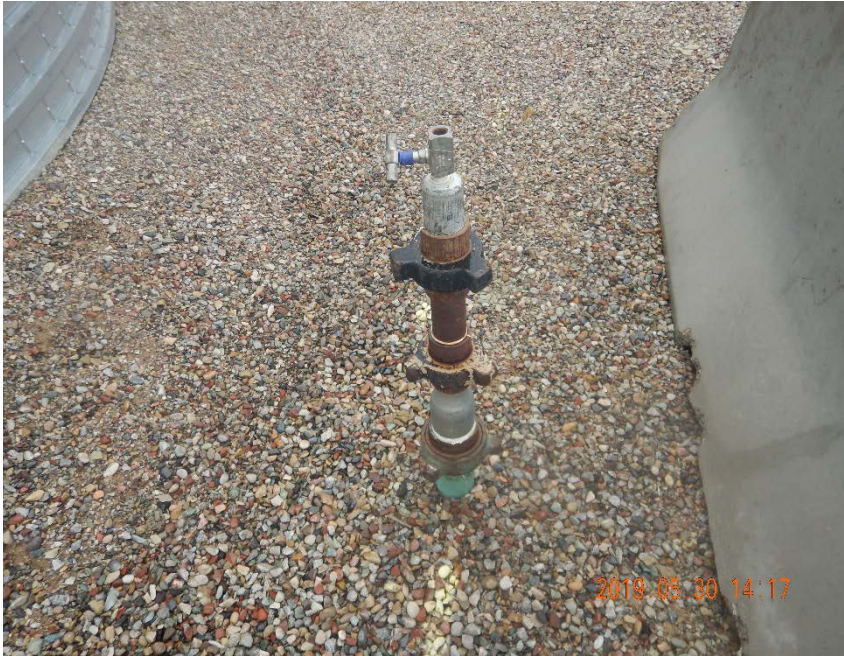
Photo #3 – Unused, unmarked flowline riser located north of condensate AST.

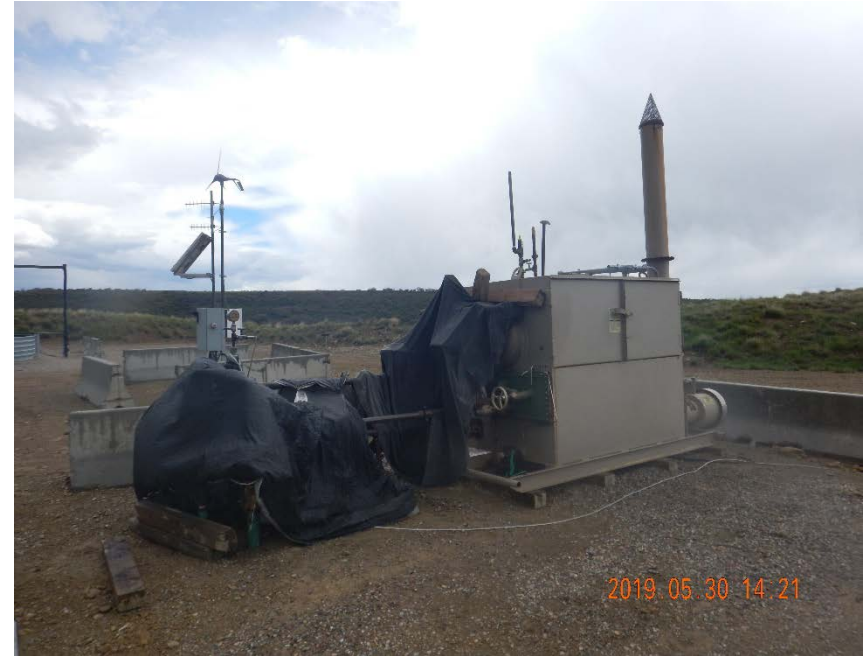
Photo #4 – View of heated horizontal separator from SE. Note wood debris and flowline risers on south side of separator (visible under tarp).

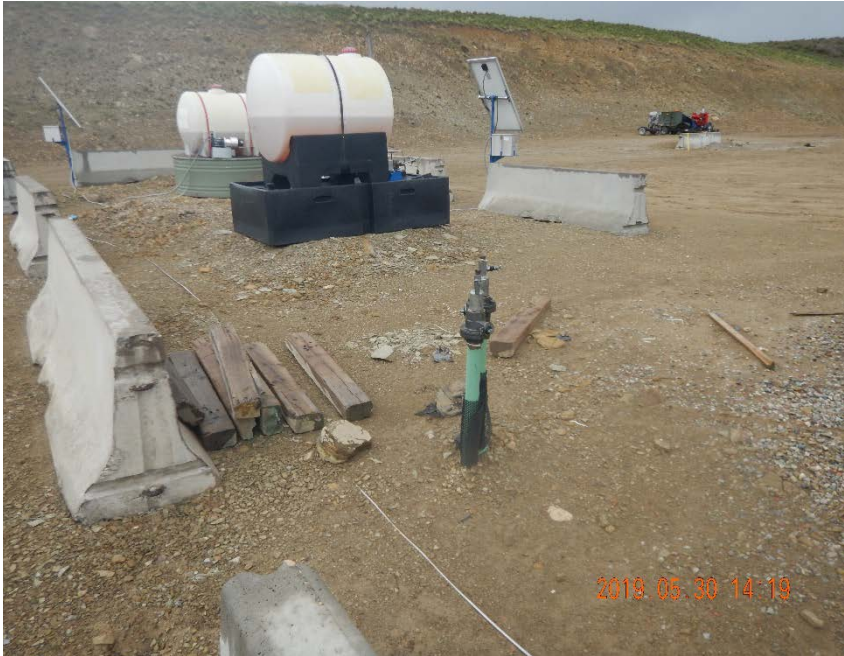
Photo #5 – Unused 2" flowline risers, wood debris, and chemical storage tanks located east of separator.

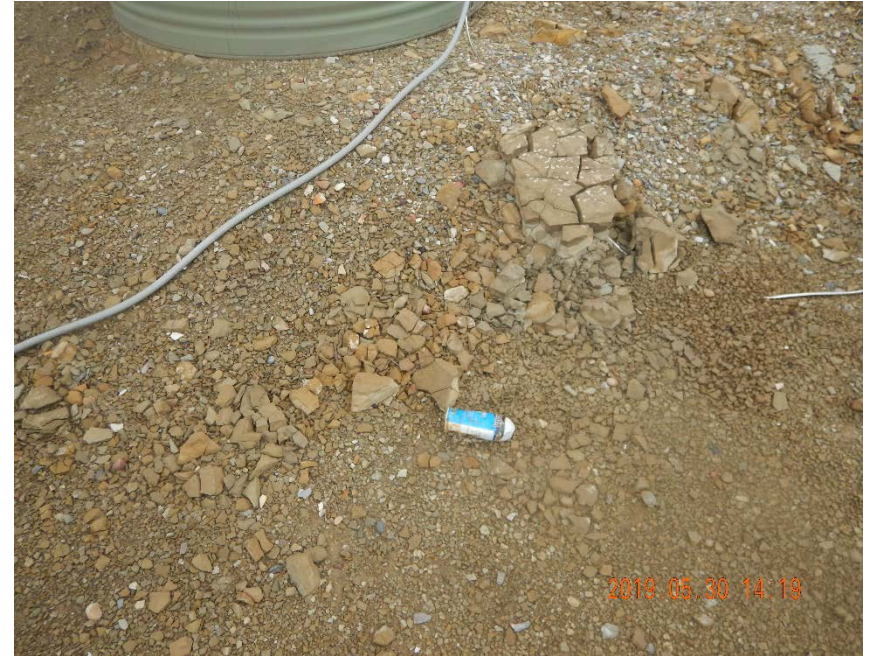
Photo #6 – Trash on location (can north of chemical storage tanks).

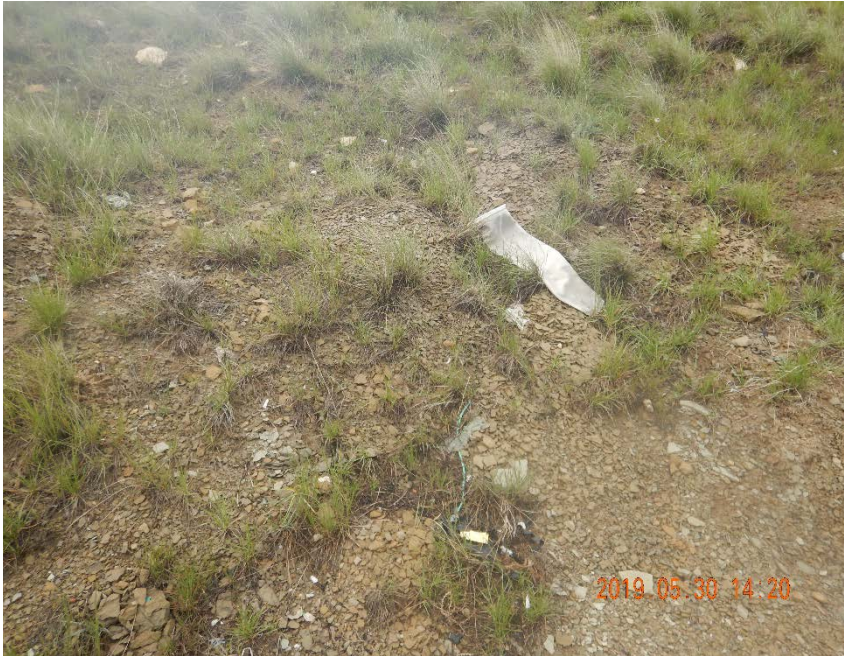
Photo #7 – Trash on location (filter sock on north side of pad).

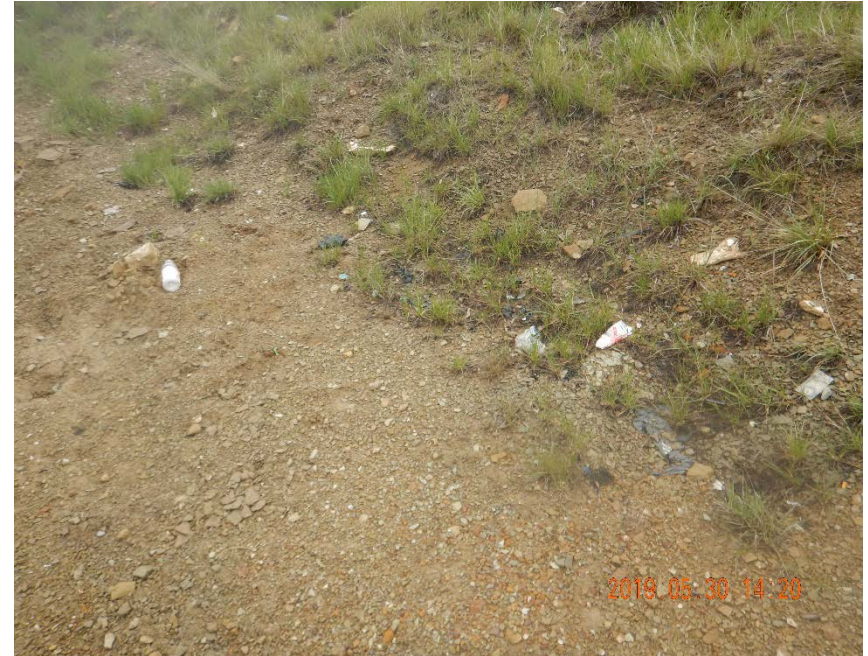
Photo #8 – Assorted trash on north side of location.

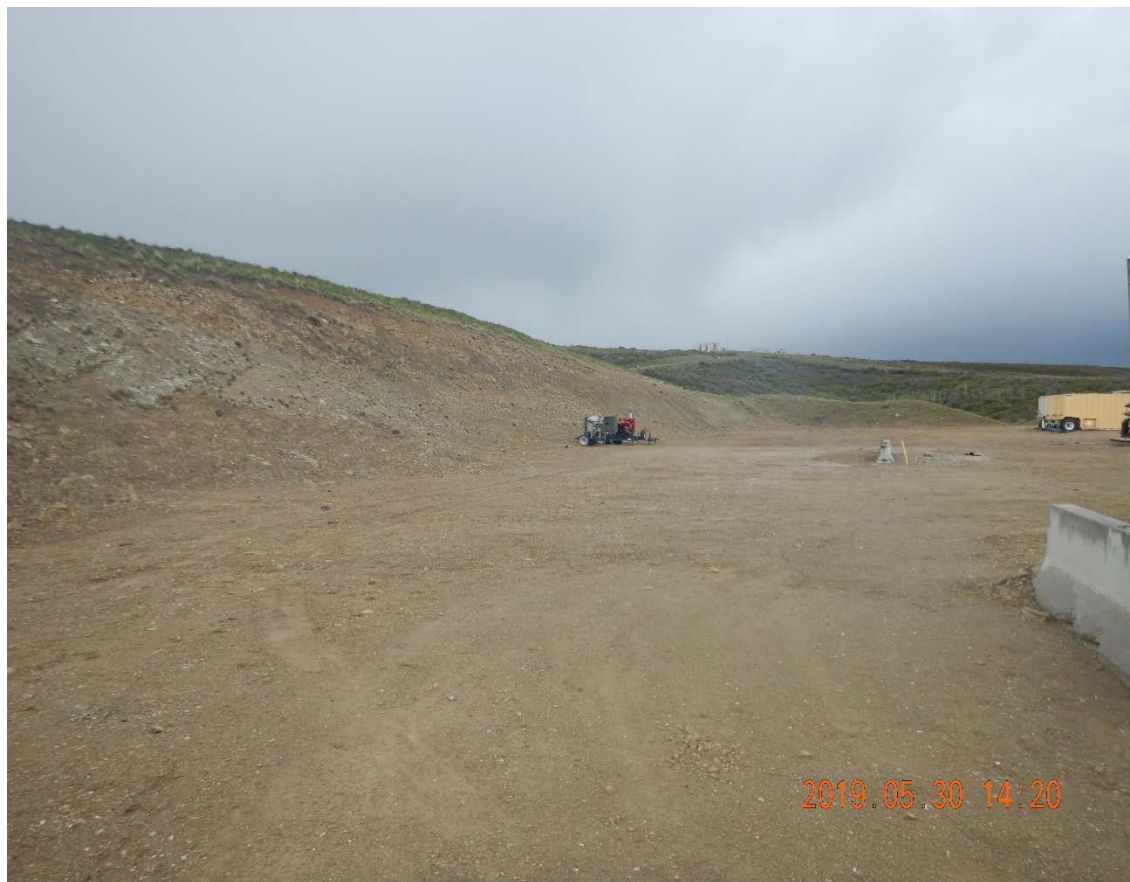
Photo #9 – Cut slope on SE side of pad. Operator has submitted eForm 04 Sundry (doc #402030679) for beneficial reuse of cuttings to reclaim this area.
