Inspection Photos
Operator Name: Caerus
Location ID: 335806

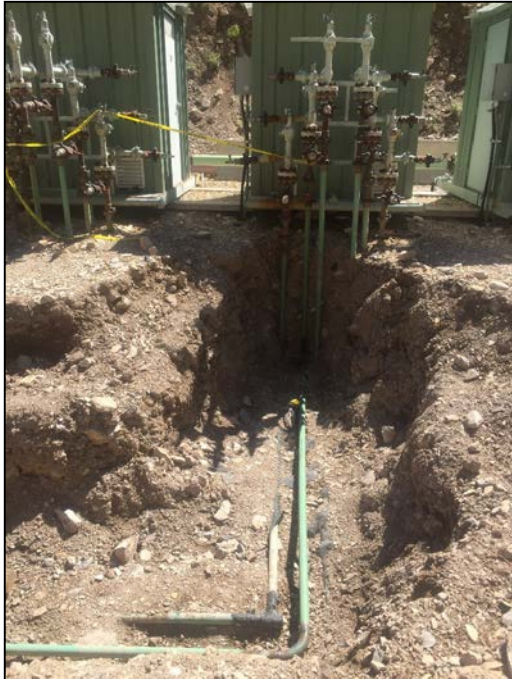
Spill location, 2" Dump line

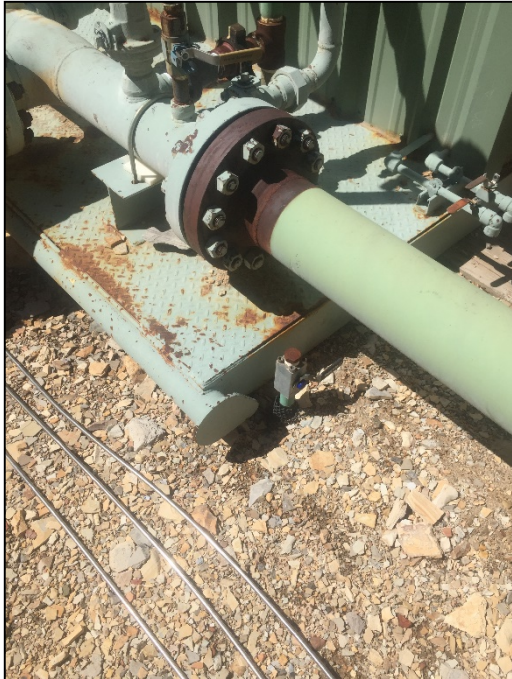
Unmarked riser

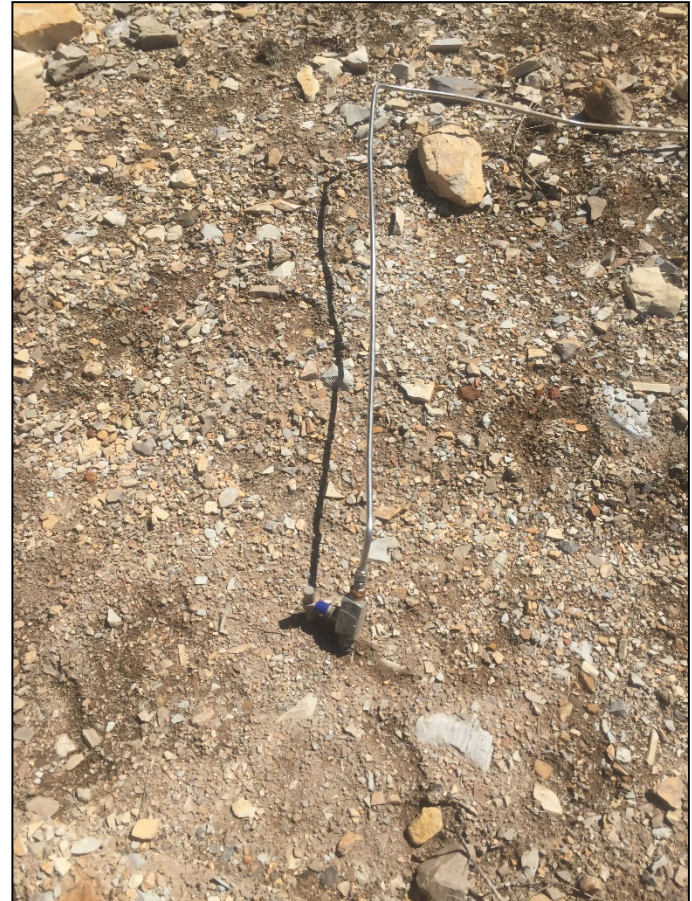
Process piping unprotected

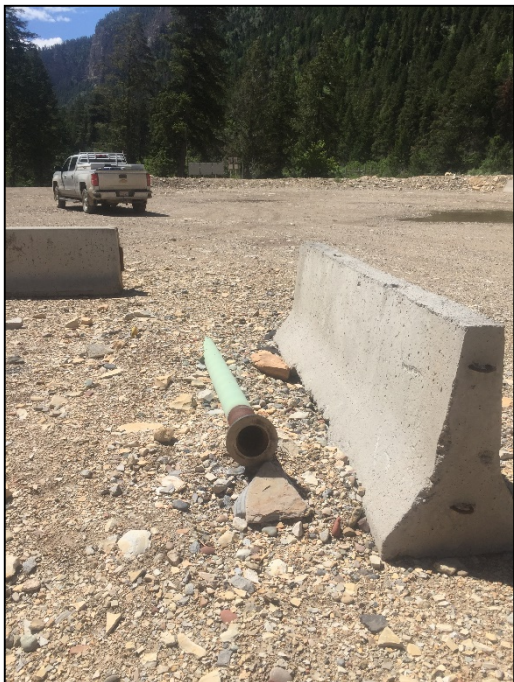
Unmarked Flowline

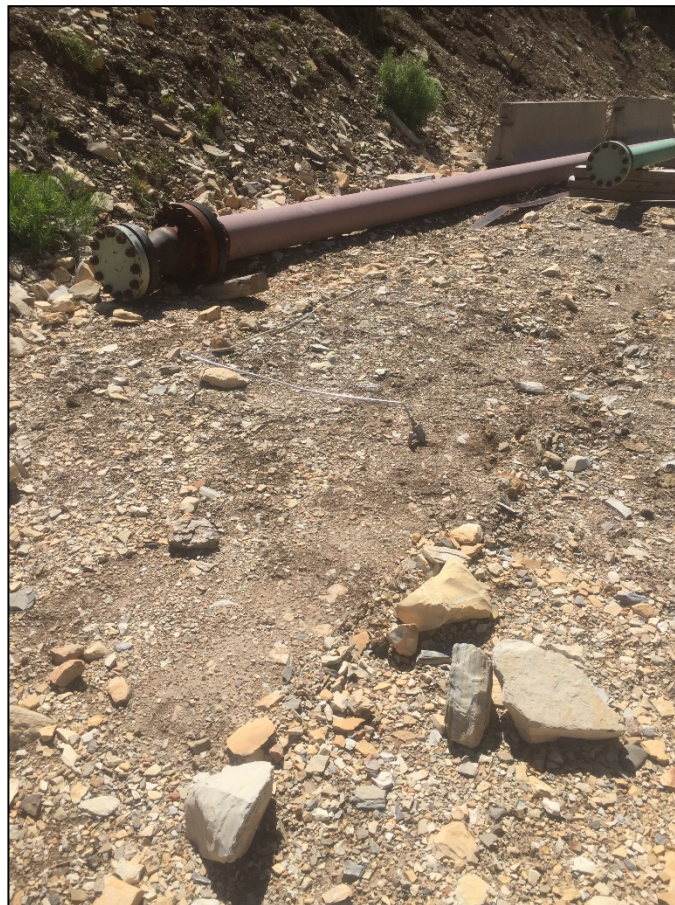
Unused flowline
