Inspection Photos

API: 05-073-06312

Operator: NIGHTHAWK PRODUCTION

Inspection Date: 6/24/2019

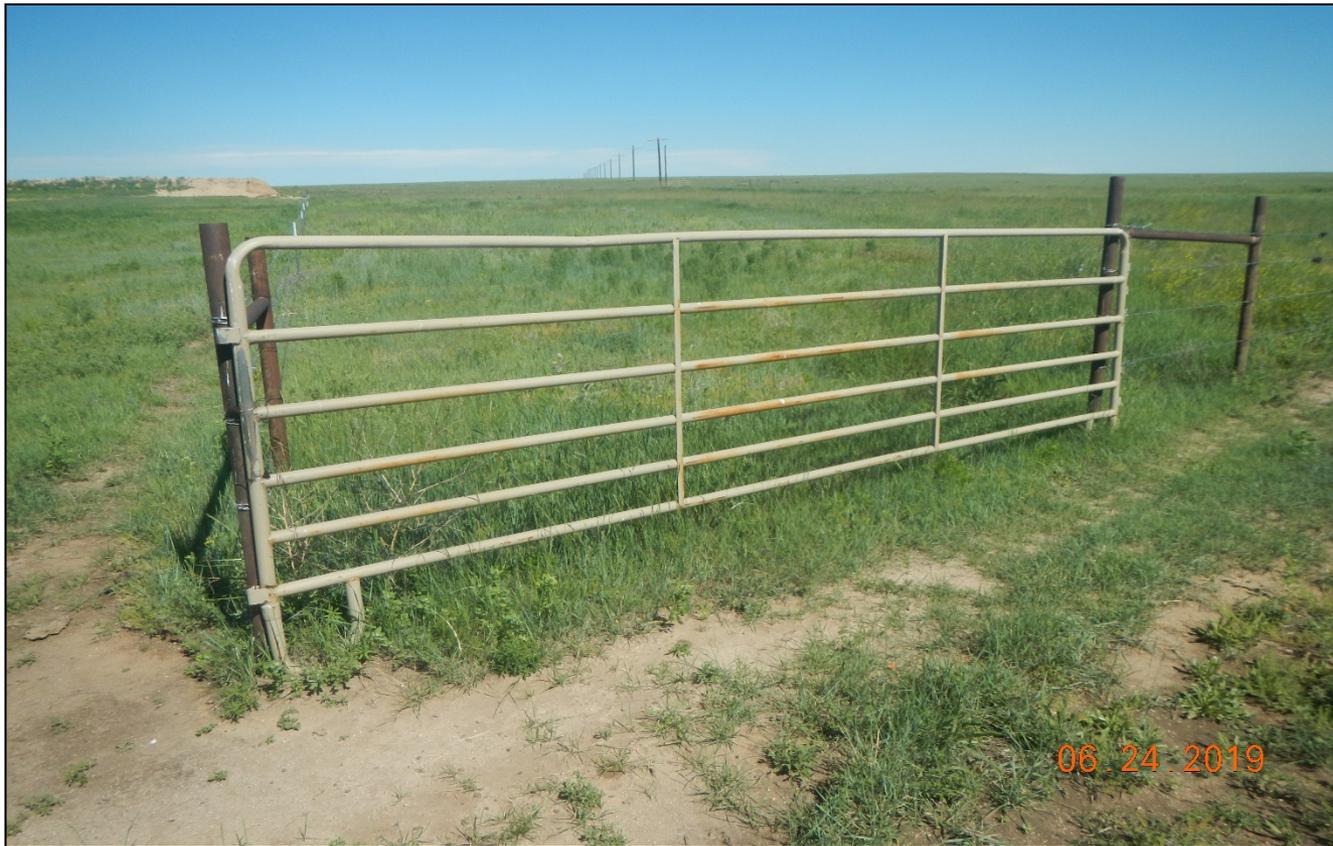
Photo 1. Facing northwest toward the location. Location is fenced.

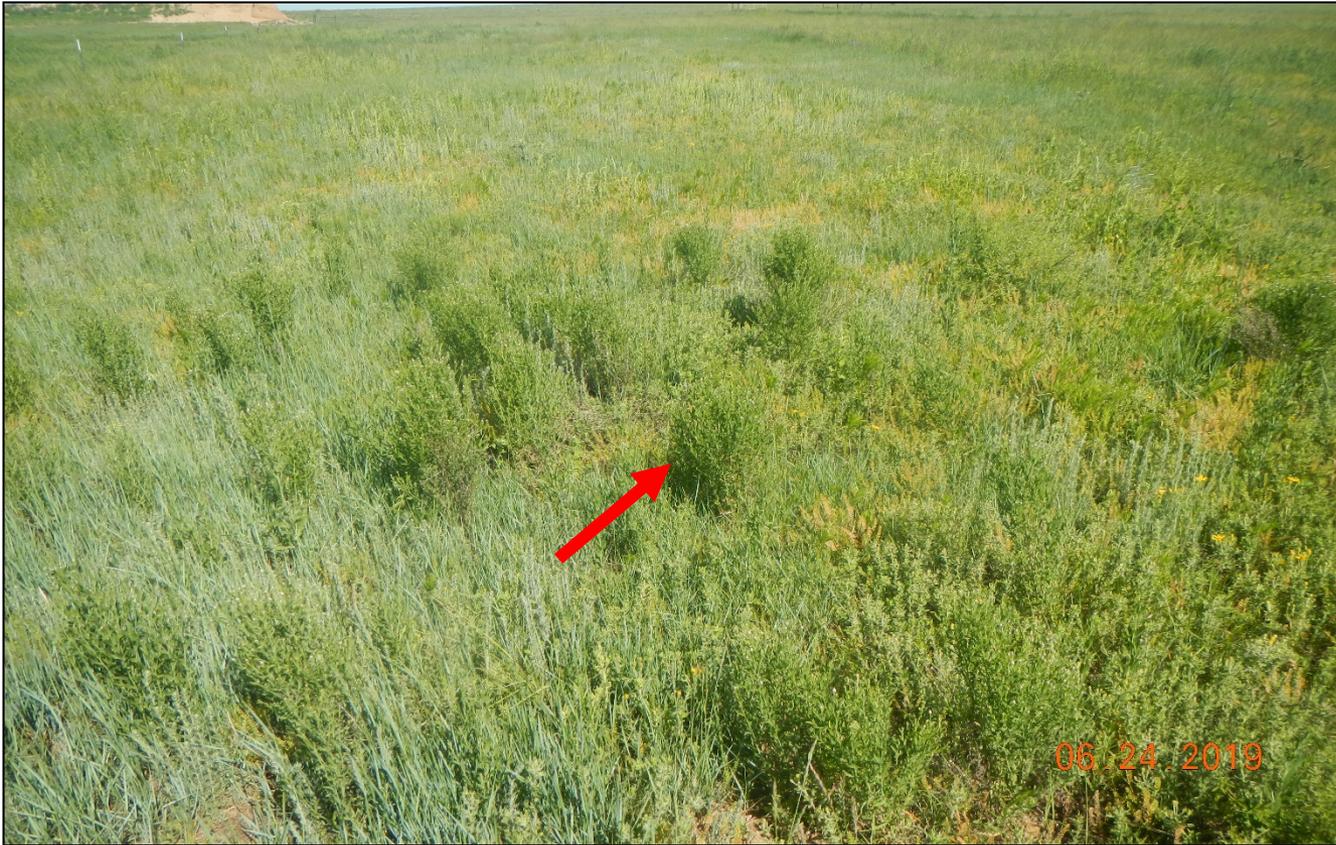
Photo 2. There is List B noxious weeds (Russian knapweed) at the southeast side of the location. Also, Chicory was observed in this area.

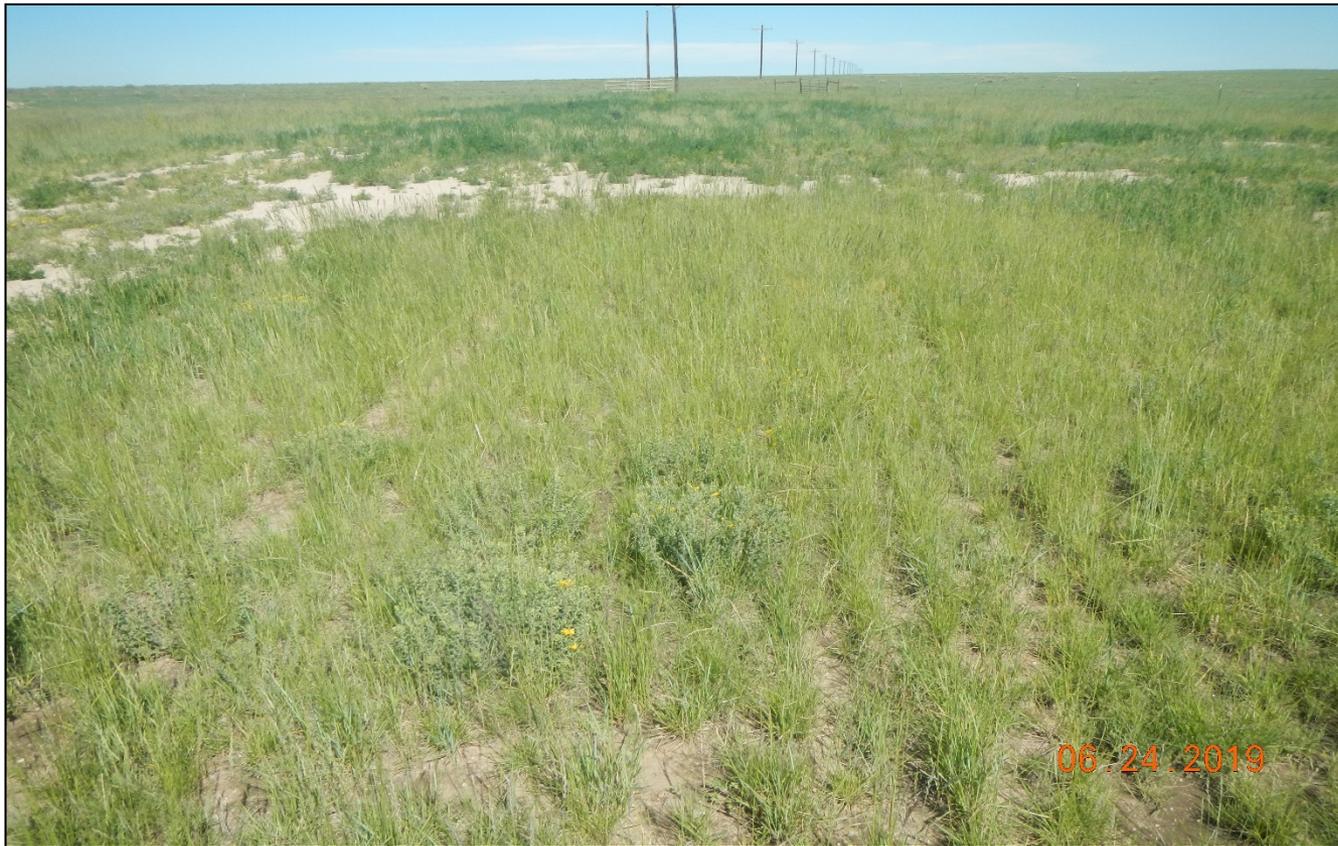
Photo 3. Facing northwest at the northern portion of the location.

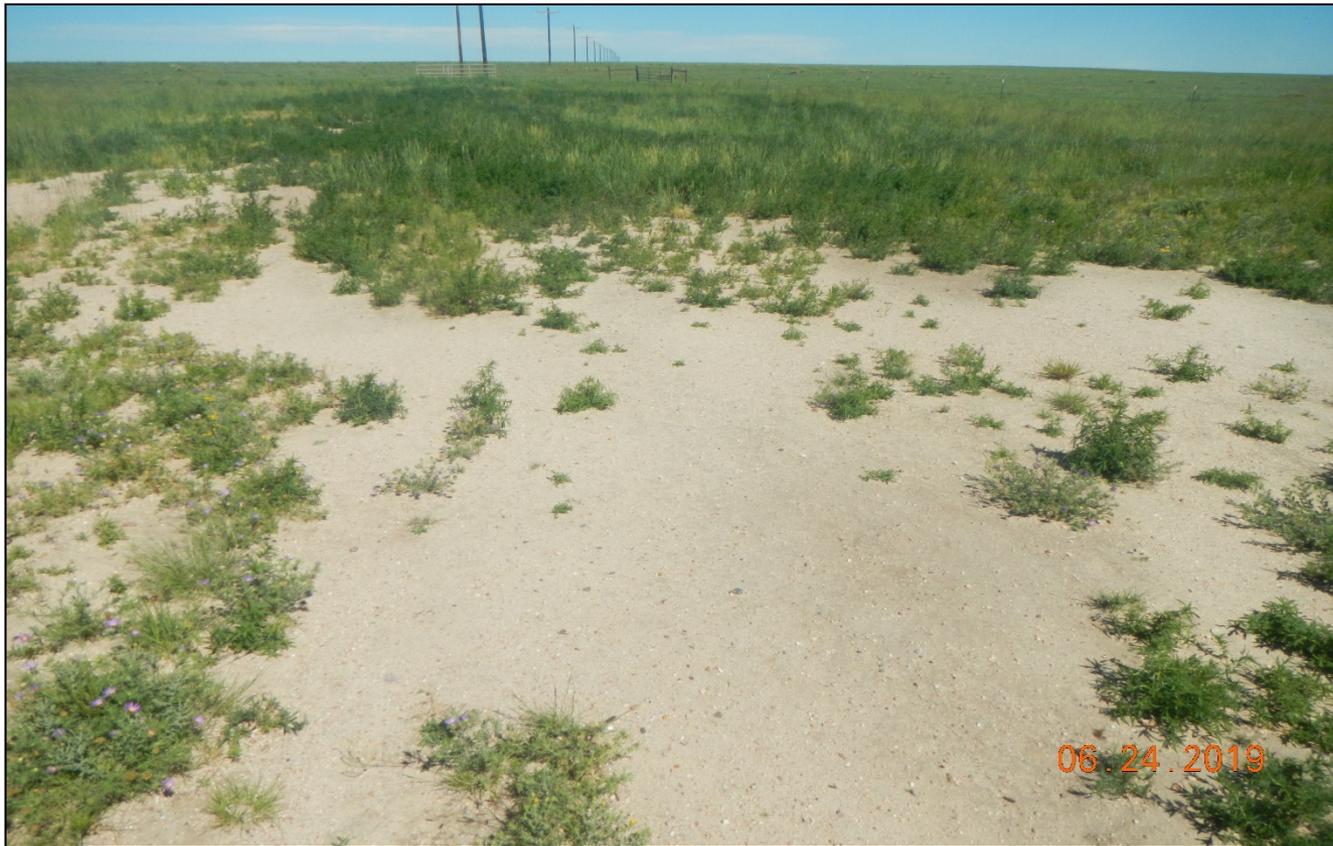
Photo 4. There is a bare area and undesirable weeds at the northern portion of the location.

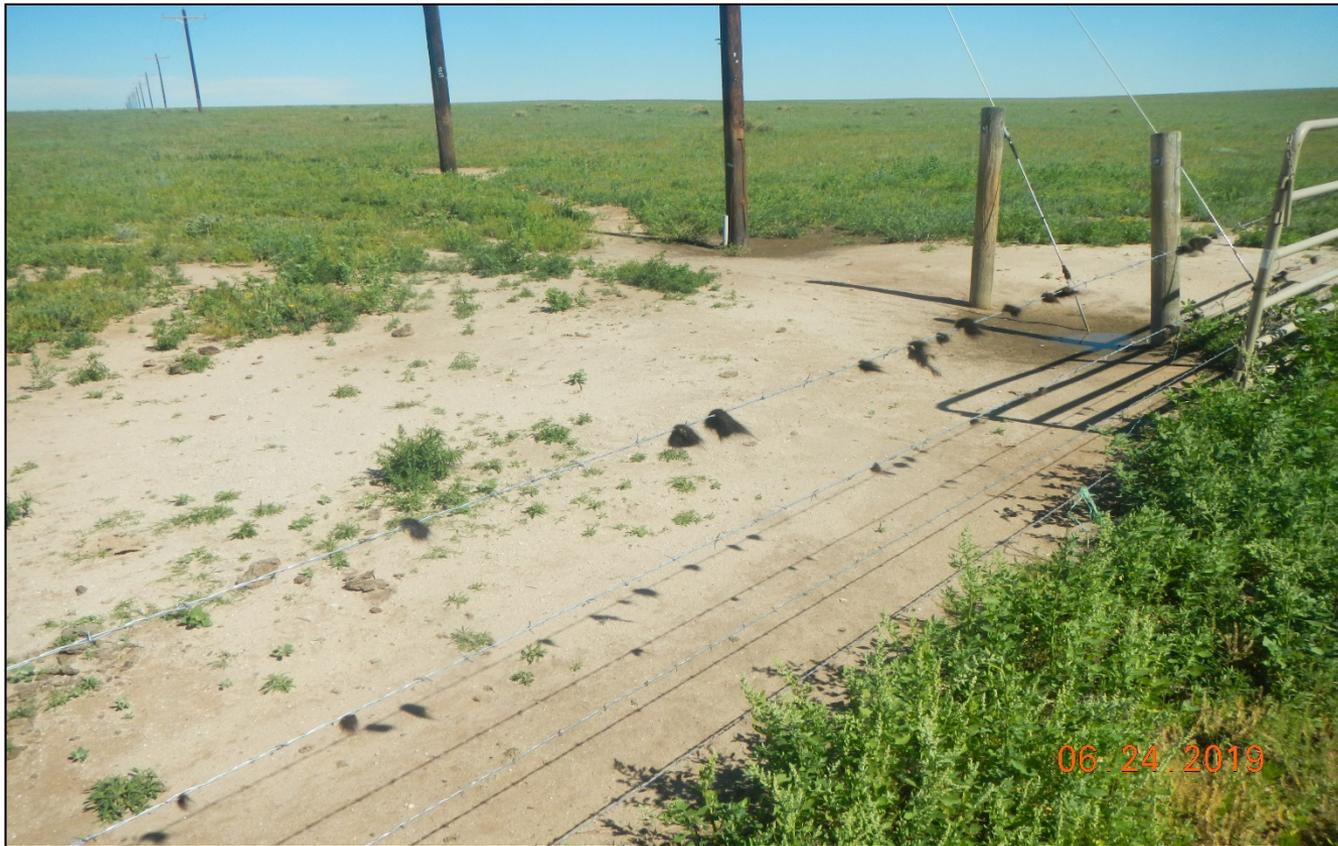
Photo 5. Northwest side of the location is bare of vegetation.

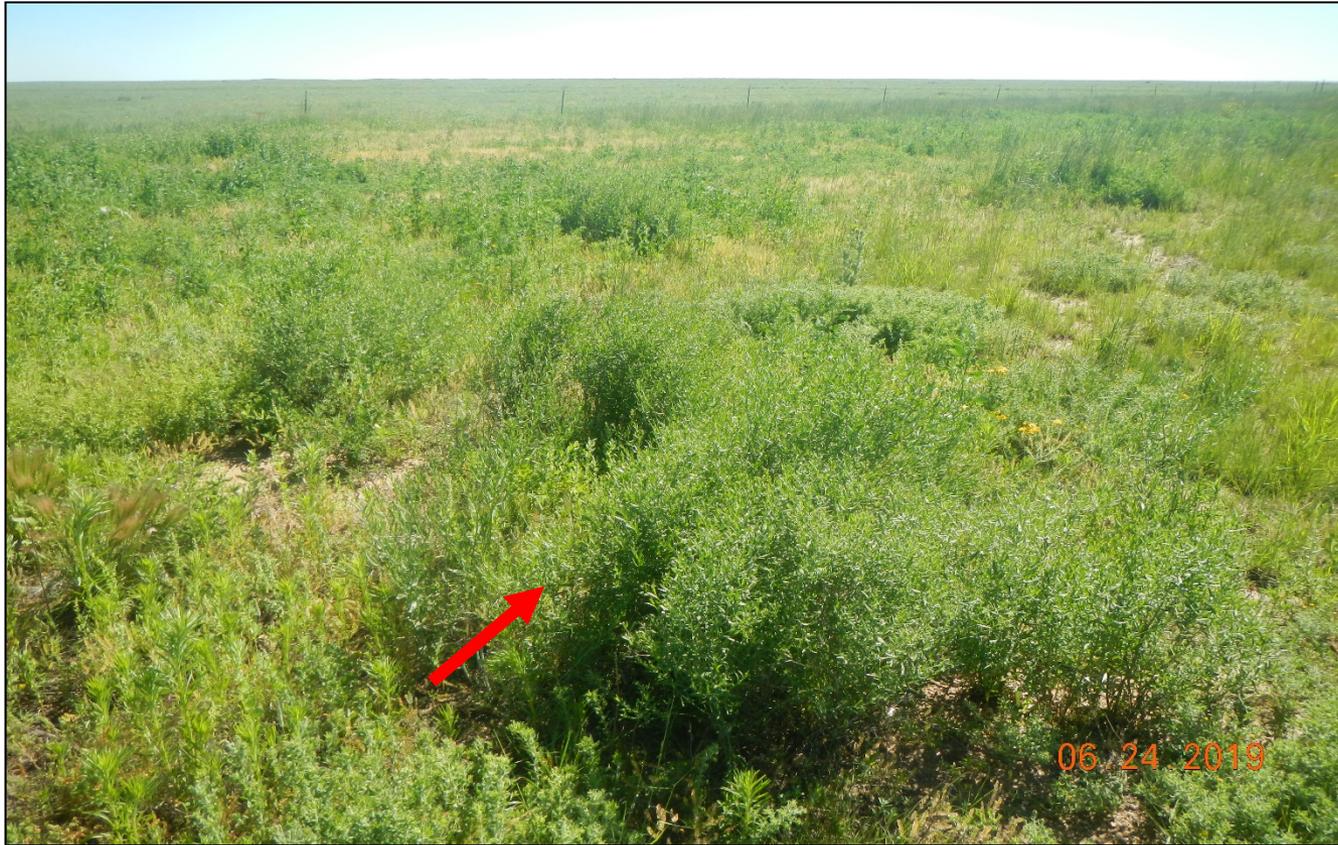
Photo 6. There is List B noxious weeds (Russian knapweed) at the west side of the location.

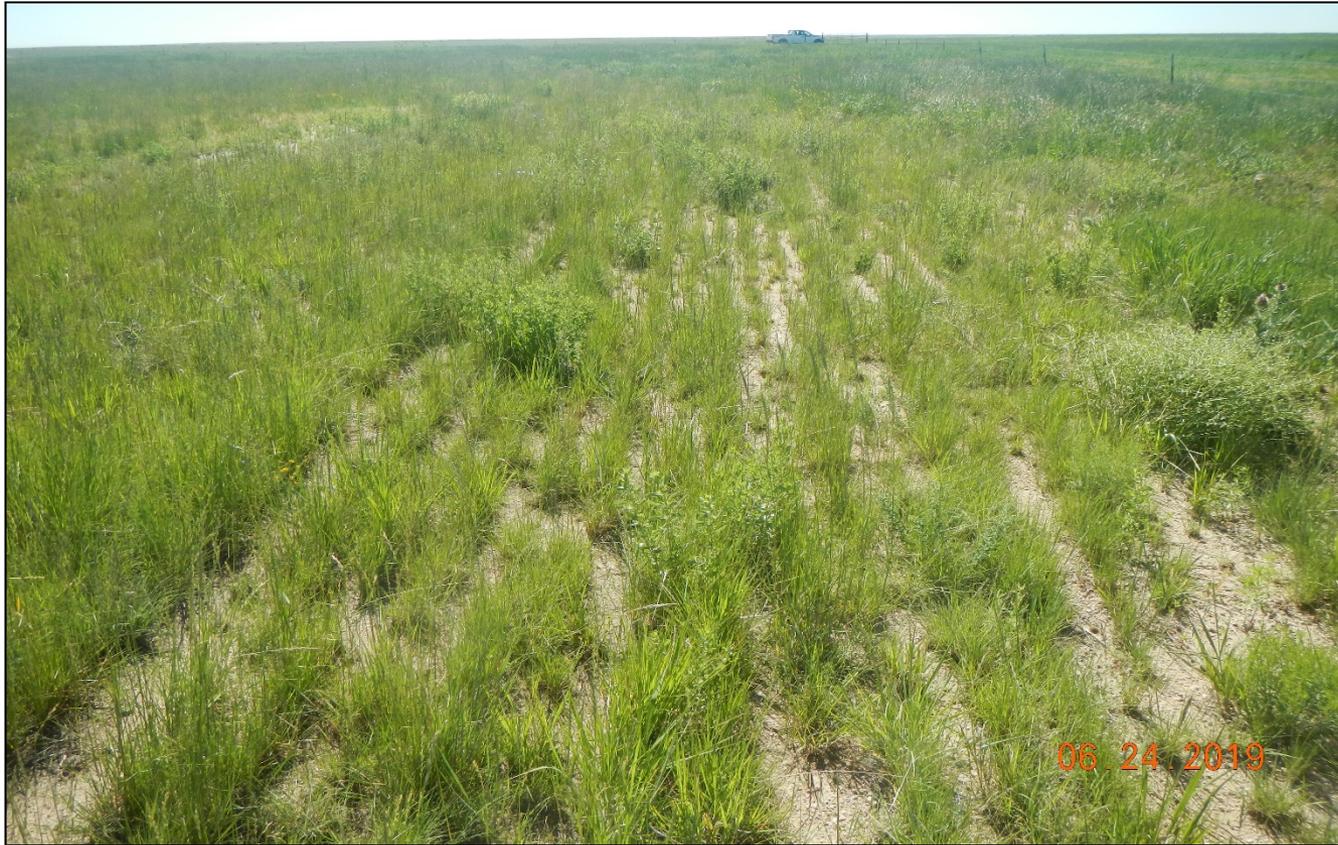
Photo 7. Facing east at the southern side of the location. Vegetation is well established in this area.
