# Inspection Photos

API: 05-071-06218

Operator: MERIDIAN OIL INC

Inspection Date: 4/18/2019

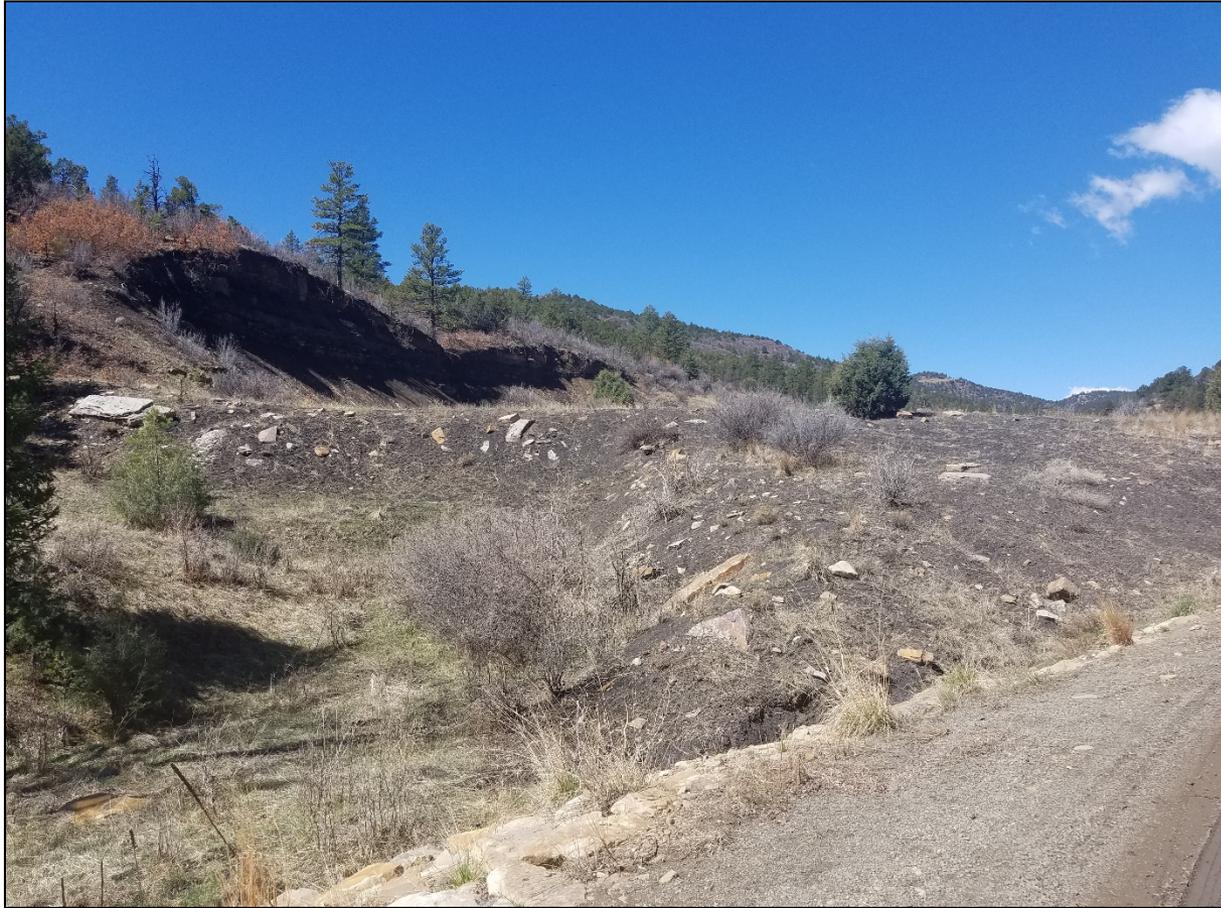
**Photo 1.** Facing west along the main road toward the location fill slope.

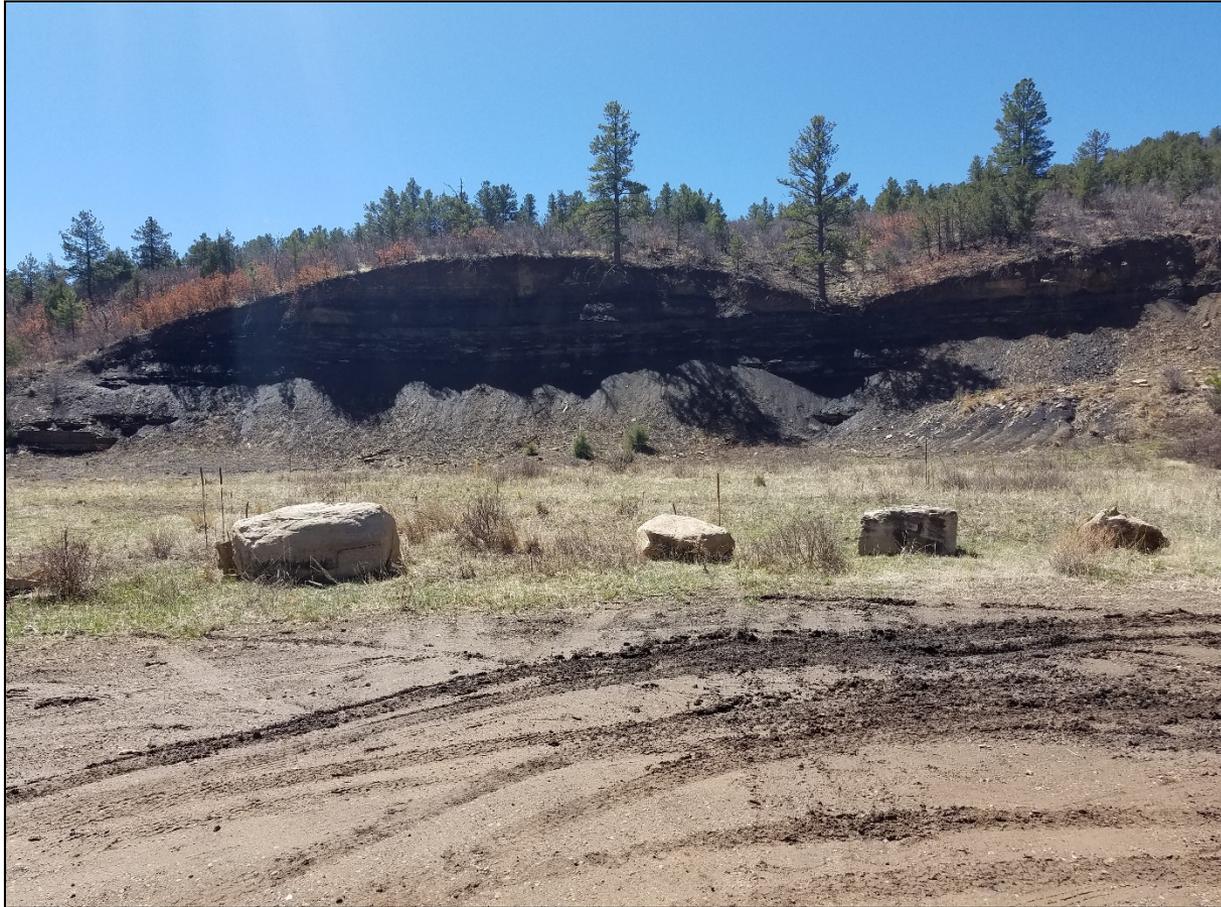
**Photo 2.** From the main road facing south toward the location.

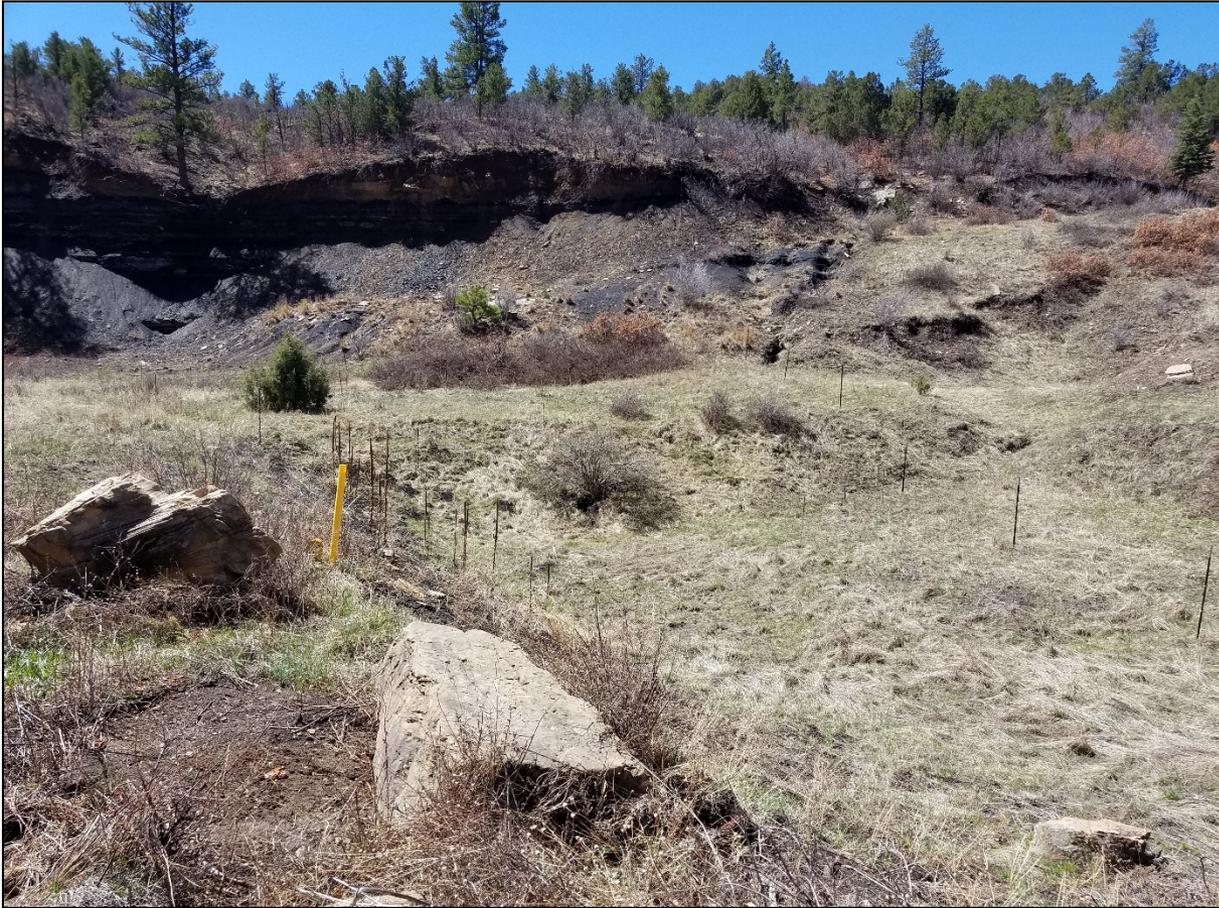
**Photo 3.** Facing southwest at the location.

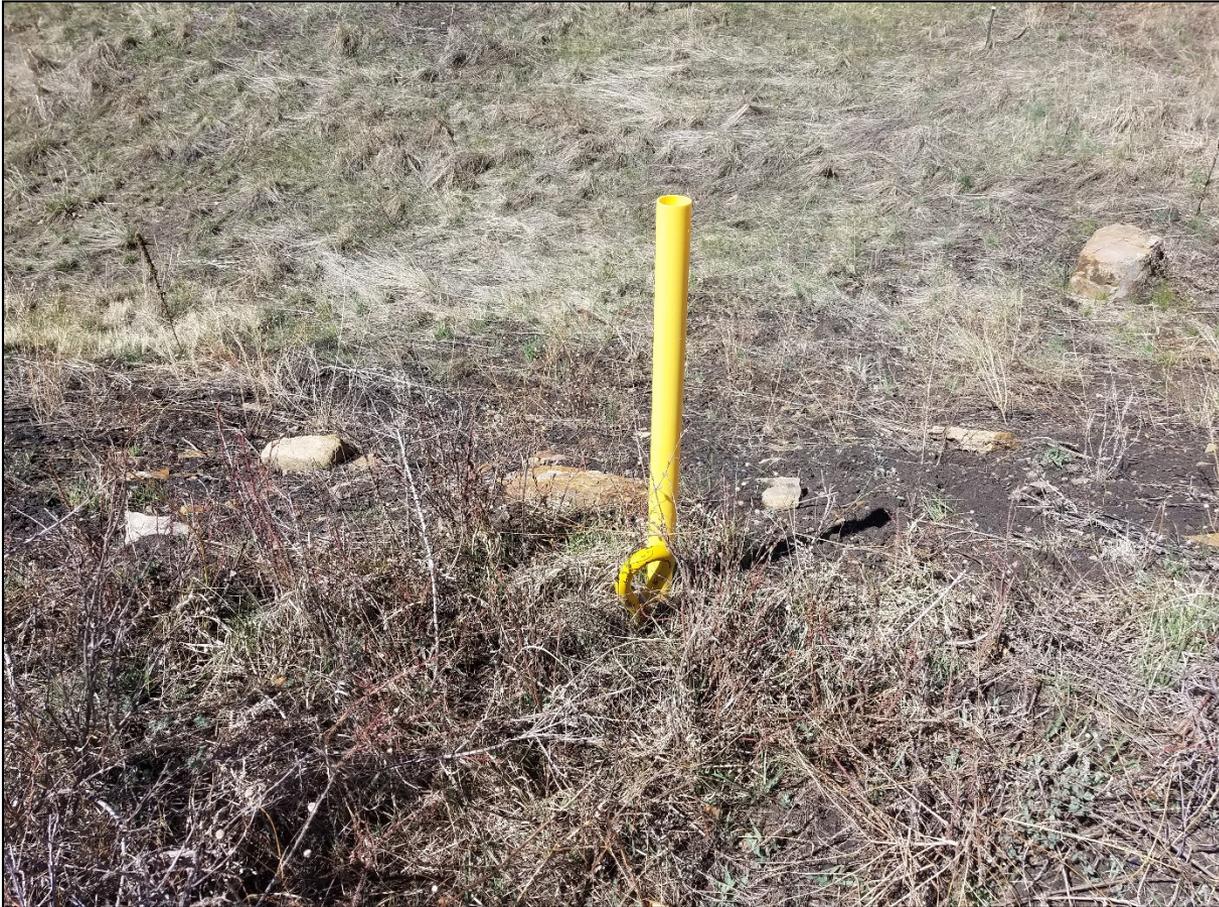
**Photo 4.** There are four guy-line anchors that remain at the location.

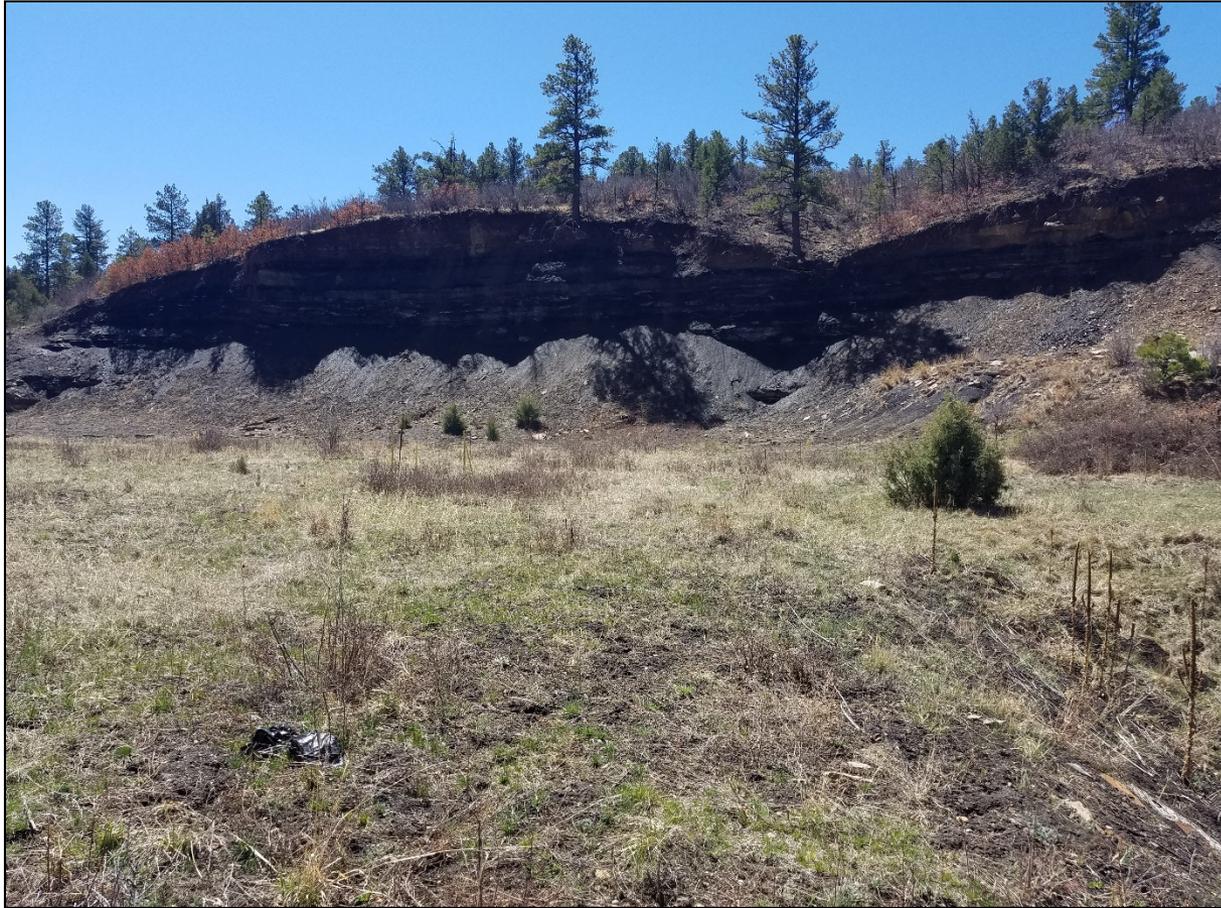
**Photo 5.** Facing toward the cut slope.

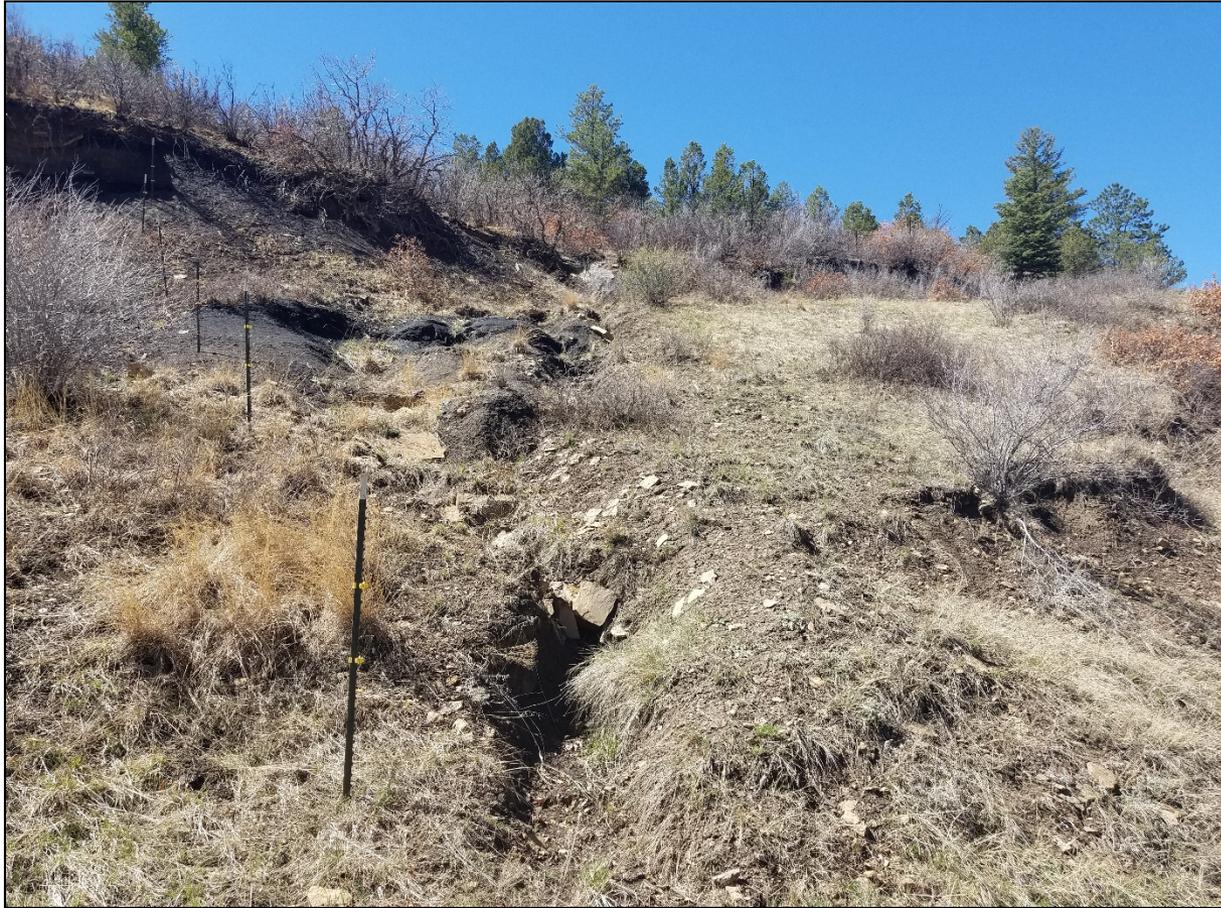
**Photo 6.** There is an erosion channel at the southwest cutslope.

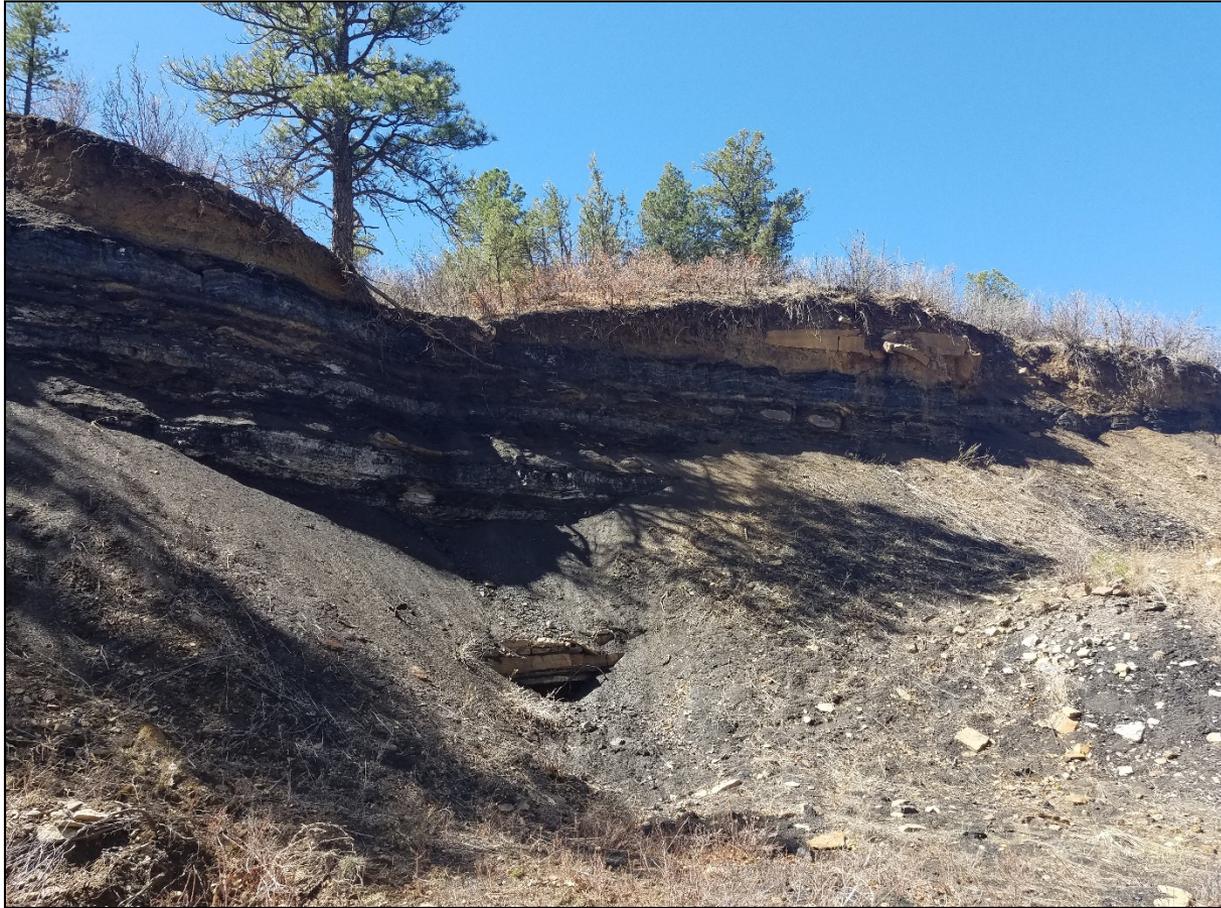
**Photo 7.** The unstable cut slope is estimated to be 100 ft. high.

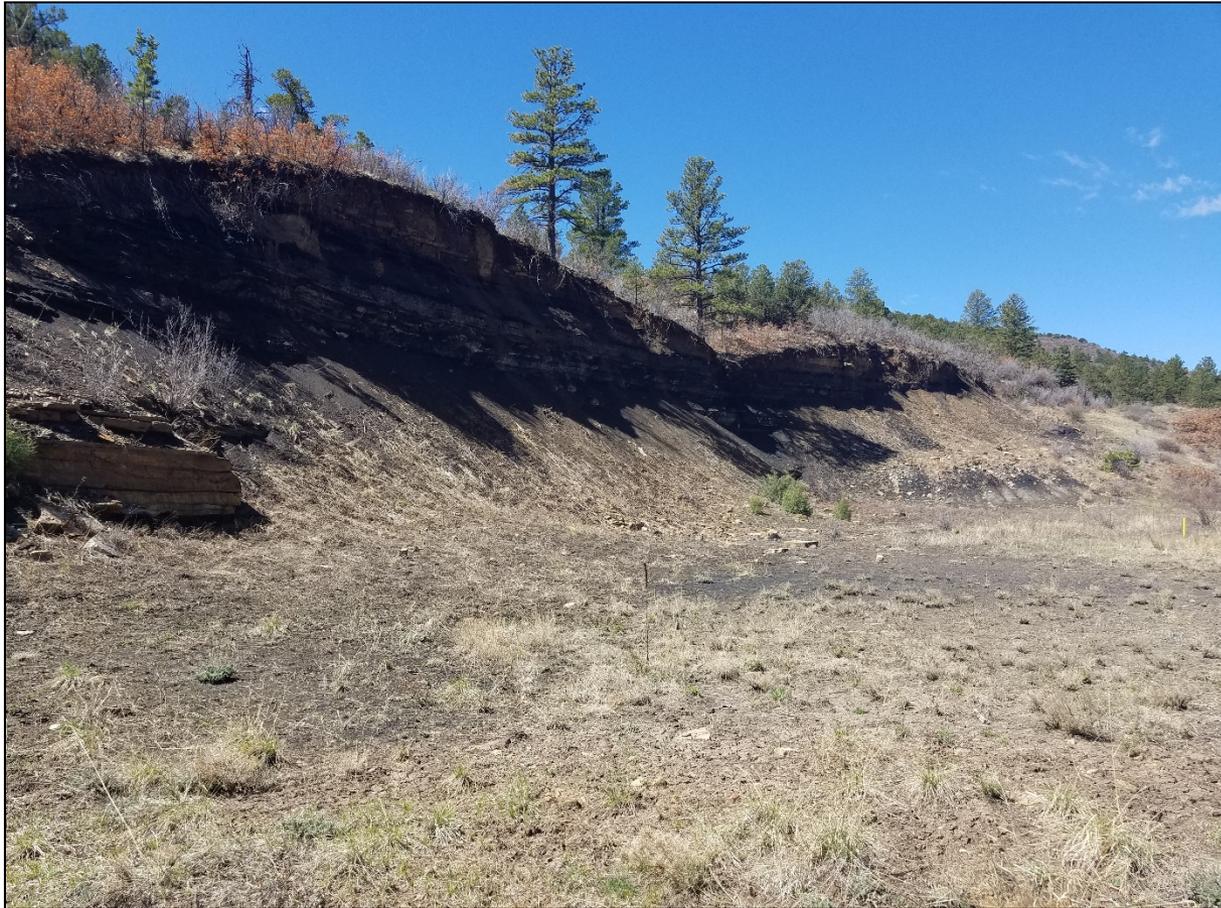
**Photo 8.** Facing toward the cut slope.

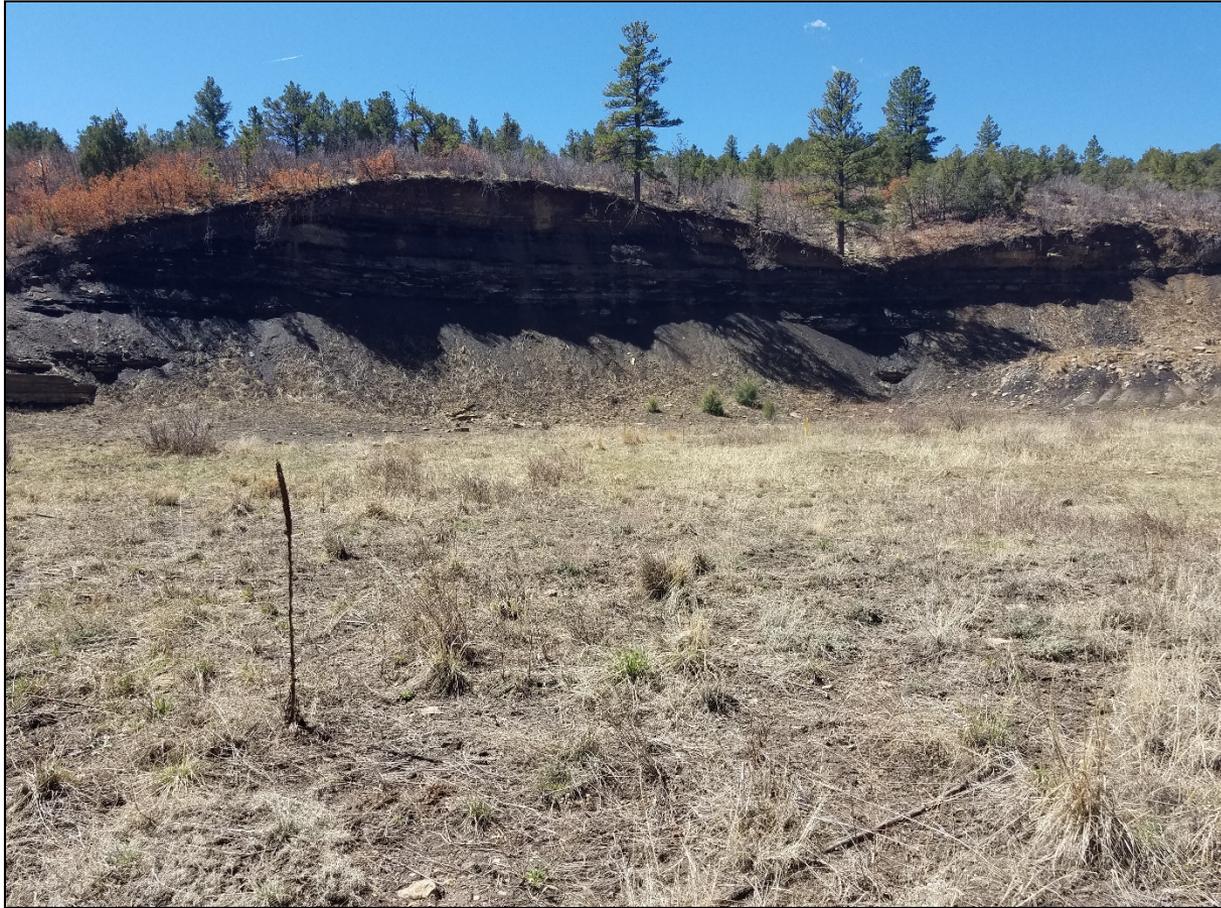
**Photo 9.** Facing south toward the cut slope.
