# Inspection Photos

API: 05-071-06218

Operator: MERIDIAN OIL INC

Inspection Date: 7/1/2019

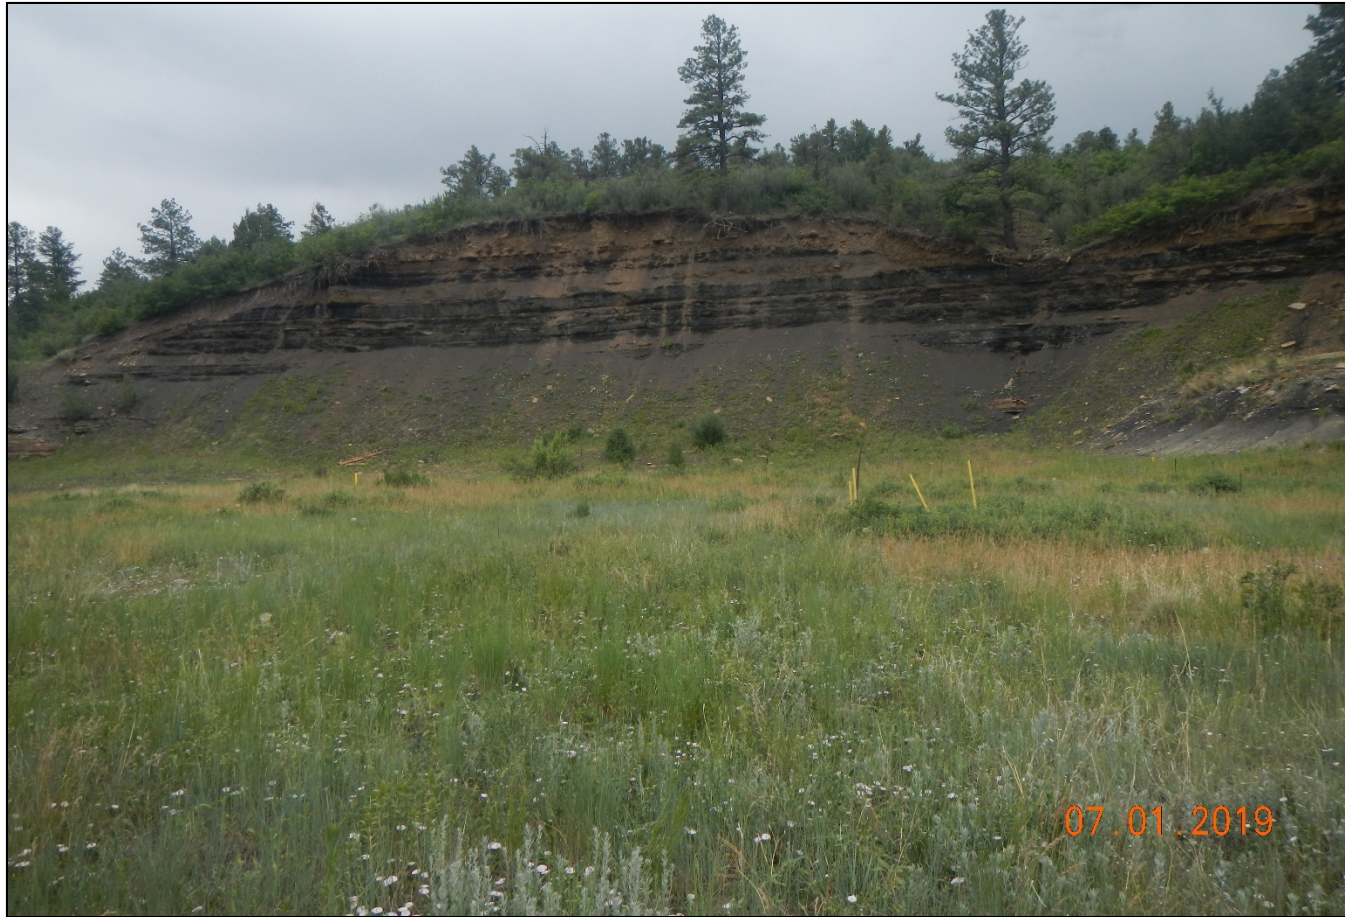
**Photo 1.** From the main road facing south toward the location. Unstable cut slope remains. Location not recontoured.

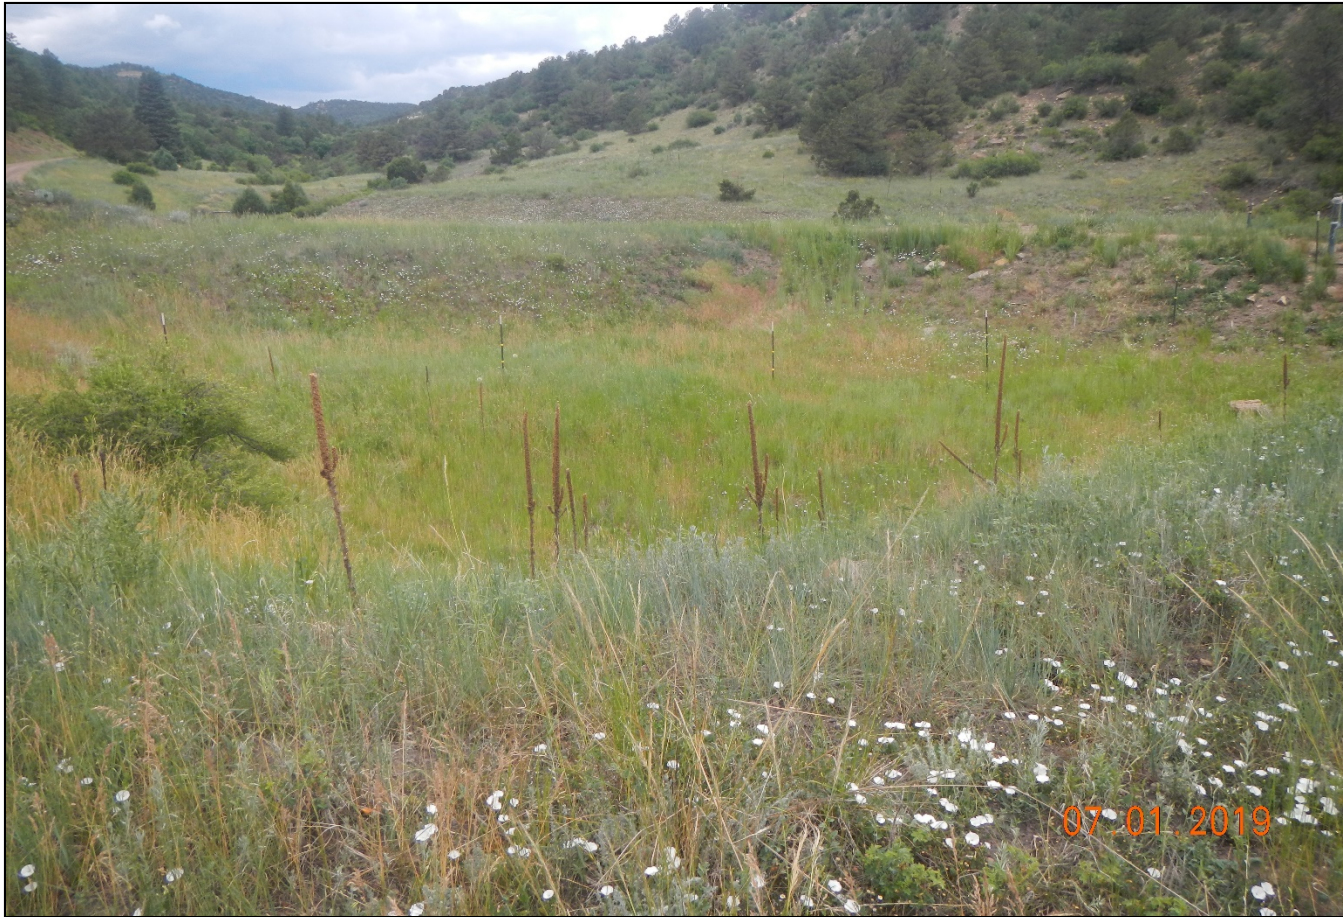
**Photo 2.** There is a pit at the west side of the location.

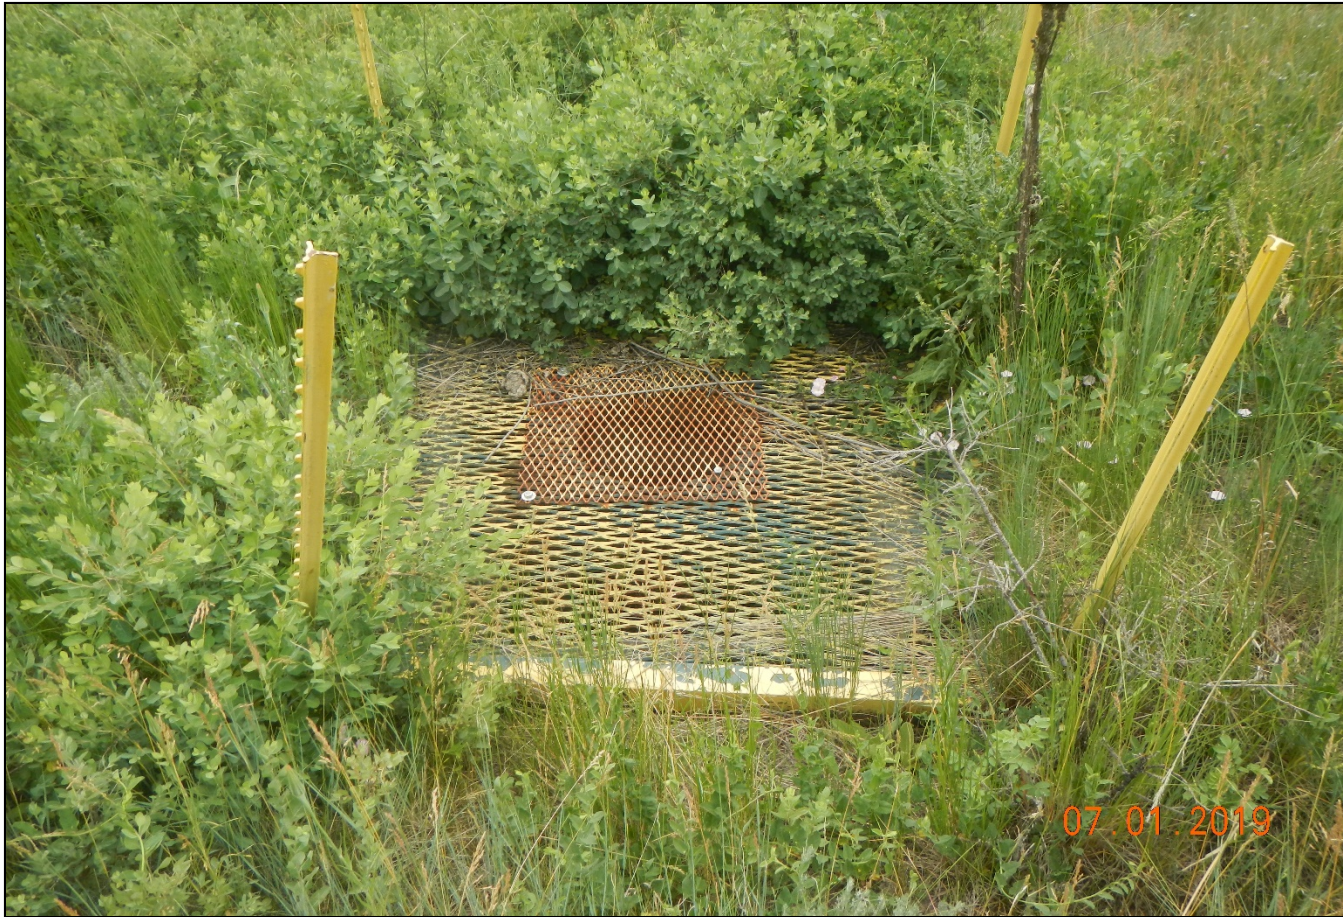
**Photo 4.** There is a hole with steel grate at center of location. Did not see conductor or casing in the hole.

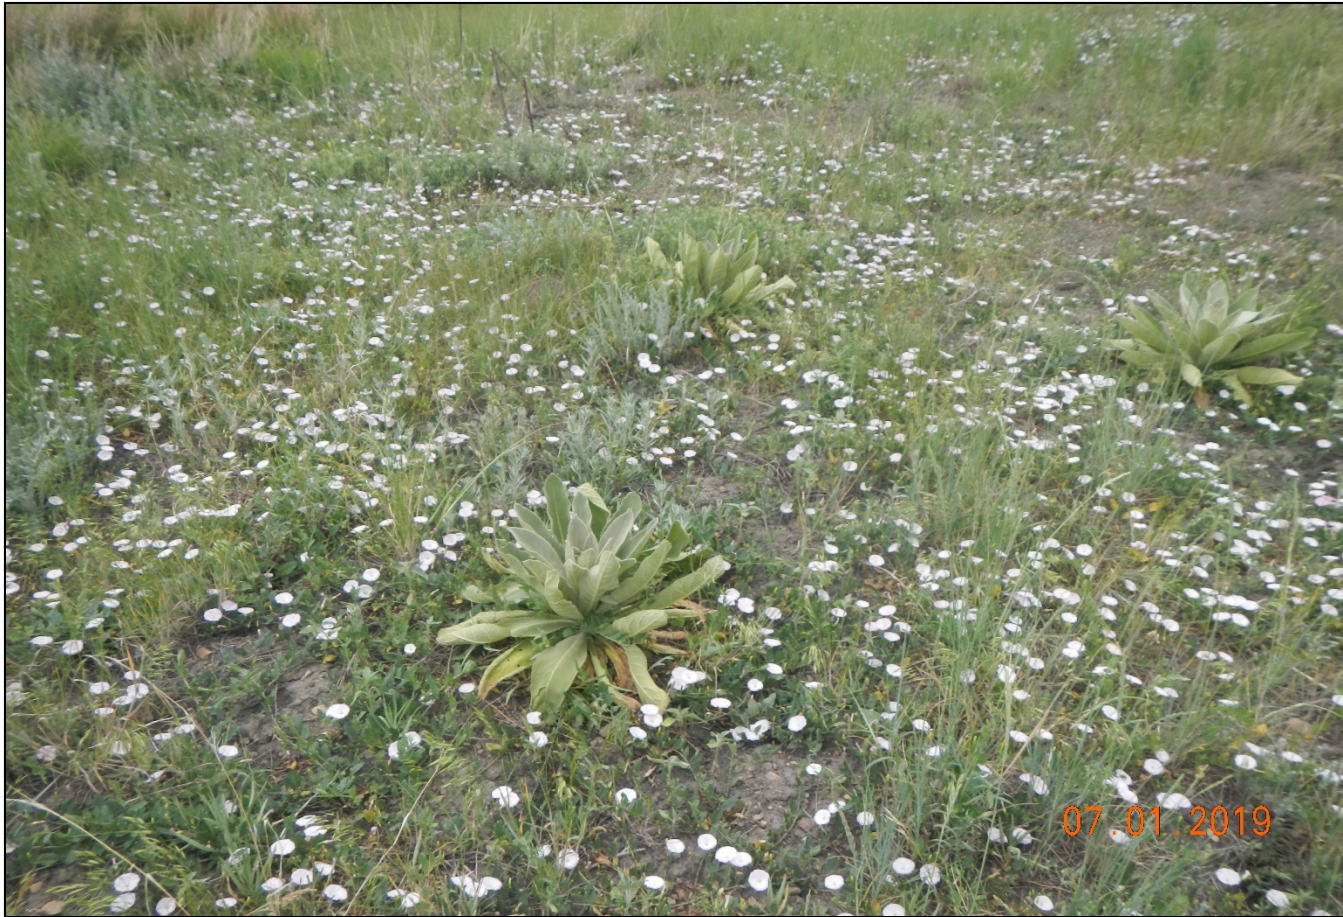
**Photo 5.** There are numerous noxious weeds throughout the site. Shown in photo is Common mullein and Field bindweed.

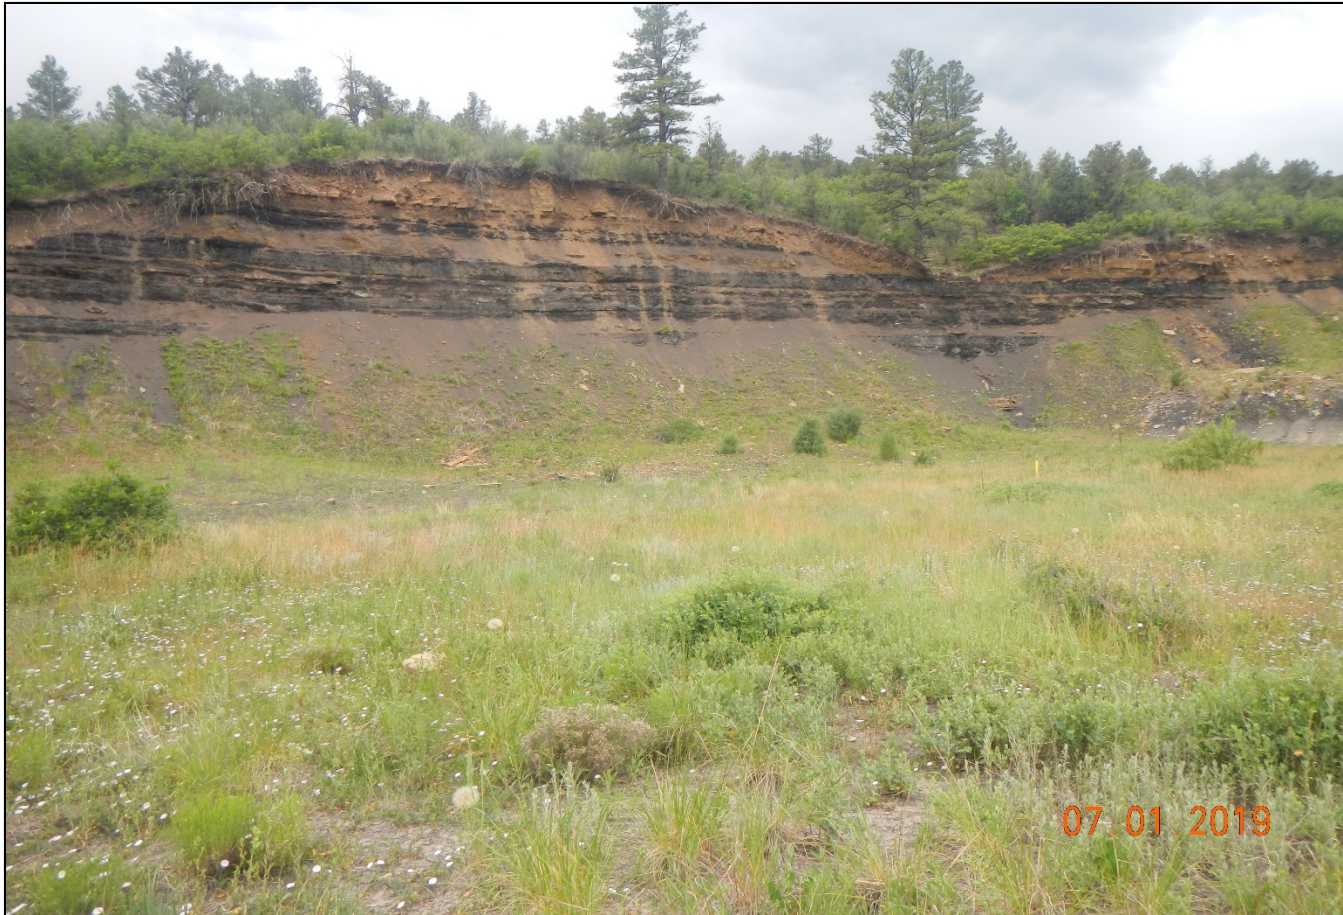
**Photo 6.** Facing toward the cutslope. The unstable cut slope is estimated to be 100 ft. high.

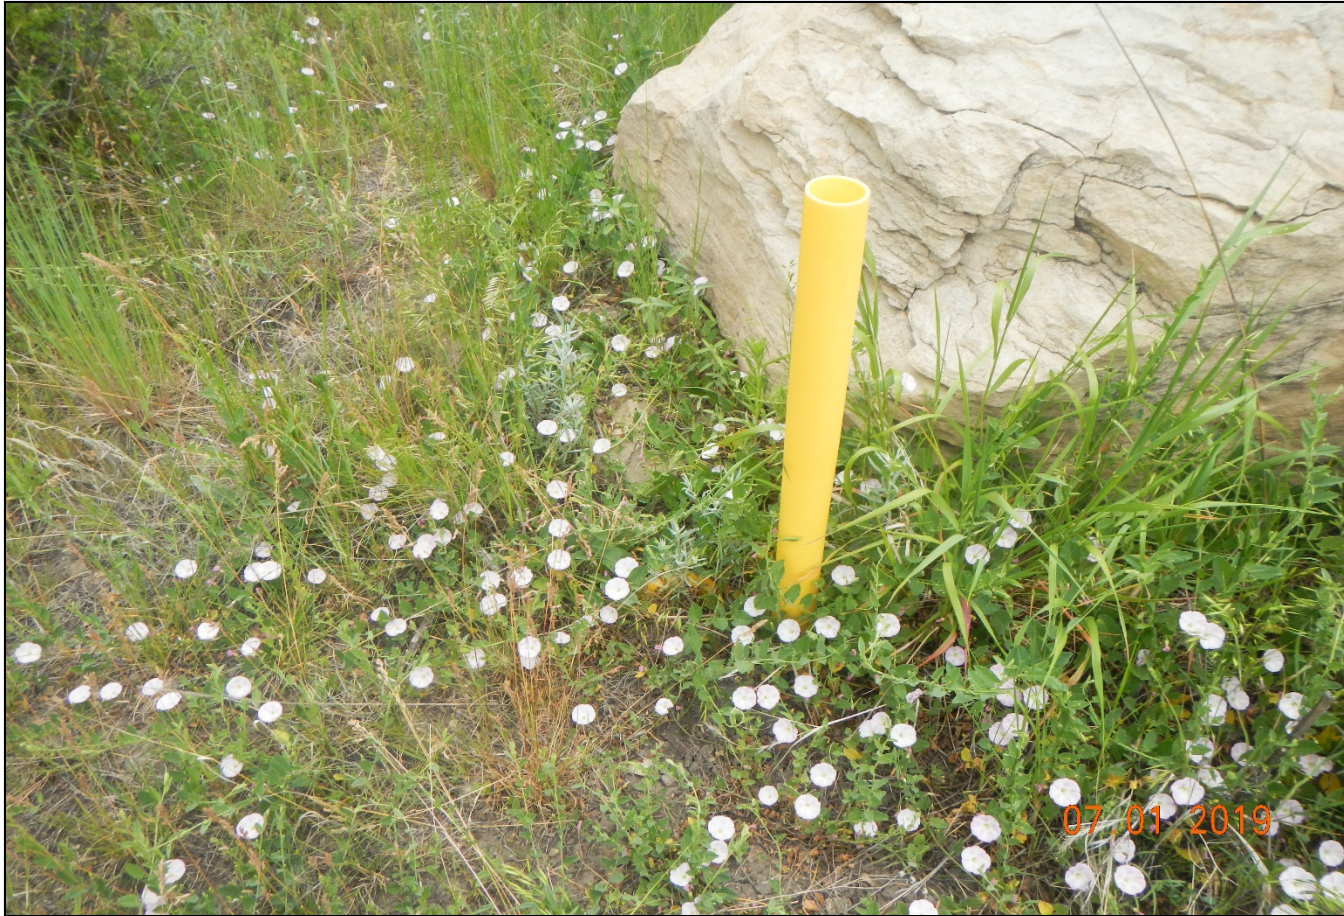
**Photo 7.** There are four guyline anchors that remain at the location.
