Inspection Photos

API: 05-055-06316

Operator: OXY USA INC

Inspection Date: 8/1/2019

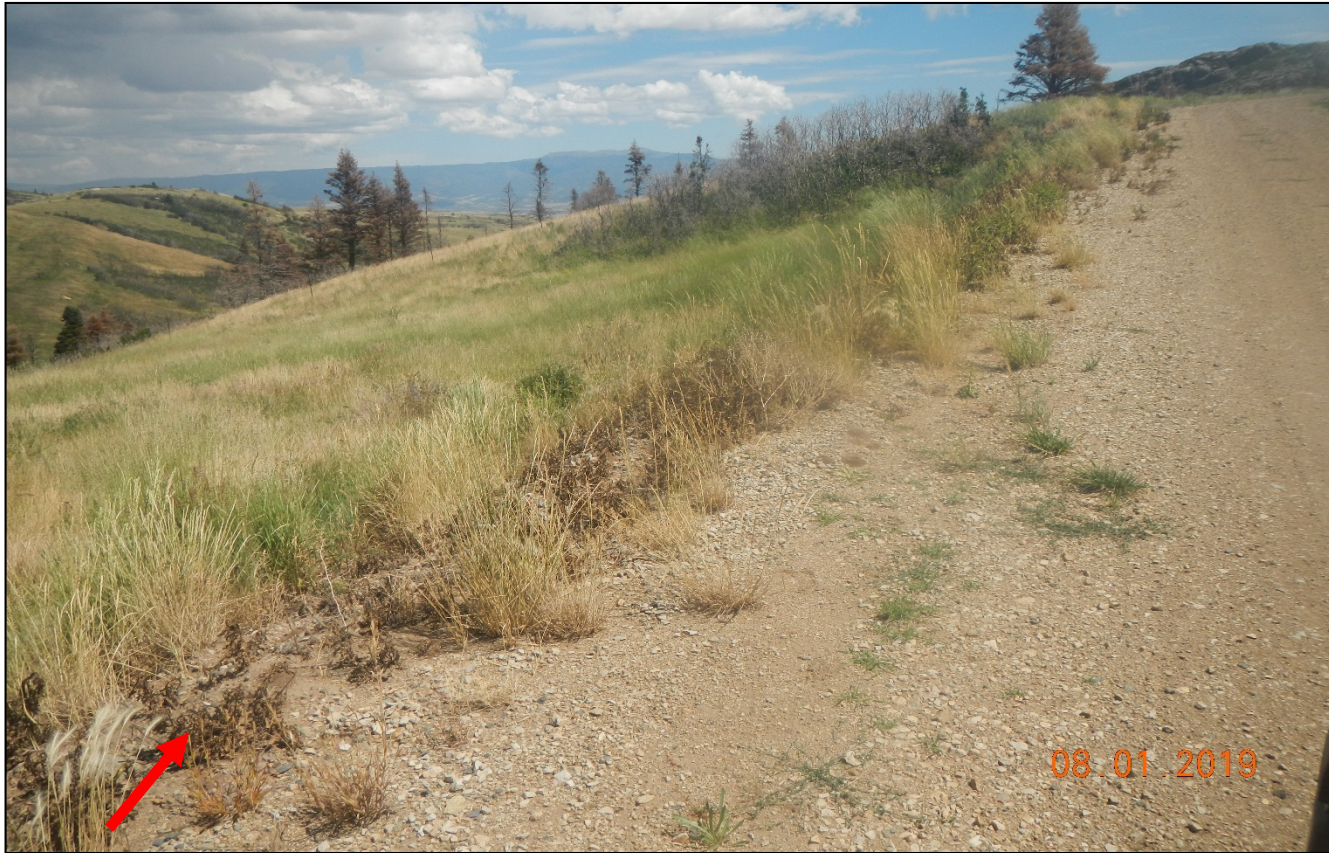
Photo 1. Facing east along the main access road. There are some noxious weeds along the road that are wilting.

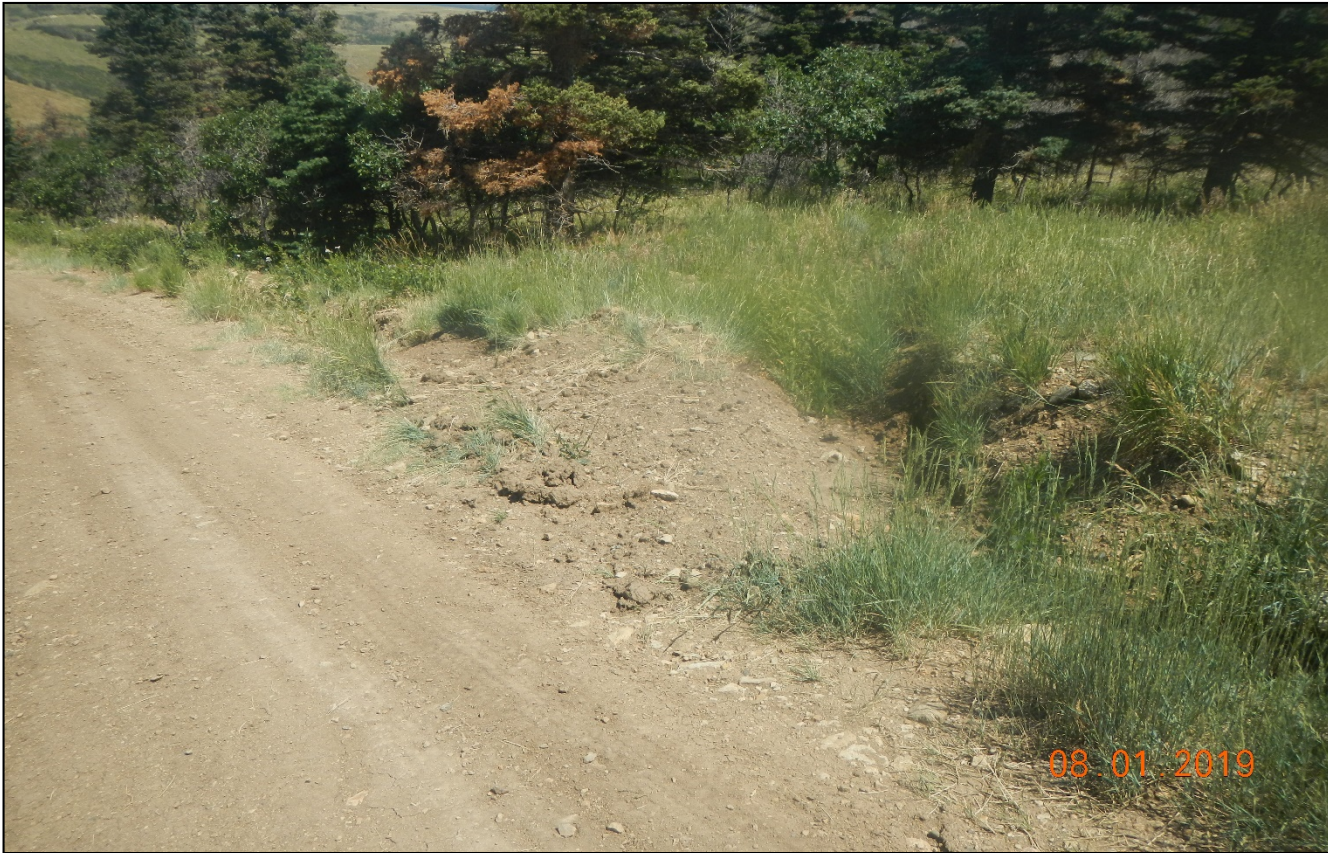
Photo 2. The road was graded and rock wattle damns were repaired. The sediment trap was cleaned out and erosion repaired.

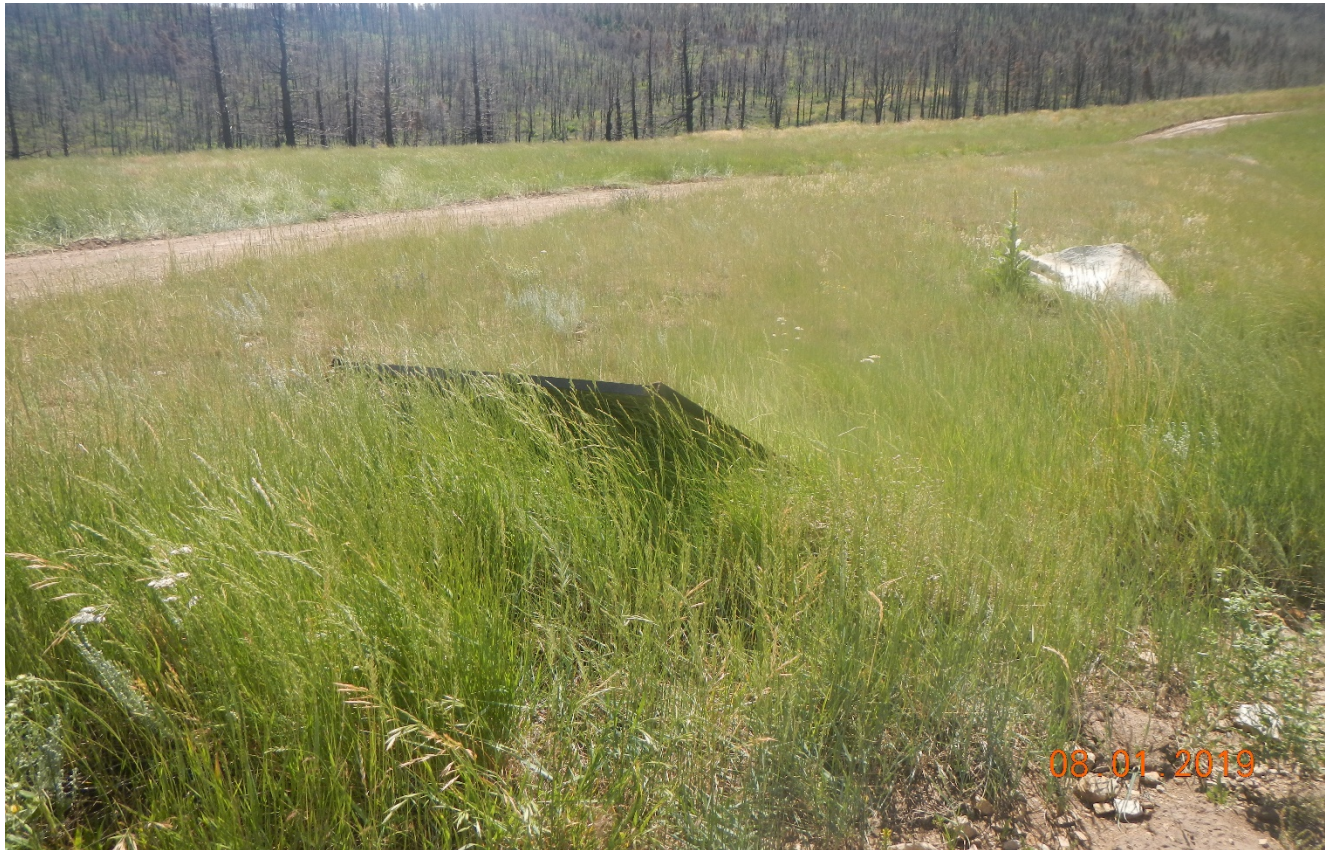
Photo 3. The well sign has fallen over. This has not been repaired since previous inspection.

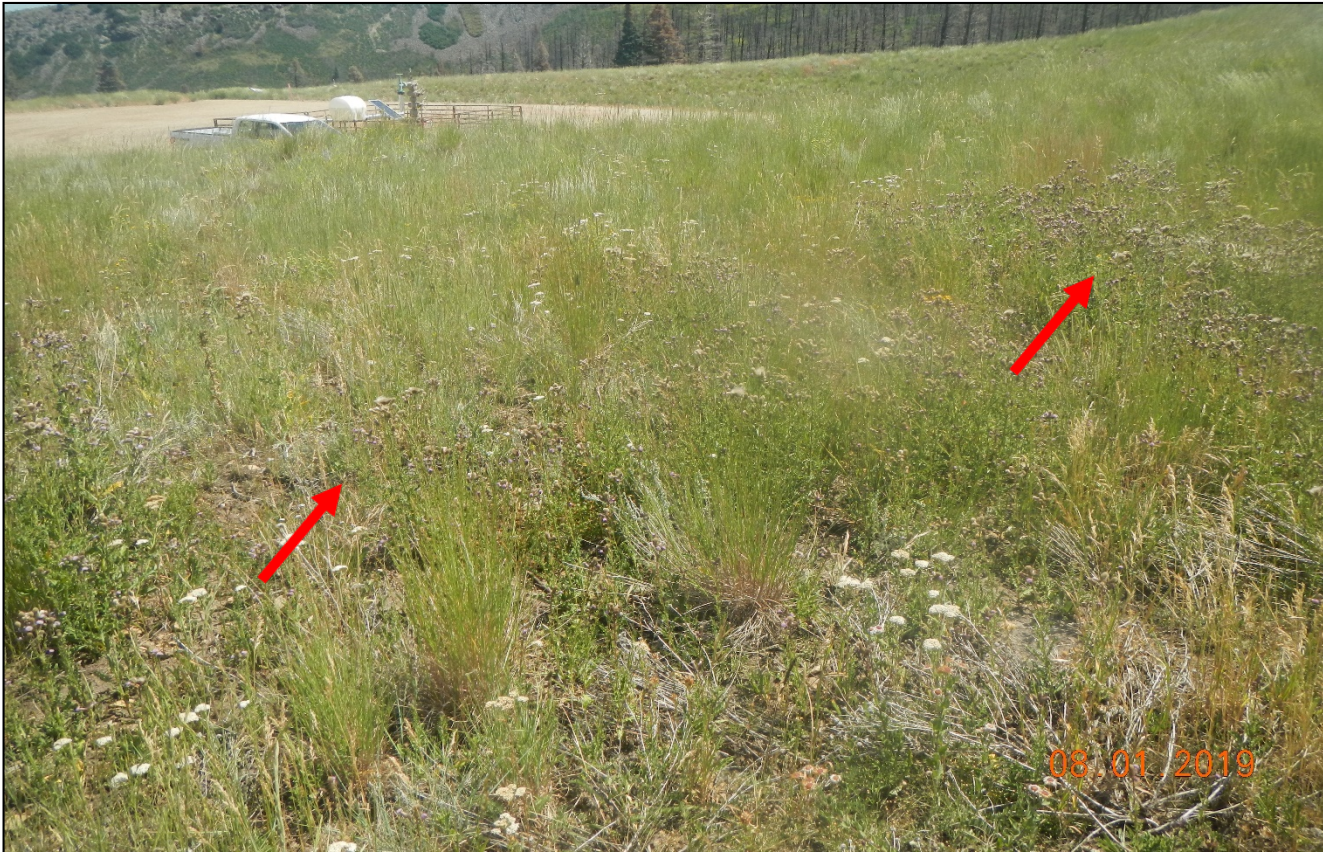
Photo 6. Facing northeast along the hill side at the location. There are numerous noxious weeds (Canada thistle) in this area that have not been controlled since previous inspection.
