# Inspection Photos

08/08/2019

Operator: FOUNDATION ENERGY  
MANAGEMENT LLC - 10112

Location ID: 447523  
Weld County, CO

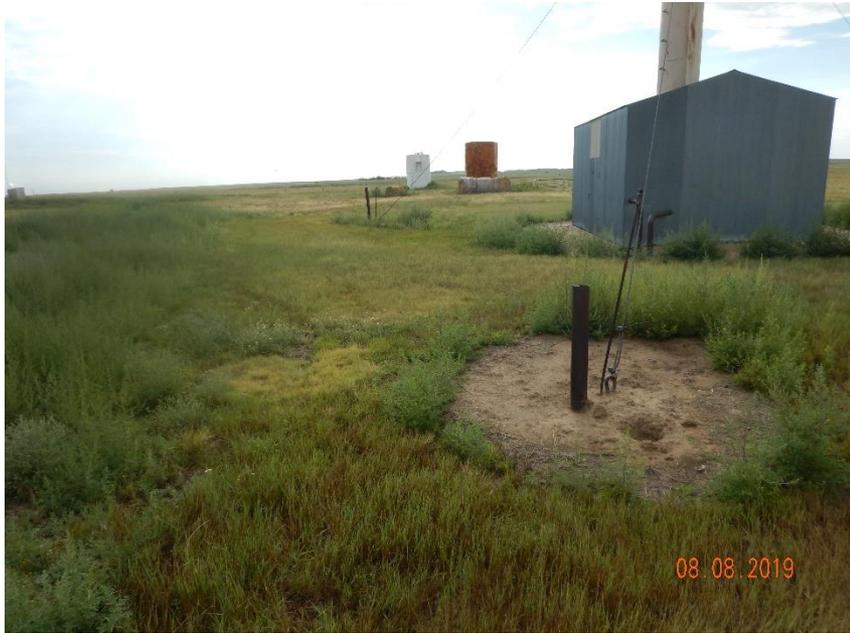
**Photo 1:** Photo taken from the southwest end of the location, facing east. Photo shows overview of the location. Photo also shows equipment/facilities remaining. Unable to find evidence of final reclamation activities.

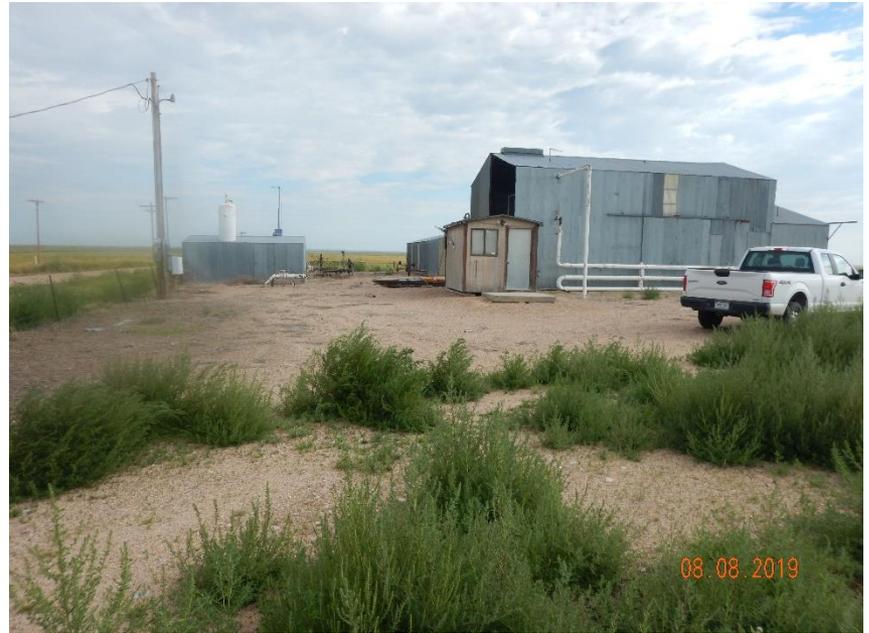
**Photo 2:** Photo taken from the southwest end of the location, facing north. Photo shows overview of the location. Photo also shows equipment/facilities remaining. Unable to find evidence of final reclamation activities.

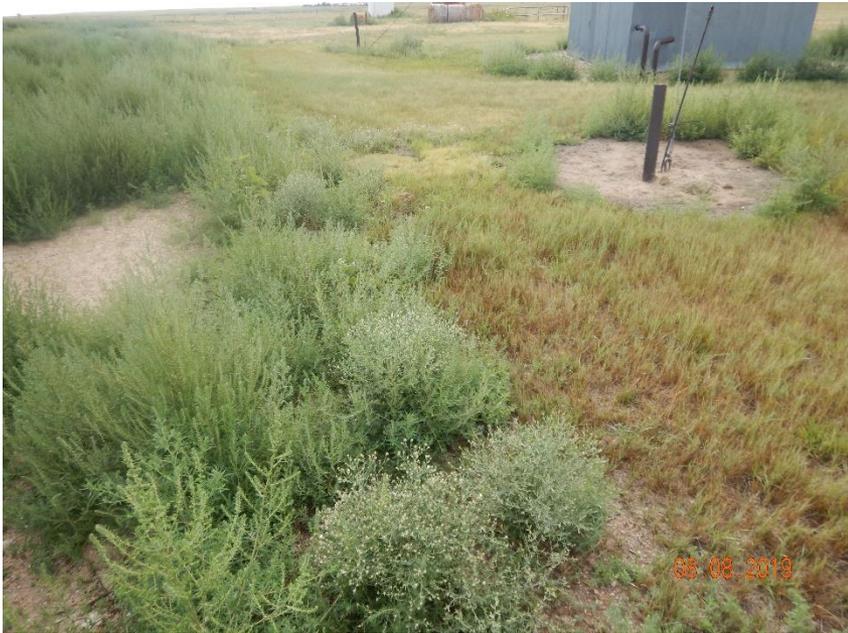
**Photo 3:** Photo taken from the southwest end of the location. Photo shows Diffuse Knapweed (Plants with white flowers in photo) remains established on the location. Sufficient and on-going weed management does not appear to be occurring.

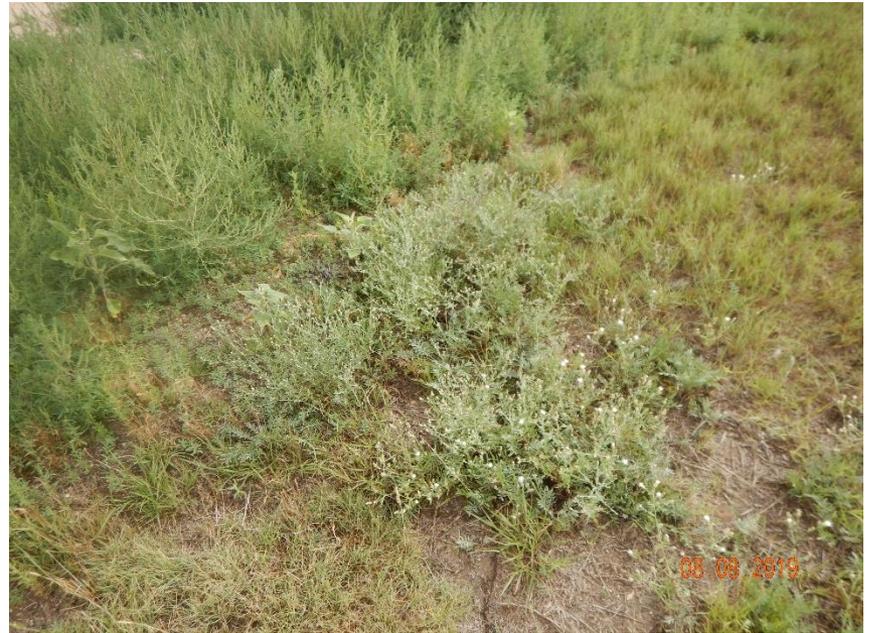
**Photo 4:** See comments under photo 3.

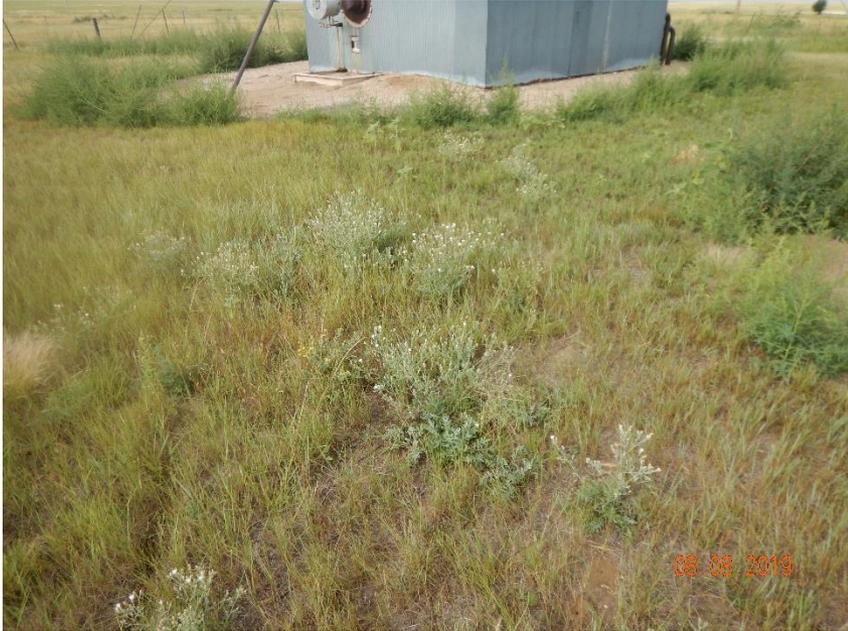
**Photo 5:** See comments under photo 3.

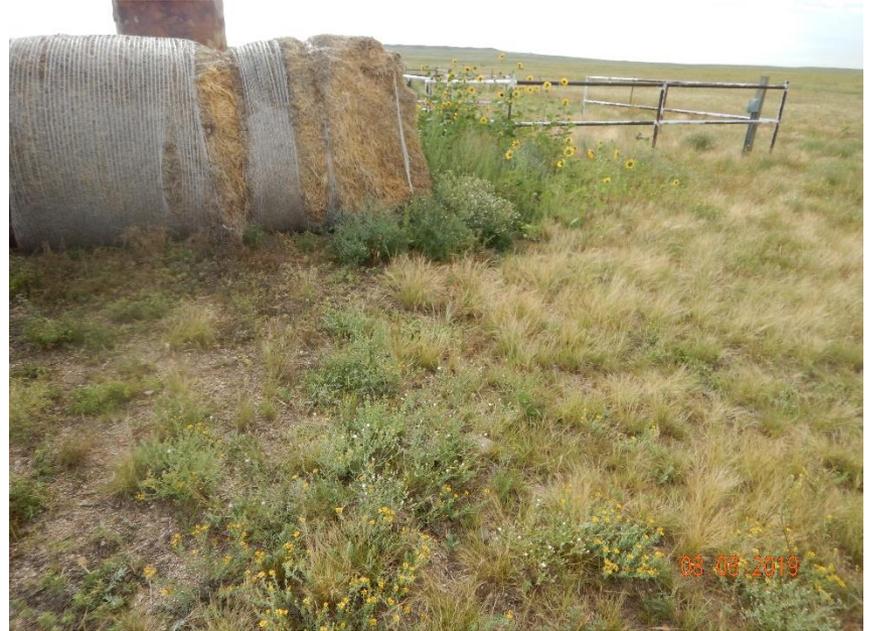
**Photo 6:** Photo taken from the south end of the location, facing east. Photo shows equipment/facilities remaining, and Diffuse Knapweed (Plants with white flowers in photo) remains established on the location

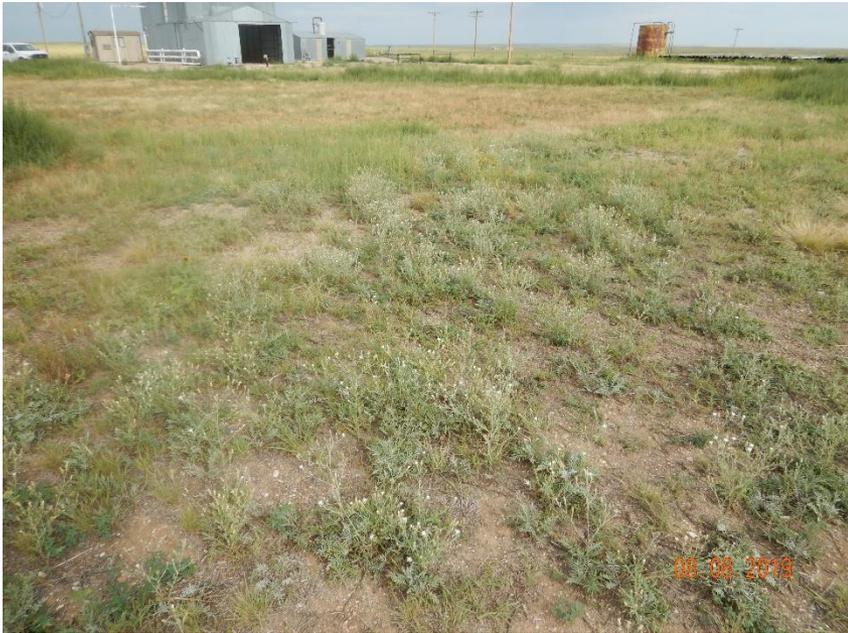
**Photo 7:** Photo taken from the east end of the location , facing west. Photo shows equipment/facilities remaining, and Diffuse Knapweed (Plants with white flowers in photo) remains established on the location

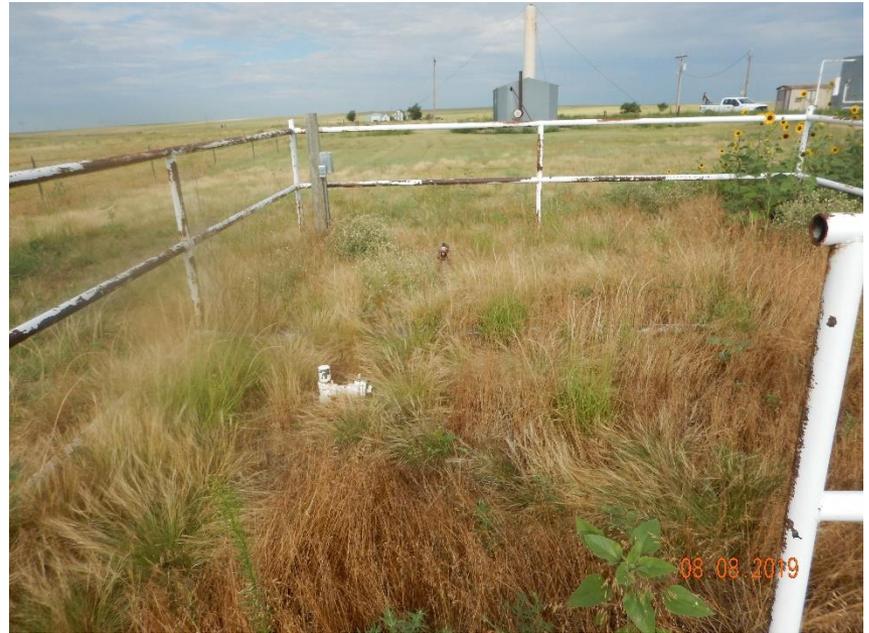
**Photo 8:** Photo taken from the south end of the location, facing west. Photo of risers/equipment remaining on location.

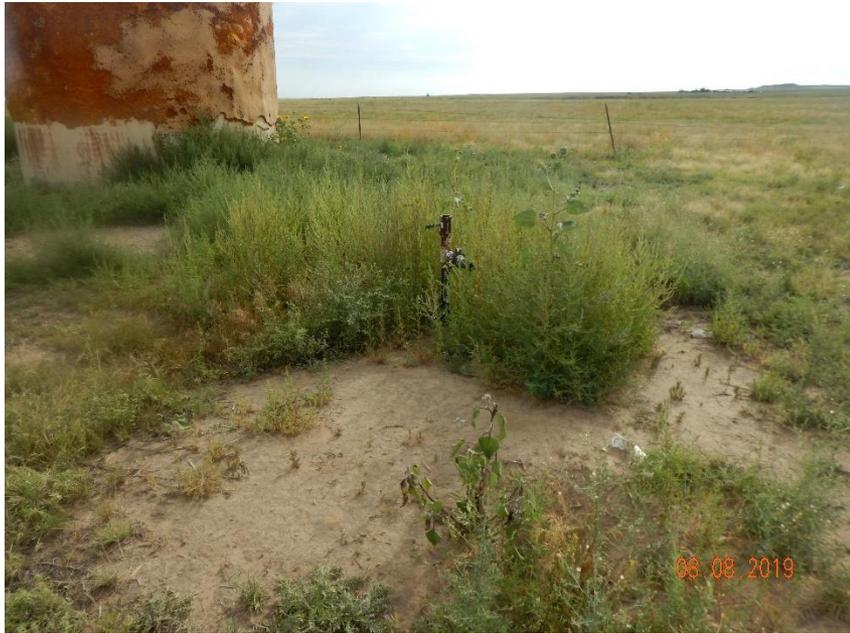
**Photo 9:** Photo taken from the south end of the location, facing east. Photo of risers/equipment remaining on location.

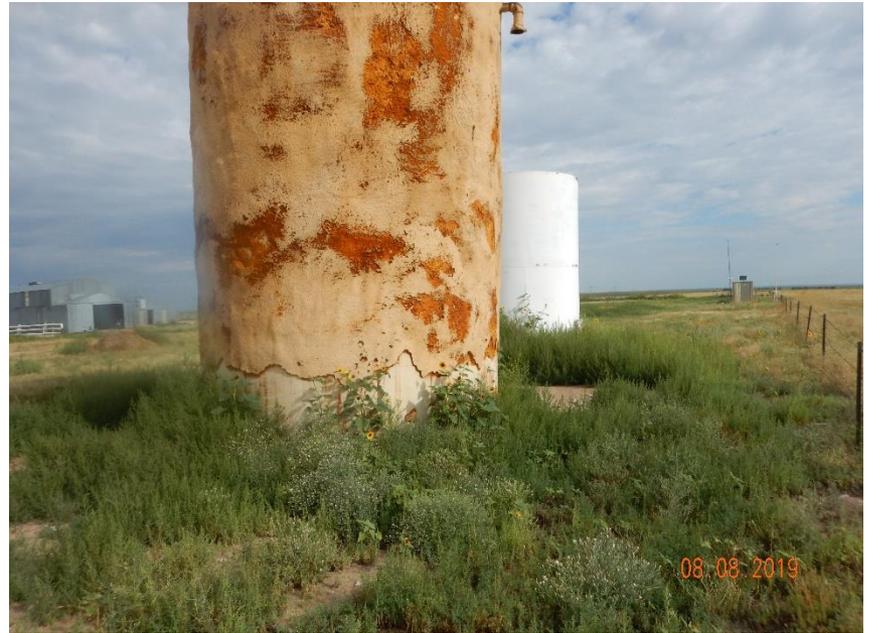
**Photo 10:** Photo taken from the south end of the location, facing north. Photo of equipment remaining on location.

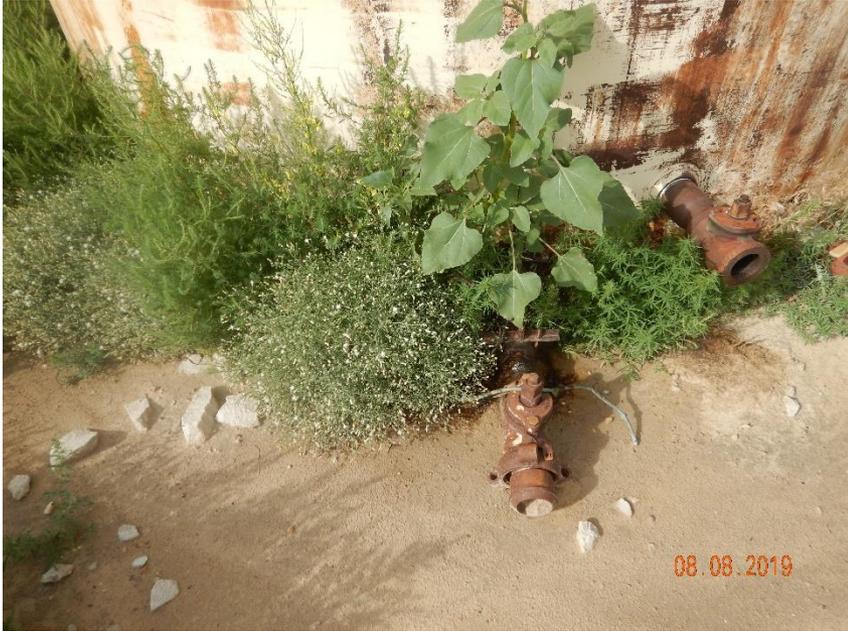
**Photo 11:** Photo taken from the tank (photo 10) on the southeast end of the location. Diffuse Knapweed (Plants with white flowers in photo) remains established on the location. Photo also shows stained soil due to chemical discharge from the tank

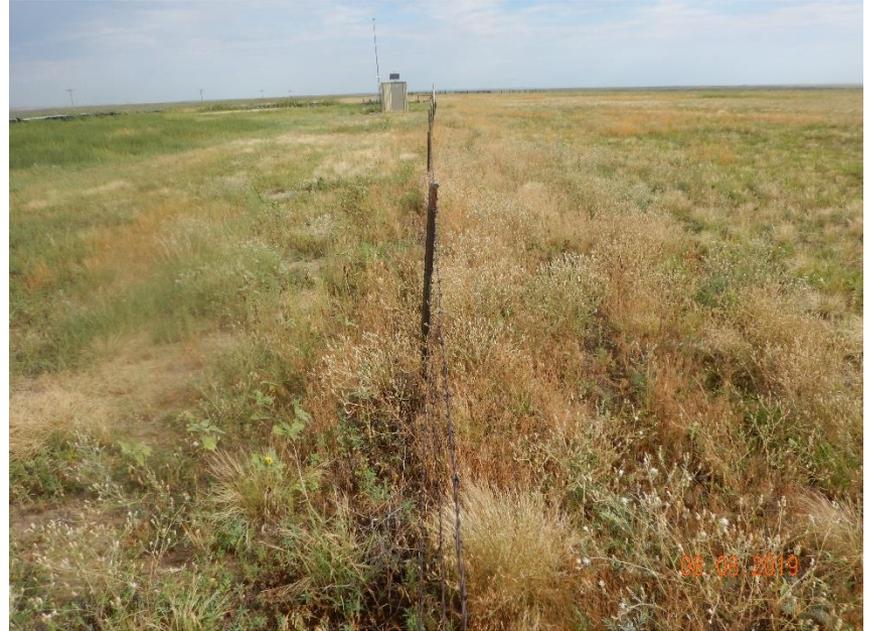
**Photo 12:** Photo taken from the perimeter fence line on the east end of the location. Photo shows Diffuse Knapweed has continued to establish on the location (left of fence) and has continued to spread onto the adjacent lands (right). Operator has failed to conduct sufficient and on going weed management on location and adjacent lands.

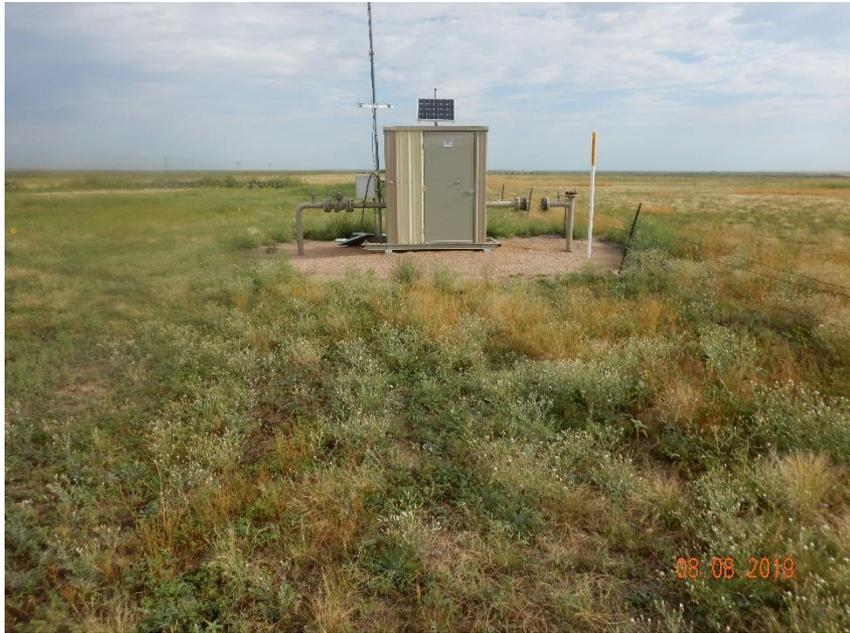
**Photo 13:** Photo taken from the east end of the location , facing north. Photo shows equipment/facilities remaining, and Diffuse Knapweed (Plants with white flowers in photo) remains established on the location

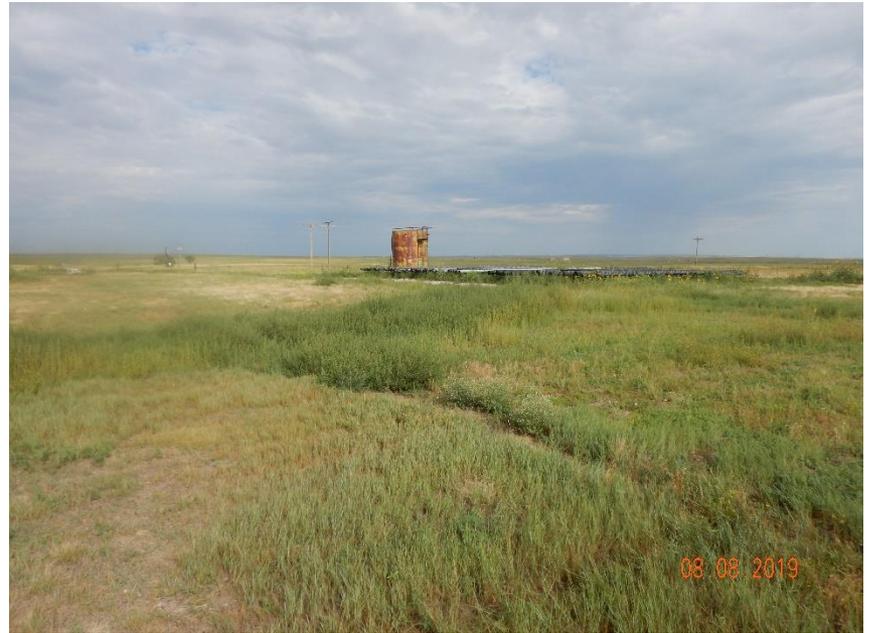
**Photo 14:** Photo taken from the east end of the location, facing northwest. Photo shows equipment/facilities remaining, and Diffuse Knapweed (Plants with white flowers in photo) remains established on the location

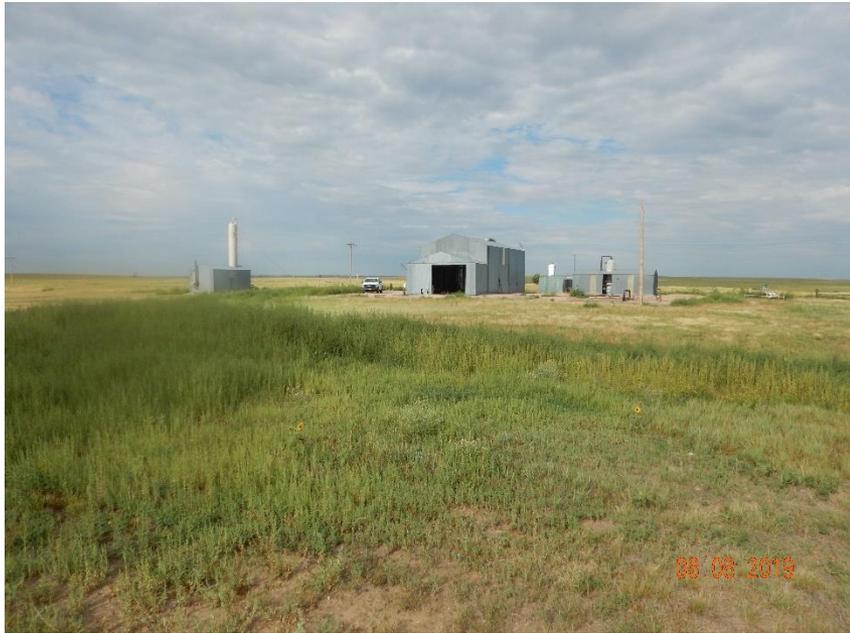
**Photo 13:** Photo taken from the east end of the location, facing west. Photo shows equipment/facilities remaining, and Diffuse Knapweed (Plants with white flowers in photo) remains established on the location

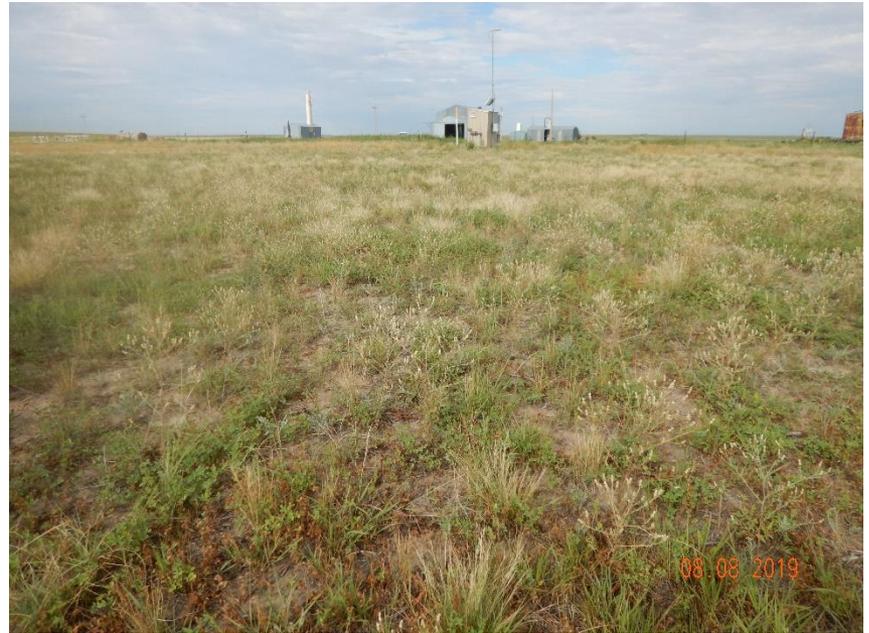
**Photo 14:** Photo taken from the adjacent lands east of the location facing southwest. Photo shows noxious weeds have not been managed and continues to spread from the location.

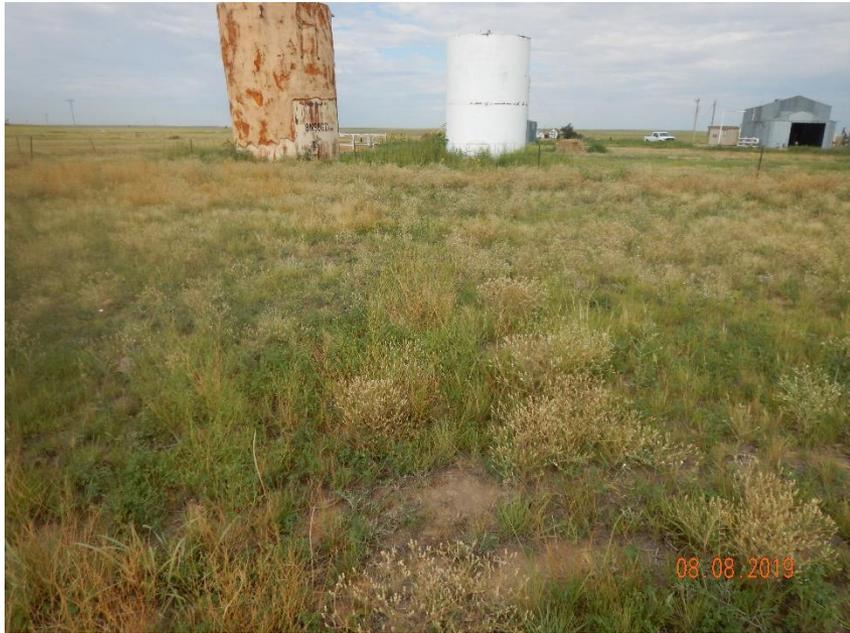
**Photo 19:** Photo taken from the adjacent lands east of the location facing west. Photo shows noxious weeds have not been managed and continues to spread from the location.

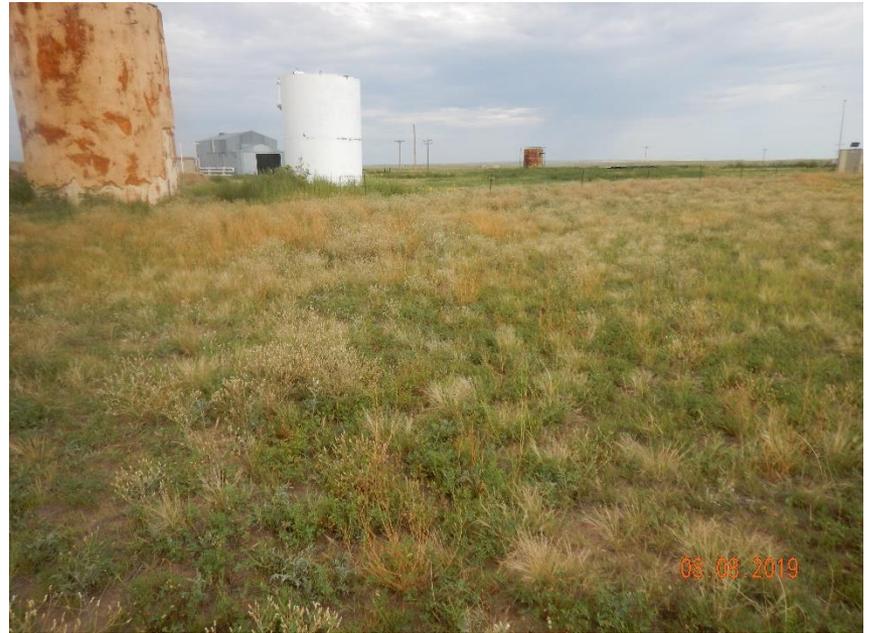
**Photo 20:** Photo taken from the adjacent lands east of the location facing northwest. Photo shows noxious weeds have not been managed and continues to spread from the location.

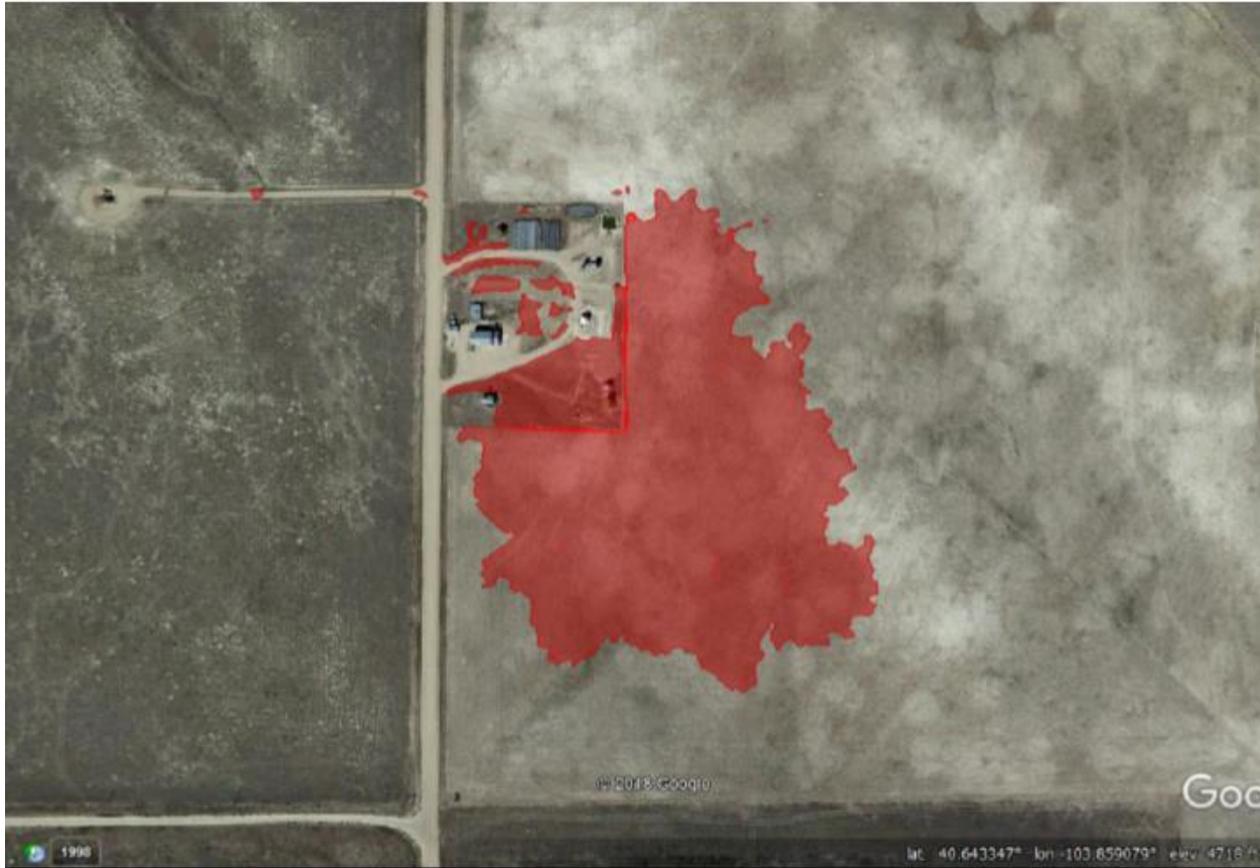
**Photo 21:** Photo from documentation within previous inspection. Photo shows areas where Diffuse Knapweed was mapped on the location and the adjacent lands. Diffuse Knapweed has continued to spread throughout the location and adjacent lands.
