Inspection Photos

Operator: Kinder Morgan
Location/API #: 083-06730
Date: 10-3-2019

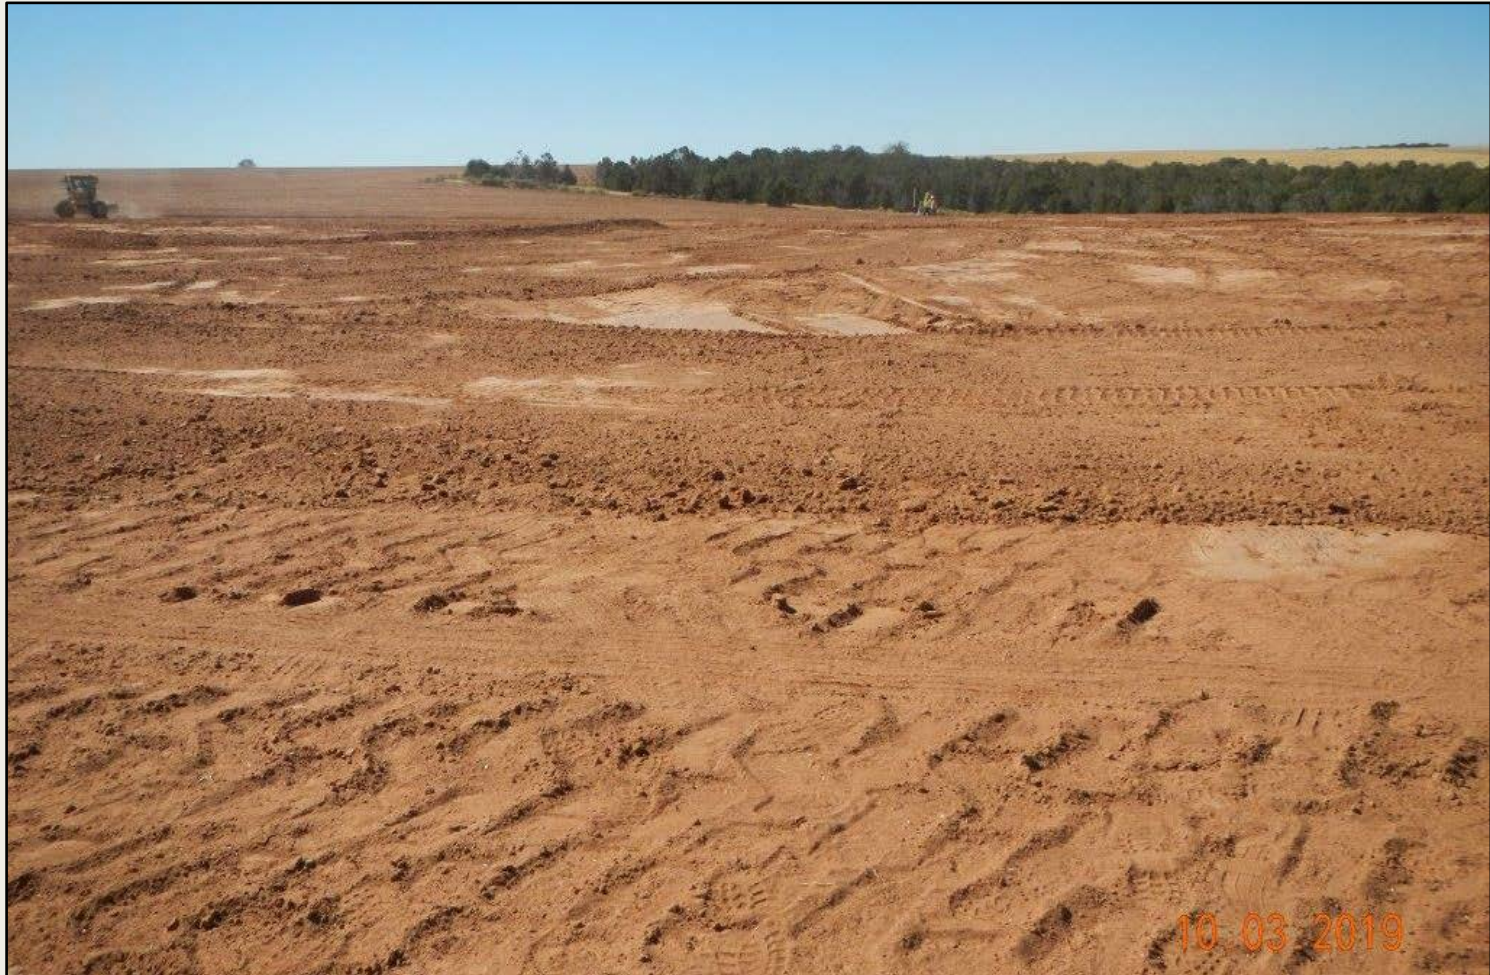
Photo 1. View of the project area from the northeastern edge facing center.

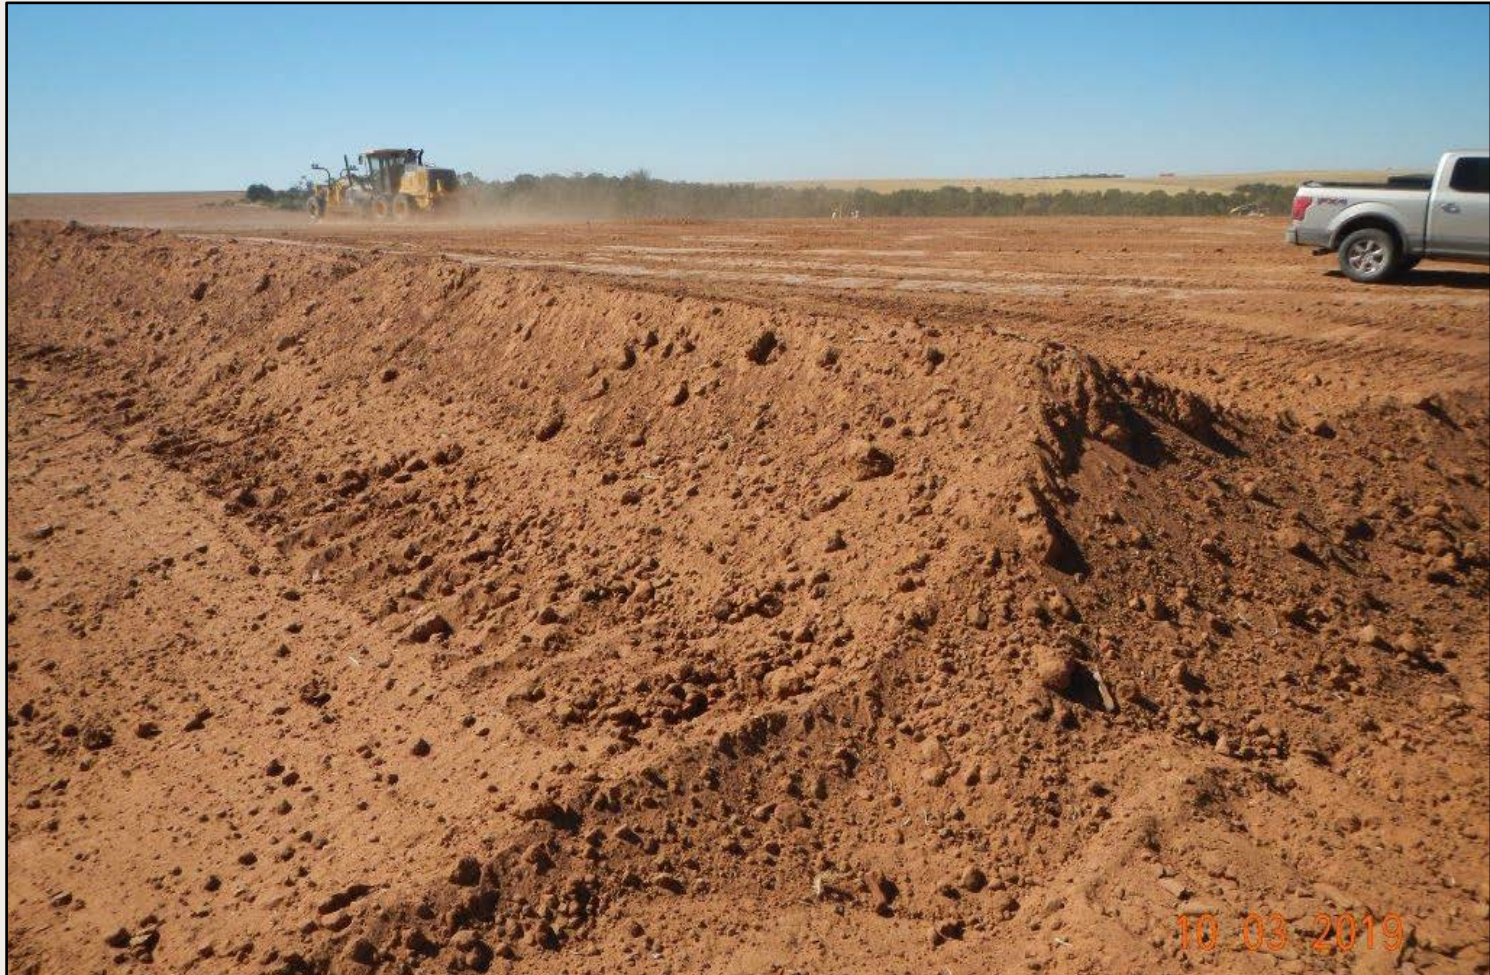
Photo 2. View of a portion of the topsoil stockpile and grader equipment operating at the time of the inspection.

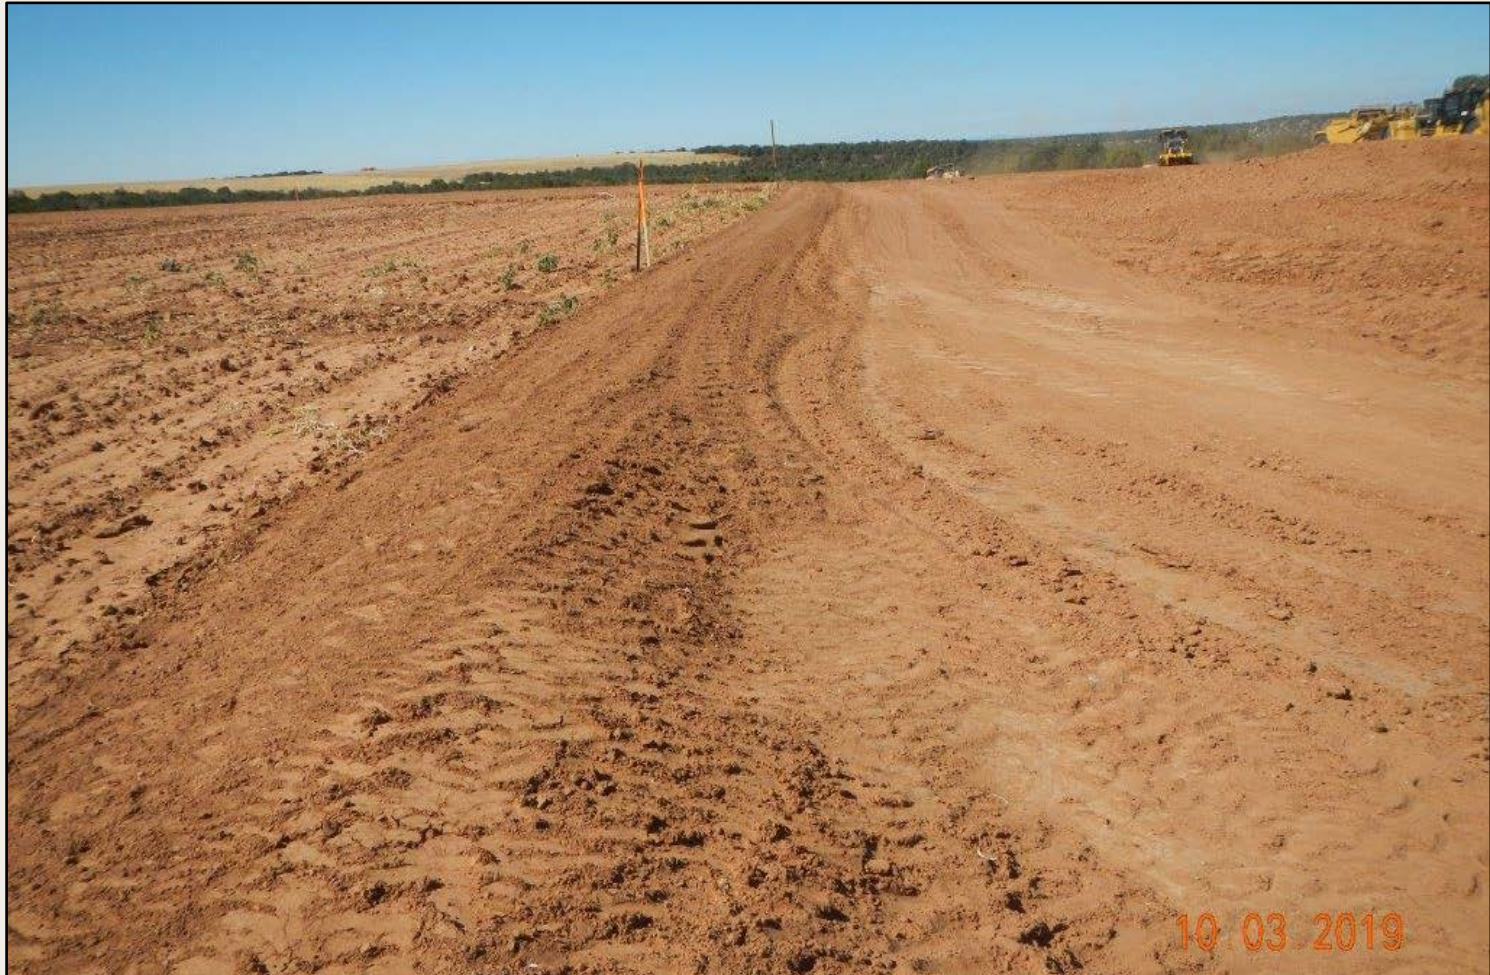
Photo 3. View of the southern edge of the project area from the southeastern corner facing westward. Ditch and berm in place. Loose soil on top of berm is not stabilized. Reference area on left side of photo is comprised of dryland crop field that is not planted at this time.

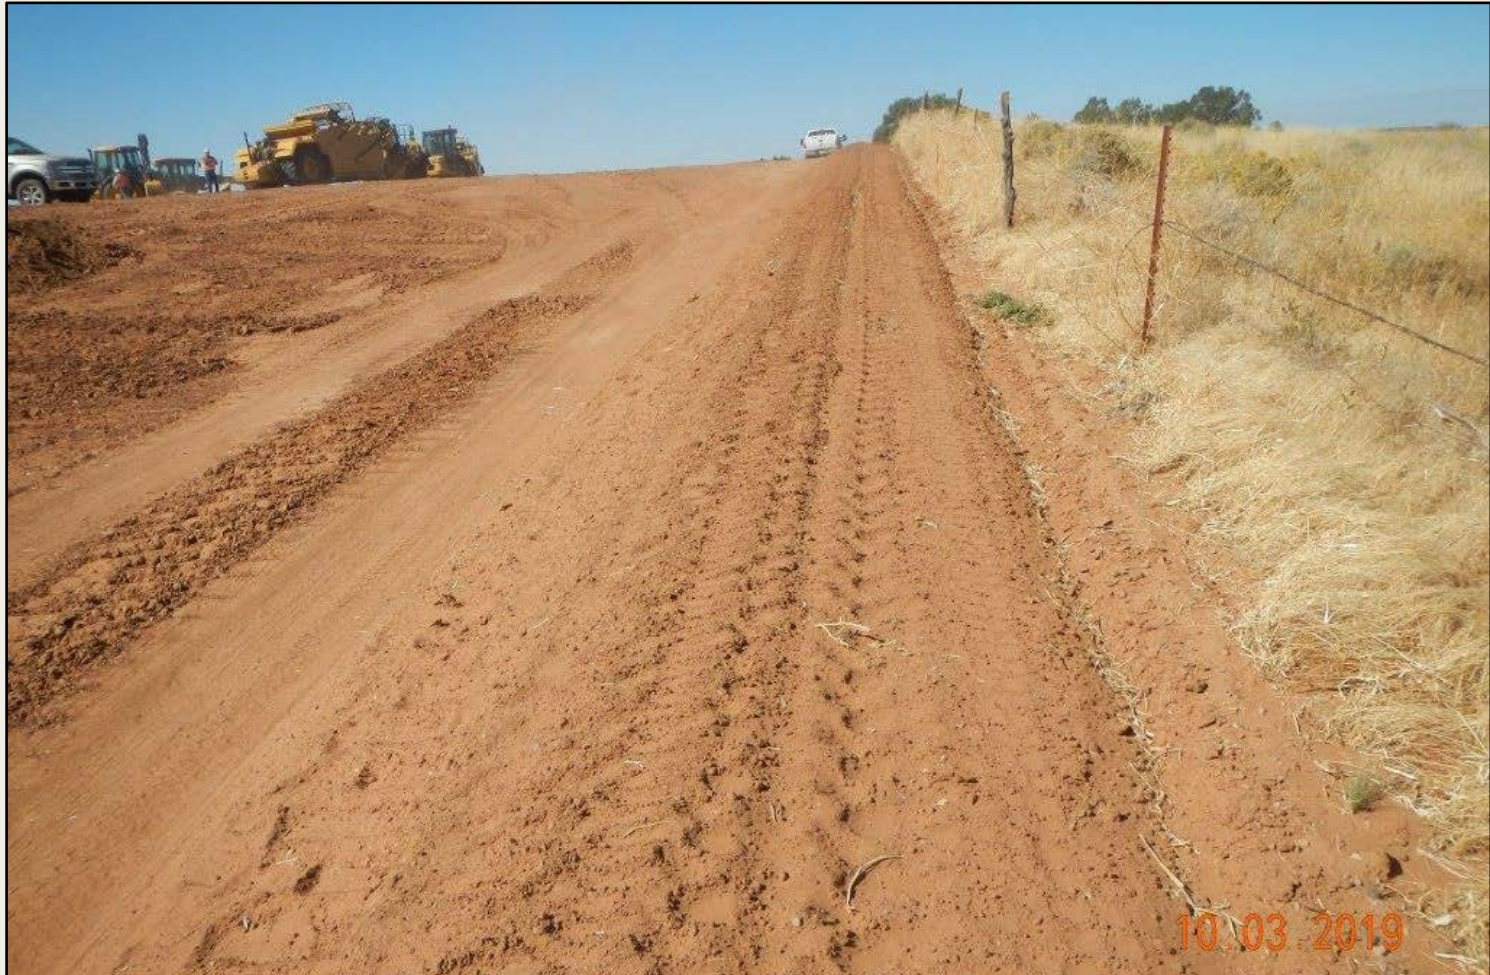
Photo 4. View of the northern portion of the project area facing westward. Ditch and berm are in place. However, loose soil on berms and in ditches is not stabilized and additional stabilization is needed.

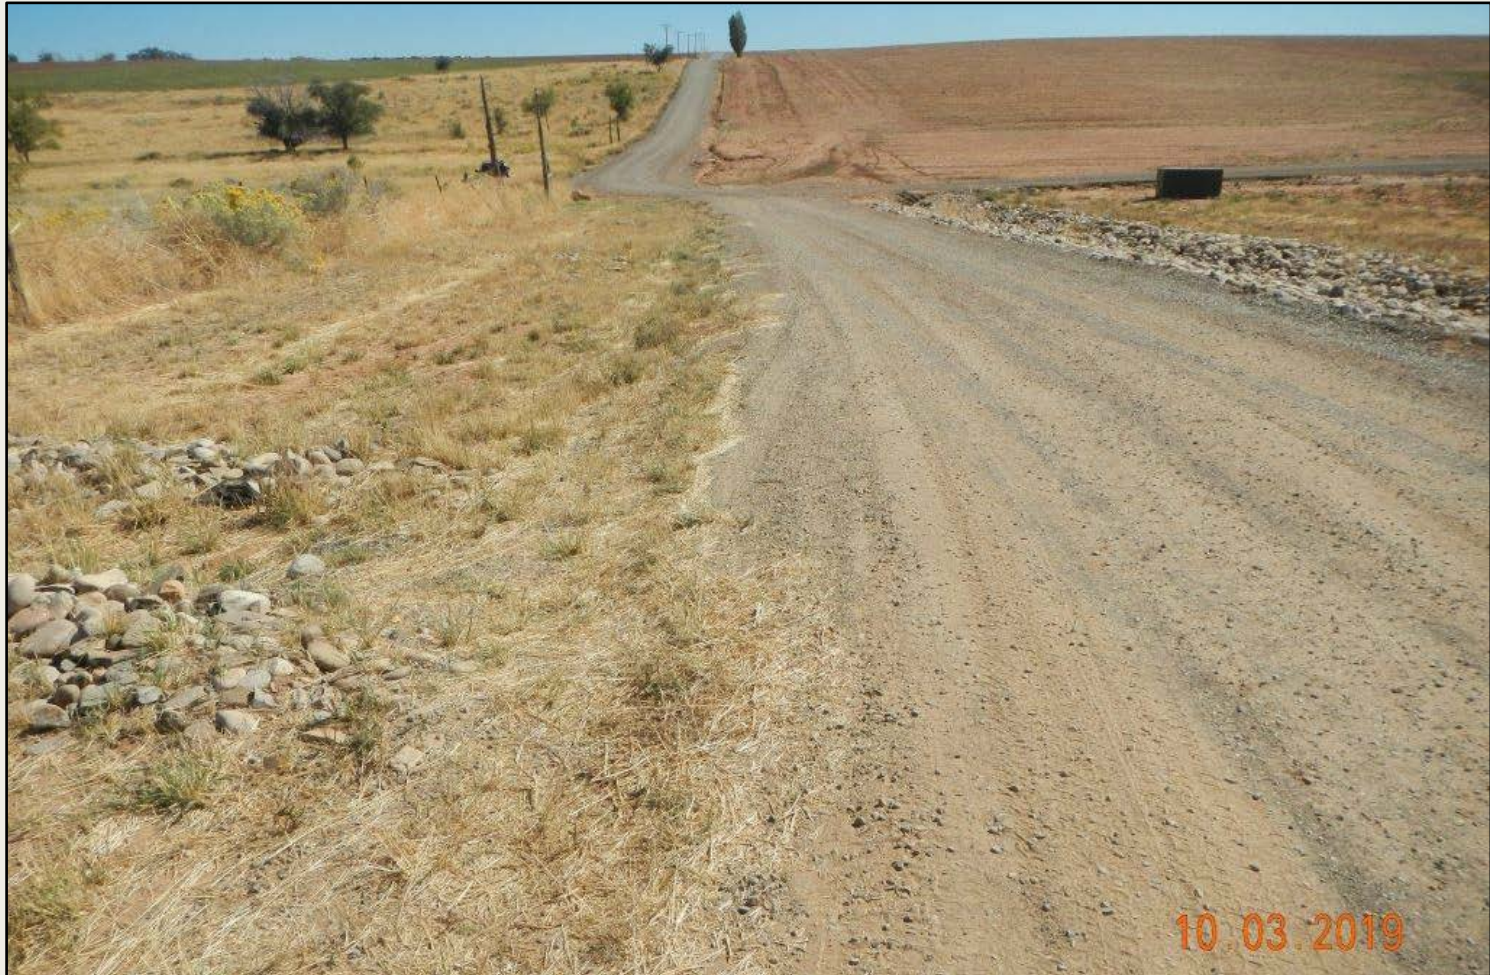
Photo 5. View of access road facing eastward to ward Montezuma County Road. Access is graveled and vegetation is becoming established on roadsides.
