**Inspection Photos**  
**Location Name: Kobe-Chevron Valve Can**  
**Spill ID 468517**

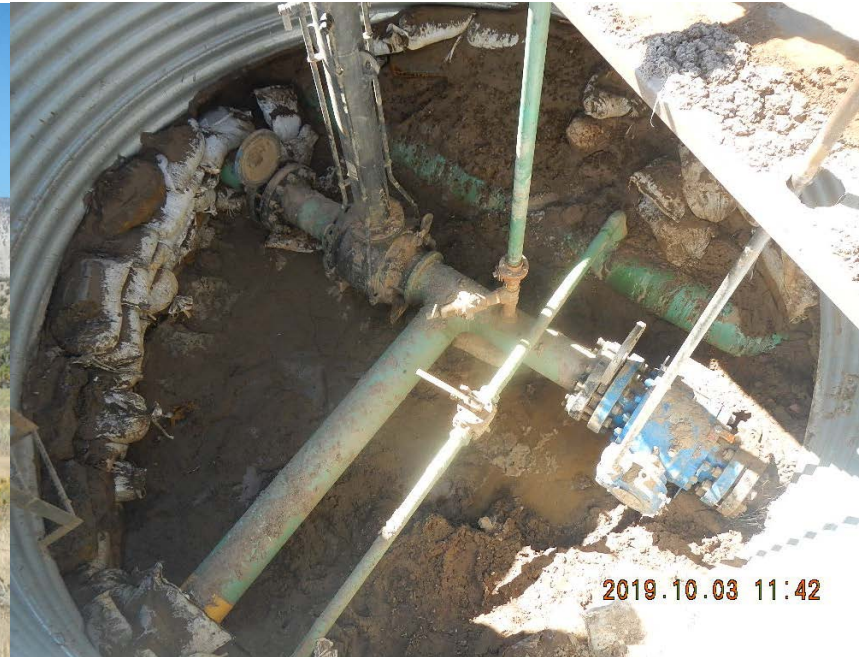
**Kobe-Chevron Valve Can app 8' in diameter, 6-8 feet in depth. Blind flange and blue valve is where failure occurred.**

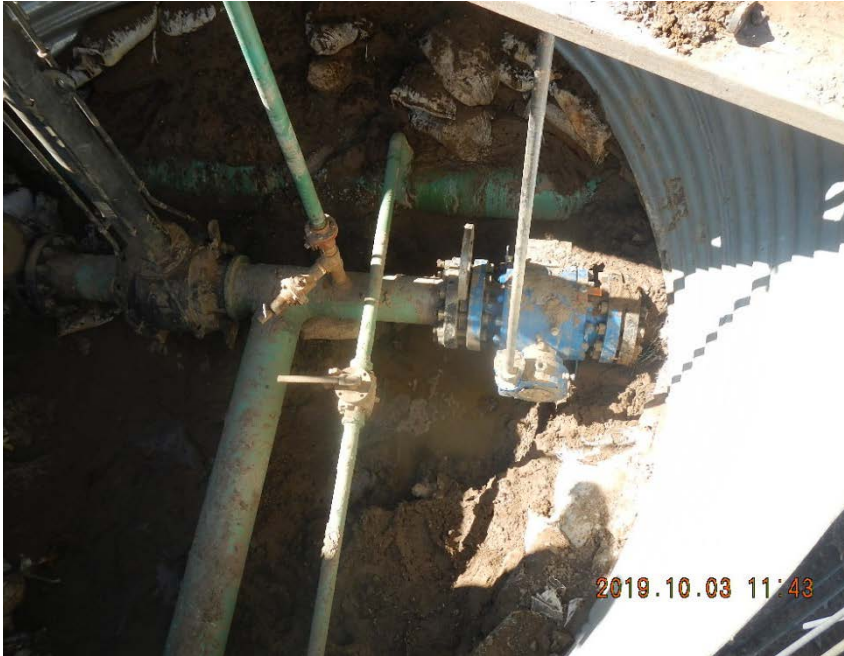
Blind flange and blue valve is where failure occurred.

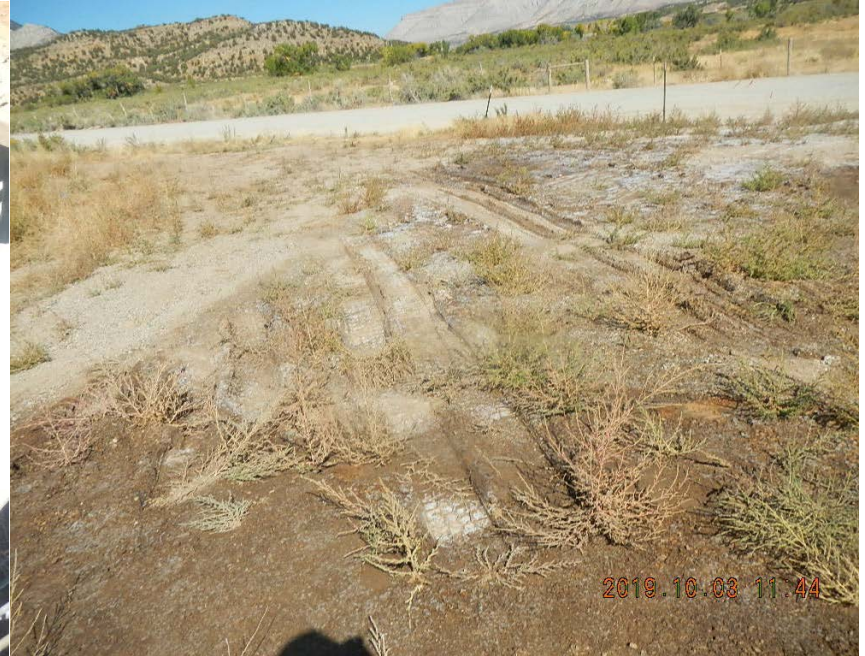
An approximate 80 feet by 50 feet impact from valve can to borrow ditch and CR200. PetroFlag sample collected and was 1776 ppm for TPH.

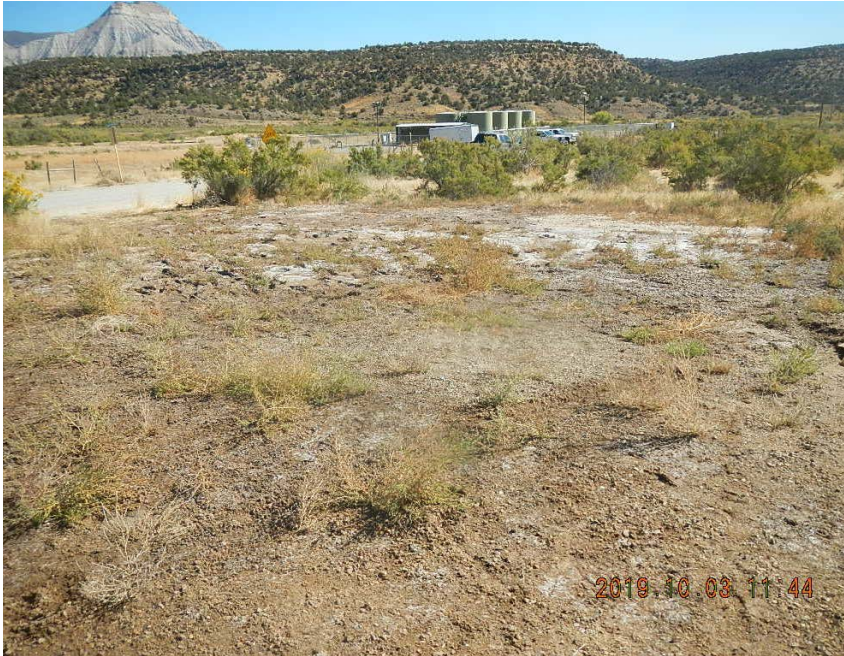
**An approximate 80 feet by 50 feet impact from valve can to borrow ditch and CR200.**

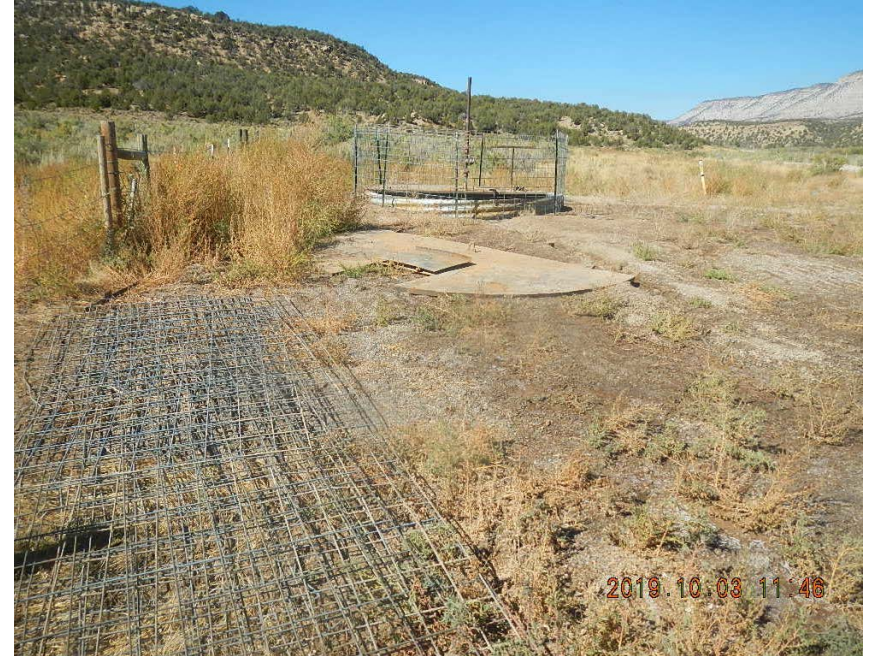
**An approximate 80 feet by 50 feet impact from valve can to borrow ditch and CR200.**

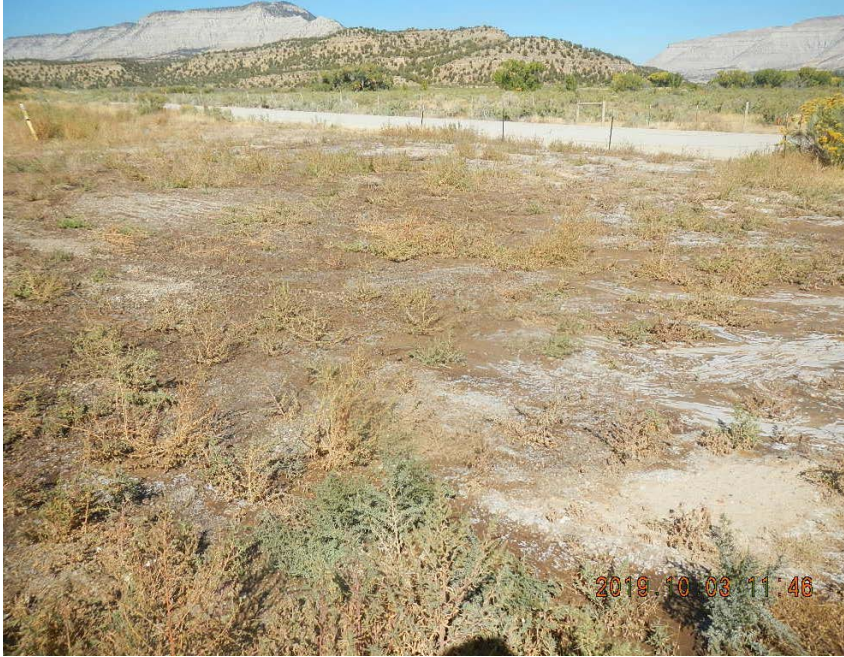
**An approximate 80 feet by 50 feet impact from valve can to borrow ditch and CR200.**

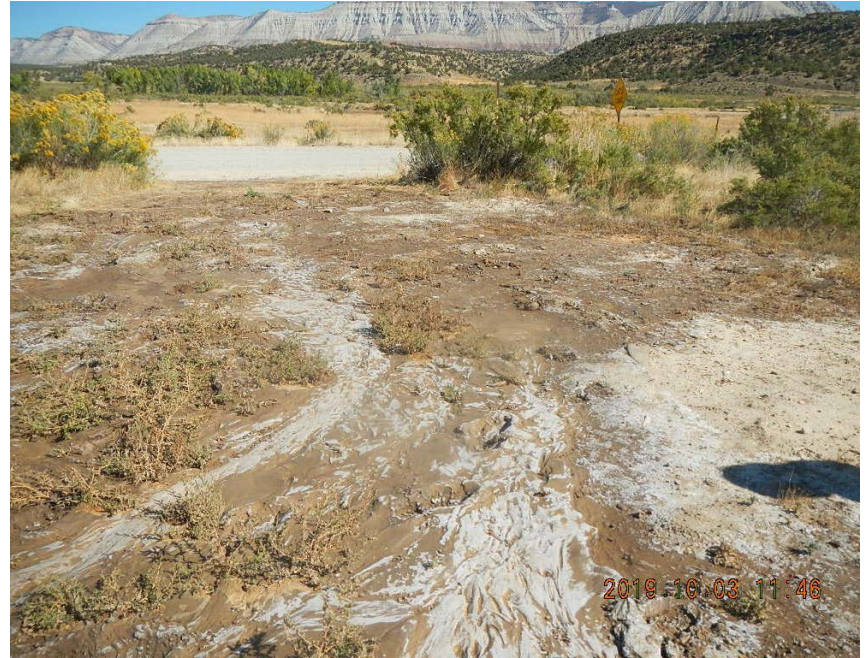
**An approximate 80 feet by 50 feet impact from valve can to borrow ditch and CR200.**

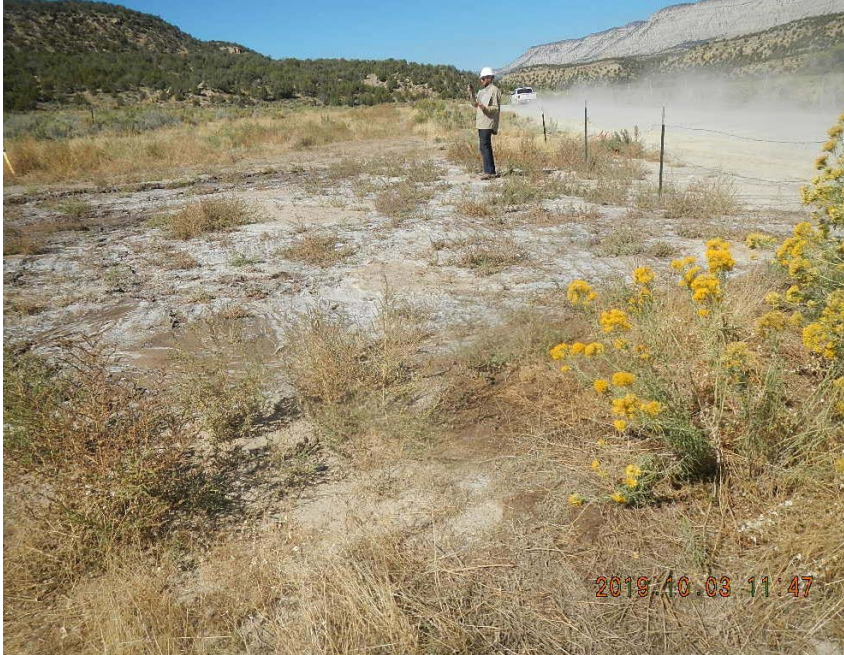
**An approximate 80 feet by 50 feet impact from valve can to borrow ditch and CR200.**

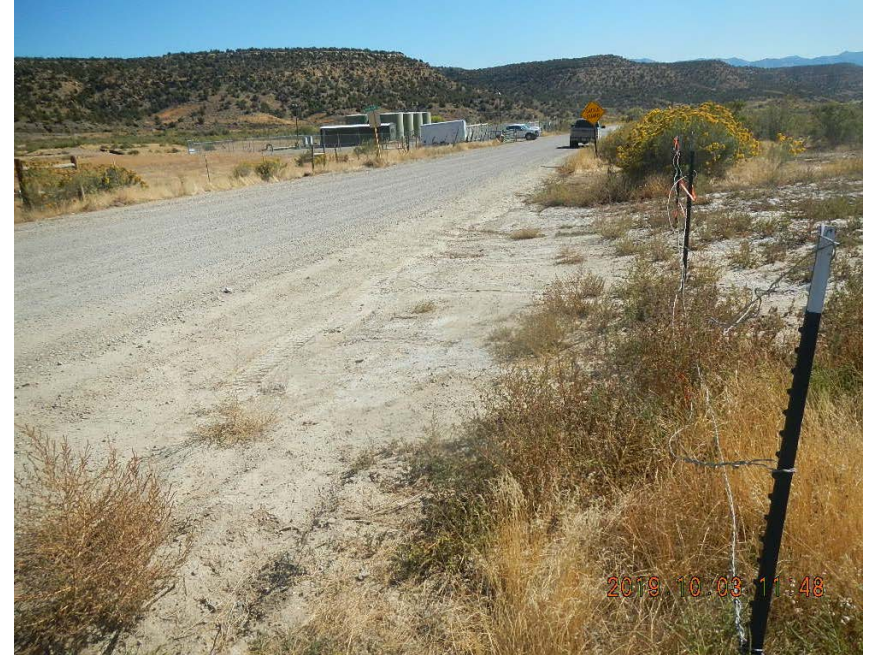
**Fluids flowed along borrow ditch and CR200. App 700 feet and at times 12-18 inches in depth by 1-4 feet in width.**

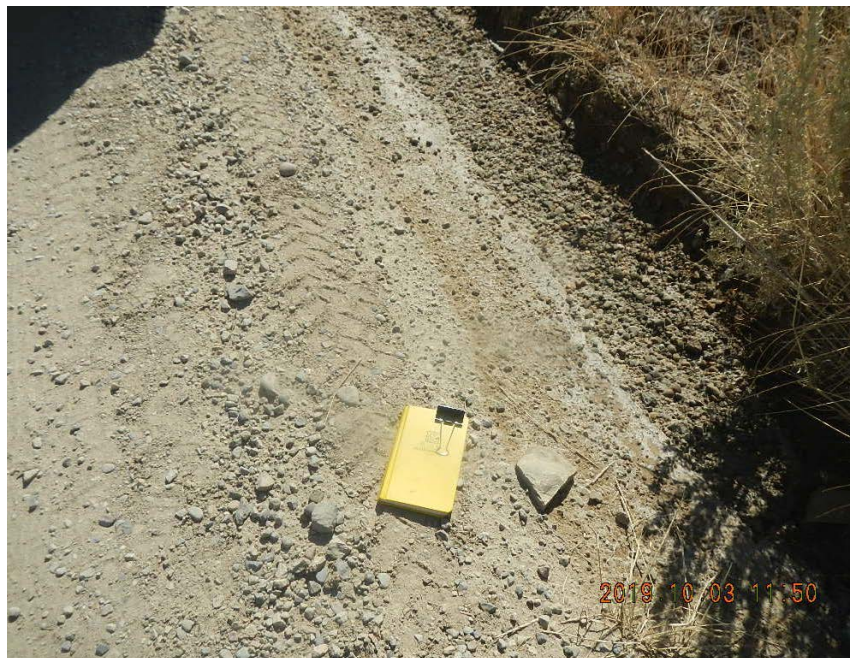
**Evidence of fluid flow.**

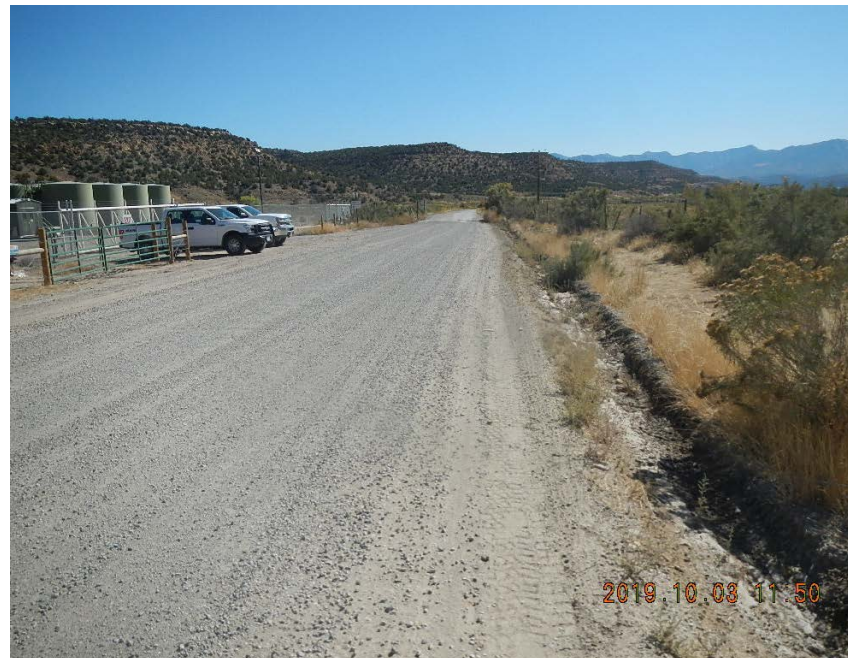
**Fluid flowed app 700 feet along the southwest side of CR 200**

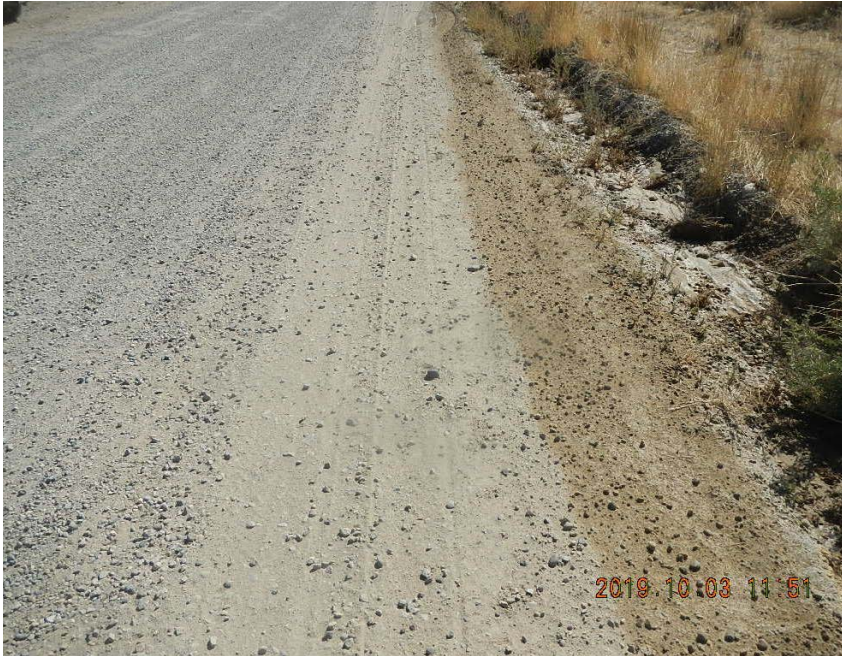
**Fluid flowed app 700 feet along the southwest side of CR 200.  
Borrow ditch is app 12" in depth and visible staining app 3' wide.**

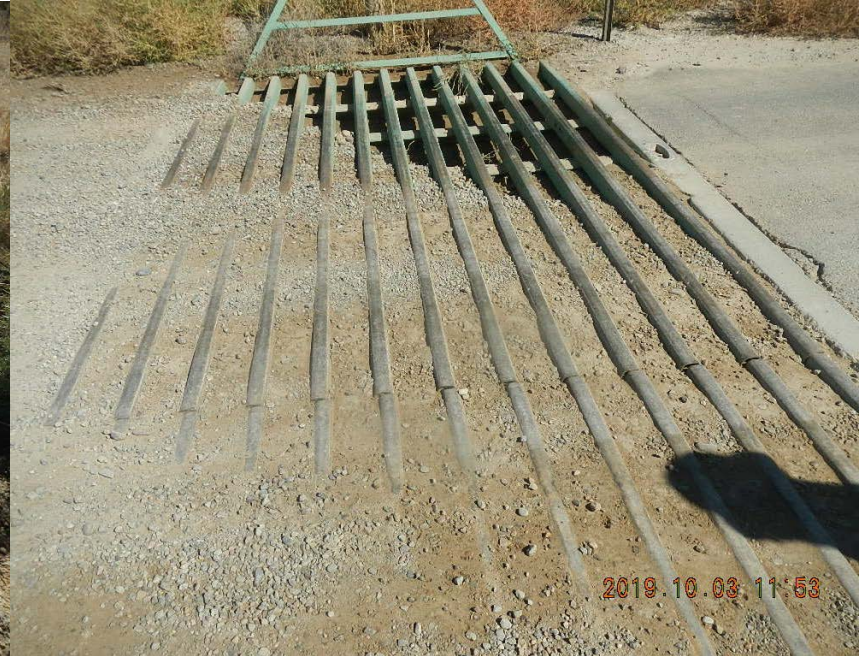
**Fluid flowed accumulated in cattle guard at the  
GARCO/Mesa County line.**

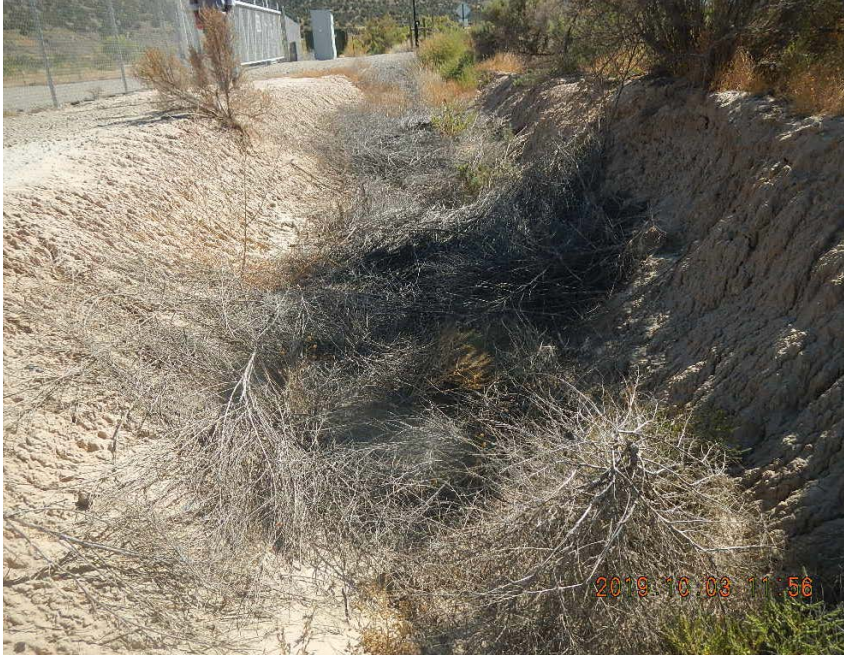
**Fluid flowed through a culvert and accumulated in sediment basin on Chevron surface.**

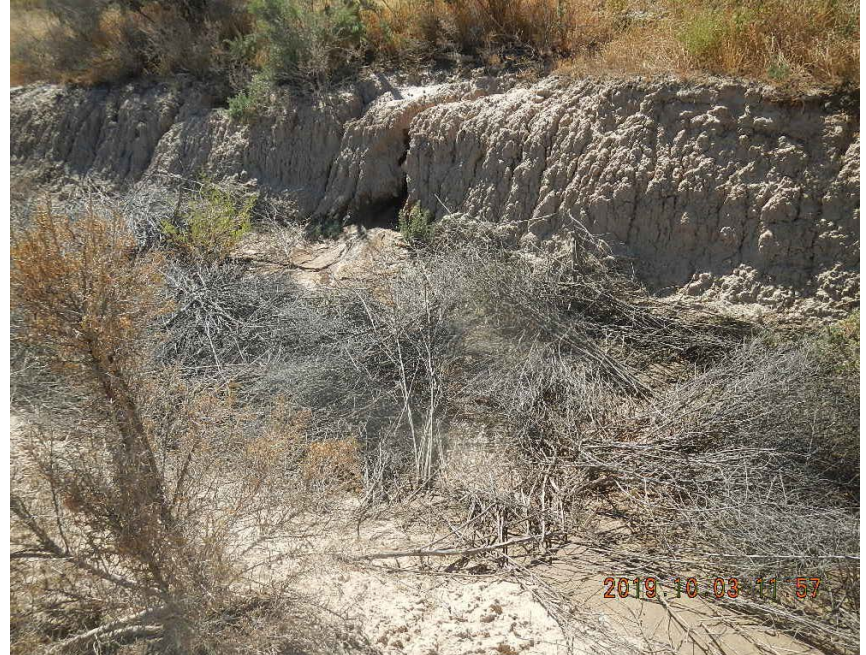
**Fluid flowed through a culvert and accumulated in sediment basin on Chevron surface.**

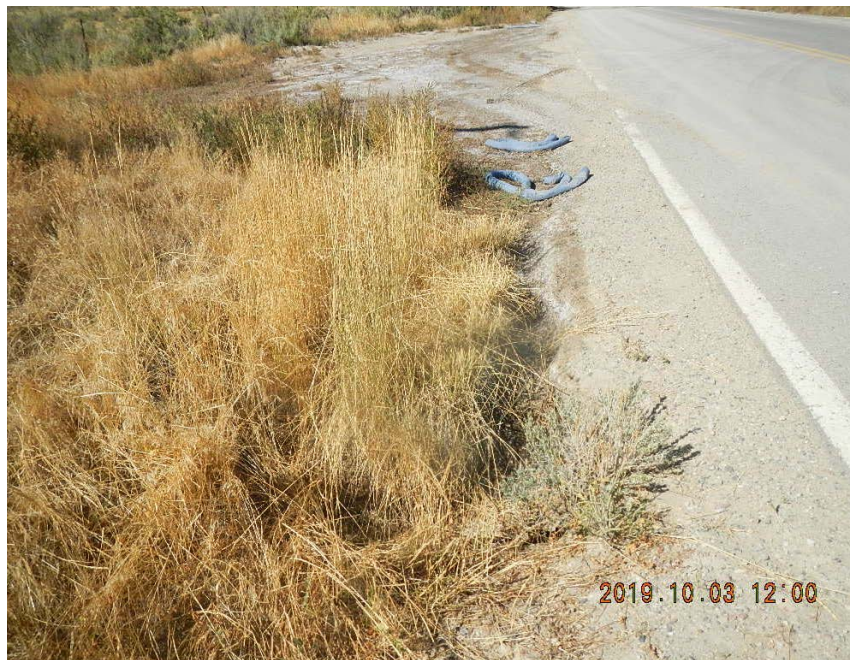
**App 100' by 30' of staining on CR 200 and in the right of way, directly across from the Kobe Station.**

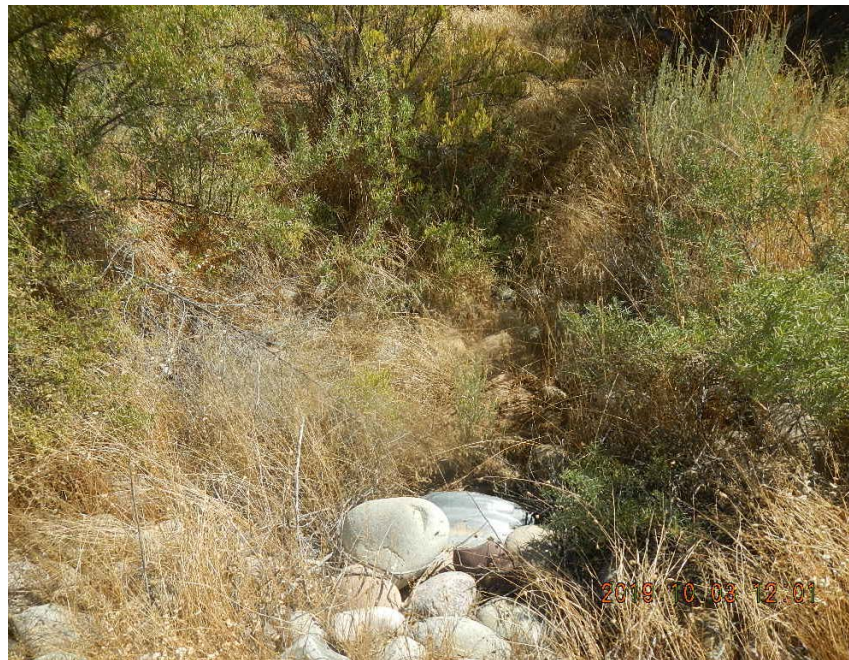
**Culvert and drainage on east side of CR 200 where fluids flowed.**

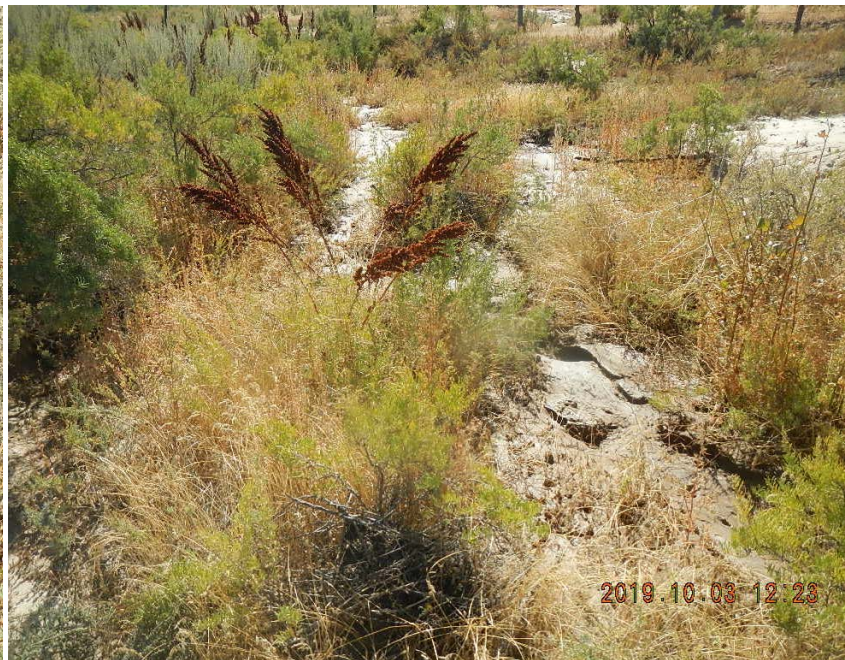
**Area of staining on ground surface.**

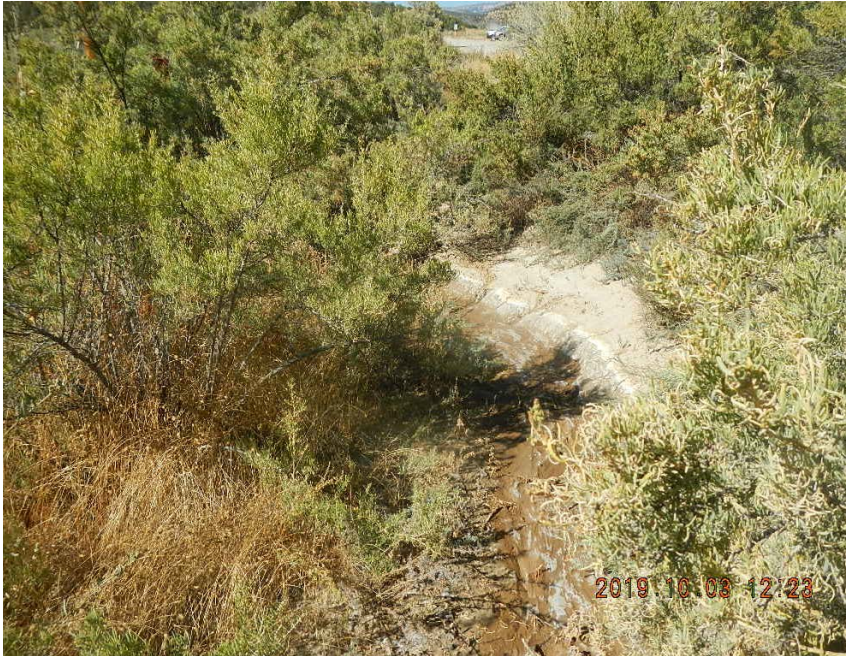
**Staining is about 18" from bottom of drainage and about 4' in width.**

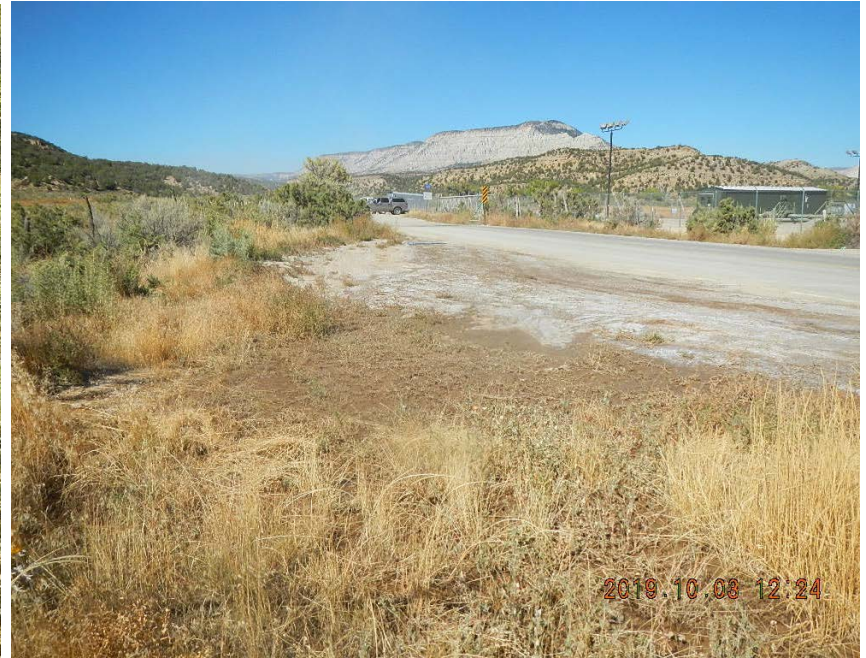
**App 100' by 30' of staining on CR 200 and in the right of way, directly across from the Kobe Station.**

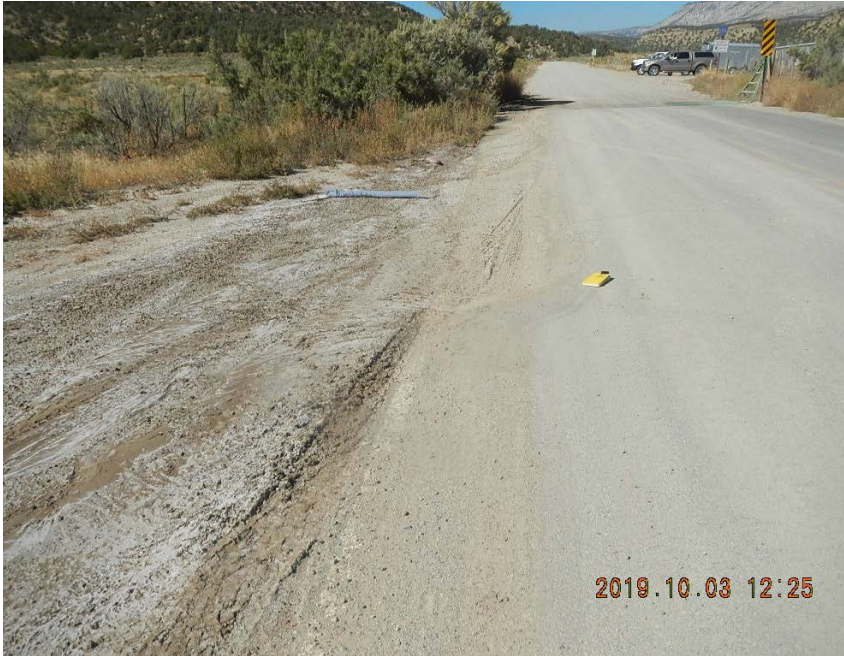
App 100' by 30' of staining on CR 200 and in the right of way.  
Yellow note book depicts edge of staining on CR 200.

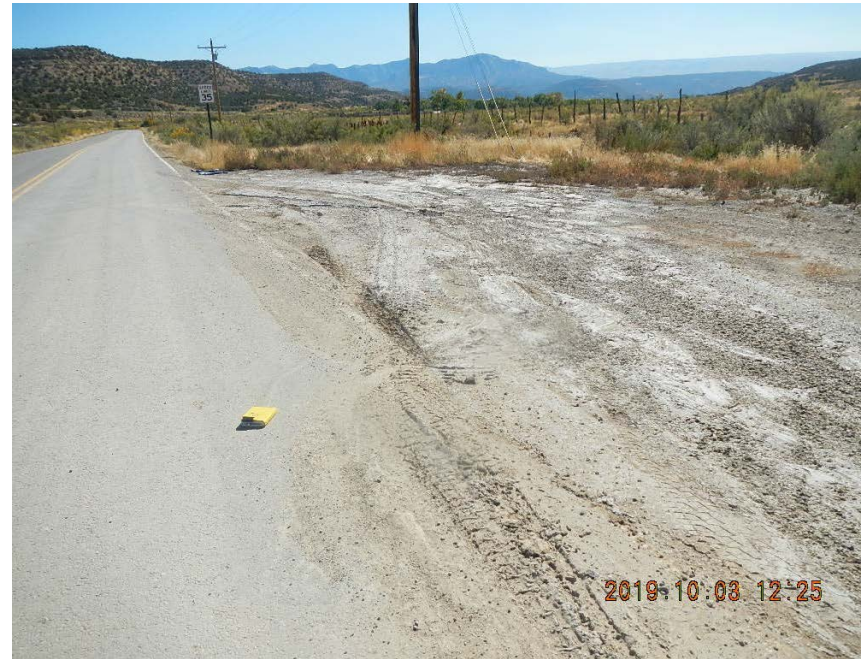
App 100' by 30' of staining on CR 200 and in the right of way.  
Yellow note book depicts edge of staining on CR 200.

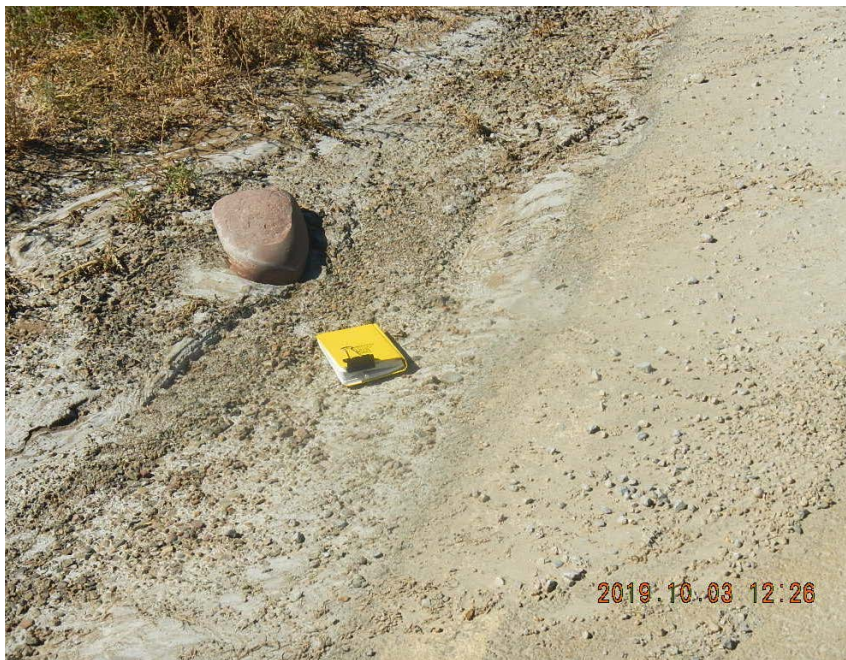
**Staining on CR 200. Note erosional features from the fluid flow.**

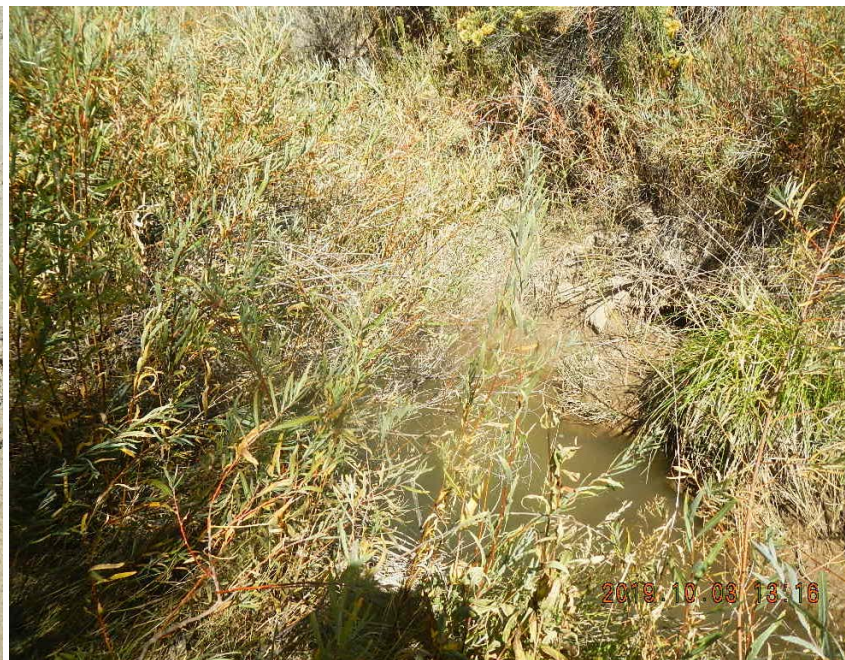
**Approximate area of where fluids enter the ditch.**

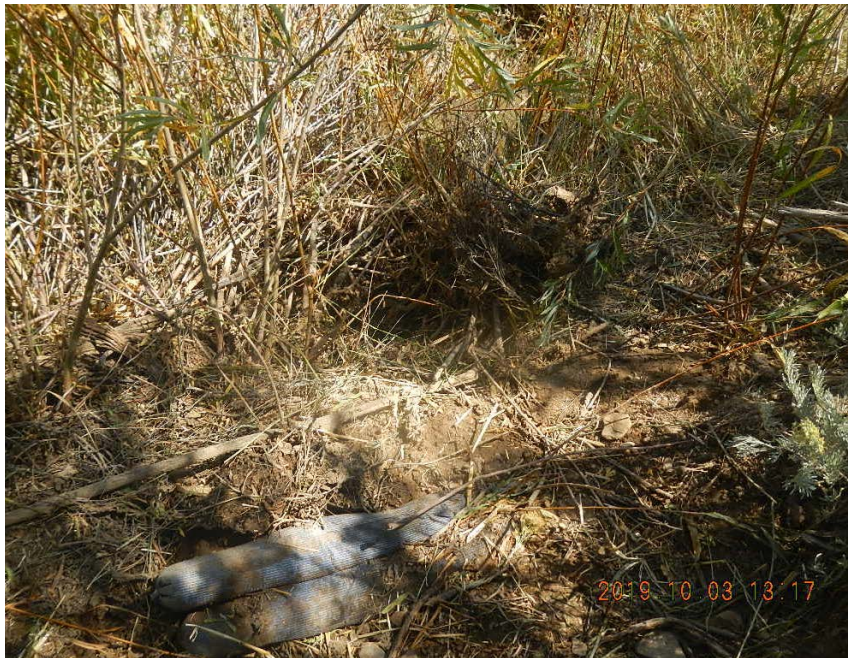
**Approximate area of where fluids enter the ditch.**

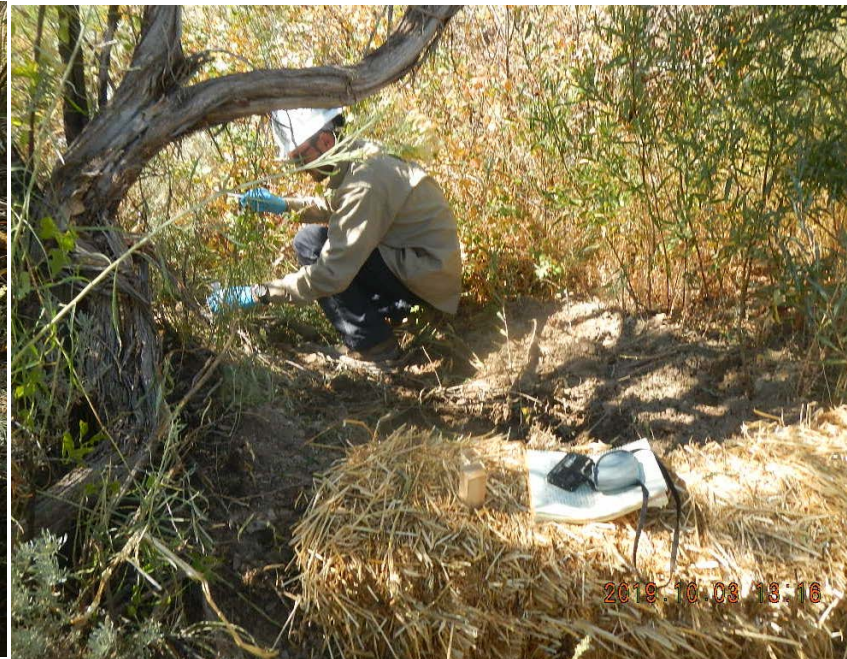
**Collecting a PetroFlag sample at the approximate area of where fluids enter the ditch. PetroFlag reading was 639 ppm for TPH.**

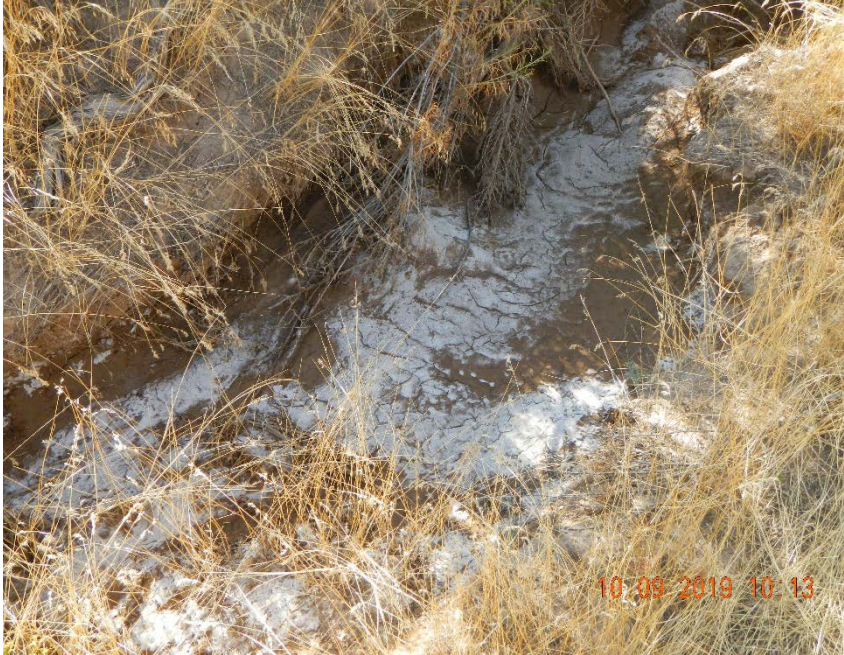
**Area of staining in the ditch approximately 10 feet long and 3 feet wide. Photo was taken 50 feet south of where the produced water entered the canal.**

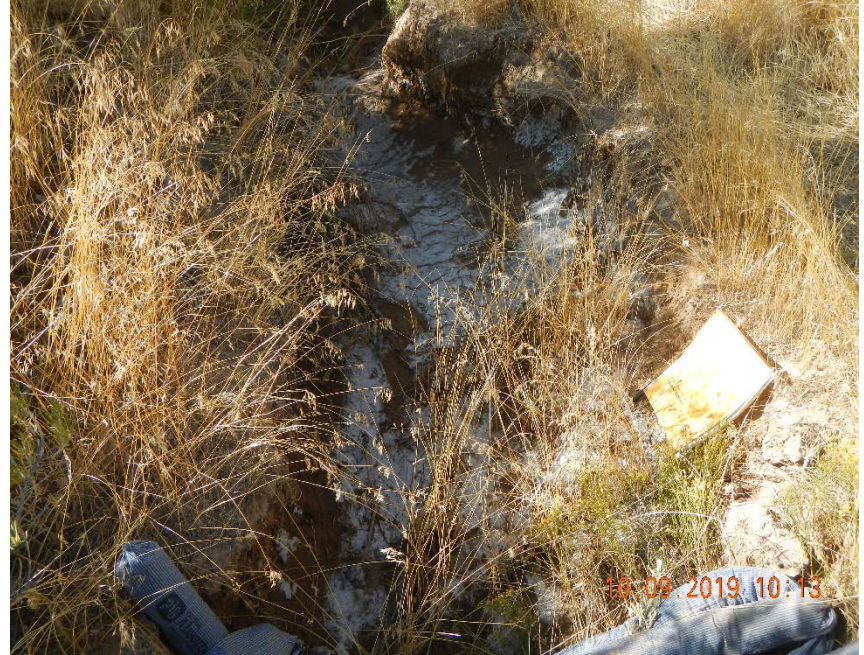
**Area of staining in the ditch approximately 10 feet long and 3 feet wide. Photo was taken 50 feet south of where the produced water entered the canal.**

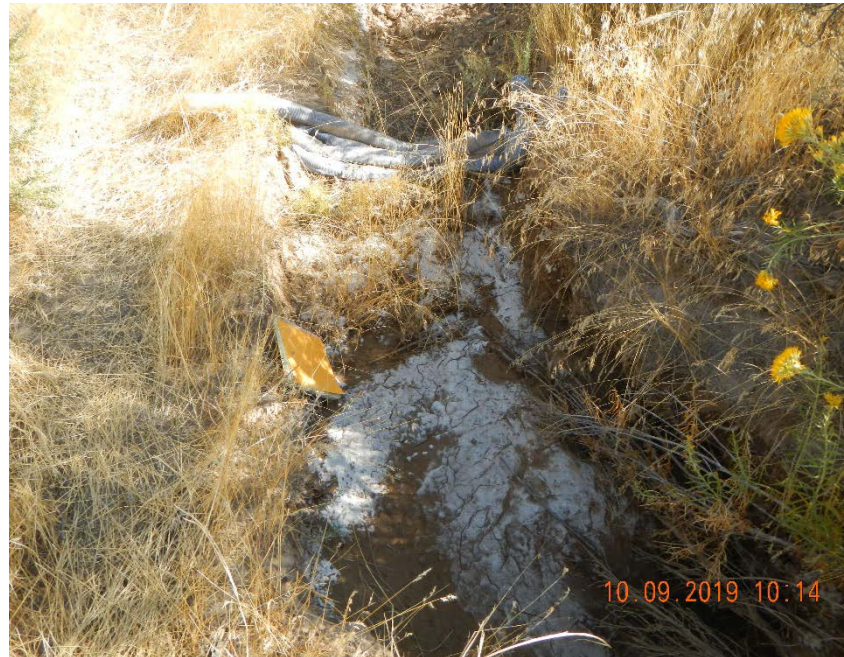
**Area of staining in the ditch approximately 10 feet long and 3 feet wide. Photo was taken 50 feet south of where the produced water entered the canal.**
