**Inspection Photos**  
**Location Name: Meyers 19-11HA**  
**Location ID: 441283**

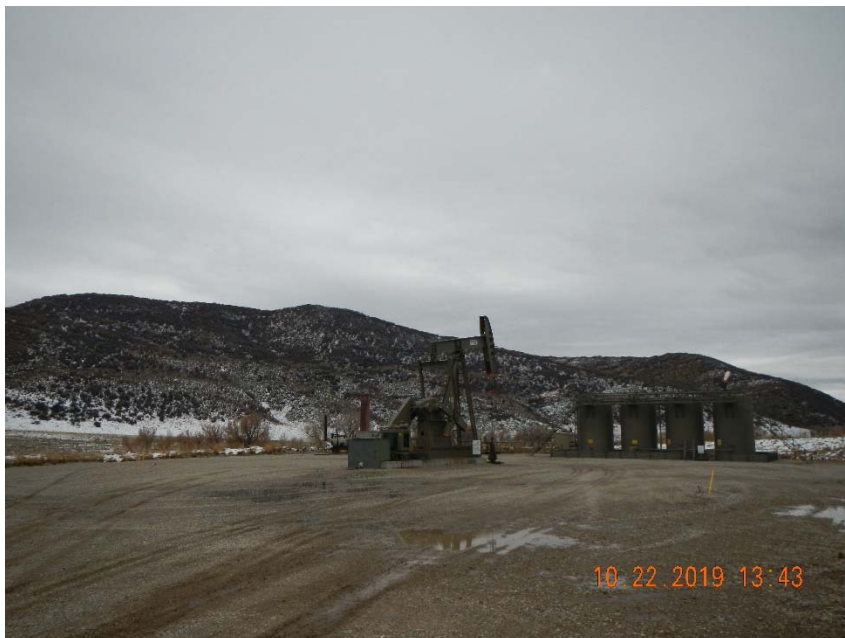
**Photo 1. Overview of location taken at entrance facing southwest.**

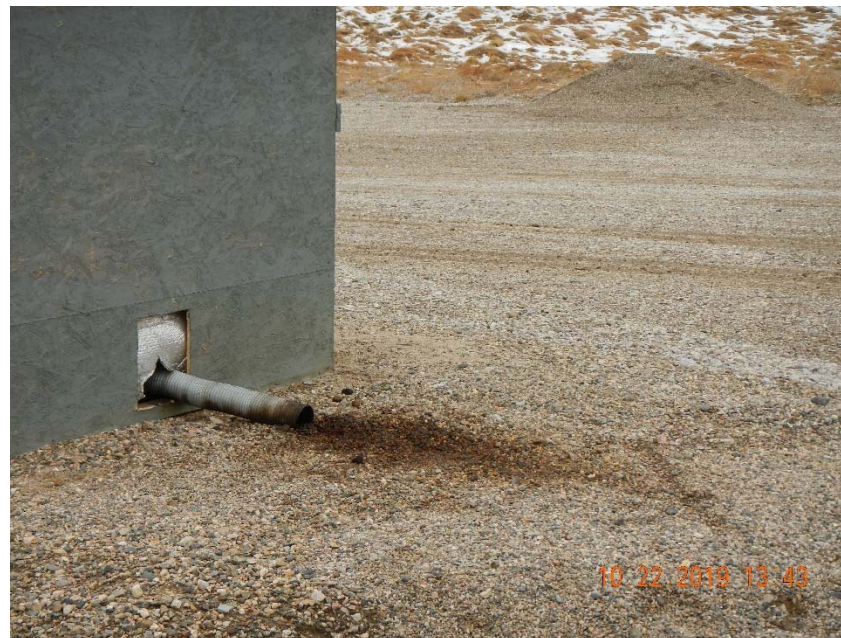
**Photo 2. Stained soil at pump jack exhaust.**
