Inspection Photos

Location Name: Facility #8 Consolidated Gas Line

Location ID: 452596

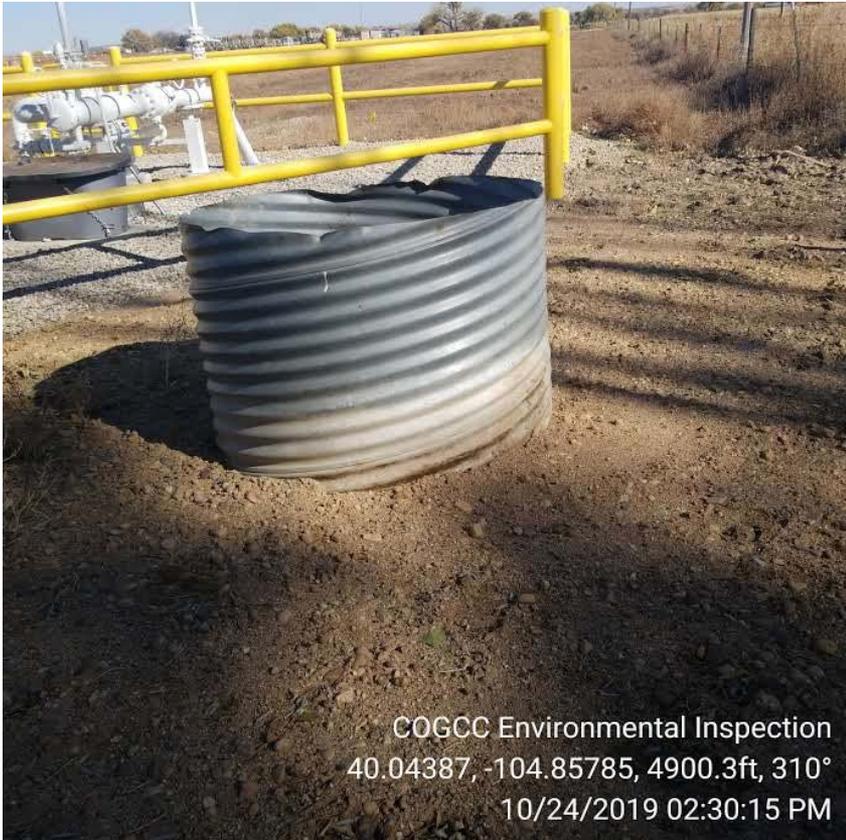
**Photo 1 – Foreground: Unmarked valve culvert
Background: Anadarko Norden Receiver**

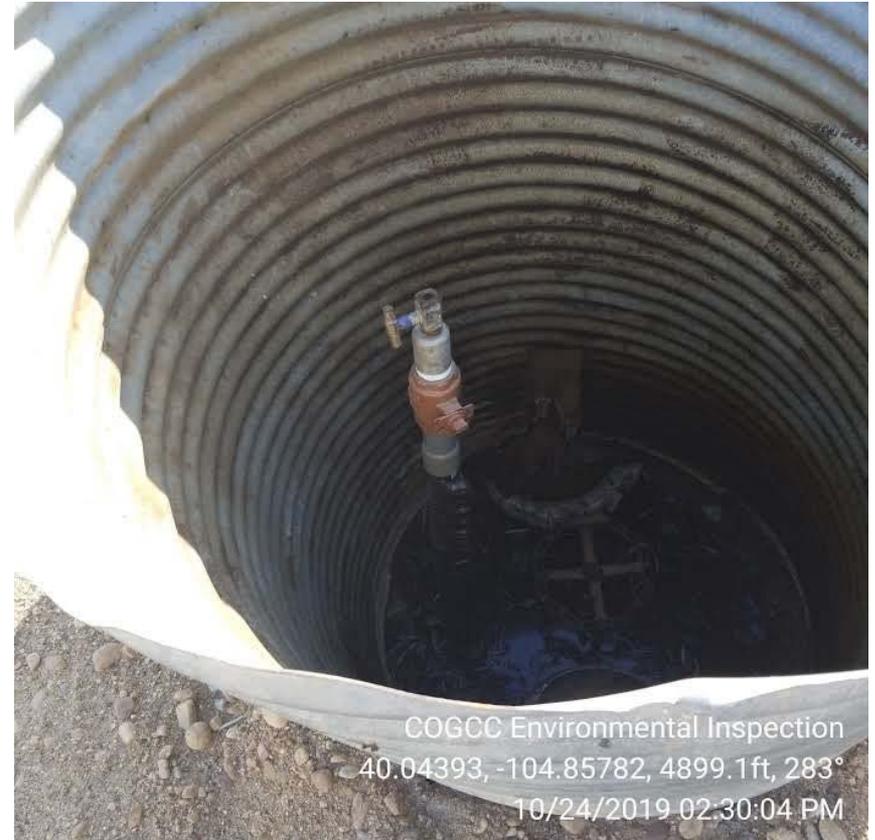
Photo 2 – Inside culvert

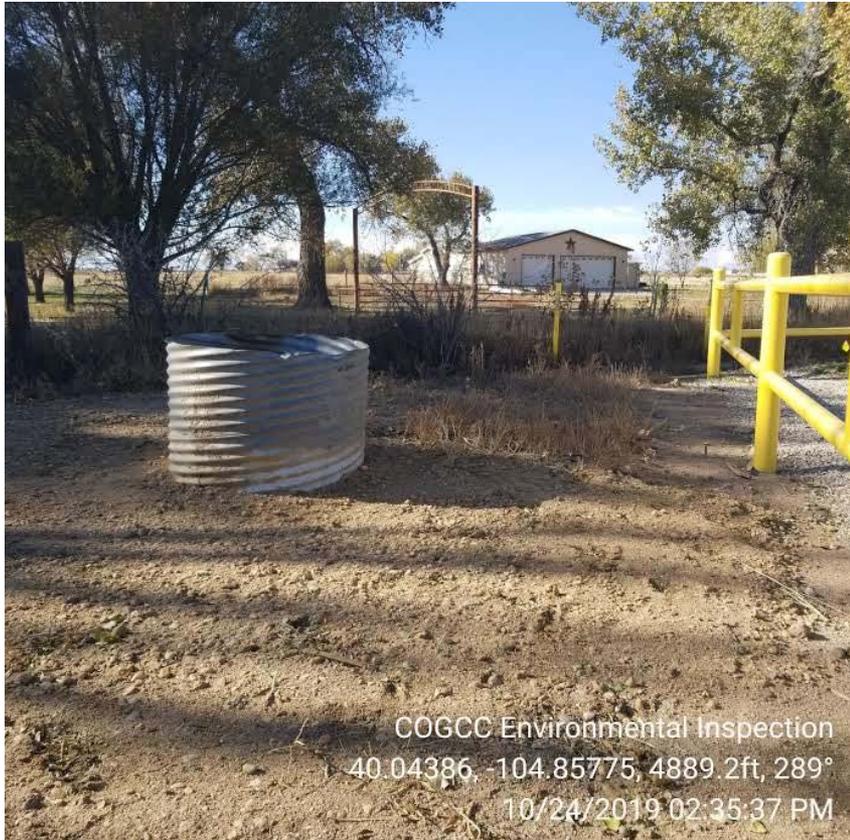
Photo 3 – Unmarked culvert. Excavation was backfilled imported material; surface appears to be road base or a similar material.

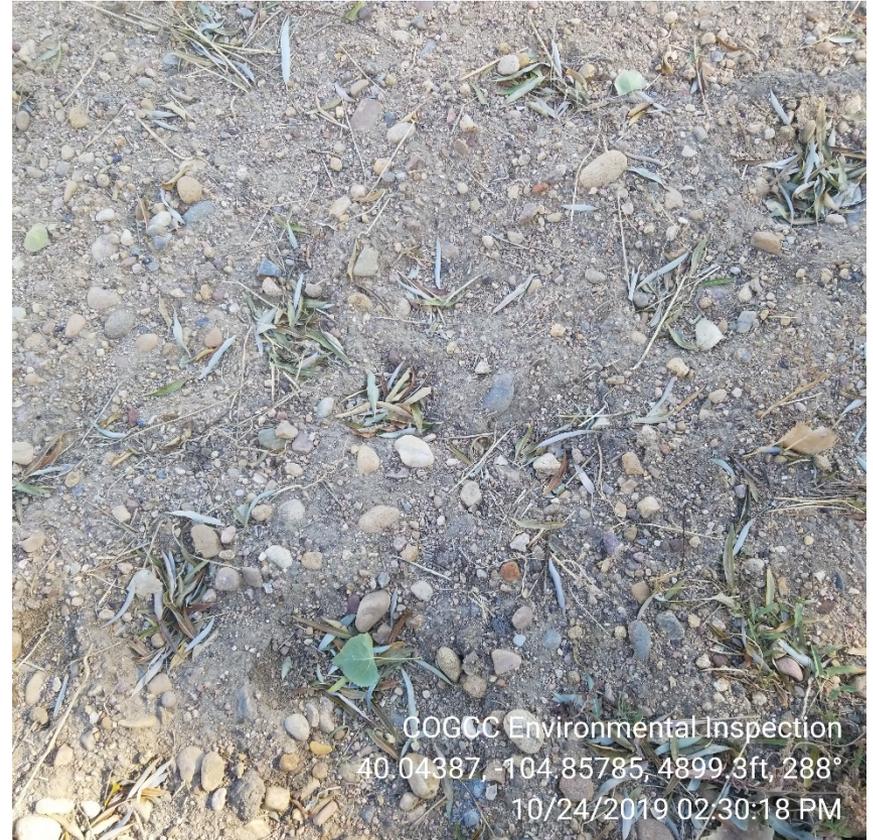
Photo 4 – Fill material adjacent to culvert.

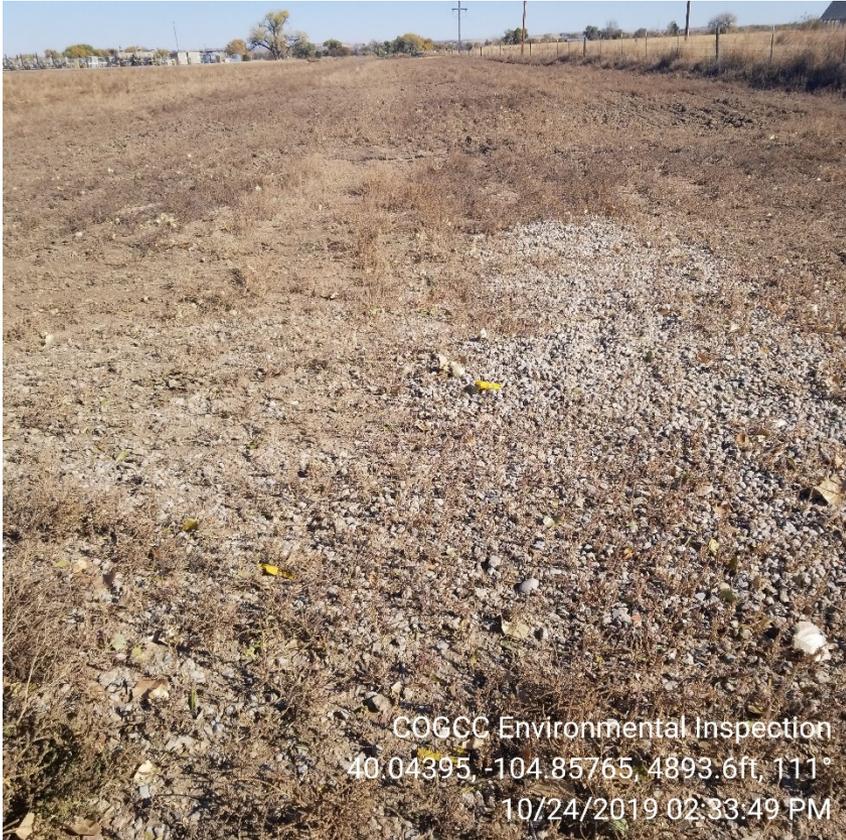
Photo 5 – Looking west; area of excavation related to Remediation #10757. Gravel is from the pigging station pad.

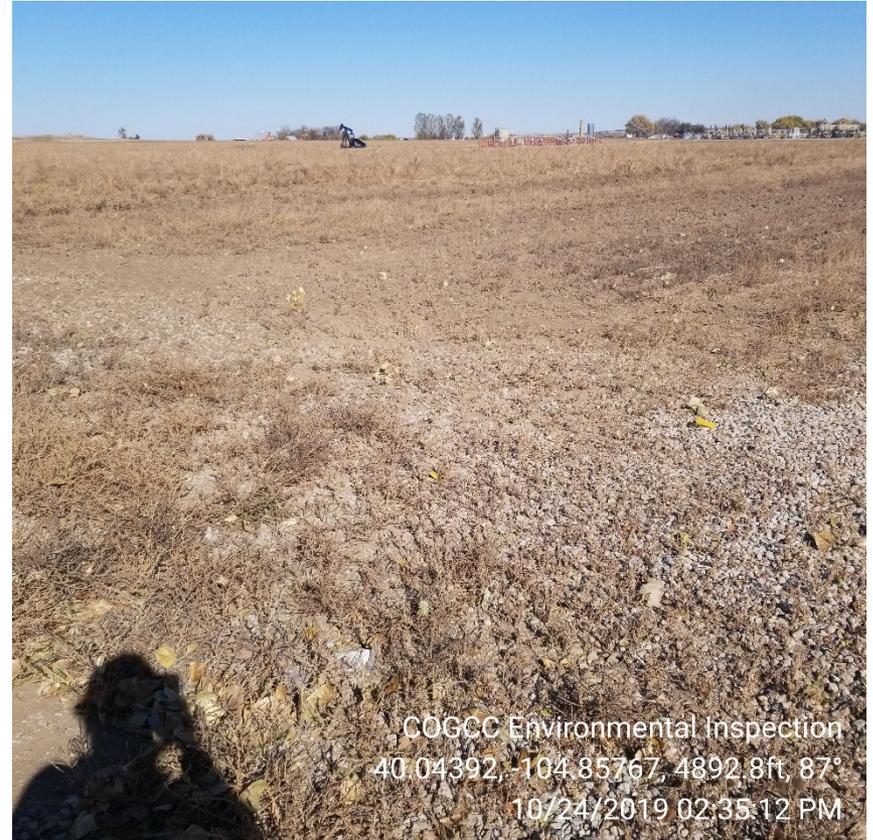
Photo 6 – Looking west; area of excavation related to Remediation #10757.

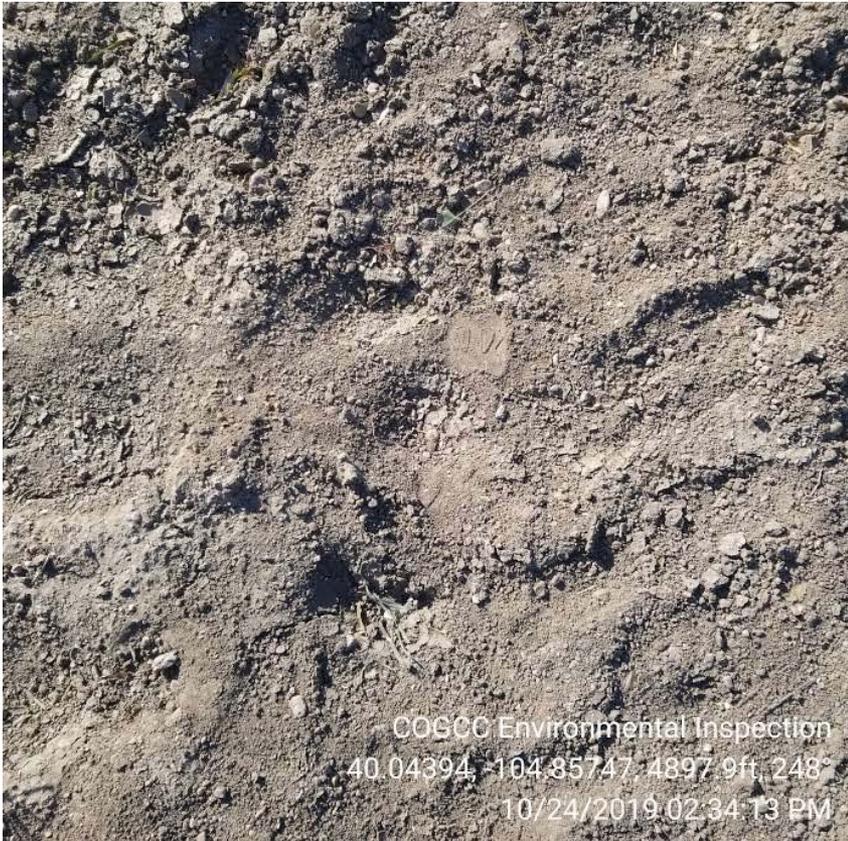
Photo 7 – Fill material

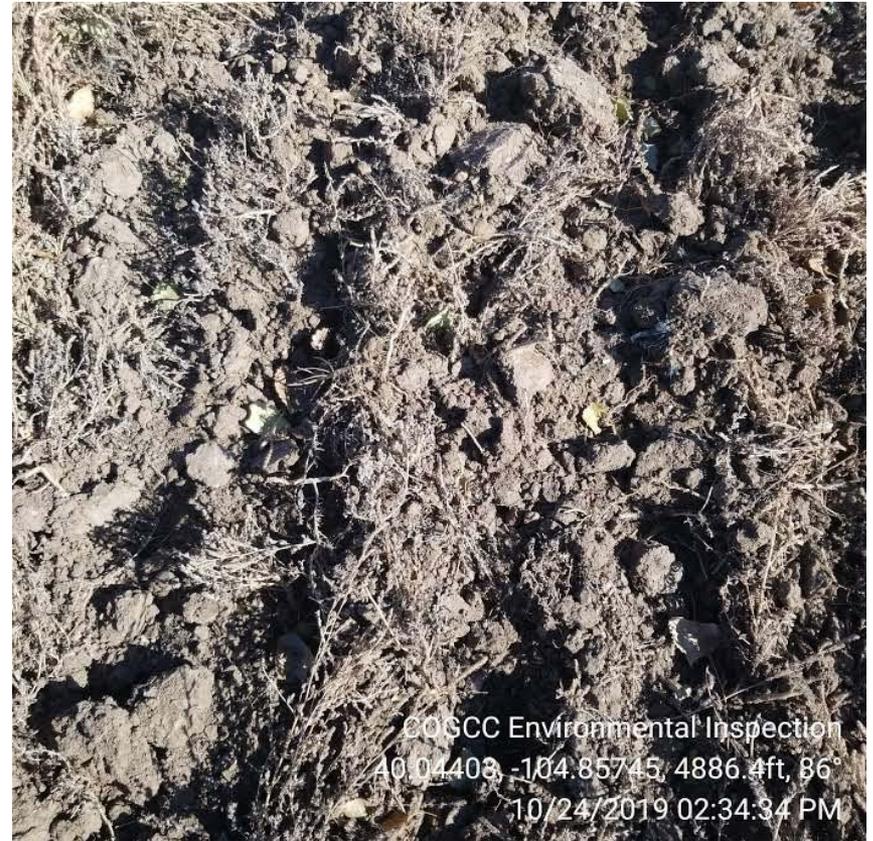
Photo 6 – Native soil
