Inspection Photos

Location Name: Cuykendall-Lauck #2

Location ID: 317921

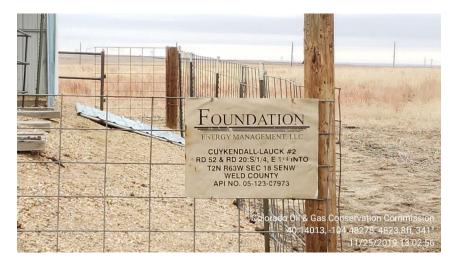
Photo1 WH sign Photo2 WH

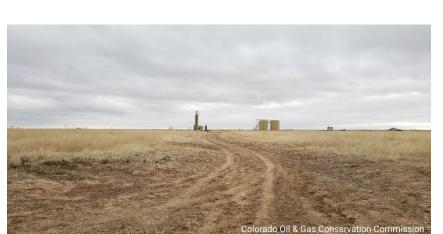
Photo3 Access rd. appears to have weeds cut and removed

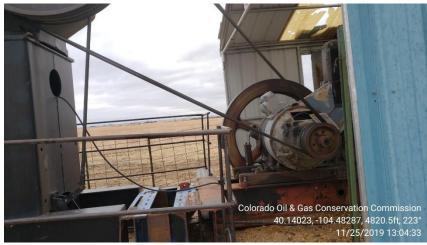
Photo4 unguarded belts on PU

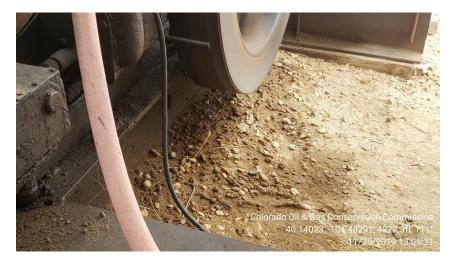
Photo5 Stained soil under PU pulley

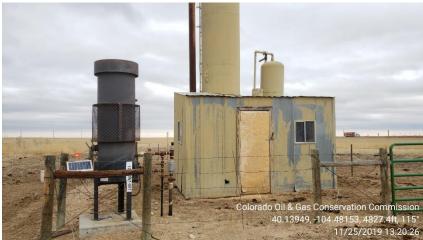
Photo6 ECD and separator house

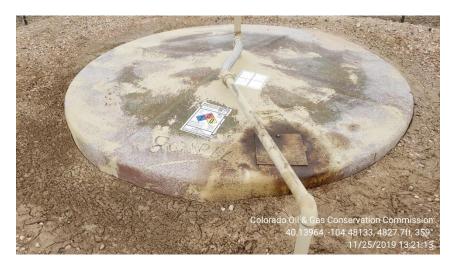
Photo7 Produced water tank has been marked with volume

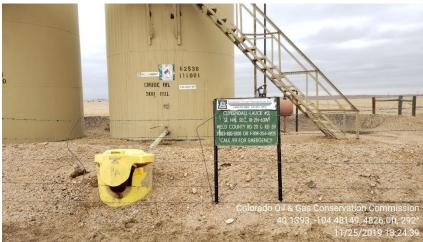
Photo8 TB sign

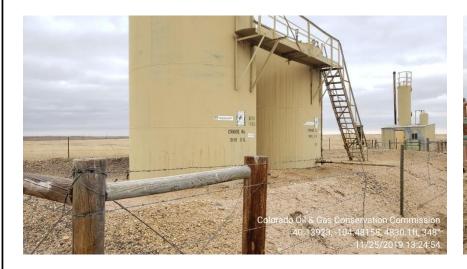
Photo 9 TB Photo 10 Gas meter run

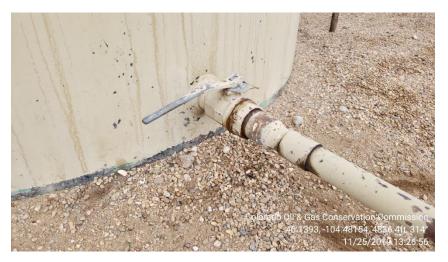
Photo11 Stained soil under Crude oil tank valve appears to have been removed

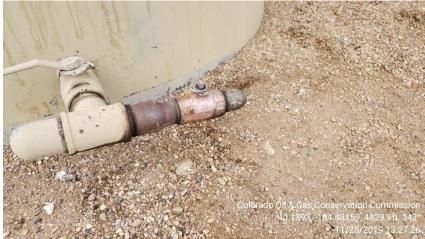
Photo12 Stained soil under Crude oil tank valve appears to have been removed
