Final Reclamation Inspection

Operator: KERR MCGEE OIL & GAS ONSHORE LP - #47120

Location ID: 310593

Inspection Photos Location Name: ENTERPRISE- USX XX #21-6

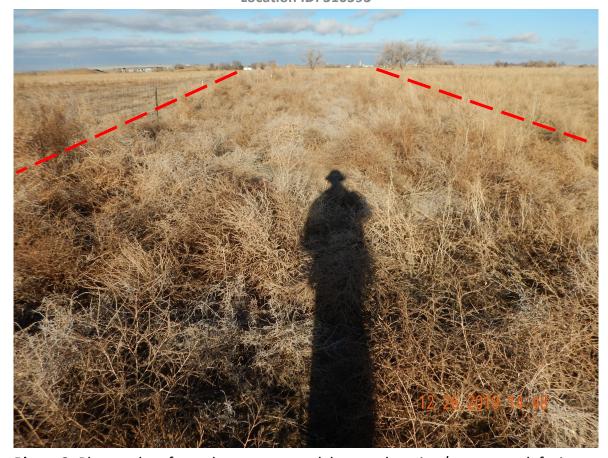
Photo 2. Photo taken from a portion of the access road just west of the tank battery, facing West. Photo illustrates Operator has failed to properly contour all of the access road west of the tank battery- refer to Photo 1.

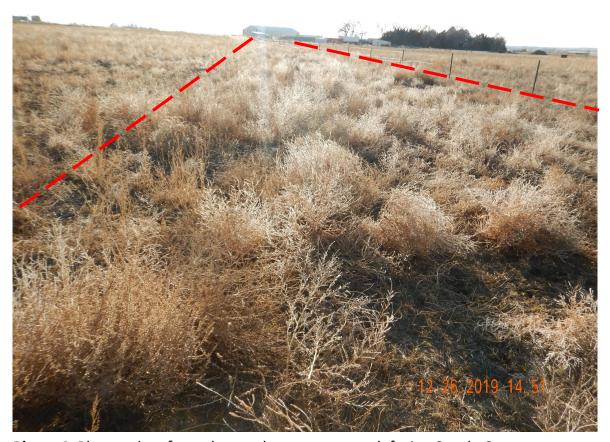
Photo 3. Photo taken from the western tank battery location/access road, facing North. Photo illustrates a high density of Russian thistle and Kochia, not reflective of reference areas. There was some germination of desirable species; however, appears much of the germination has been grazed.

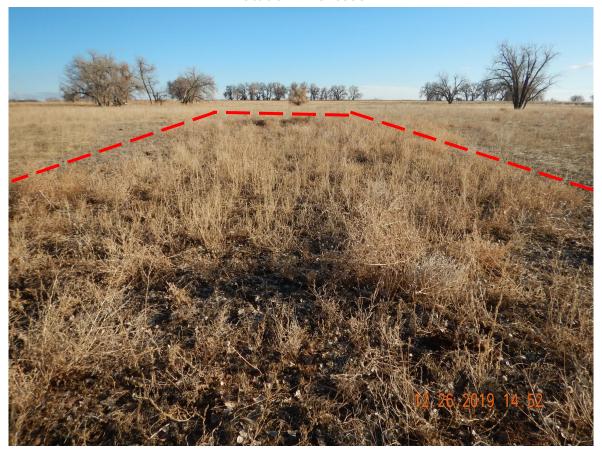
Photo 4. Photo taken from the northern access road, facing South. See comments under Photo 3.

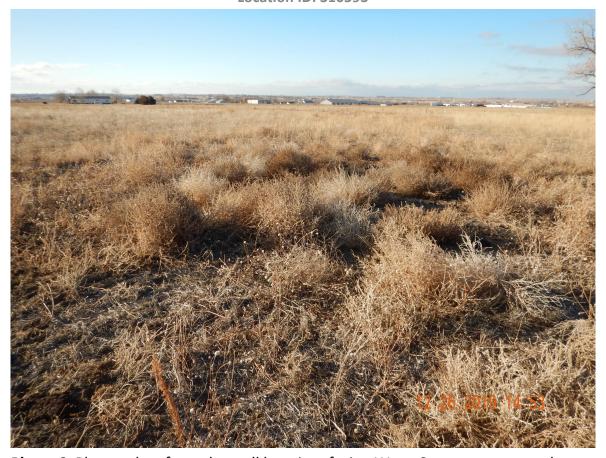
Photo 5. Photo taken from the northern access road, facing East. See comments under Photo 3.
