Well Name: Ford Olson Unit 1 **API #** 05-067-05464

Inspection Number: 693900214

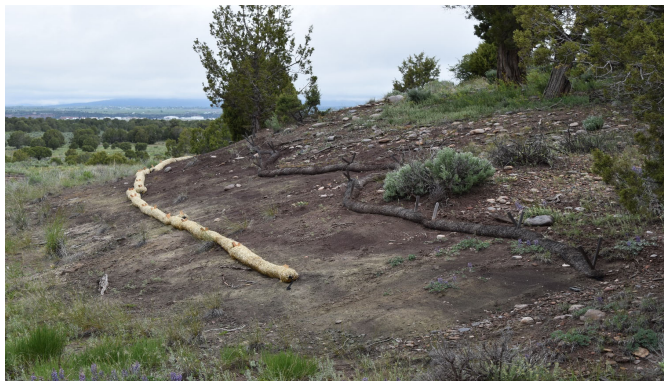
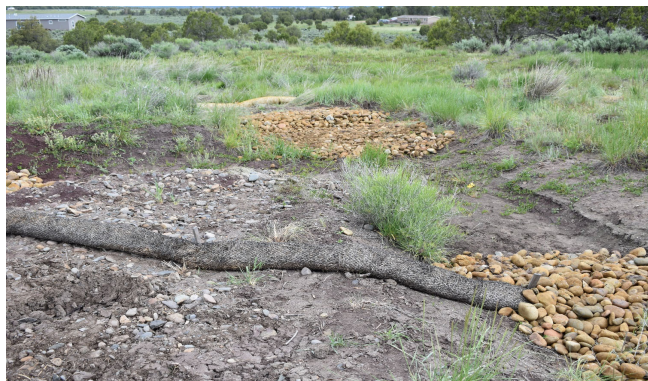
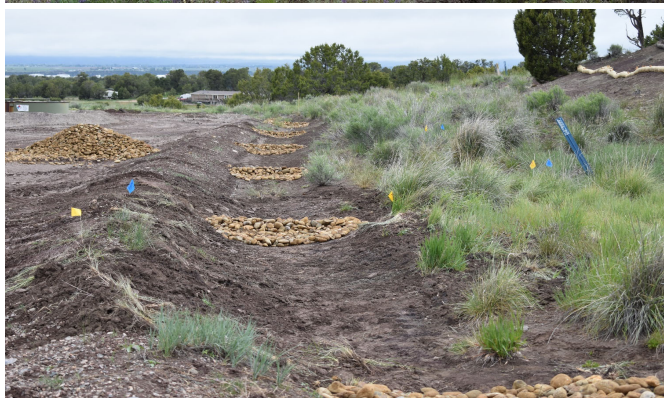
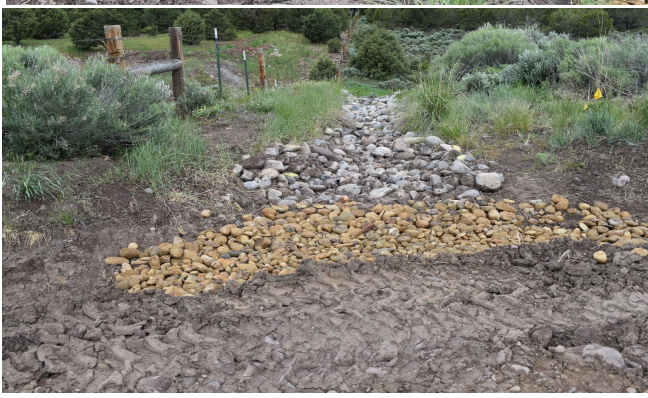
Corrective Action: Storm water controls need maintenance or replaced, additional erosion control measures need to be taken along eastern cut slope and drainage ditches.

Action Taken: Cleaned out and added waddles to eastern cut slope, cleaned out and installed rock check dams to drainage ditches.
