# Interim Reclamation and Stormwater Inspection

February 13, 2020

Operator: BONANZA CREEK ENERGY OPERATING COMPANY LLC -  
#8960

Location ID: 432395

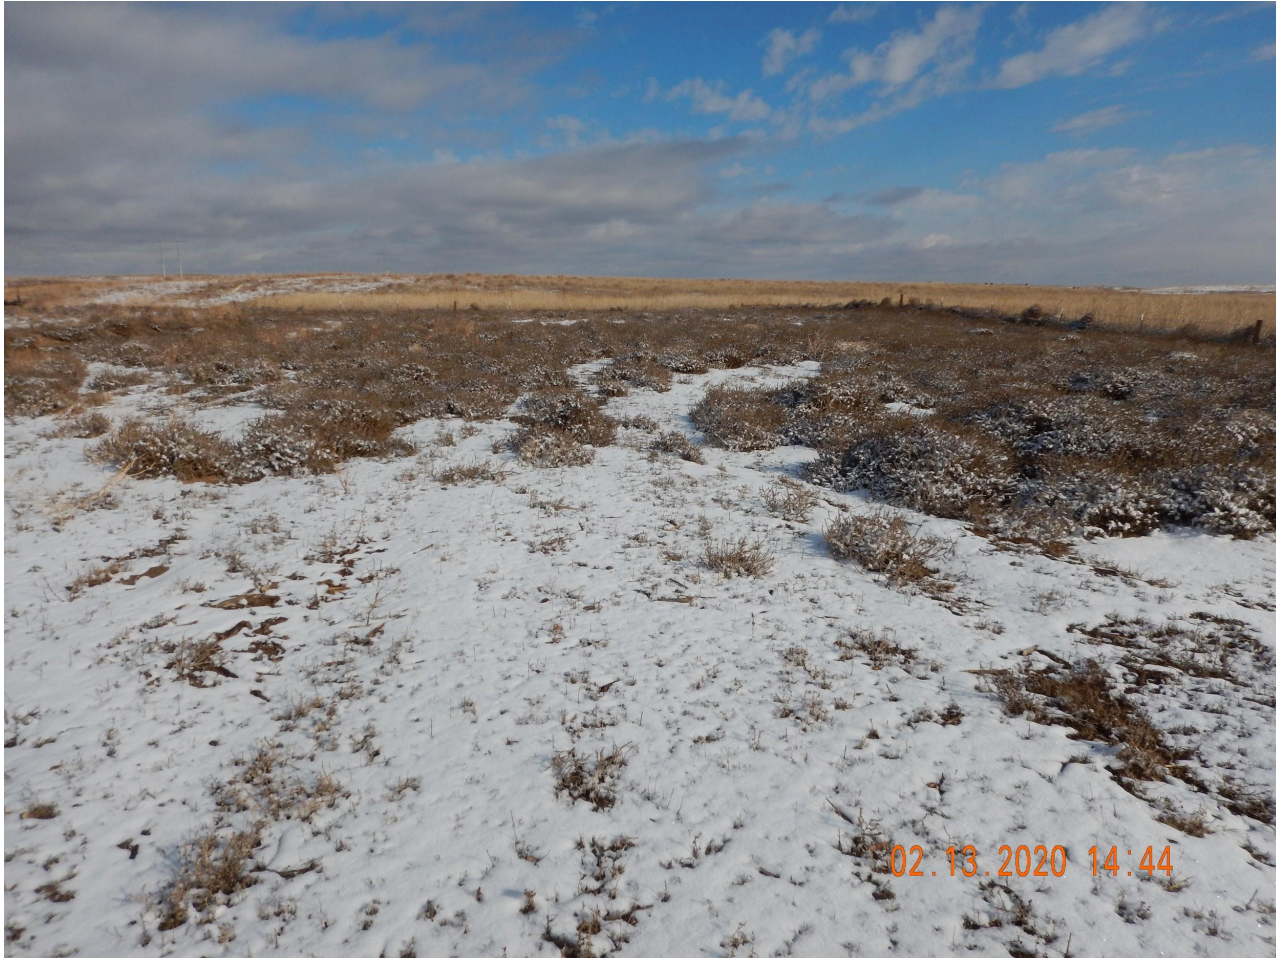
**Photo 1.** Photo taken from the southern interim reclamation area, facing East. Photo illustrates weedy annual vegetation consisting mostly of Russian thistle with little to no desirable vegetation.

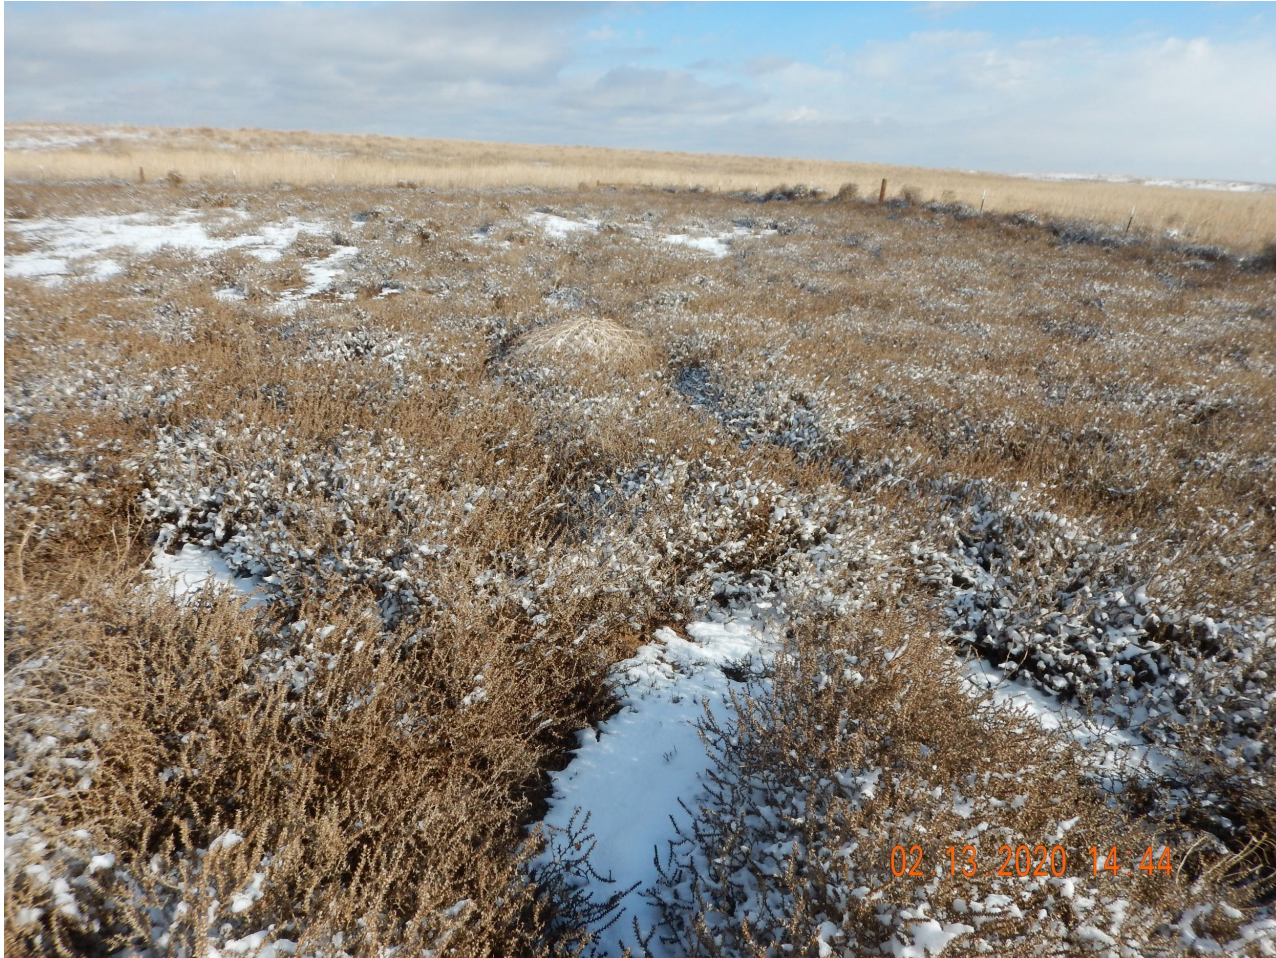
**Photo 2.** Photo taken from the southeastern interim area, facing East. See comments under Photo 1. Photo also illustrates weed debris in the perimeter fence.

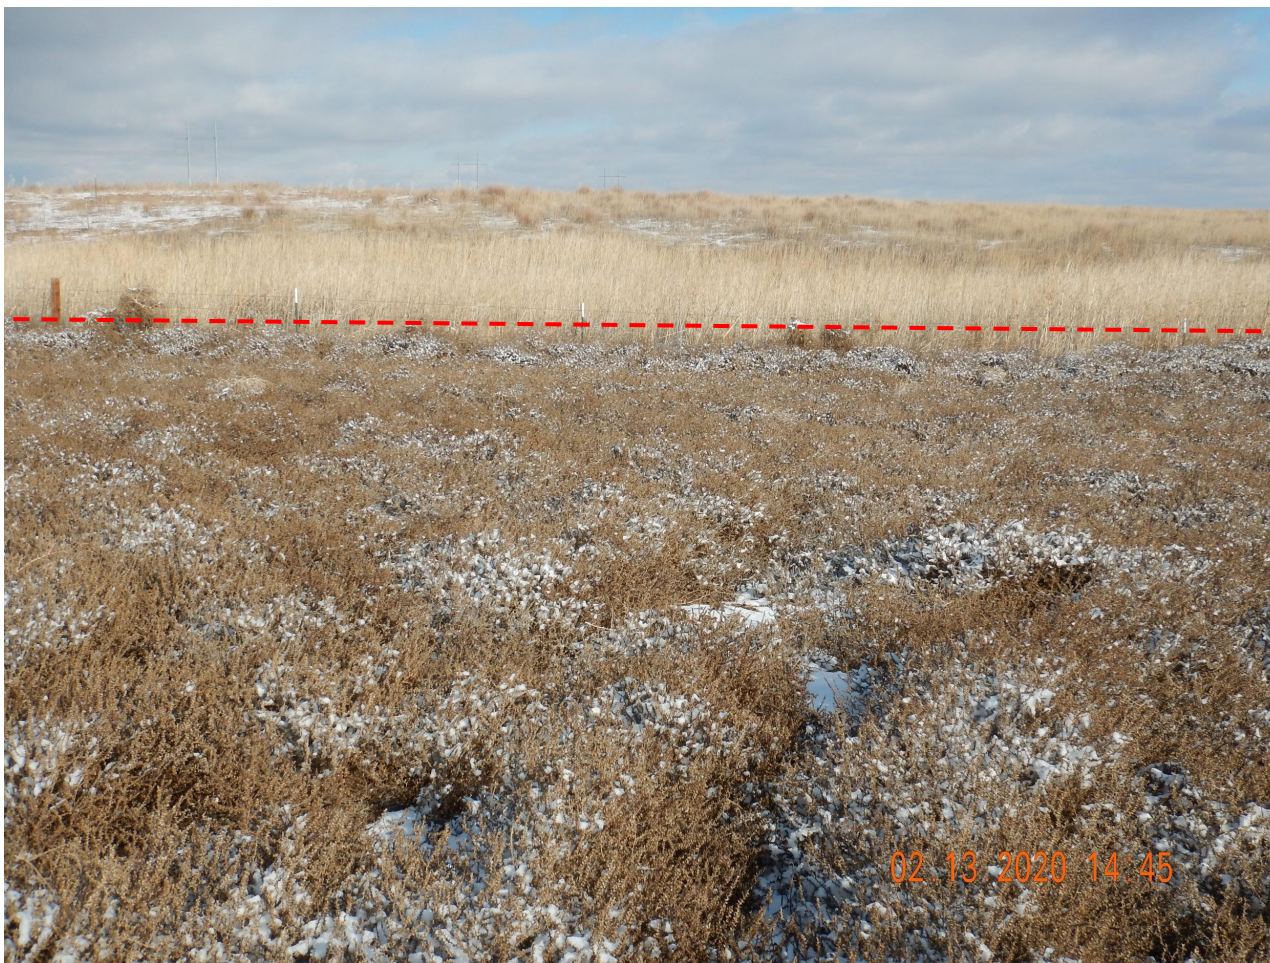
**Photo 3.** Photo taken from the southeastern interim area, facing East. Photo illustrates the interim area in contrast to the reference area vegetation.

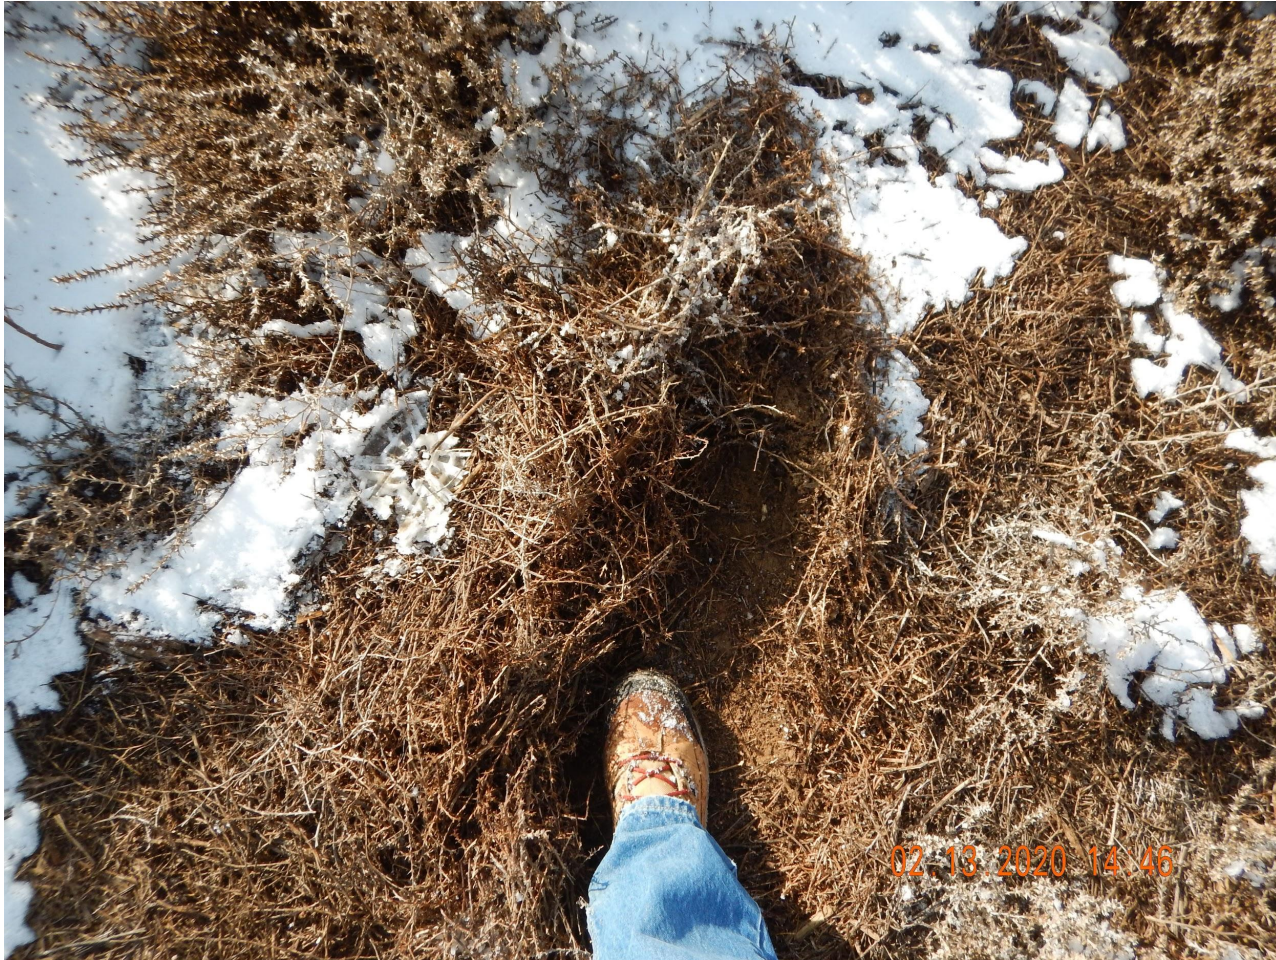
**Photo 4.** Close up photo taken with the dense patch of Russian thistle. Photo illustrates a thick (~3-5") layer of Russian thistle thatch likely negatively affecting successful germination of desirable species.

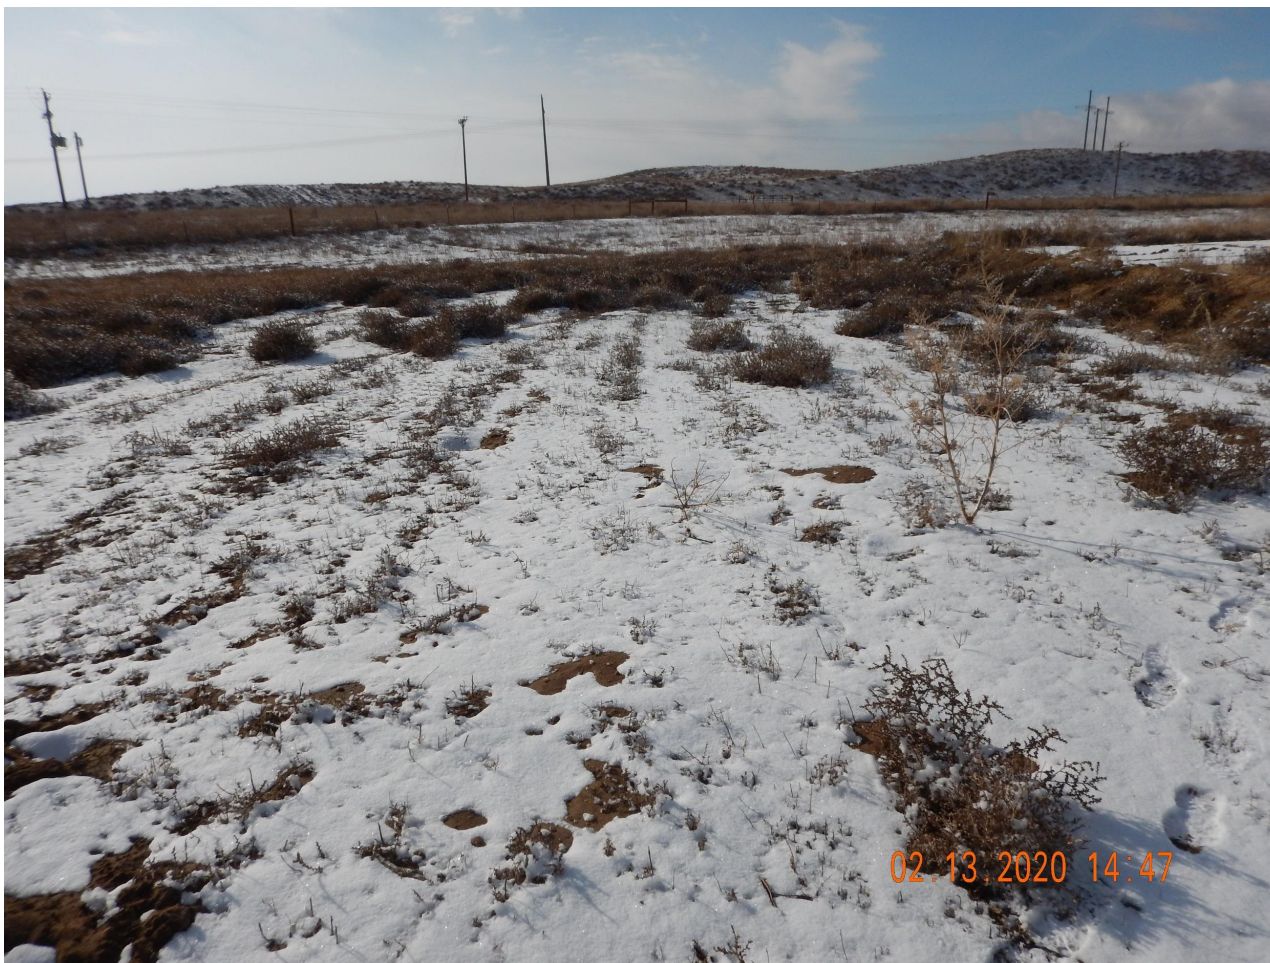
**Photo 5.** Photo taken from the southwestern interim area, facing West. See comments under Photo 1.

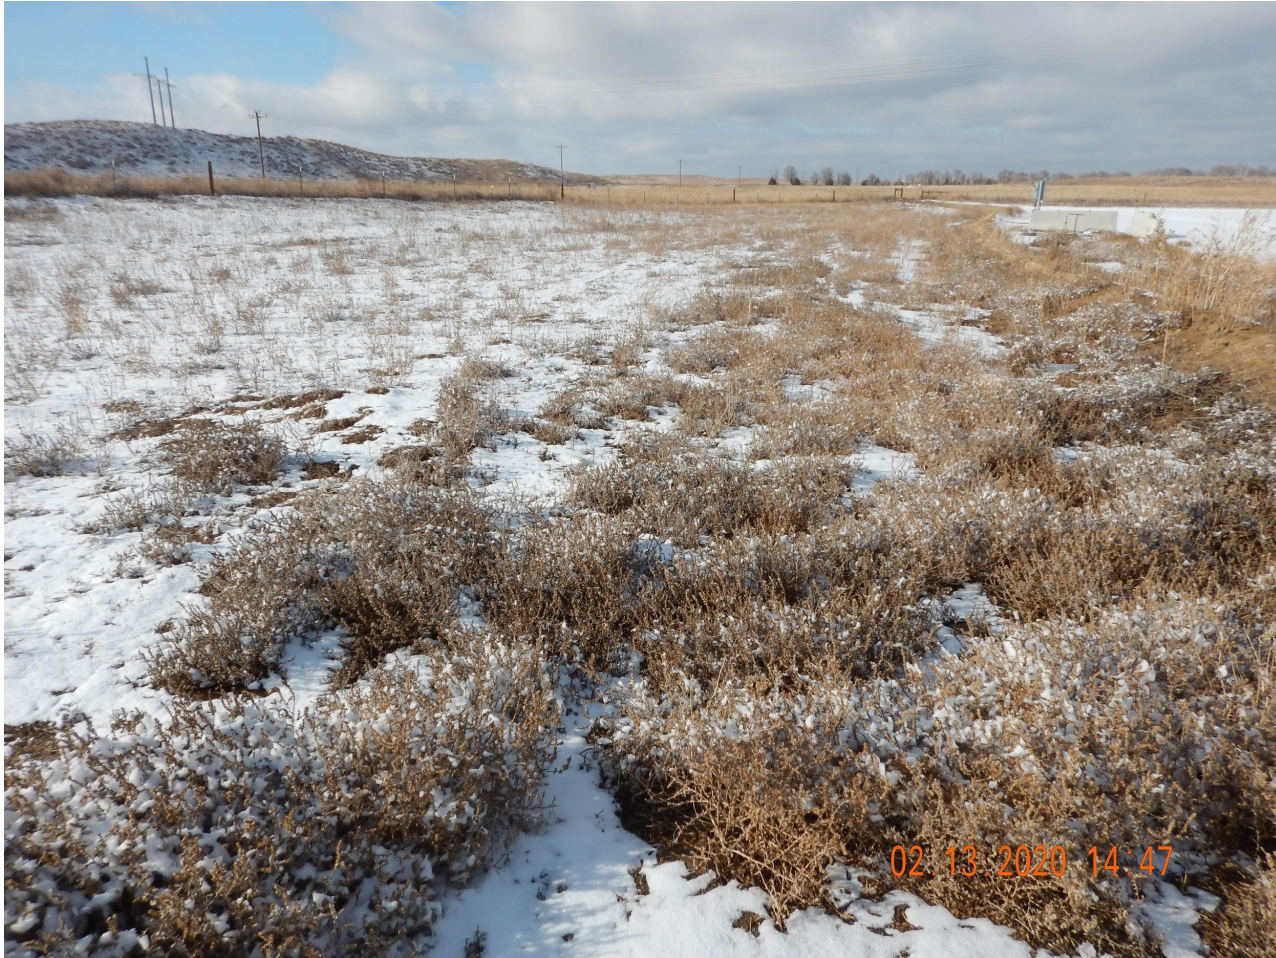
**Photo 6.** Photo taken from the southwestern interim area, facing North. See comments under Photo 1.
