# Interim Reclamation and Stormwater Inspection

Operator: NOBLE ENERGY INC- #100322

Location ID: 449370

Inspection Document #: 697501223

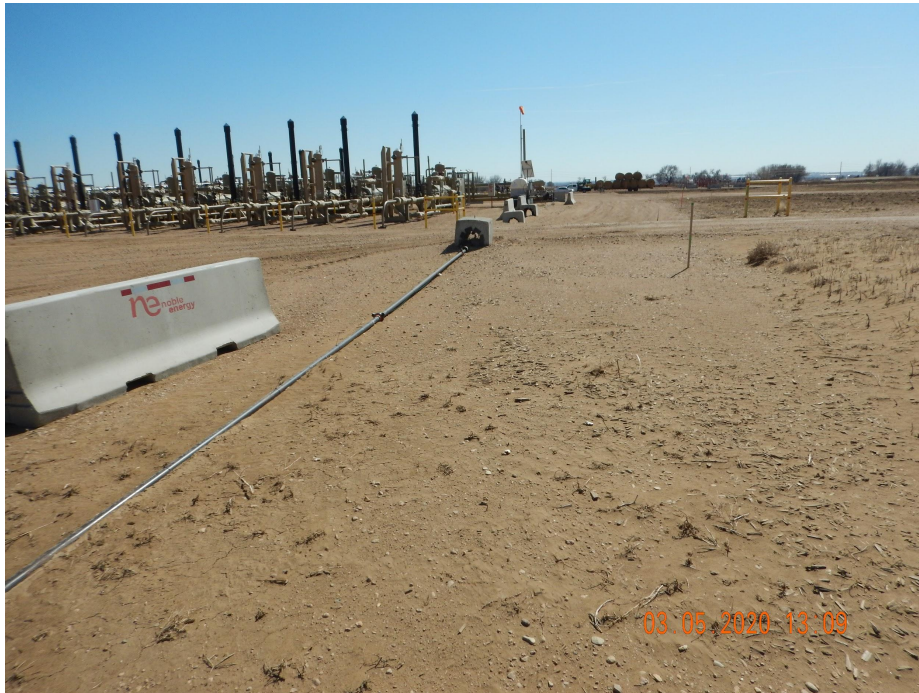
**Photo 1.** Photo taken from the western production facility location, facing South. Photo illustrates the production equipment in relation to the western disturbance area. It does not appear the Operator can reduce the size of the location any further.

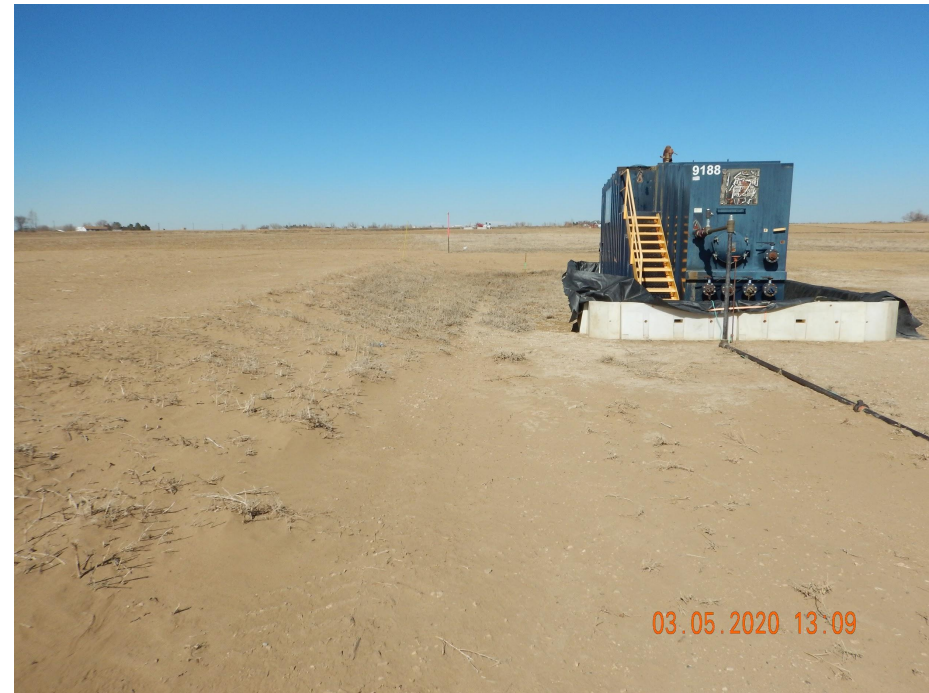
**Photo 2.** Photo taken from the western production facility location, facing North. See comments under Photo 1.

Also, photo illustrates the western portion of this location is cut.

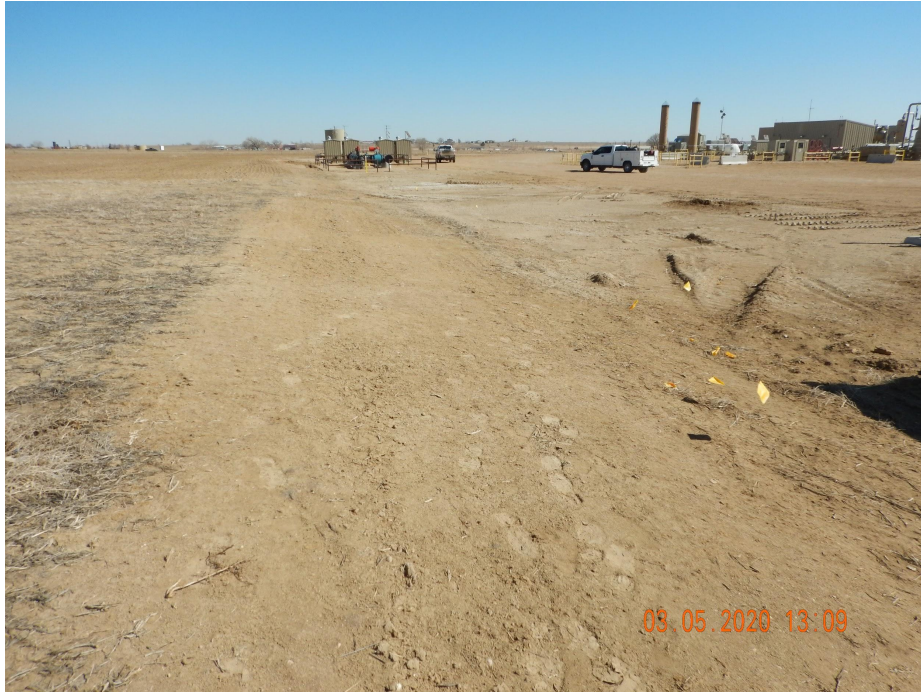
**Photo 3.** Photo taken from the northwestern production facility location, facing East. See comments under Photo 1.

Also, photo illustrates the northern portion of this location is cut.

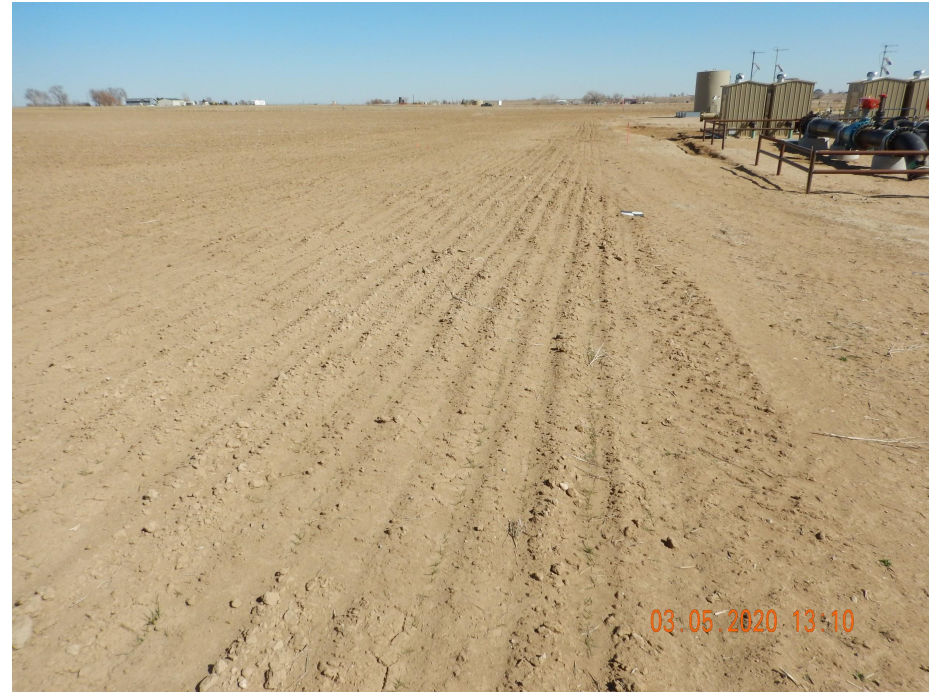
**Photo 4.** Photo taken from the northern production facility location, facing East. See comments under Photo 1.

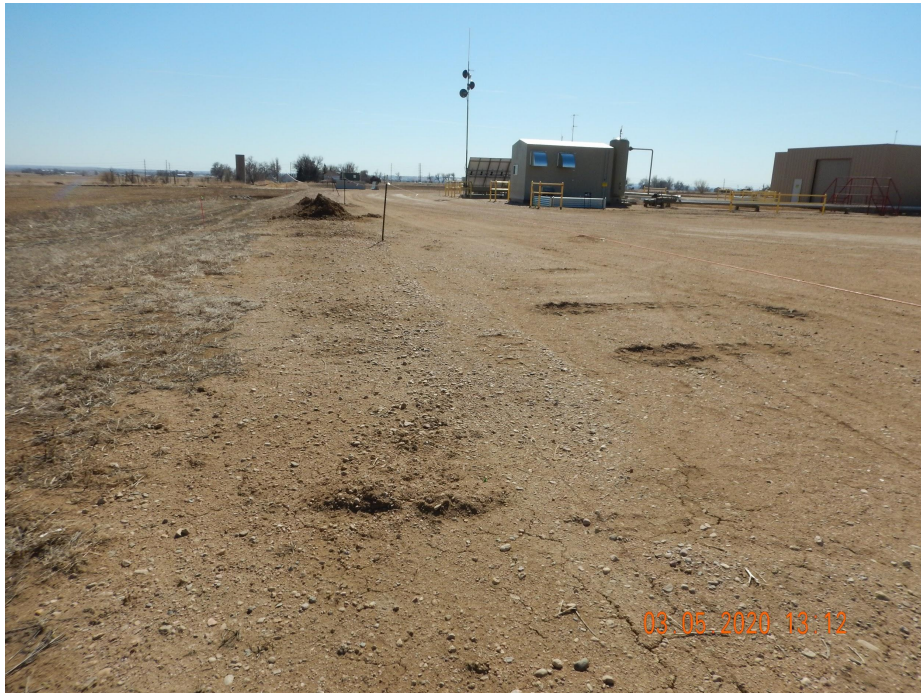
**Photo 5.** Photo taken from the northeastern production facility location, facing South. See comments under Photo 1.

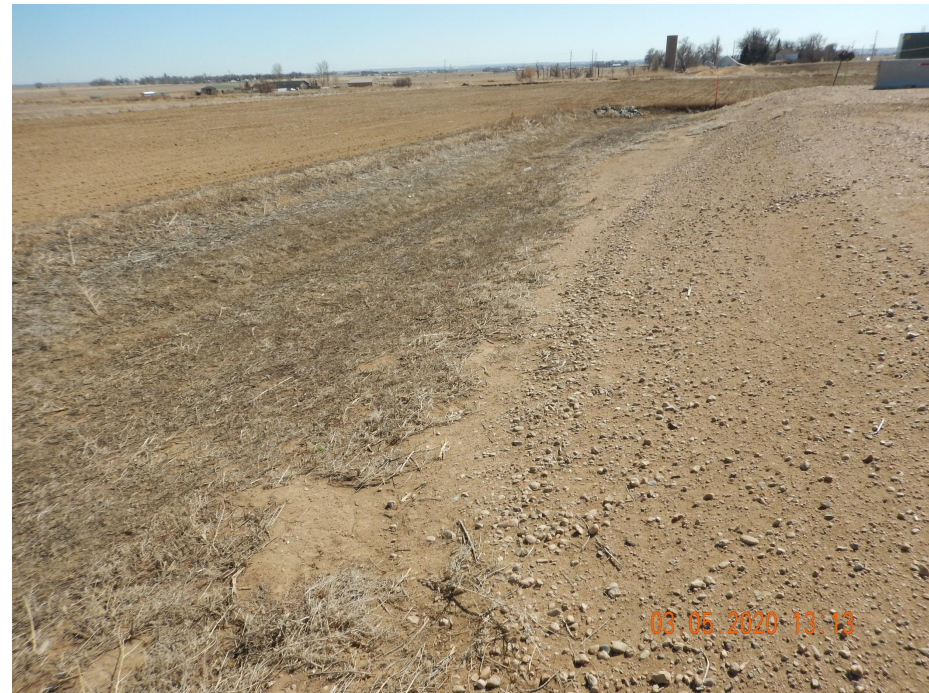
**Photo 6.** Photo taken from the eastern production facility location, facing South. Photo illustrates a retention area with a stabilized outlet (southeastern corner).

Also, photo illustrates the eastern portion is fill.

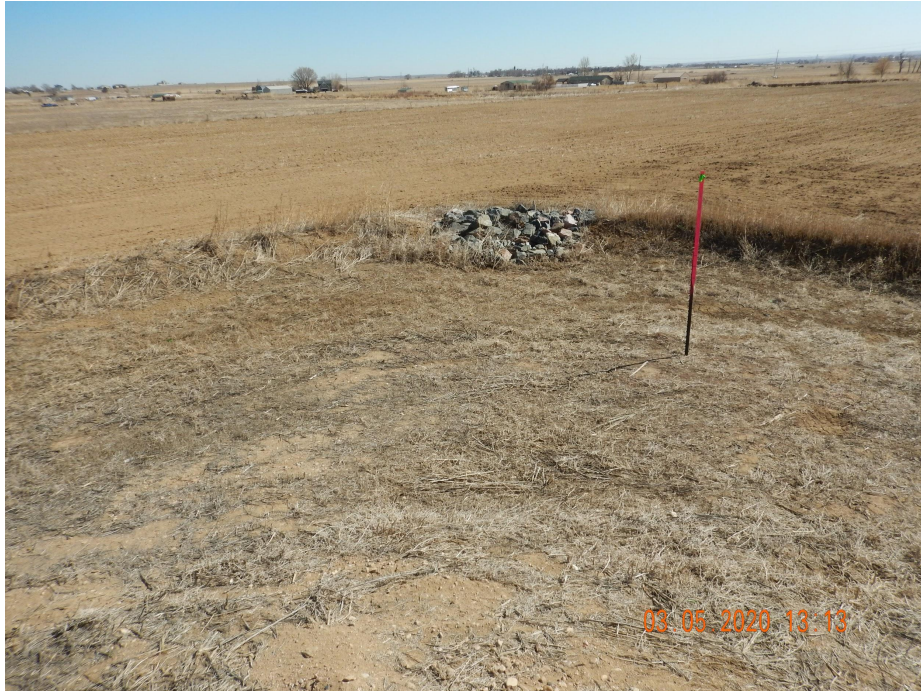
**Photo 7.** Photo taken from the southeastern production facility location, facing Southeast. Photo illustrates a stabilized outlet.

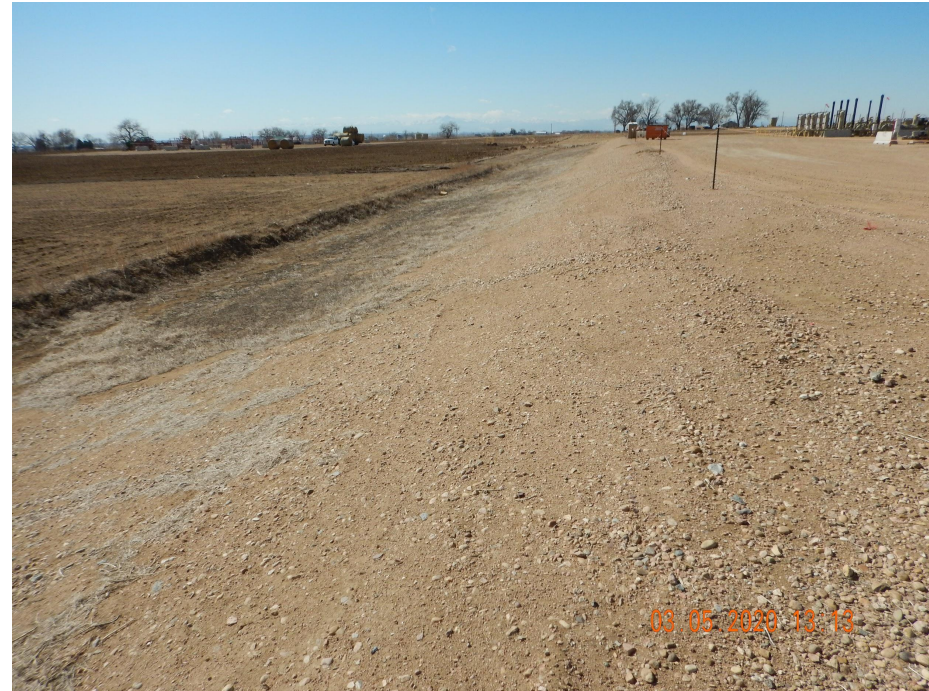
**Photo 8.** Photo taken from the southeastern production facility location, facing West. Photo illustrates a ditch and berm along the southern location that is directed to a stabilized outlet.

Also, photo illustrates the southern portion is fill.

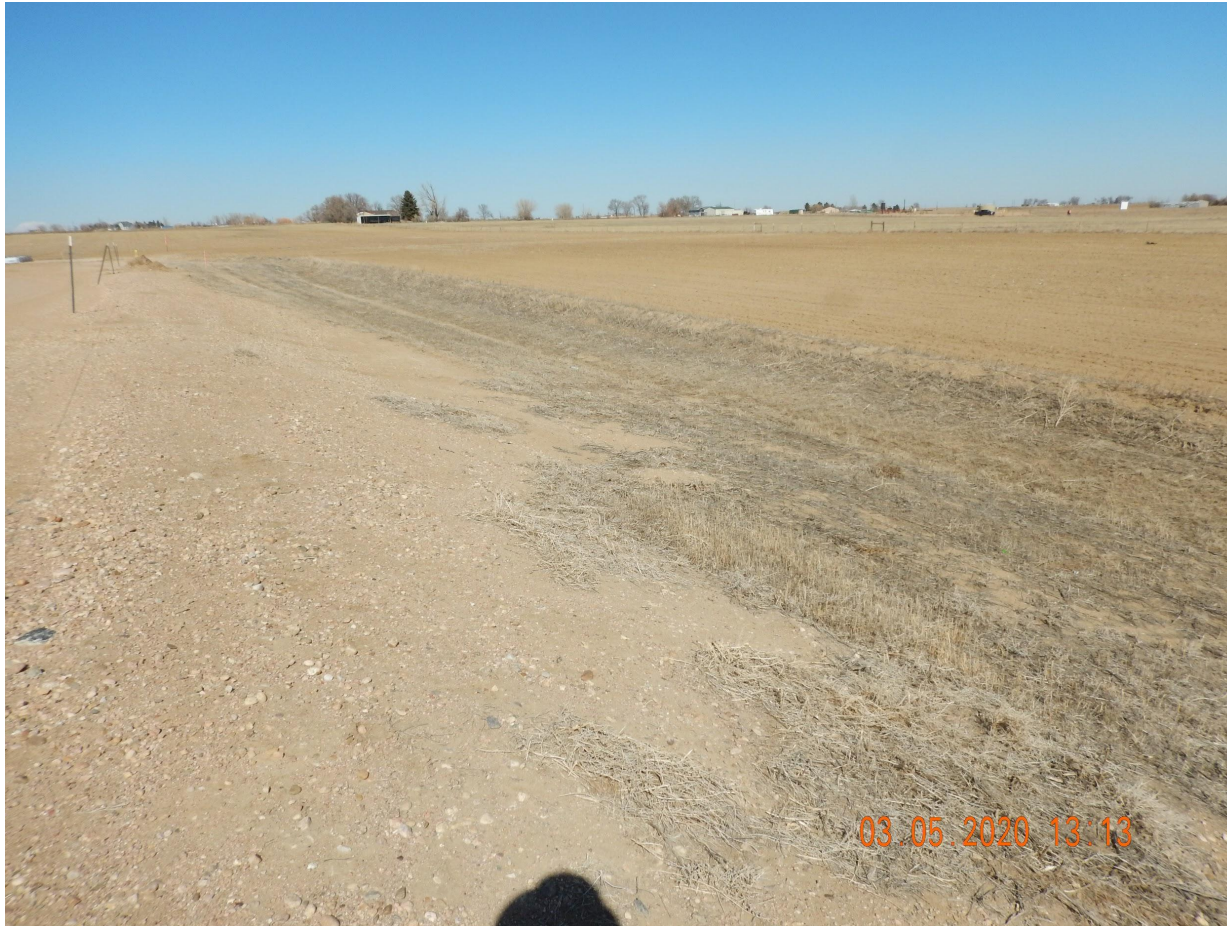
**Photo 9.** Photo taken from the southern production facility location, facing East. See comments under Photo 8.
