Inspection Photos  
Operator: Dugan Production  
API#: 067-06497  
Date: 4/3/2020

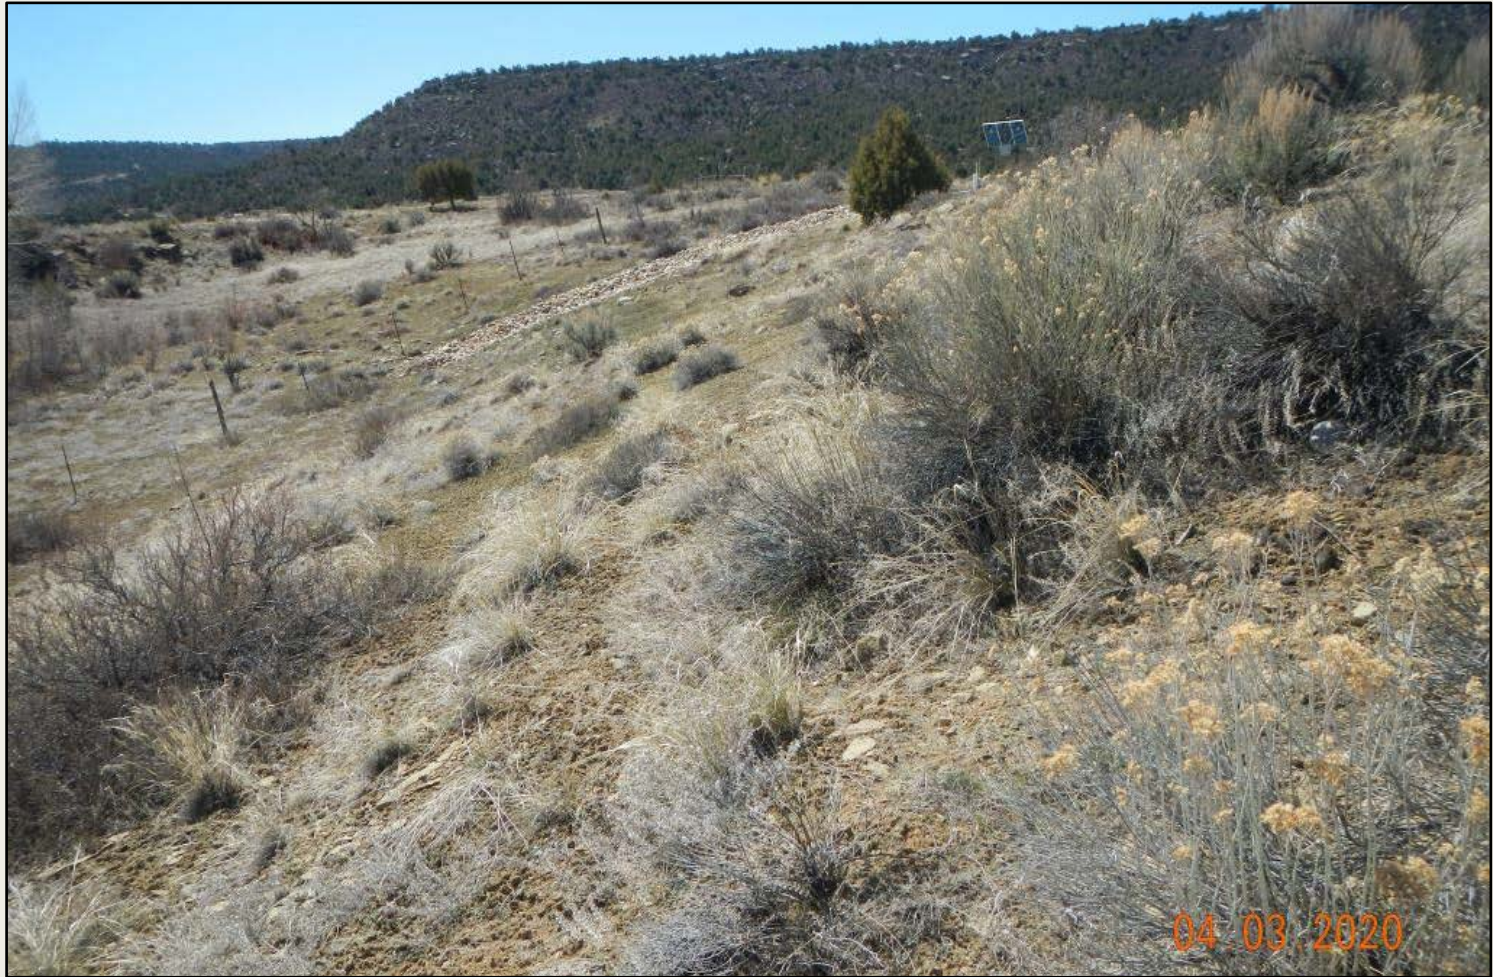
Photo 1. View of the eastern project area from the northeastern corner facing southward. Revegetation is progressing with grasses such as Indian ricegrass and shrubs such as rubber rabbitbrush and antelope bitterbrush.

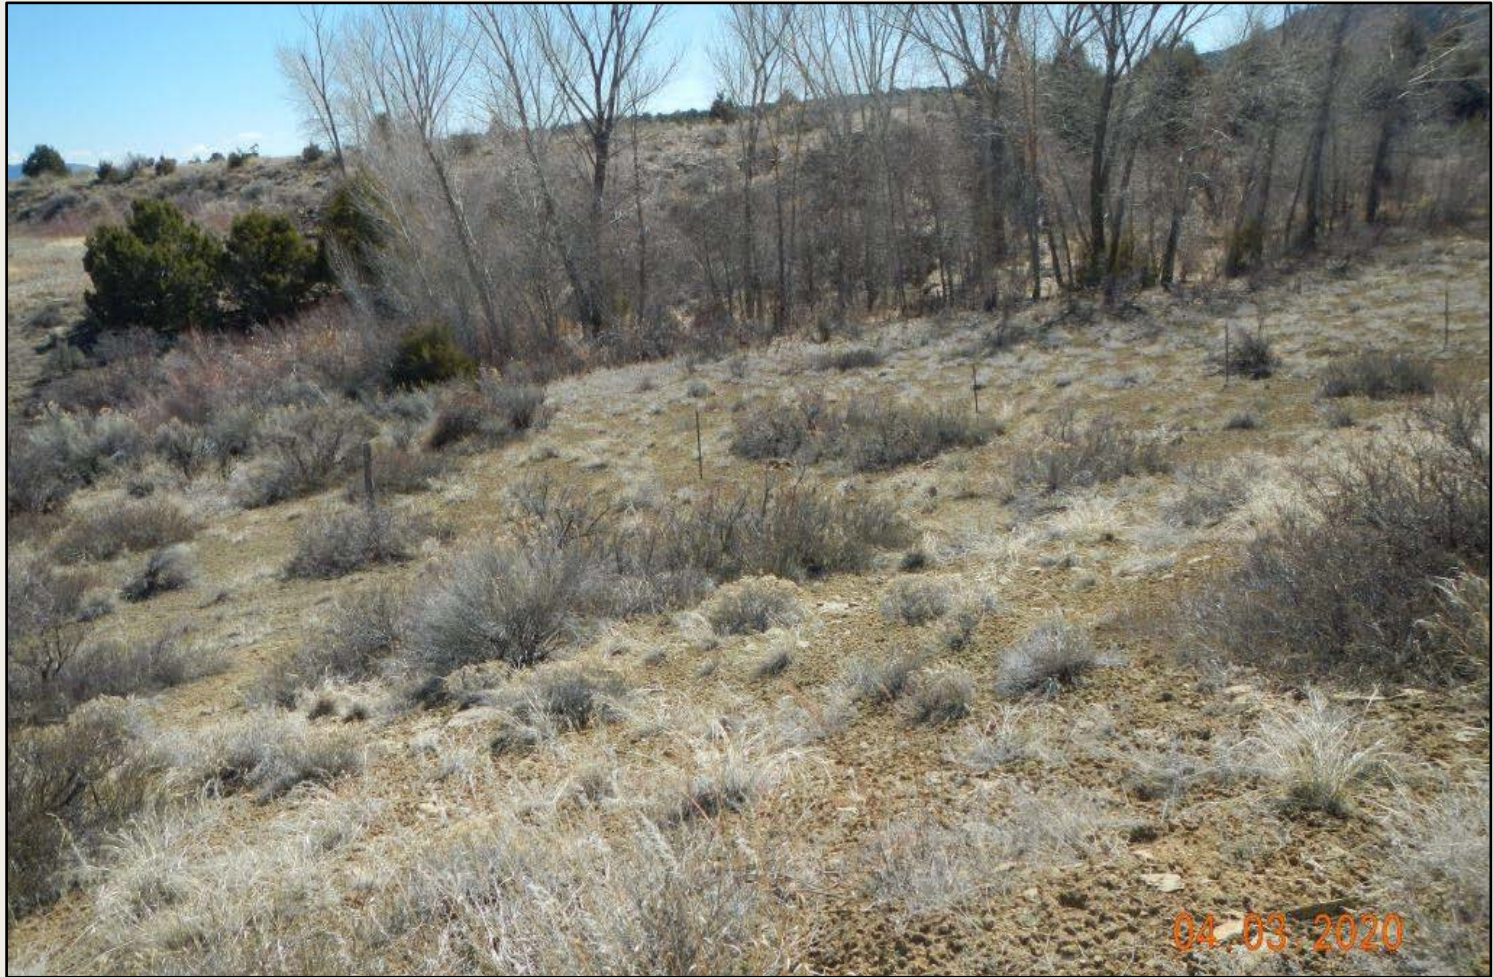
Photo 2. View of area where debris was identified in 2018 reclamation inspection. Debris is no longer present.

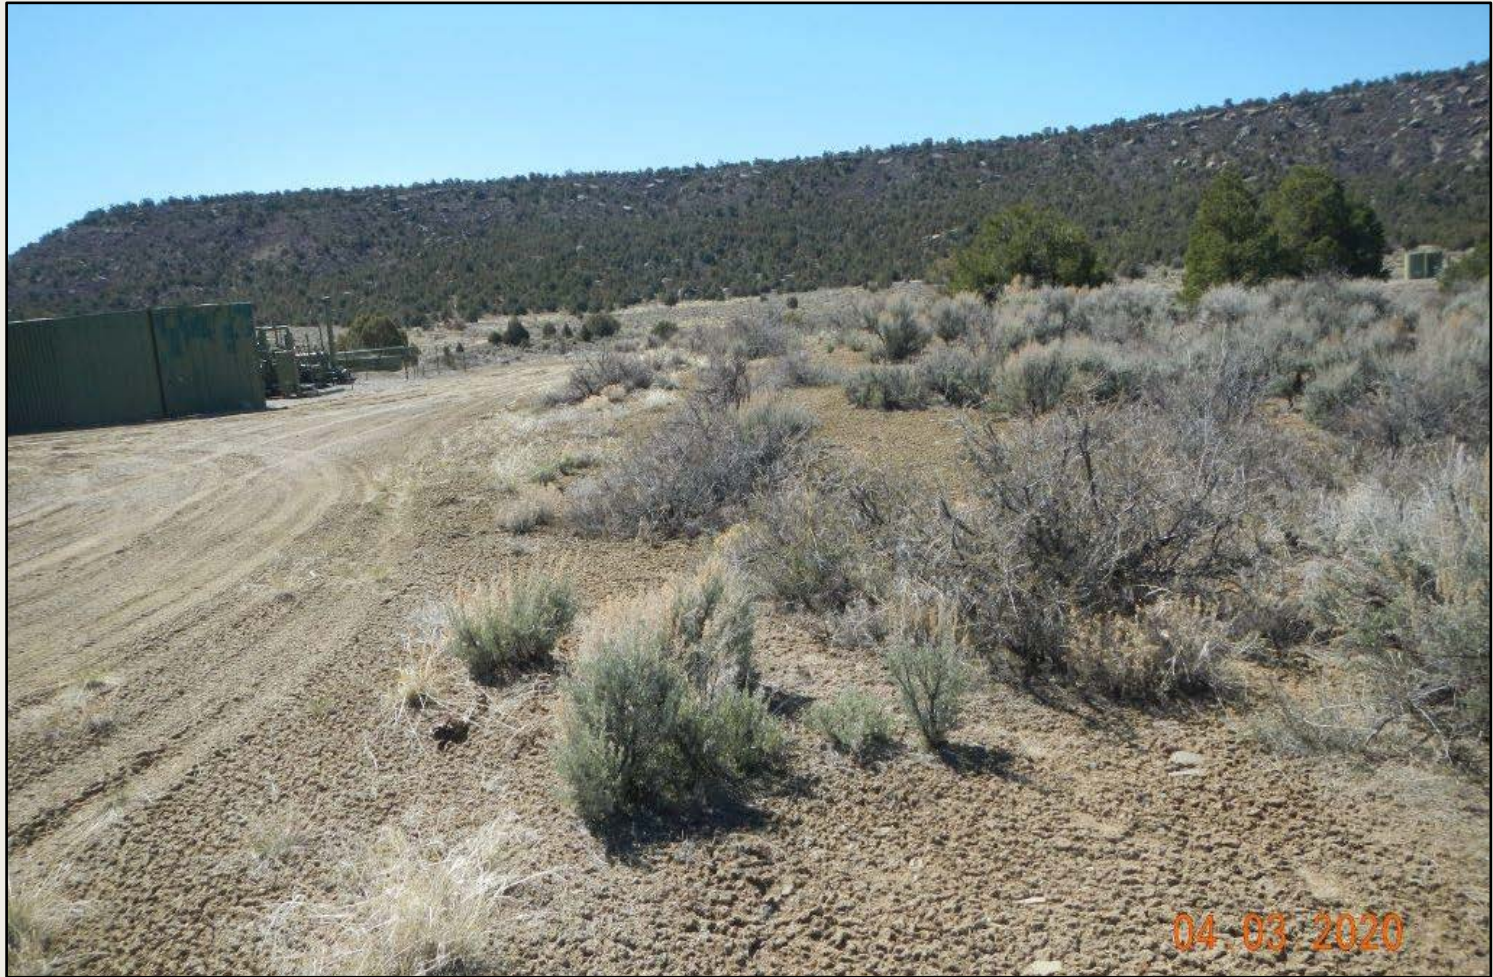
Photo 3. View of the western project area from the northwestern corner facing southward.

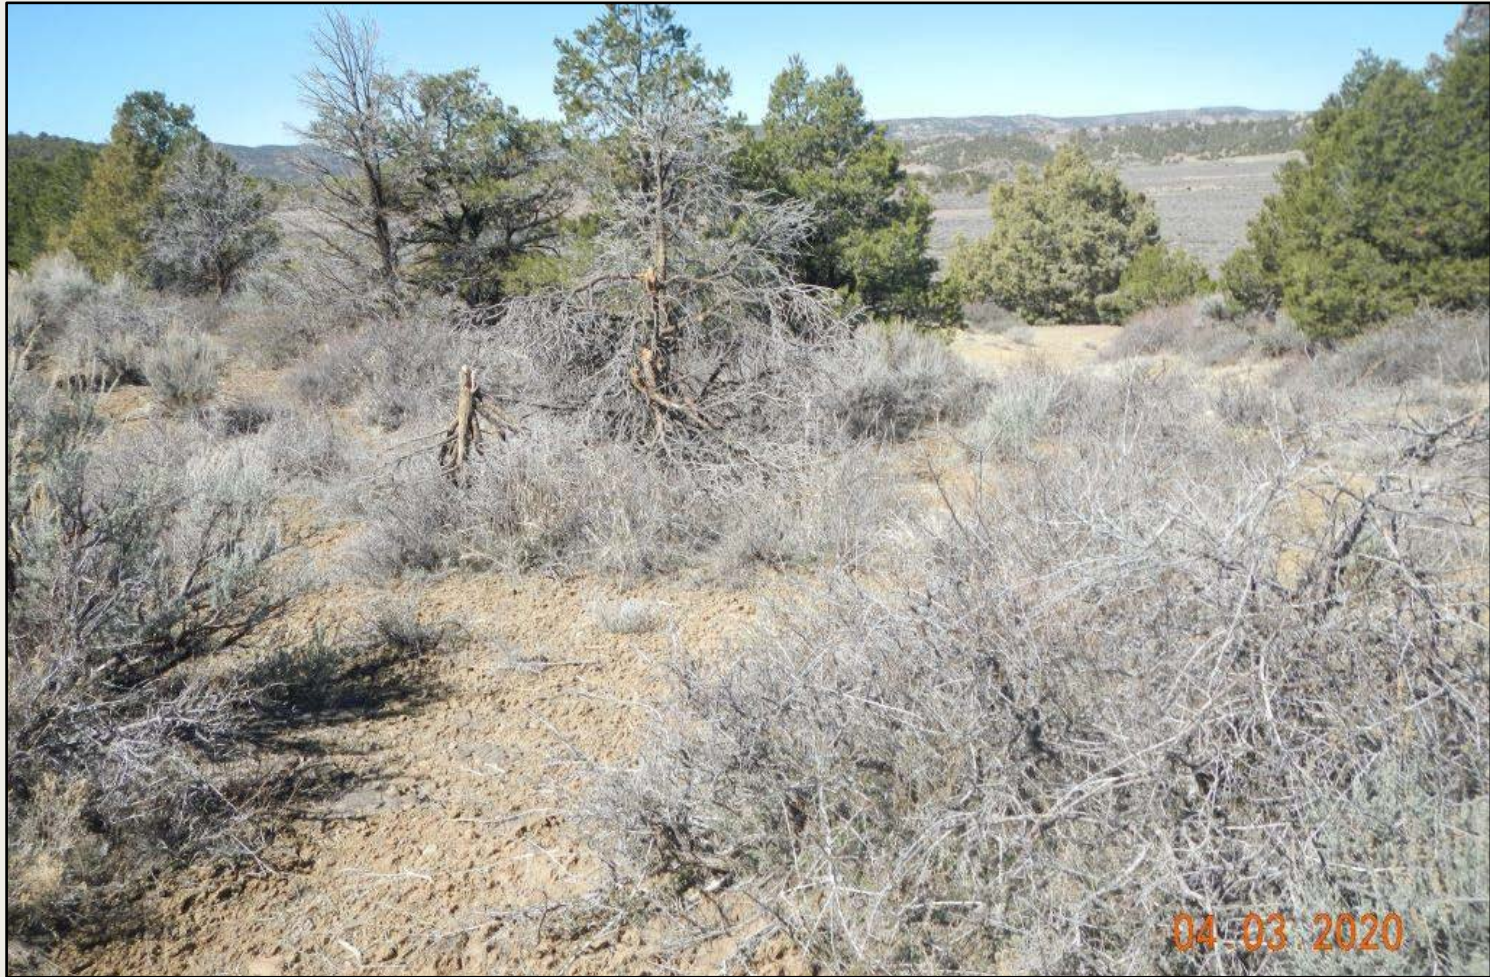
Photo 4. View of reference area vegetation comprised of pinyon-juniper woodland with shrubs such as antelope bitterbrush and sagebrush, and forbs such as Indian ricegrass.
