Inspection Photos  
Operator: Catamount Energy  
API#: 007-06122  
Date: 5/15/2020

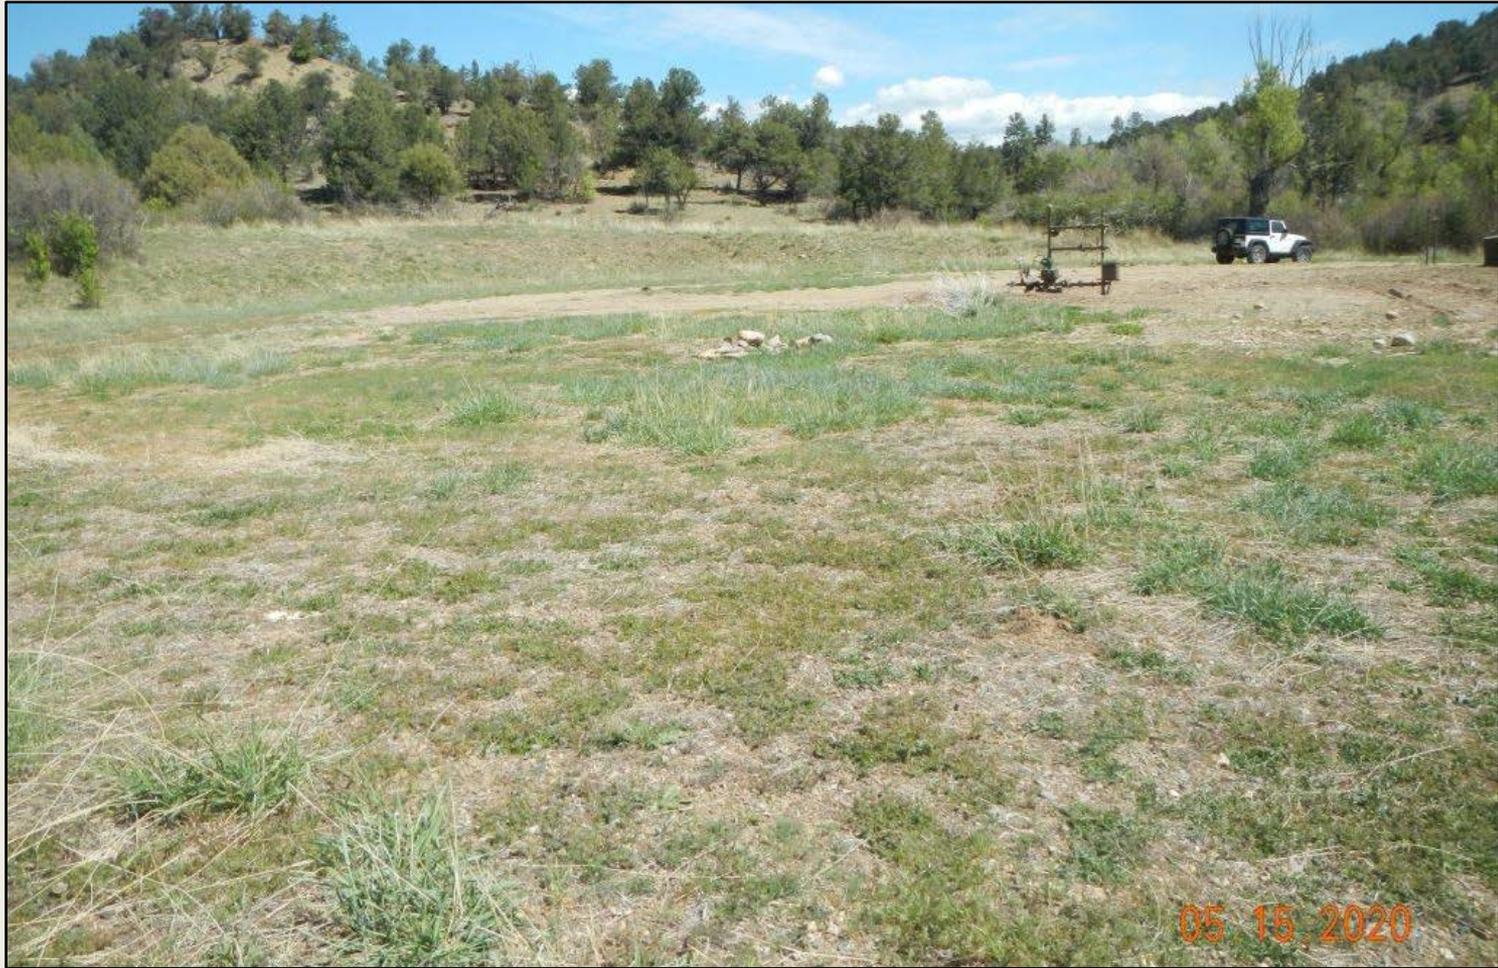
Photo 1. View of the project area from the southern corner facing center.

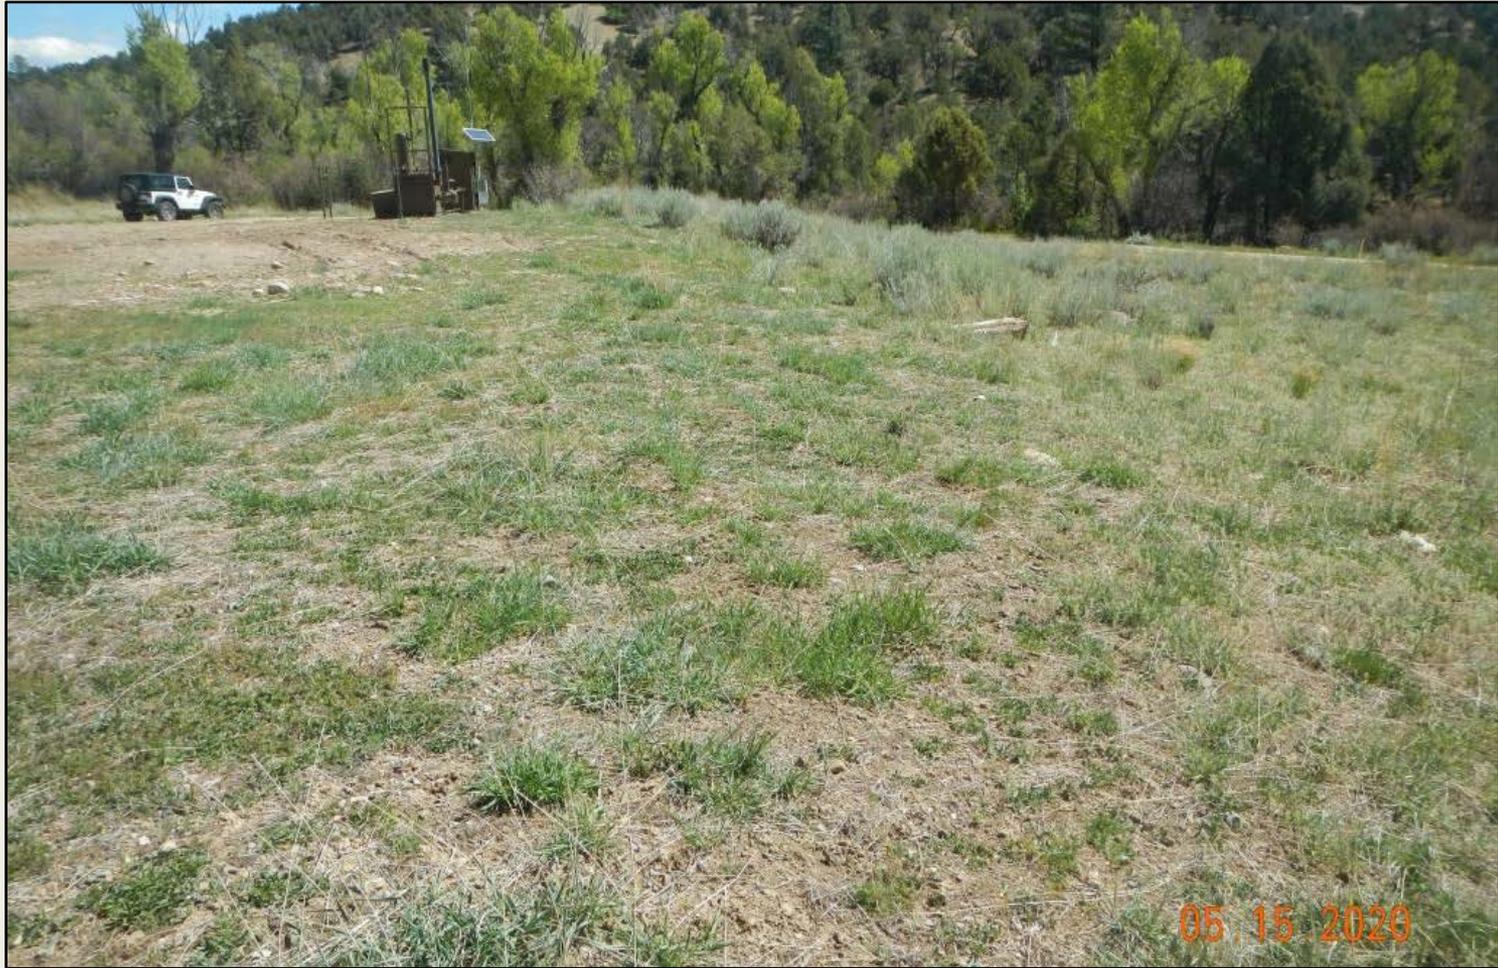
Photo 2. View of the southeastern project area from the southern corner facing northeastward. Revegetation is progressing with mixed wheatgrasses and rubber rabbitbrush.

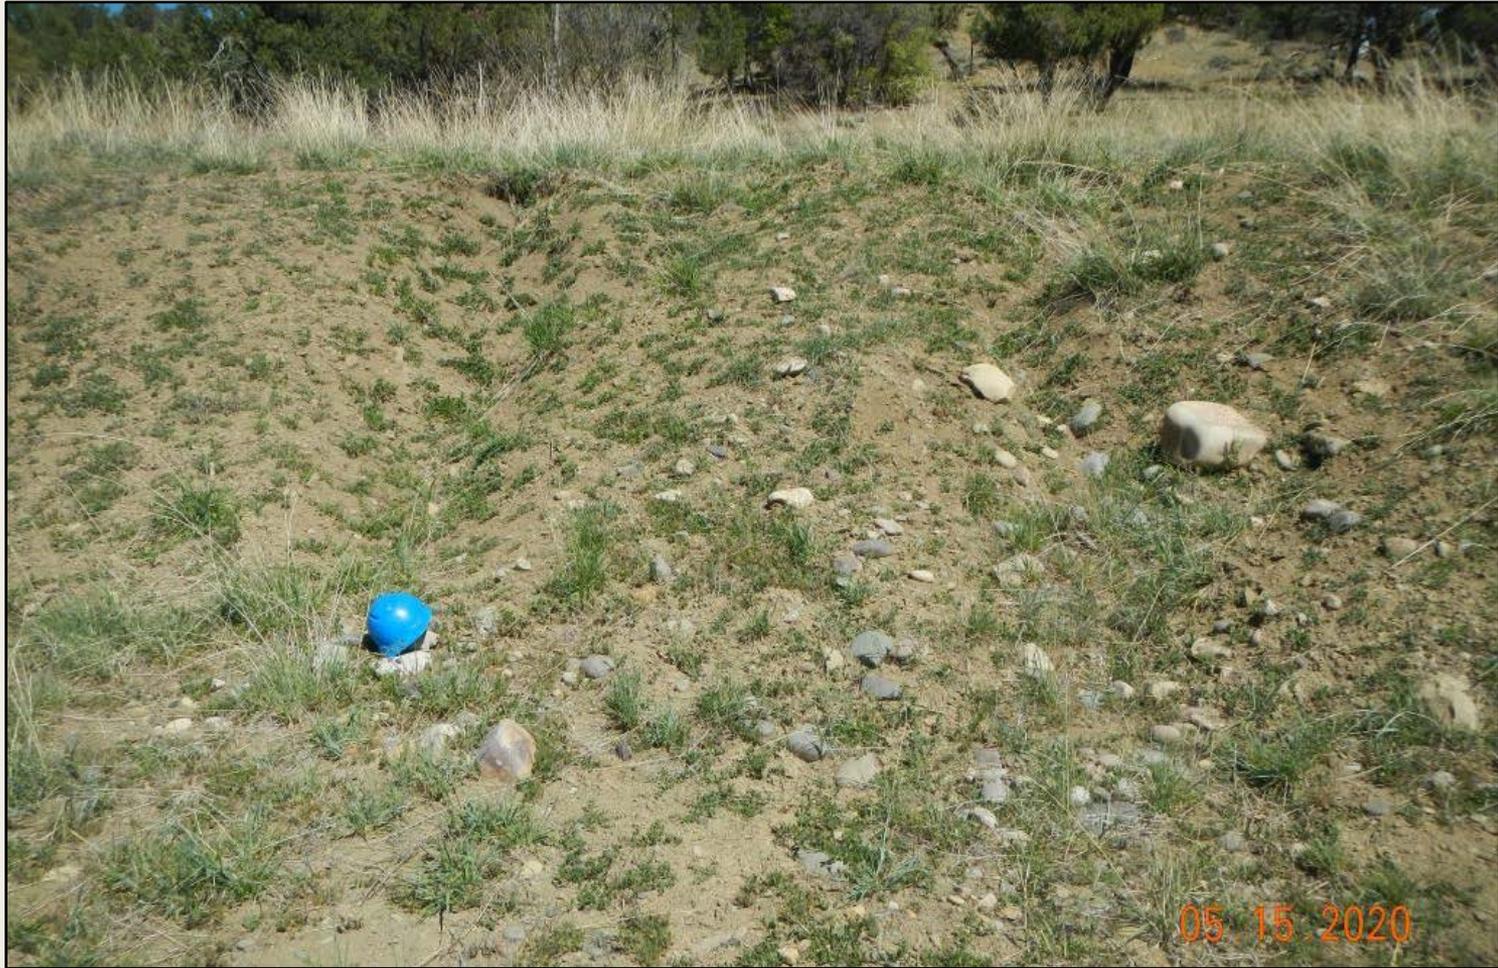
Photo 3. View of erosional channeling (approximately 1 foot wide and deep), within the northern project area. Hard hat in place for scale.

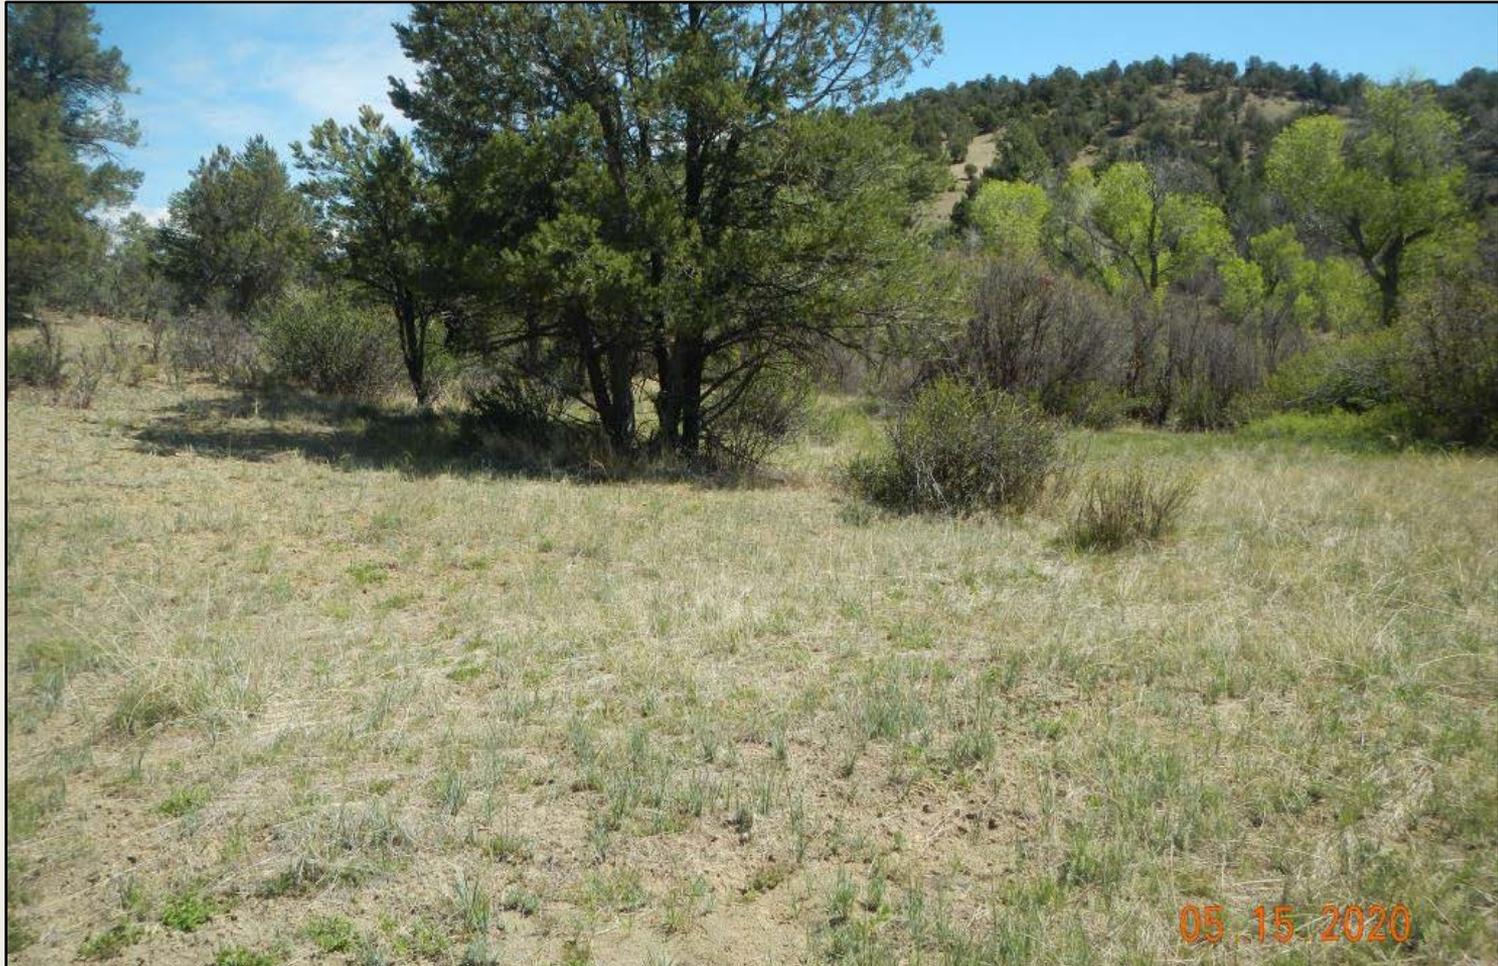
Photo 4. View of reference area vegetation comprised of mixed pinyon and juniper woodland, with gamble oak and mosaic, with grasses such as western wheatgrass and forbs such as *Penstemon* spp. in the understory.
