Location Name: – Ward and Son Operating - Loc ID 317166

Inspection Date: 06/23/2020

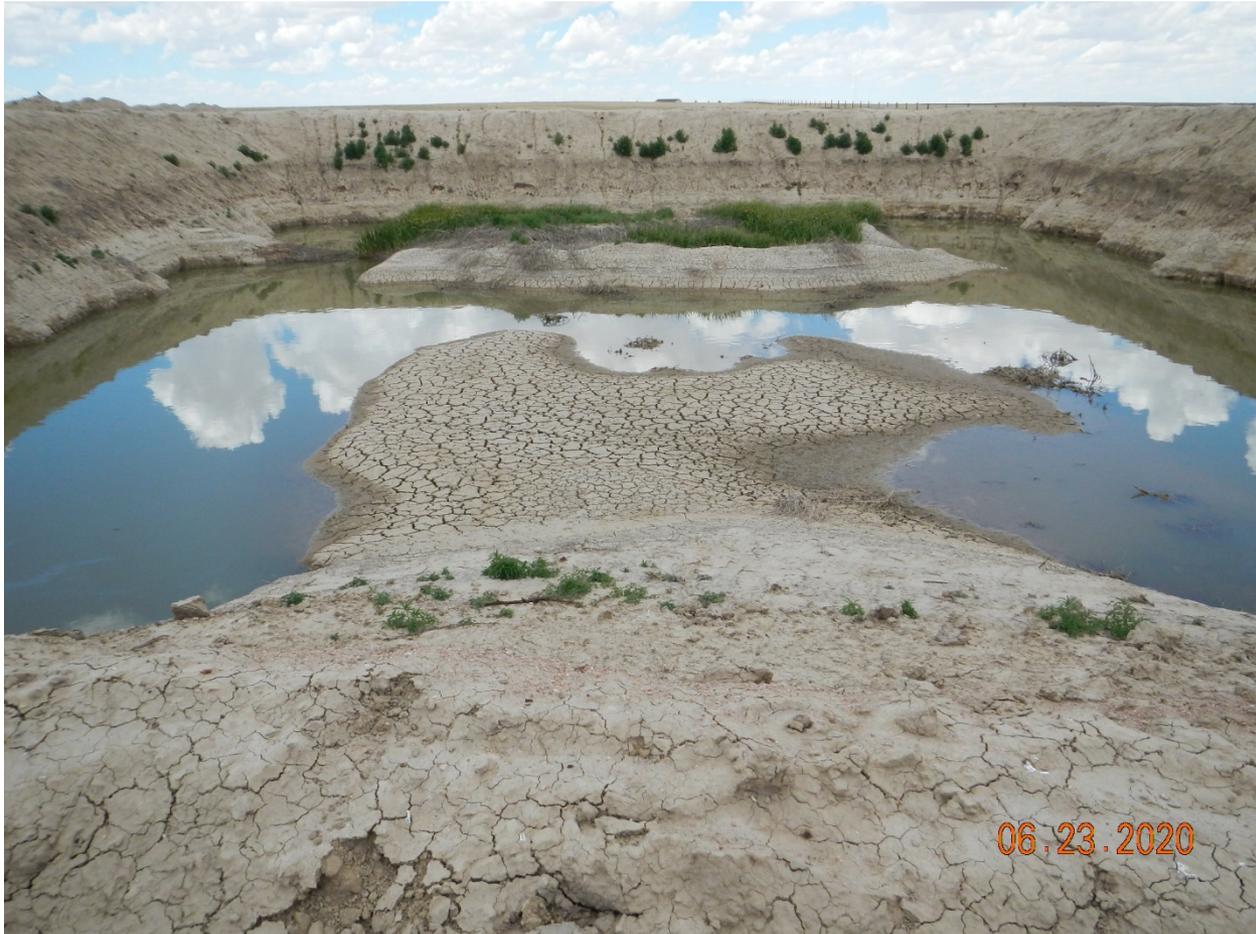
Photo # 5 – View north across Pit ID 117639 subject of Spill ID 476164

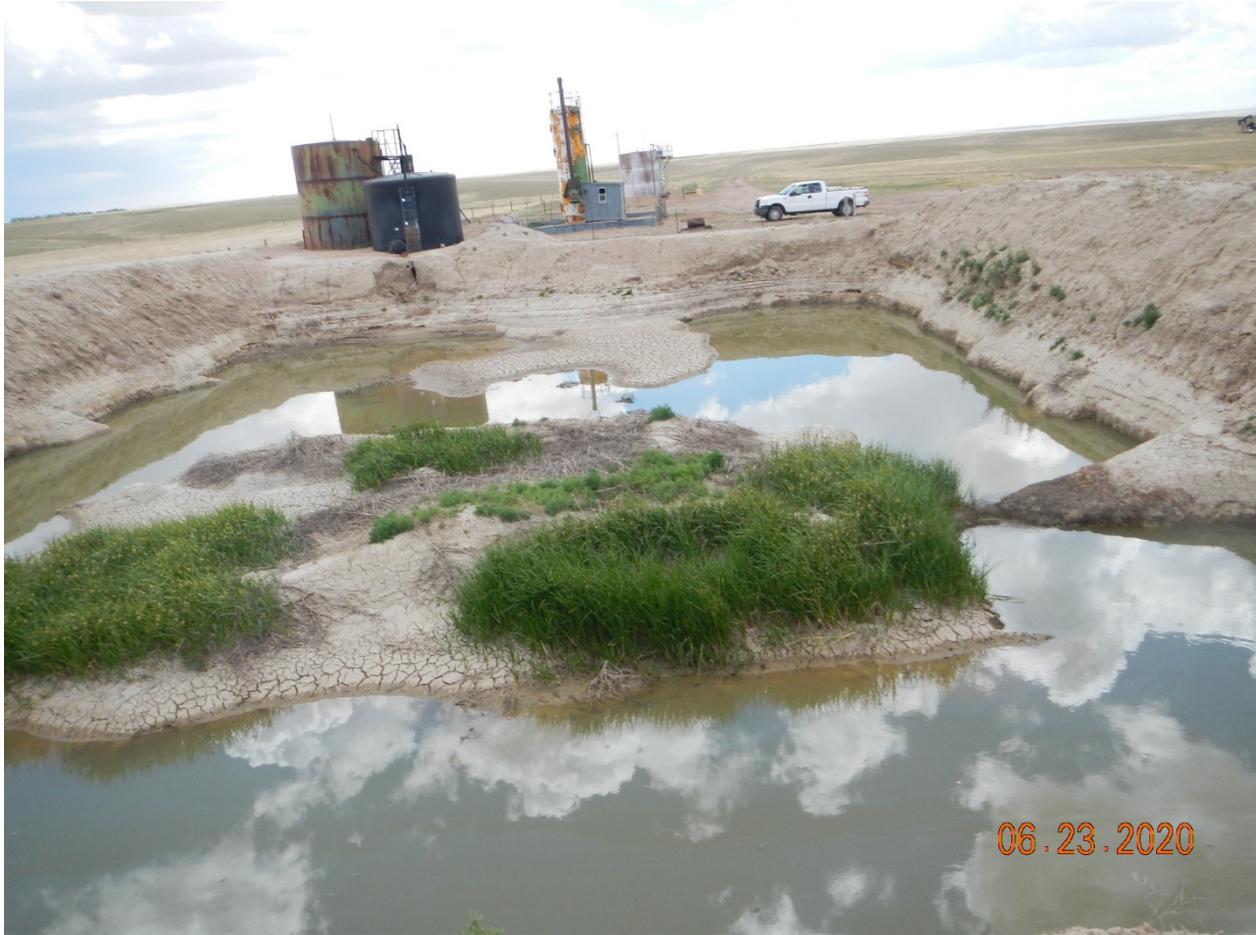
Photo # 6 – View south across Pit ID 117639 subject of Spill ID 476164

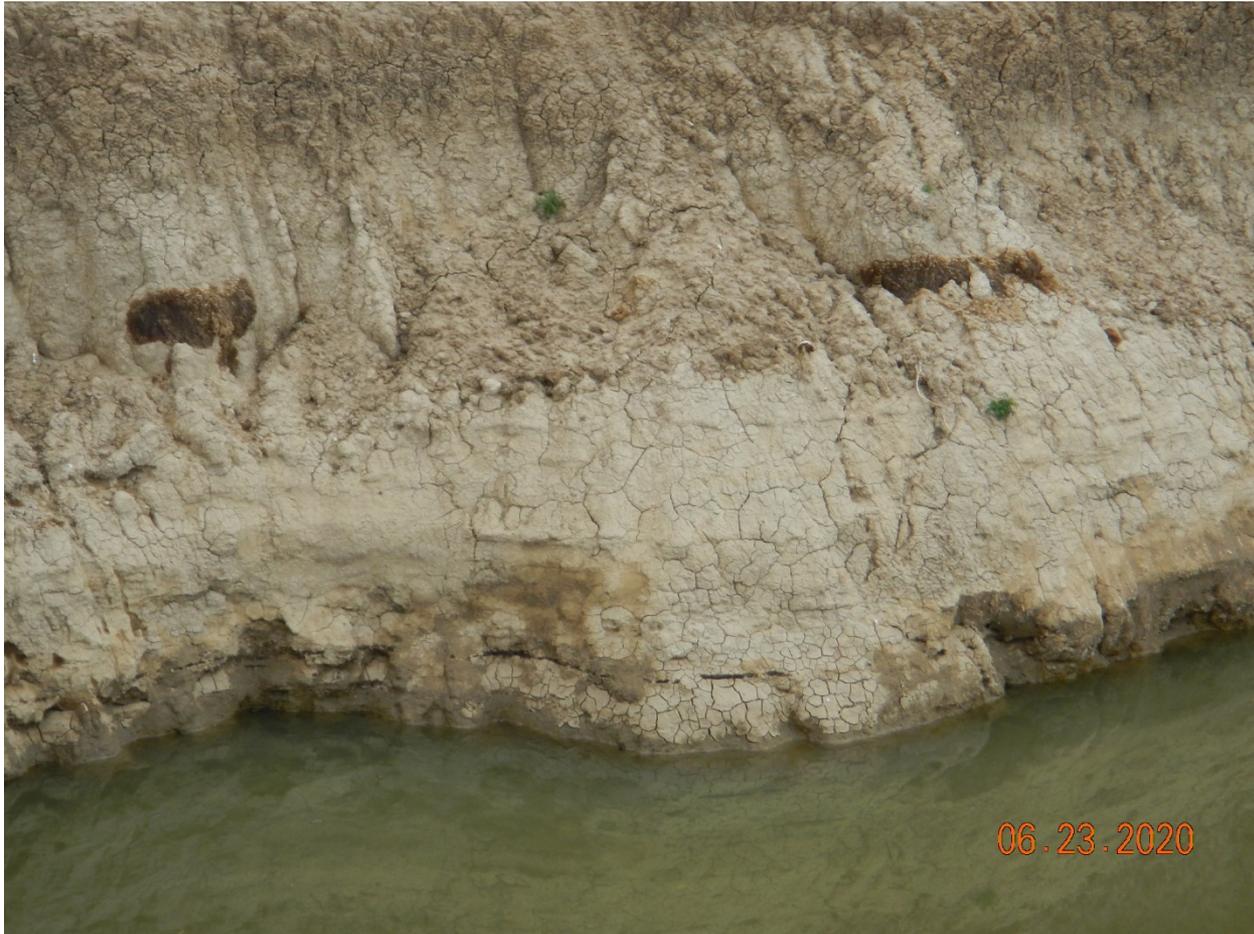
Photo # 7 – Pit ID 117639 subject of Spill ID 476164. Discontinuous oil stains in pit wall

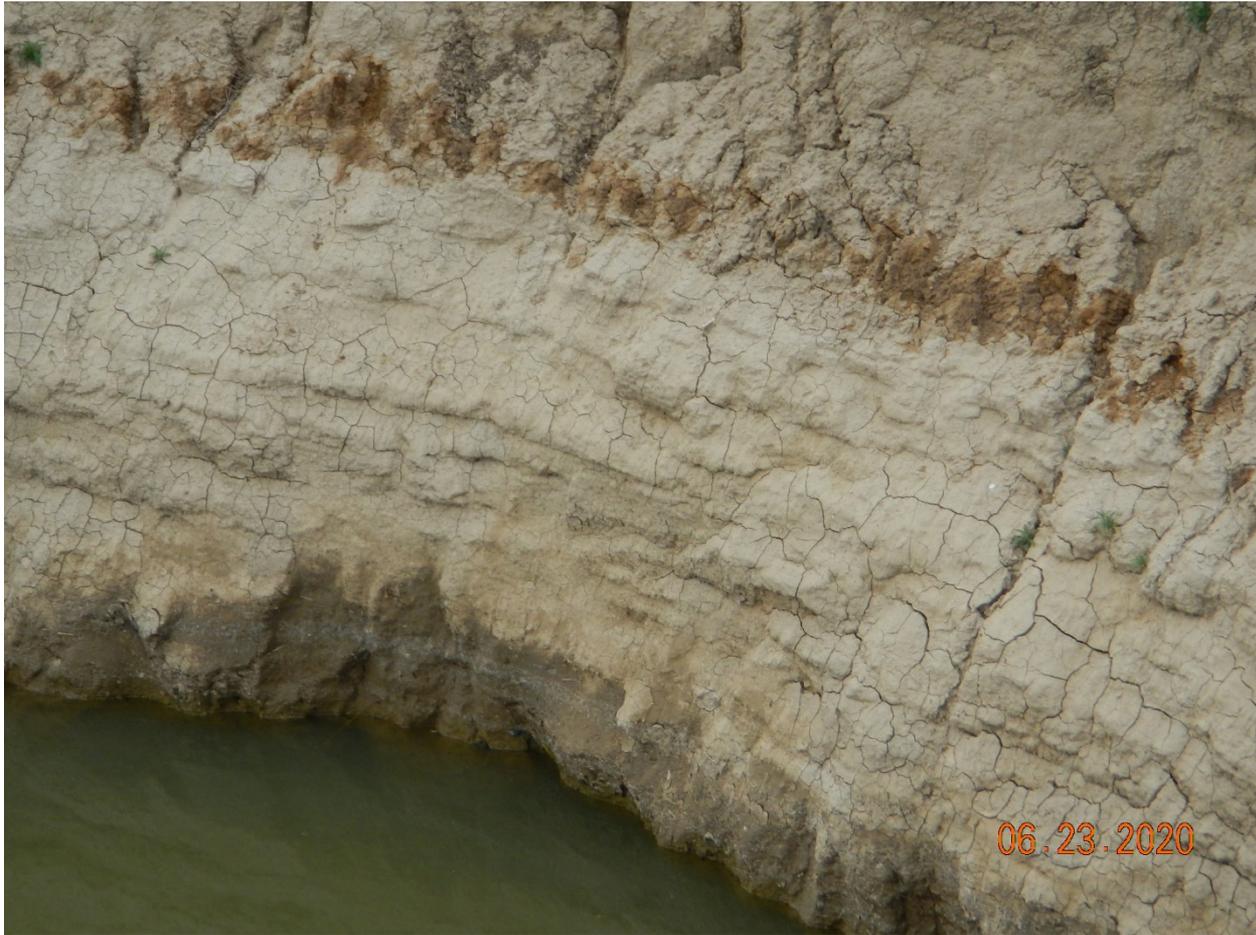
Photo # 8 – Pit ID 117639 subject of Spill ID 476164. Oil stained soil in pit wall

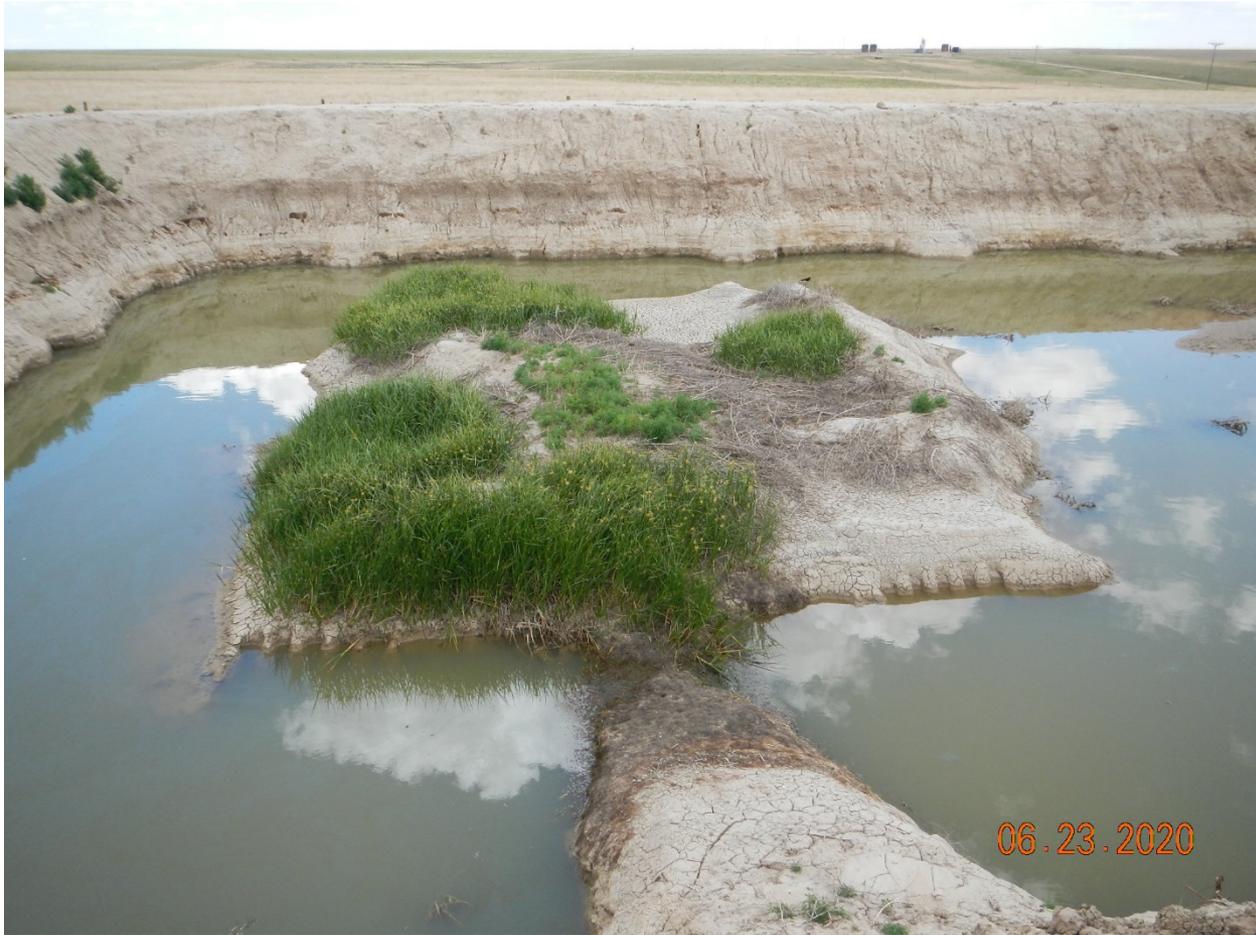
Photo # 9 – View east across Pit ID 117639 subject of Spill ID 476164. Discontinuous oil stained soil in eastern pit wall

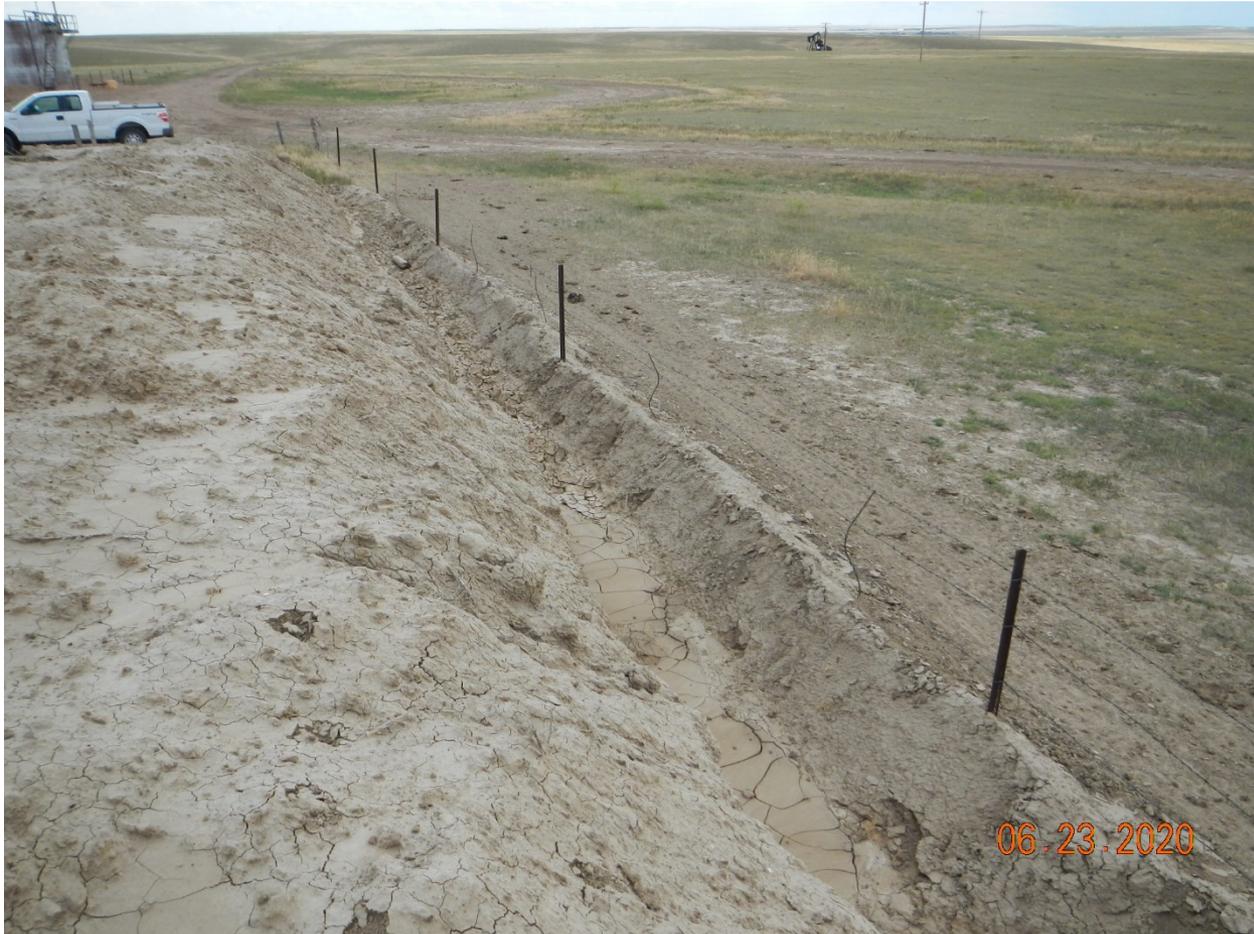
Photo # 10 – View south along BMP installed on the west side of Pit ID 117639 subject of Spill ID 476164.

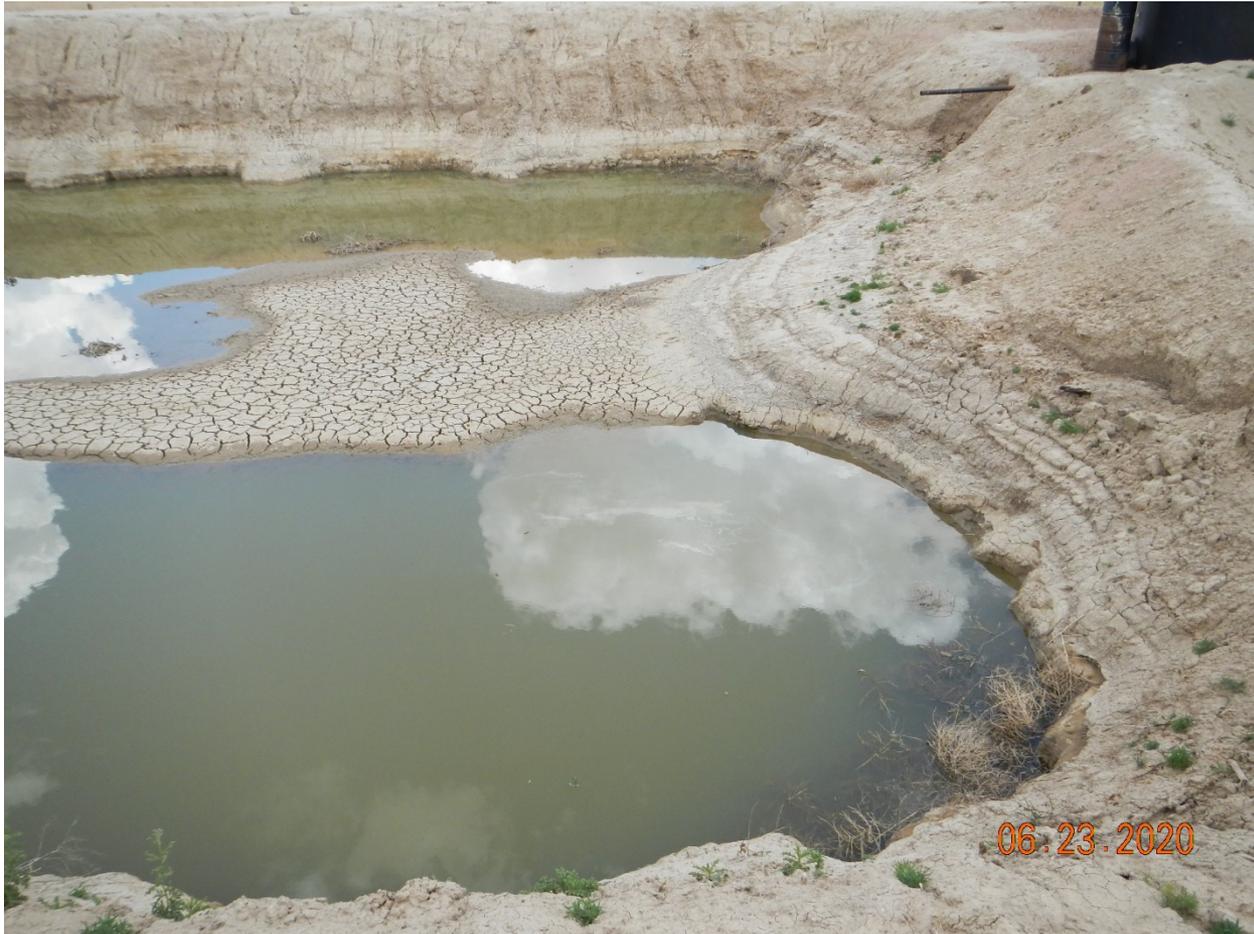
Photo # 10 – View east across southern side of Pit ID 117639 subject of Spill ID 476164.
