Inspection Photos

Operator: Paradox Upstream
API: 113-06235
Date: 7/16/2020

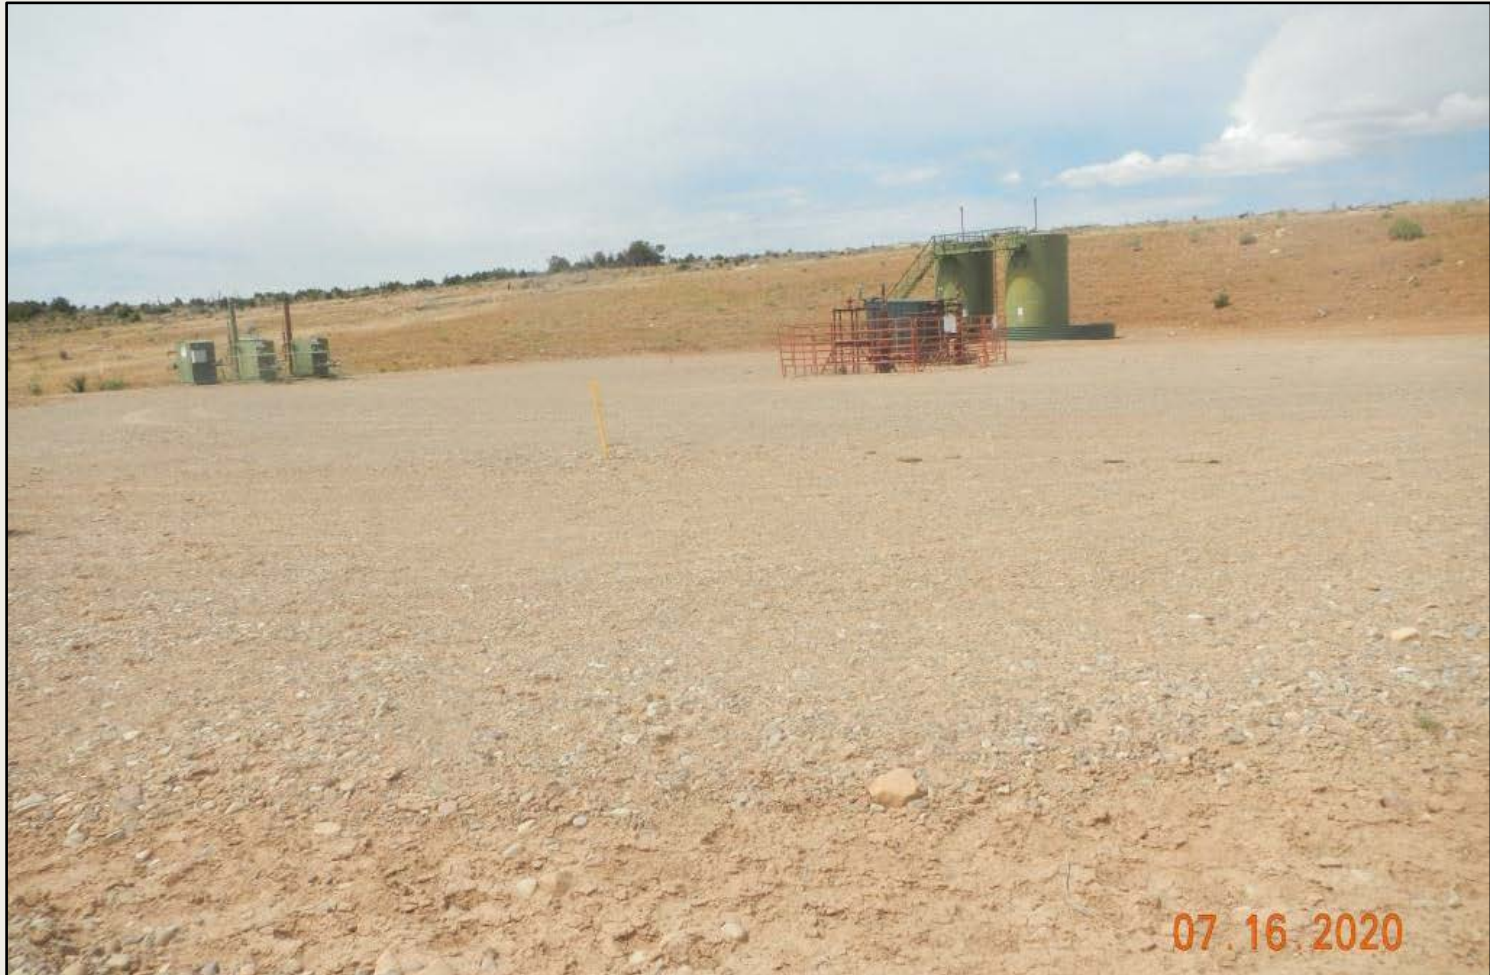
Photo 1. View of the project area from the northeastern corner facing center.

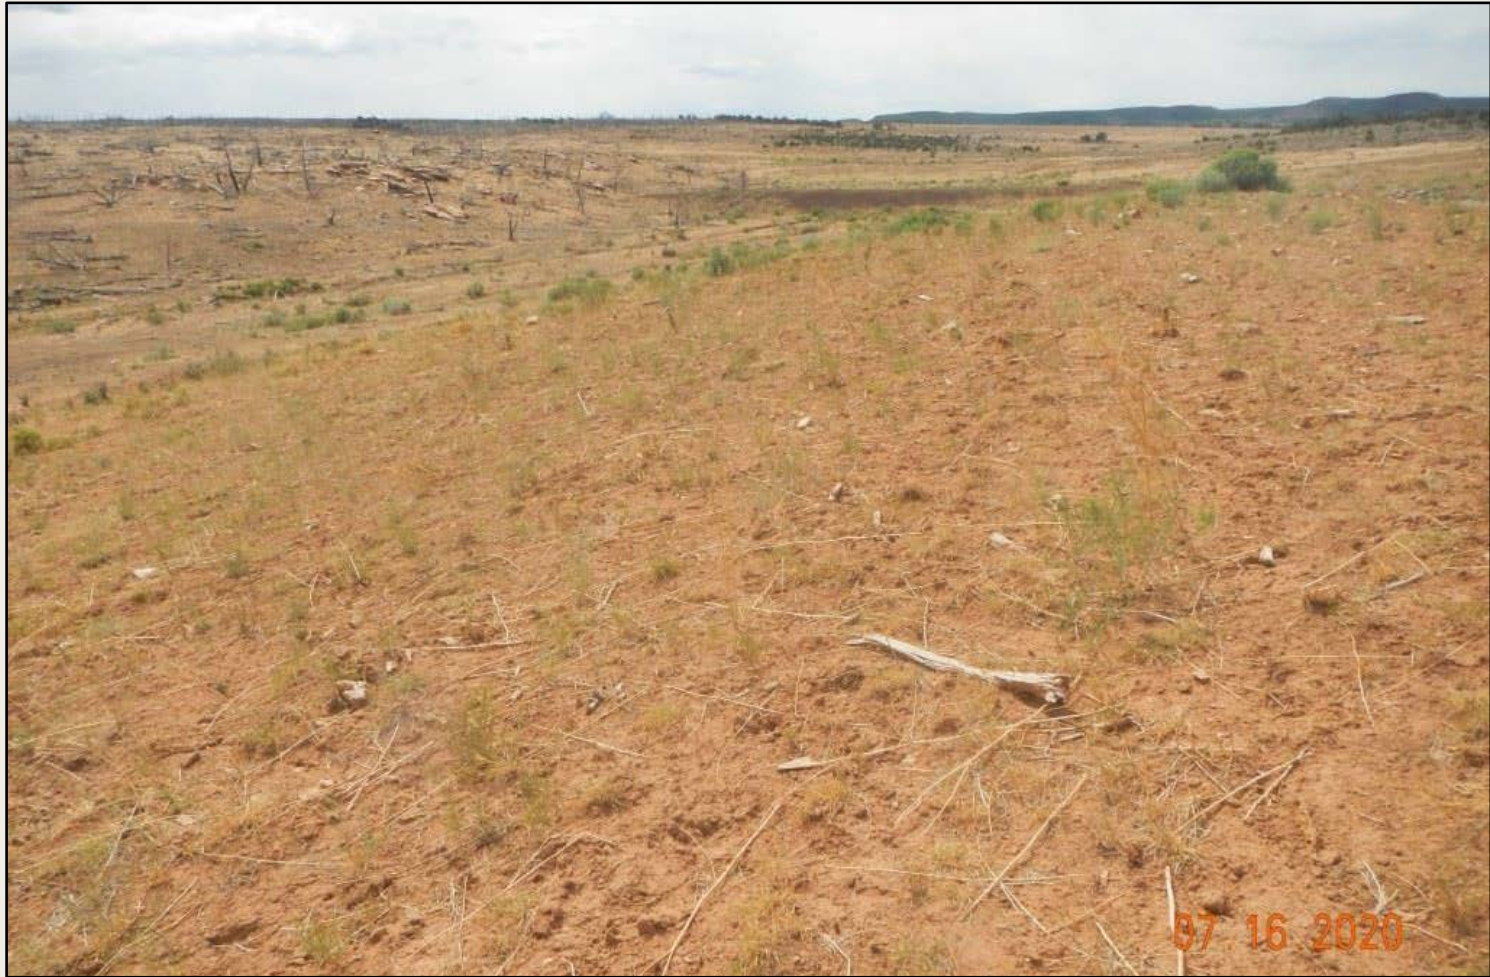
Photo 2. View of the eastern project area from the northeastern corner facing southward. Revegetation is progressing in a grazed condition with grasses and shrubs such as western wheatgrass, Indian ricegrass, and rubber rabbitbrush.

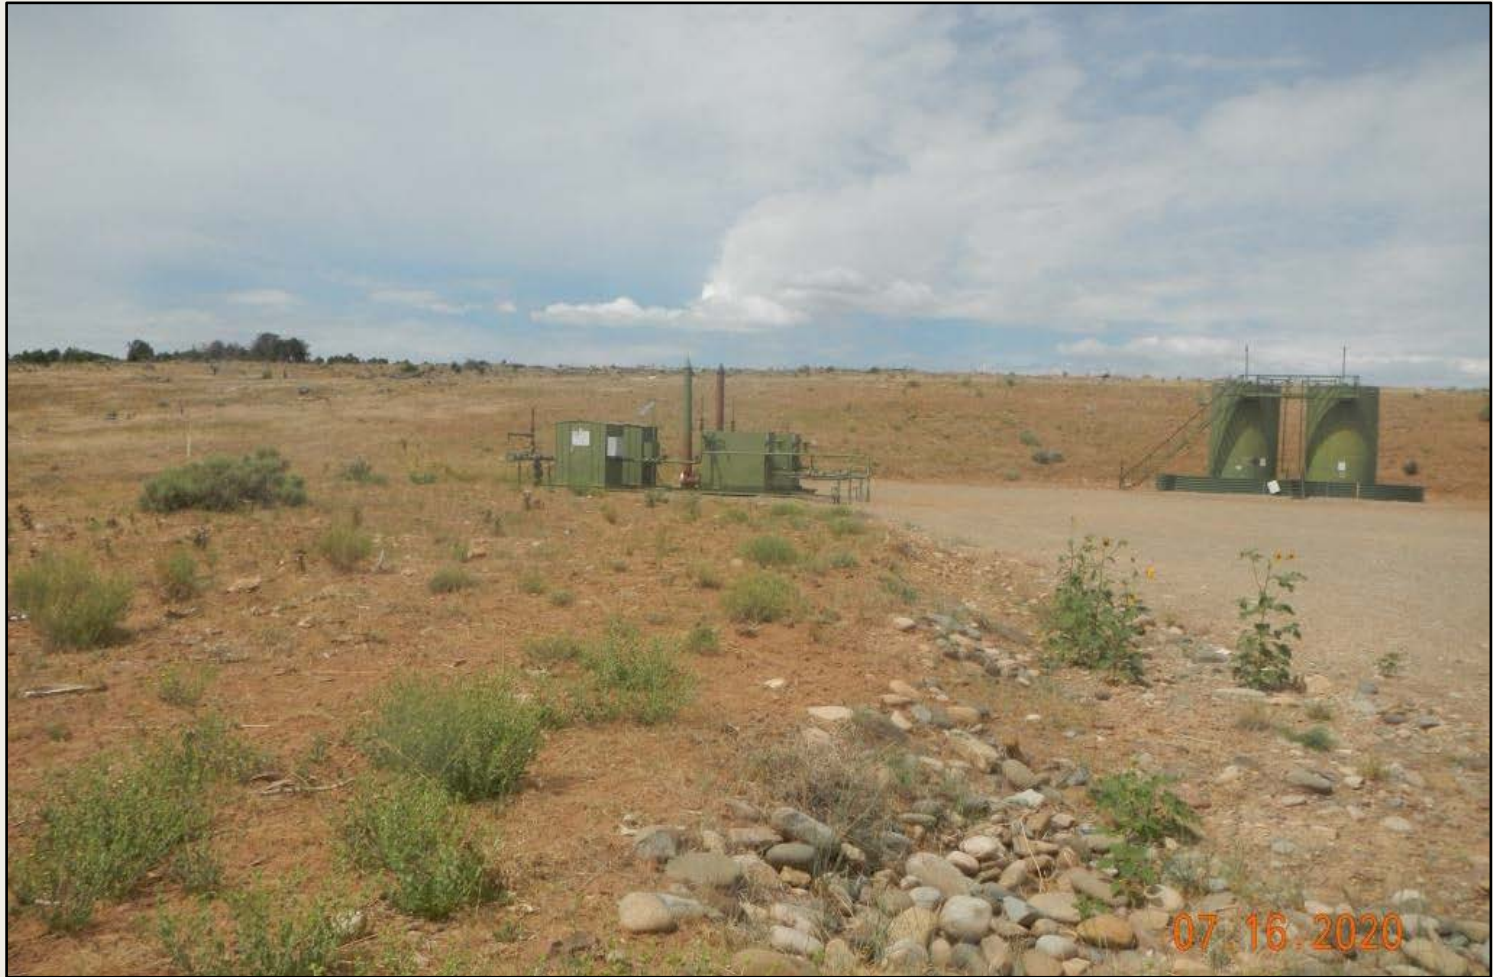
Photo 3. View of the southern project area from the southeastern corner facing westward.

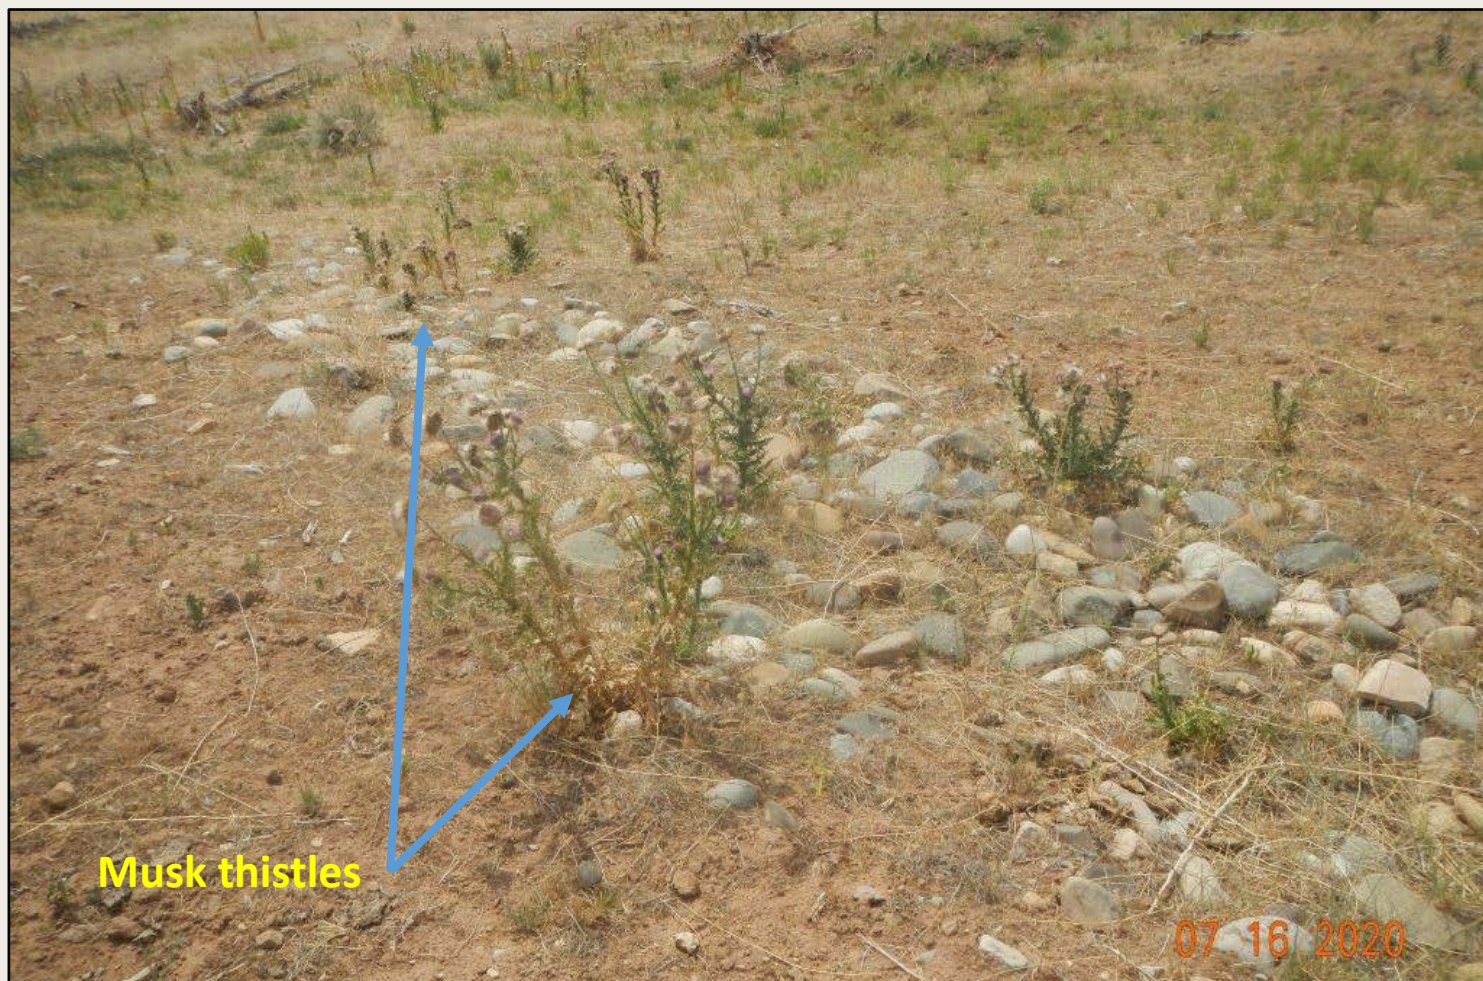
Photo 4. View of musk thistles within the southeastern project area. Approximately 200 individuals observed.

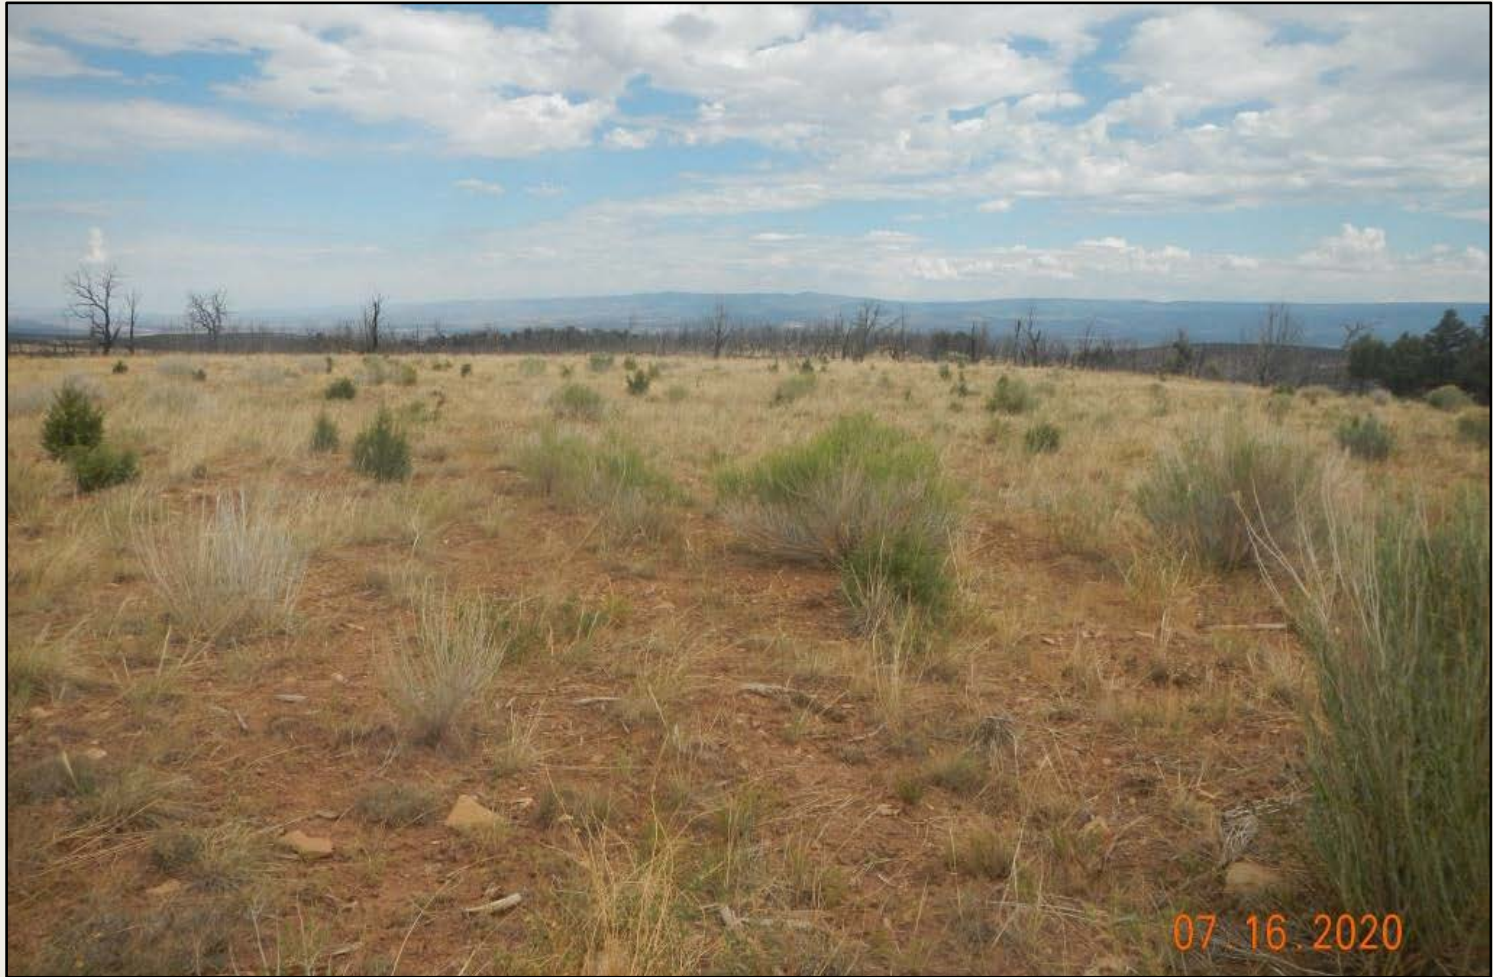
Photo 5. View of reference area comprised of post-burn vegetation community with young pinyon and juniper trees, rubber rabbitbrush, sand dropseed, and western wheatgrass.
