Inspection Photos  
Location Name: HILL RANCH 36-13  
API#: 05-071-08253  
INSP. #: 695103248

Colorado Oil & Gas Conservation Commission  
37.03499, -104.95365, 2539.0m, 343°  
2020/08/24 14:18:10

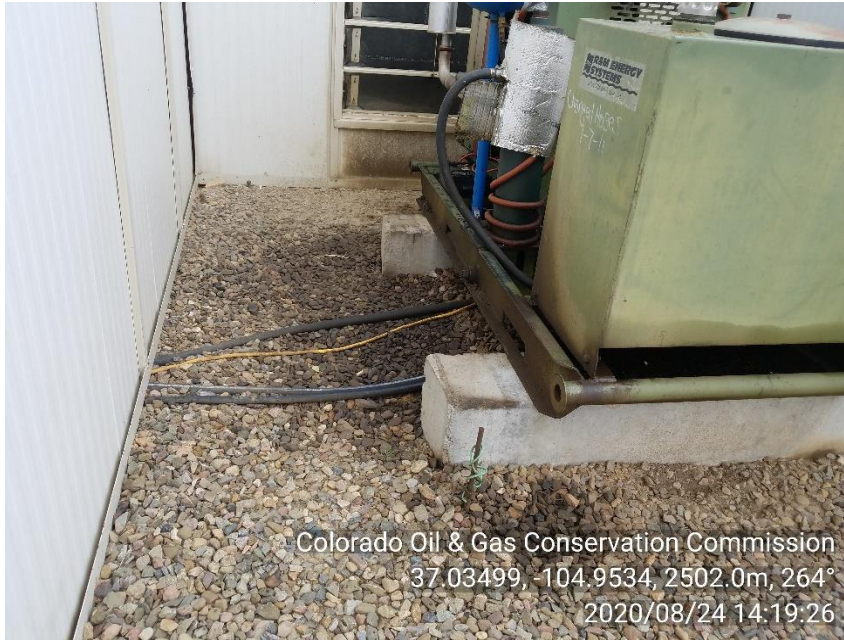
**PHOTO 3: AREA OF IMPACTED SOIL AROUND DRIVEHEAD ENGINE SKID. Conduct maintenance on equipment, cleanup IMPACTED SOIL and review self inspection processes. CA DATE 11-24-20.**

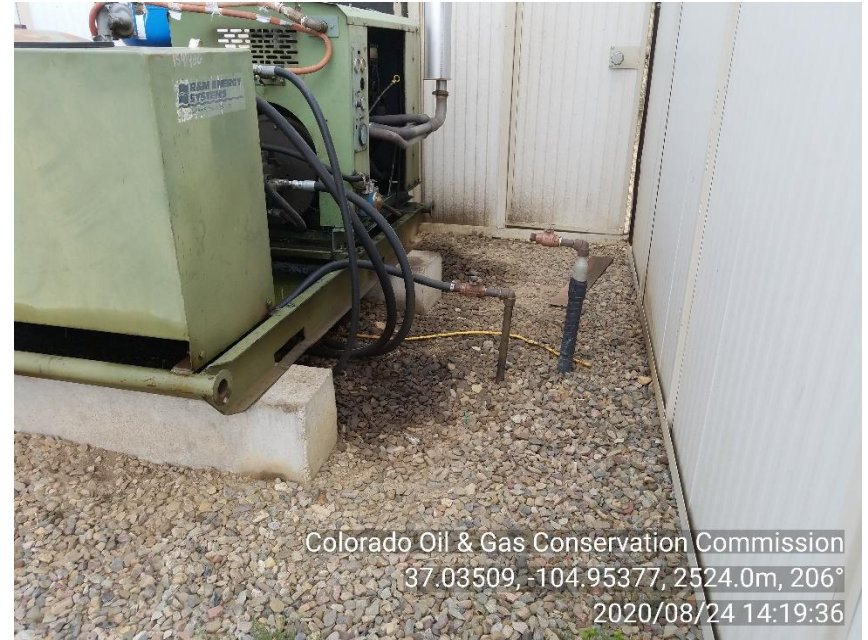
**PHOTO 4: ANOTHER IMAGE OF IMPACTED SOIL AROUND ENGINE SKID.**

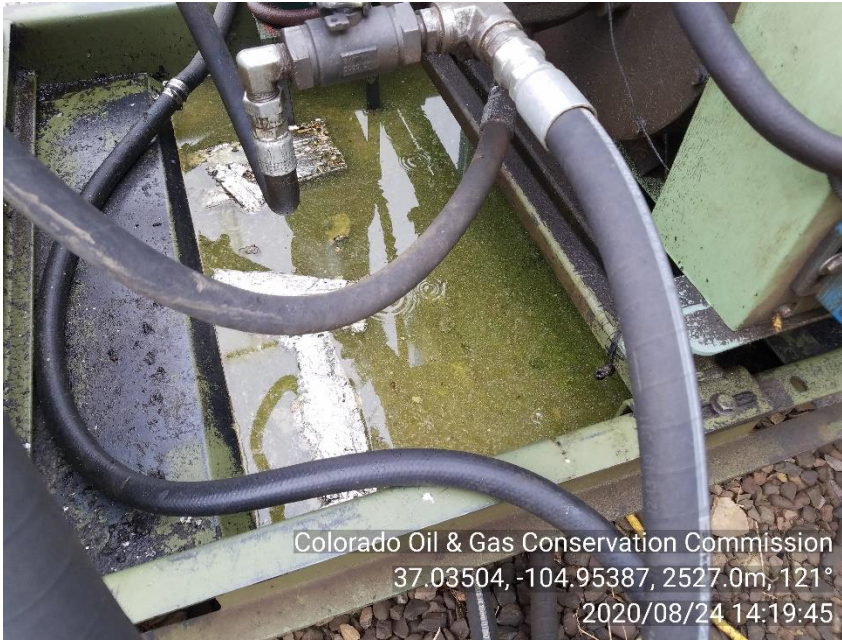
**PHOTO 5: OILY FLUID STORED IN ENGINE SKID.**

**Comply with general provisions of the oil and gas act for wildlife protection. CA DATE 8-29-20.**
