# Inspection Photos

8/31/2020

Operator: GUNNISON ENERGY LLC - 10515

Location ID: 324457

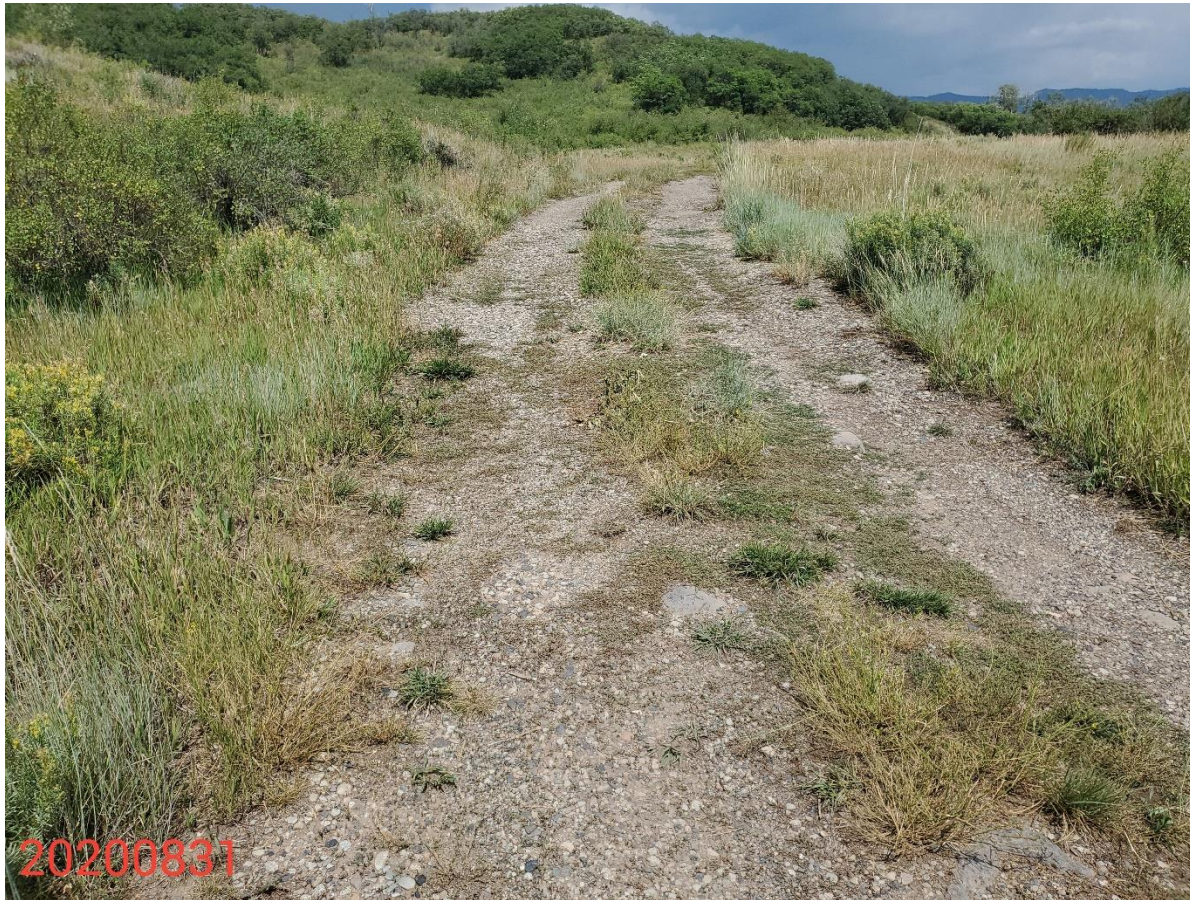
**Photo 1:** Photo taken from the access road, facing northeast. Photo shows Location remains out of compliance with 1004 rules and corrective actions; Final reclamation of the Location has not been conducted.

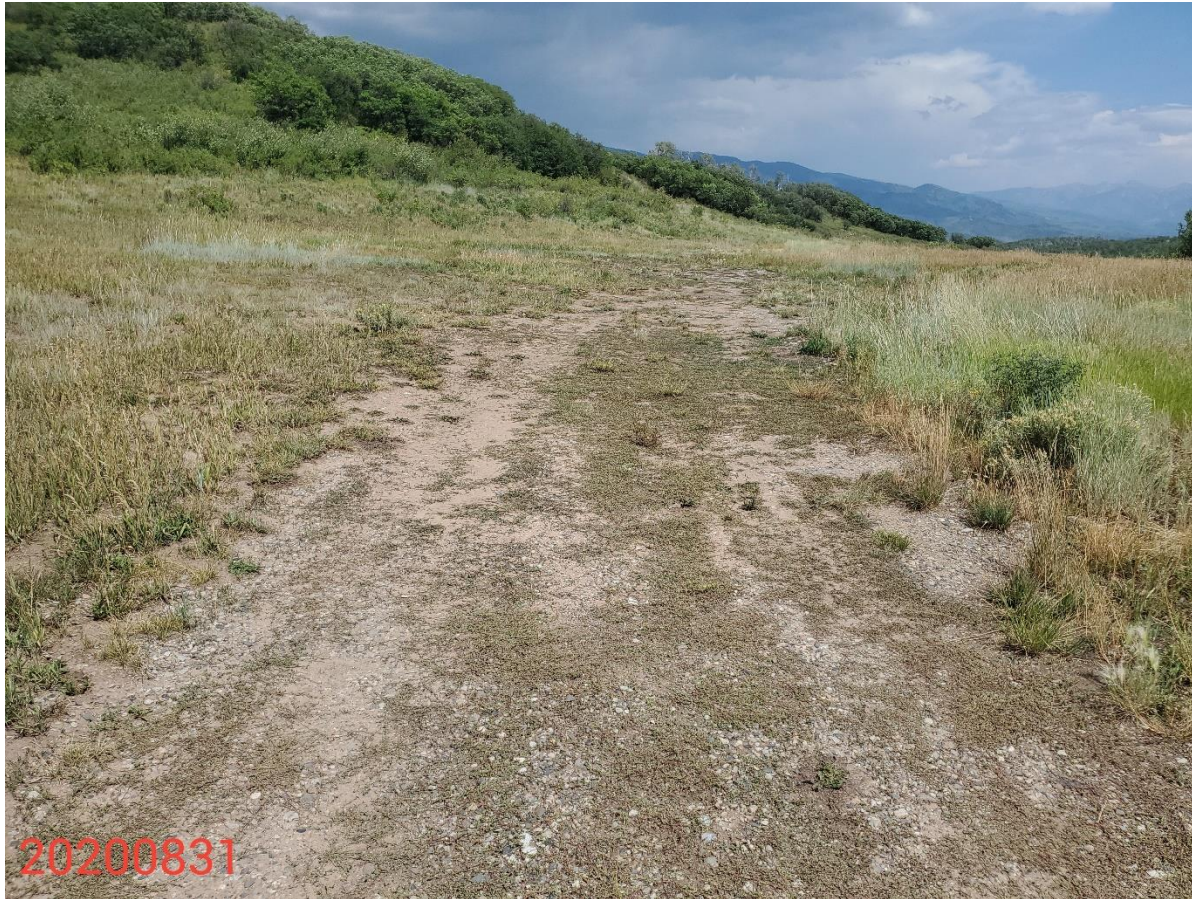
**Photo 2:** Photo taken from the west end of the Location, facing east. Photo shows Location remains out of compliance with 1004 rules and corrective actions; Final reclamation of the Location has not been conducted.

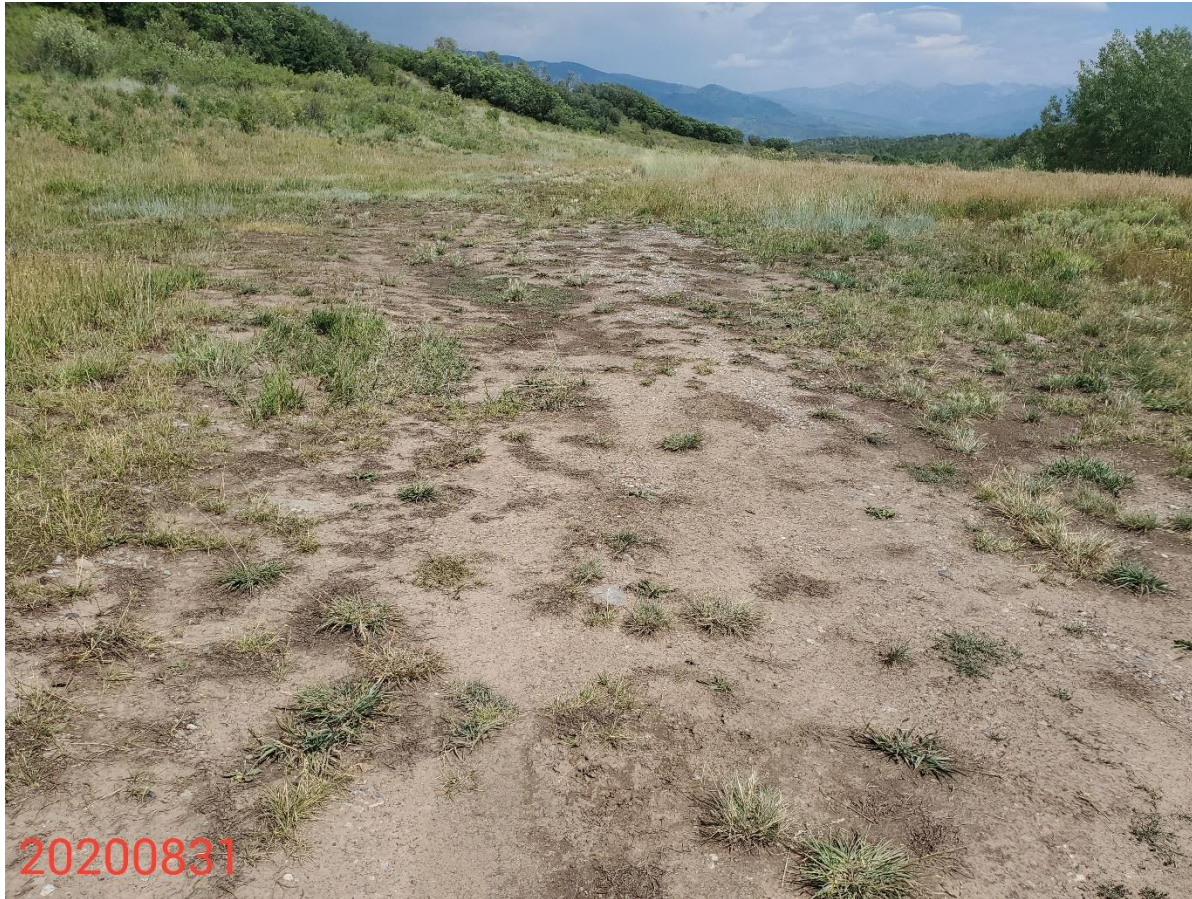
**Photo 3:** Photo taken from the west end of the Location, facing east. Photo shows Location remains out of compliance with 1004 rules and corrective actions; Final reclamation of the Location has not been conducted.

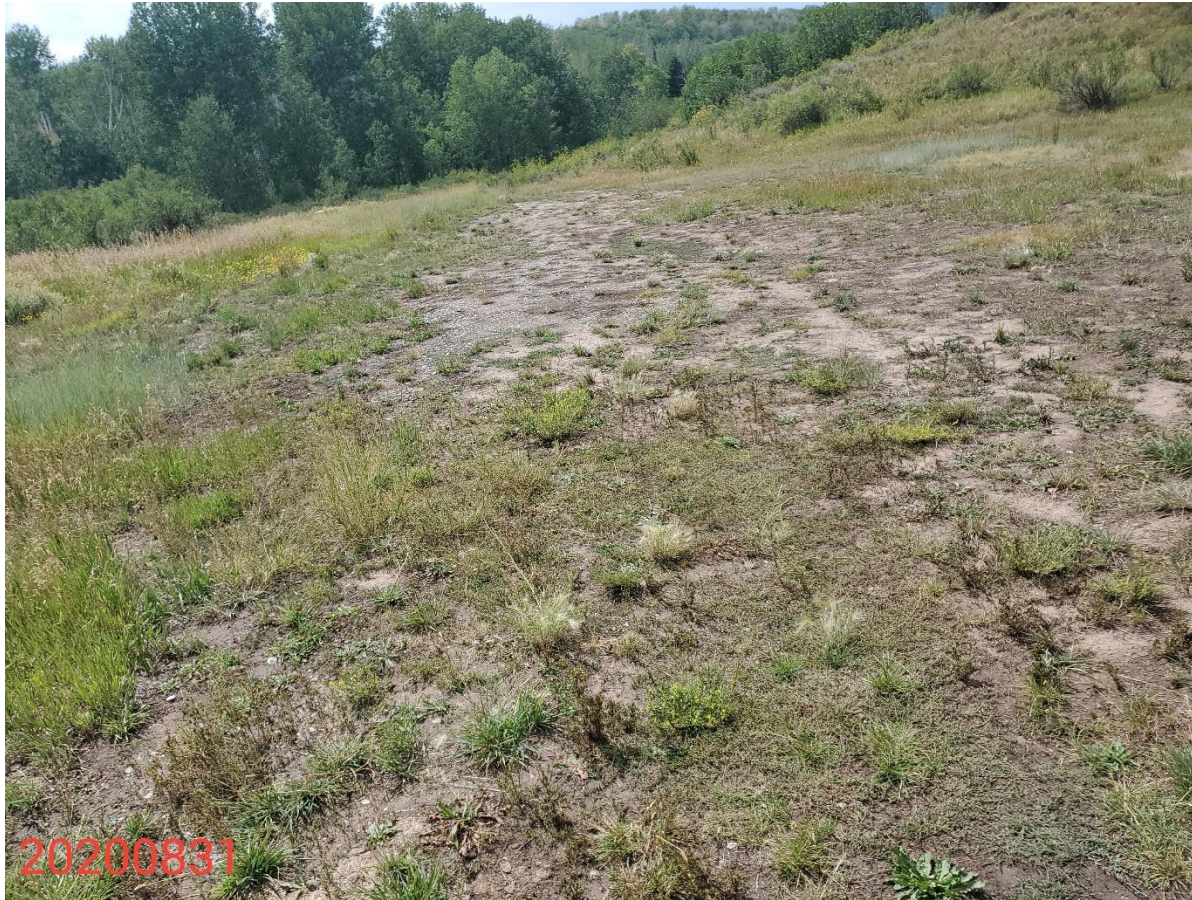
**Photo 4:** Photo taken from the Location, facing west. Photo shows Location remains out of compliance with 1004 rules and corrective actions; Final reclamation of the Location has not been conducted.

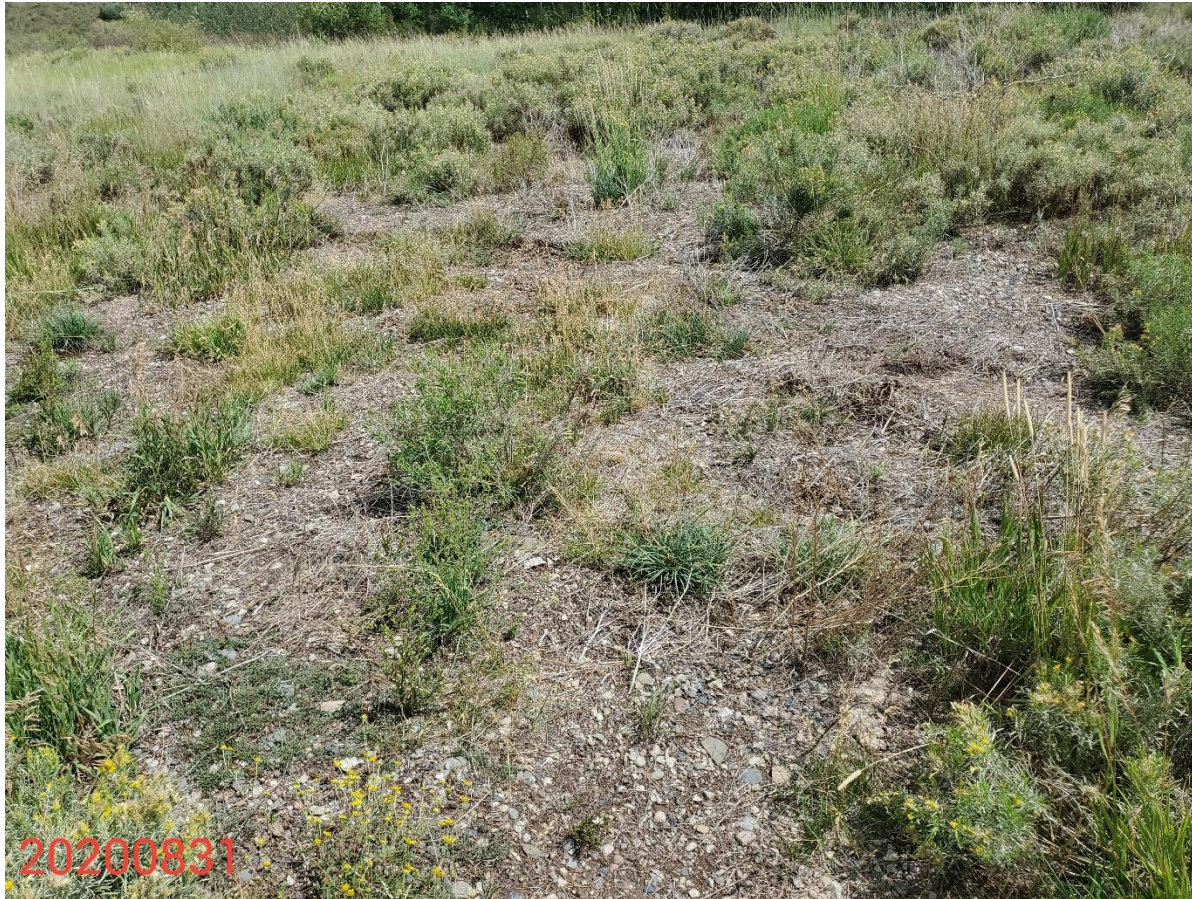
**Photo 5:** Photo shows areas of the Location where gravel has not been removed.

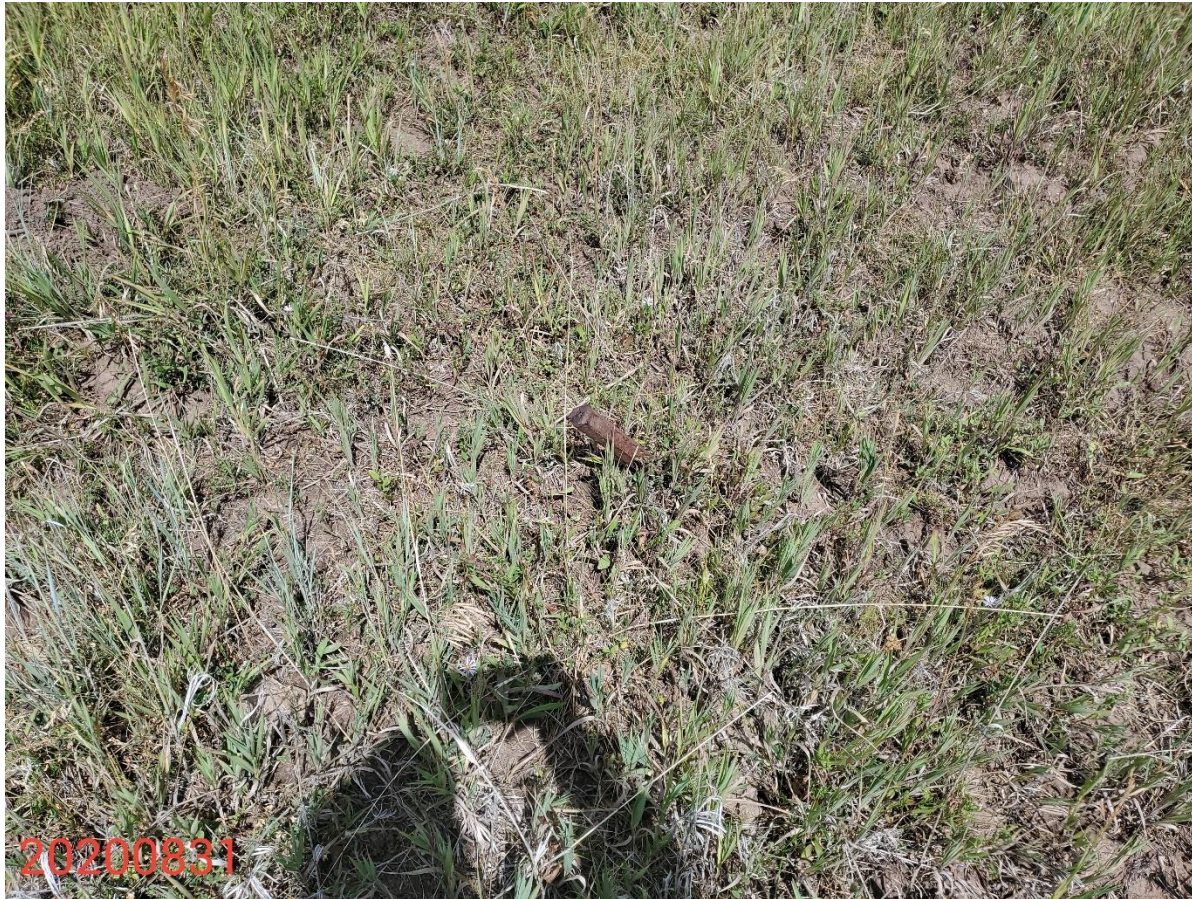
**Photo 6:** Photo taken from the northwest end of the Location. Photo shows anchor has not been removed.

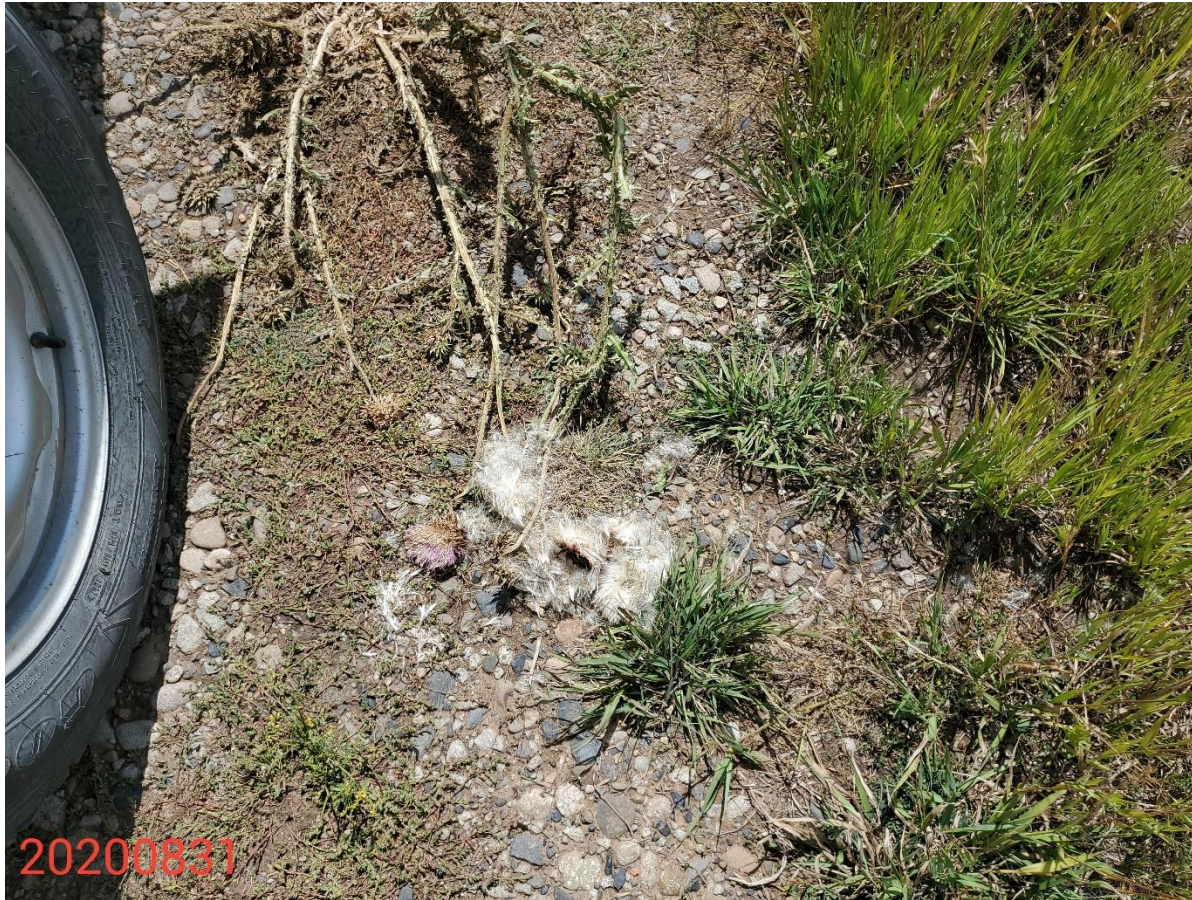
**Photo 7:** Photo taken from the access road. Evidence of weed management was observed, however the time appears to have been insufficient; Photo shows Musk thistle plat with viable seed head. Ongoing noxious weed management is required.

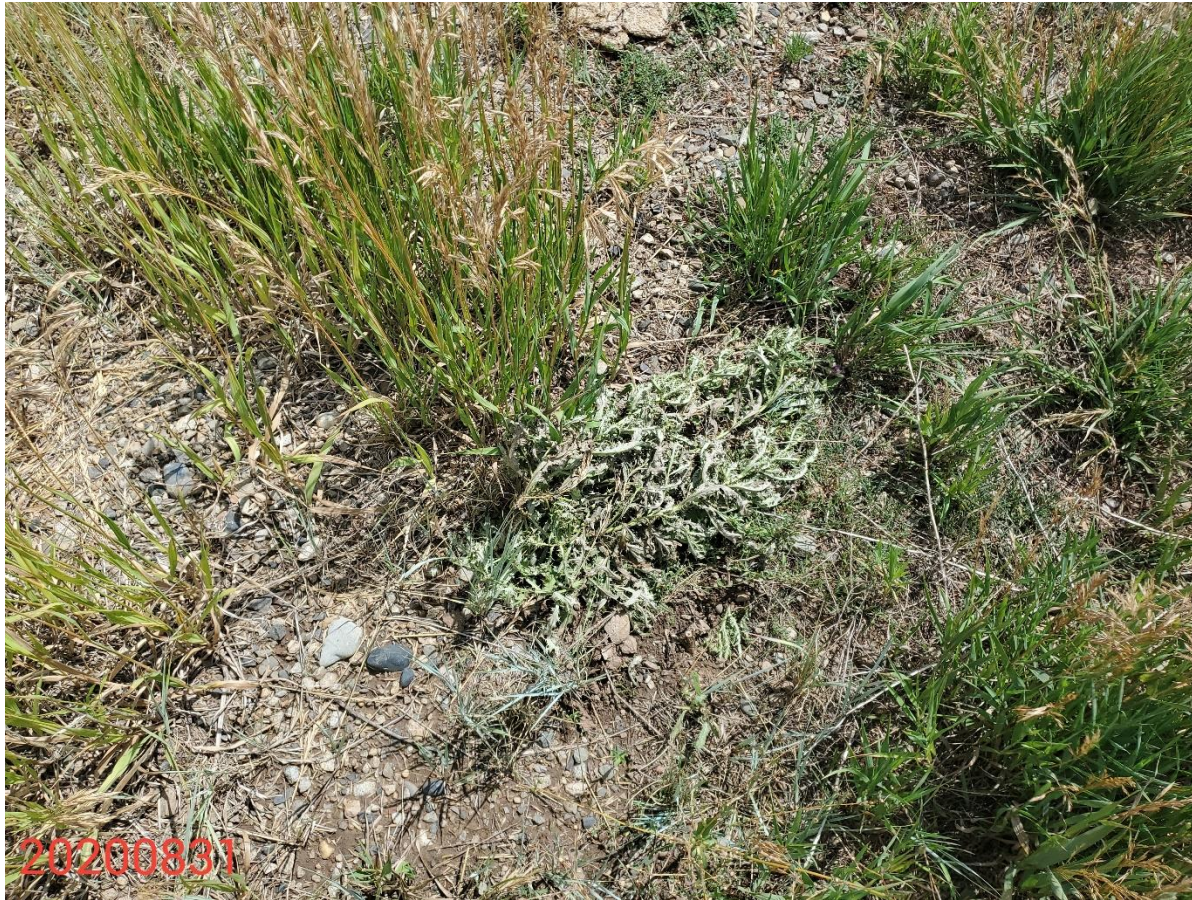
**Photo 8:** Photo shows musk thistle in the process of dying back.
