# Inspection Photos

API: 071-09177

Operator: EVERGREEN NATURAL RESOURCES

Inspection Date: 9/16/2020

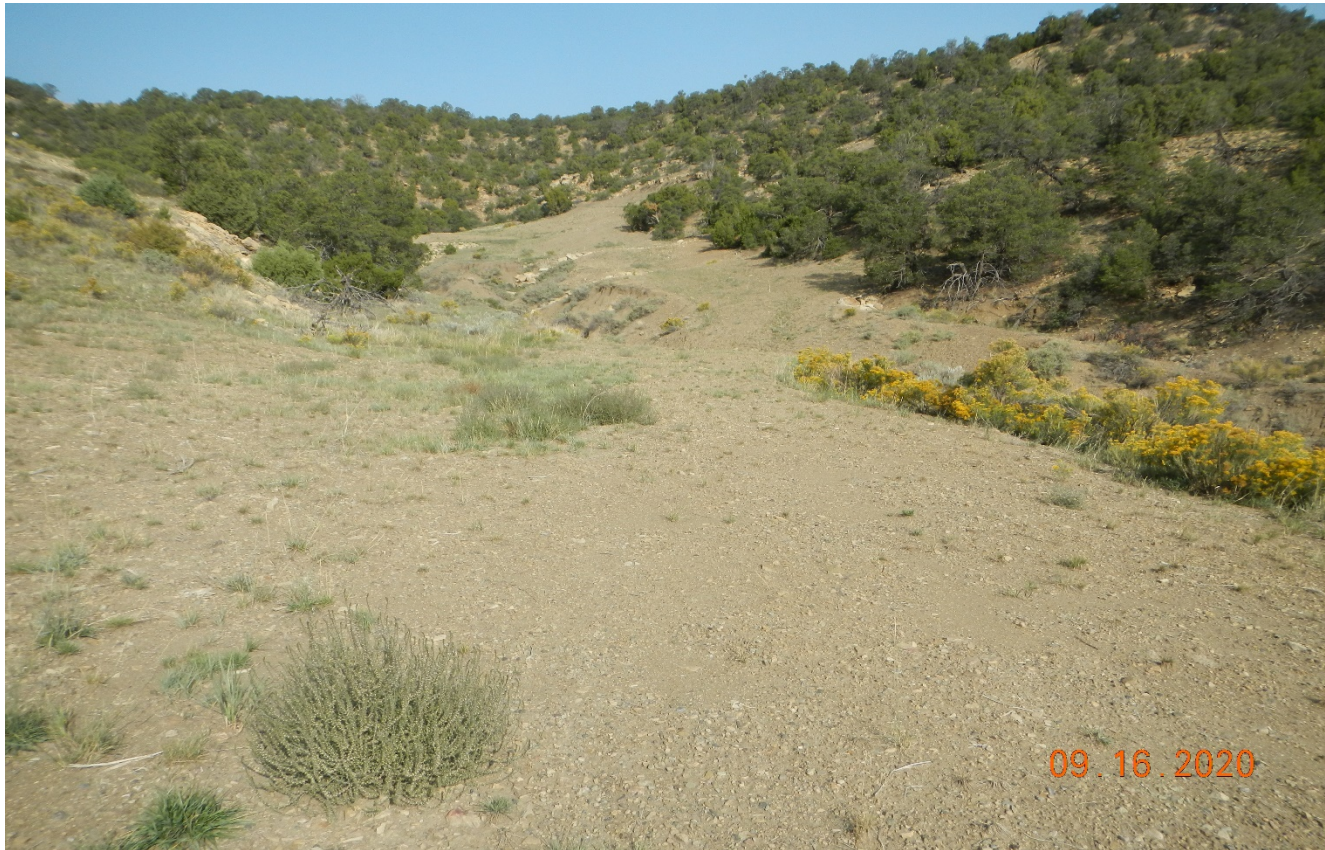
**Photo 1.** Facing northwest along the former access road.

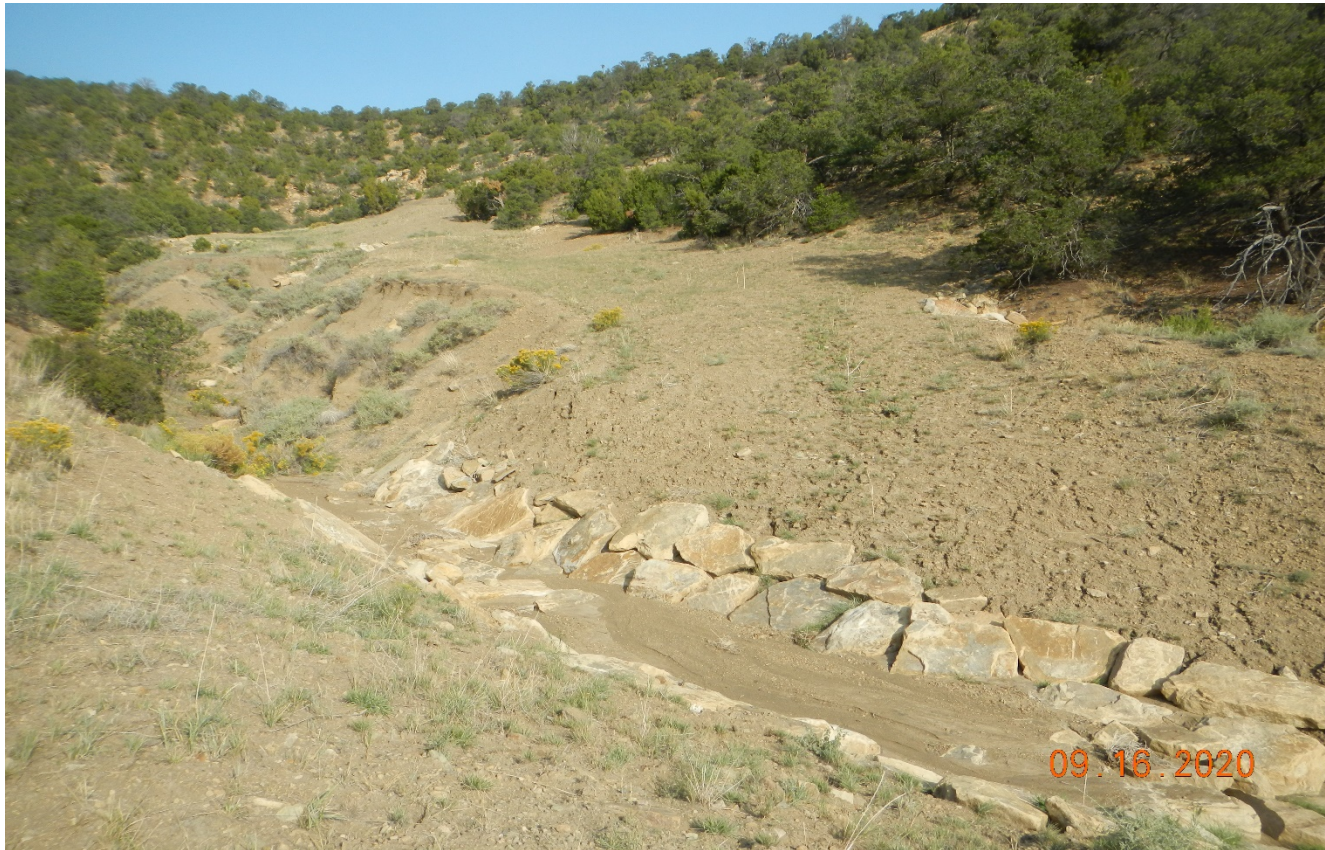
**Photo 2.** Facing northwest along the access road crossing the drainage area. The culverts have been removed and the road is recontoured.

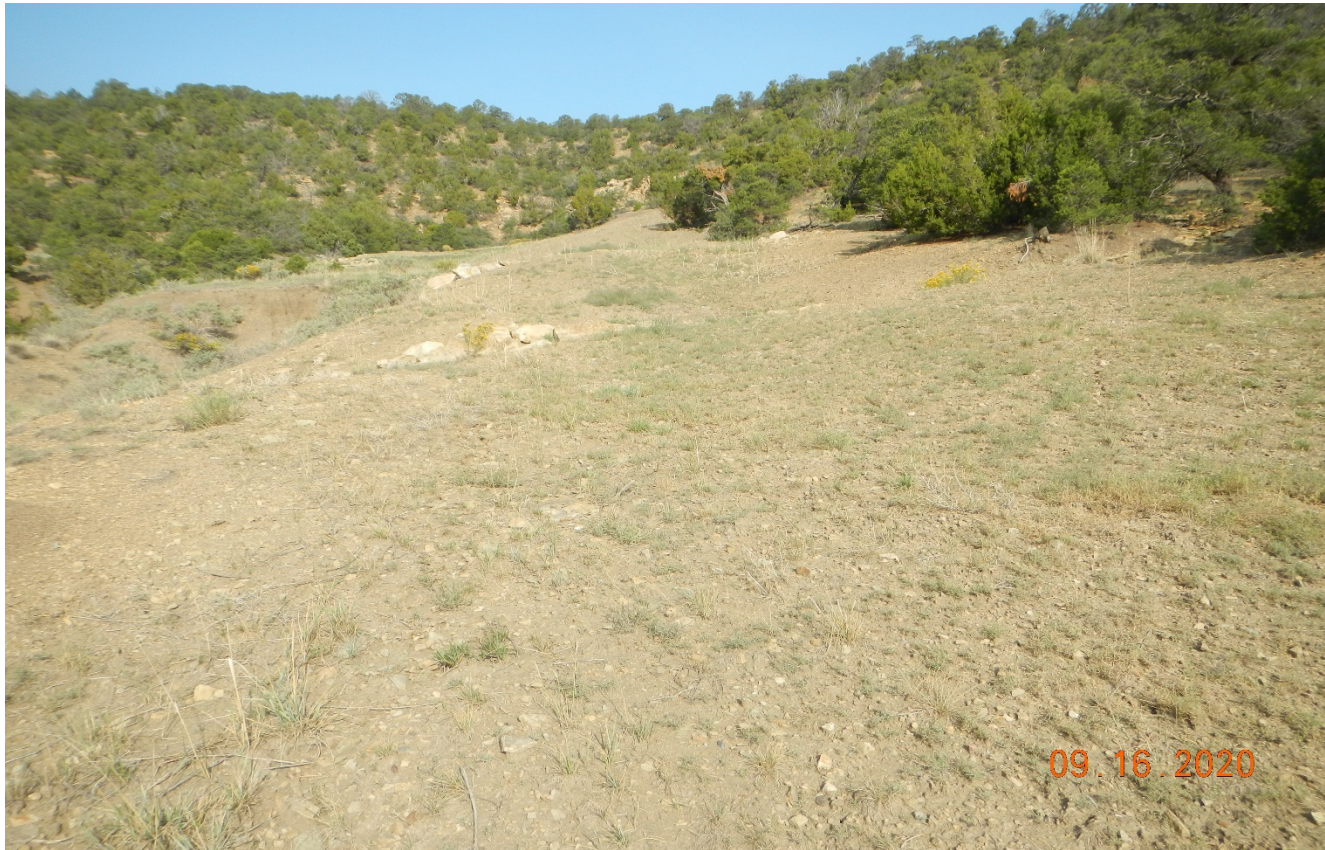
**Photo 3.** Facing northwest along the reclaimed road.

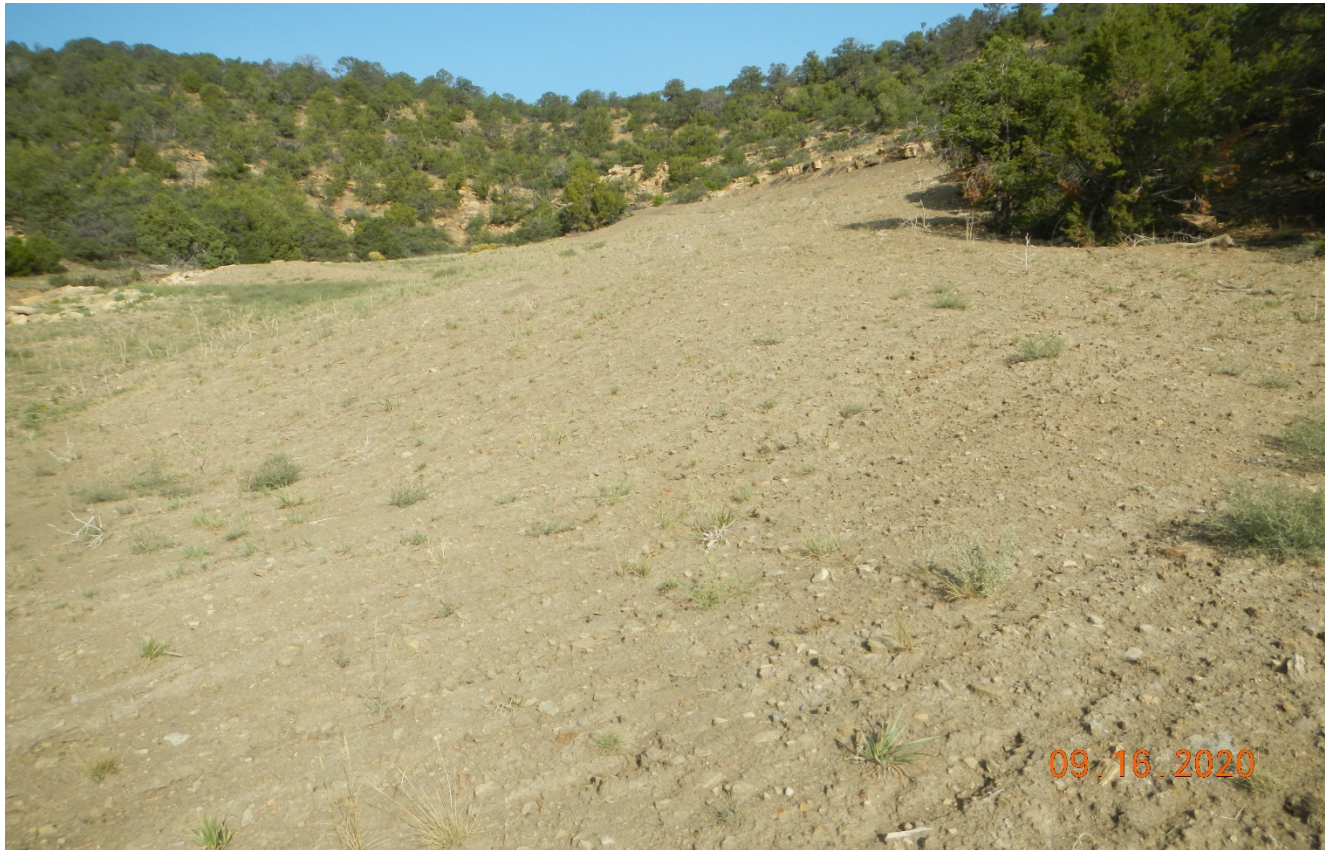
**Photo 4.** The vegetation has not established along the road and additional seeding will need to be performed.

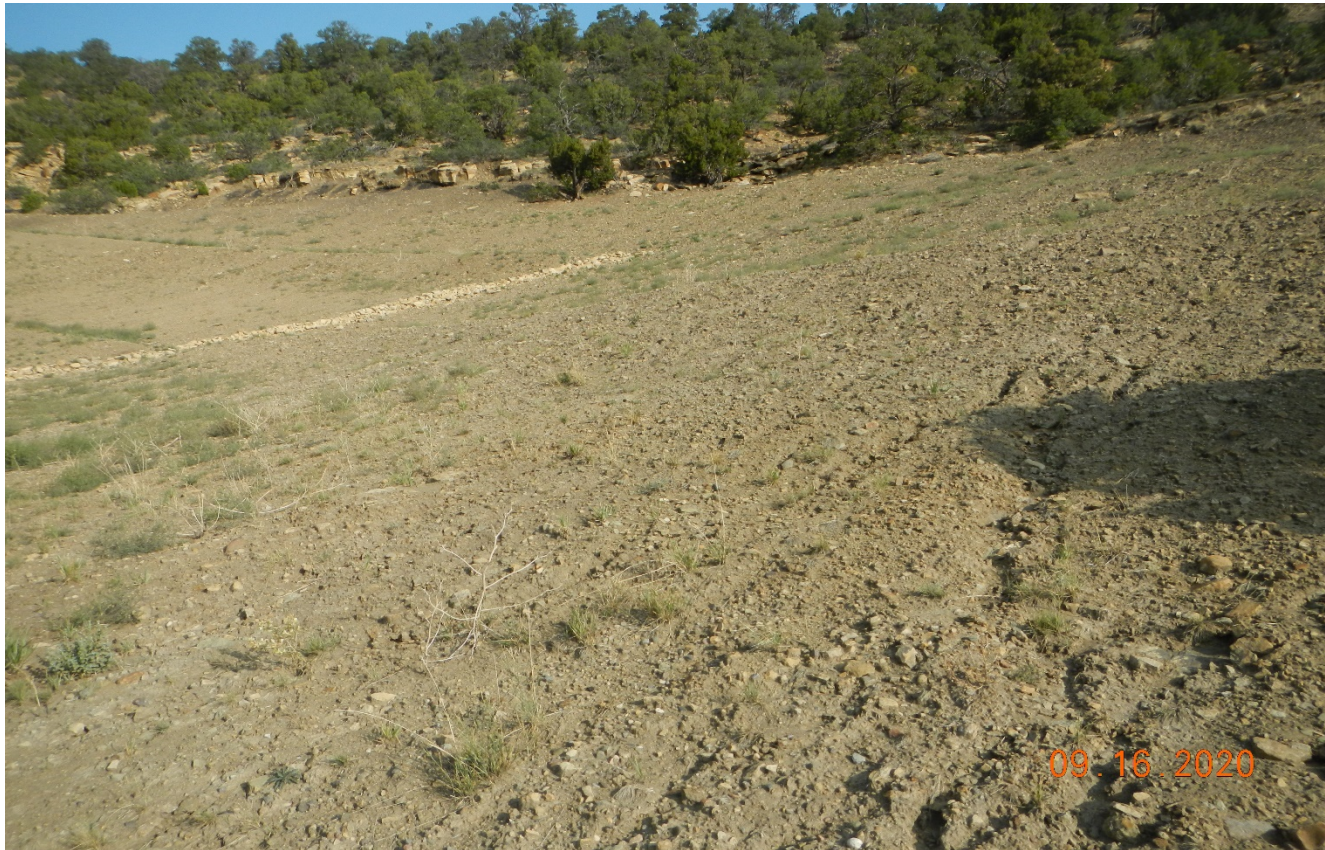
**Photo 5.** Facing north toward the location.

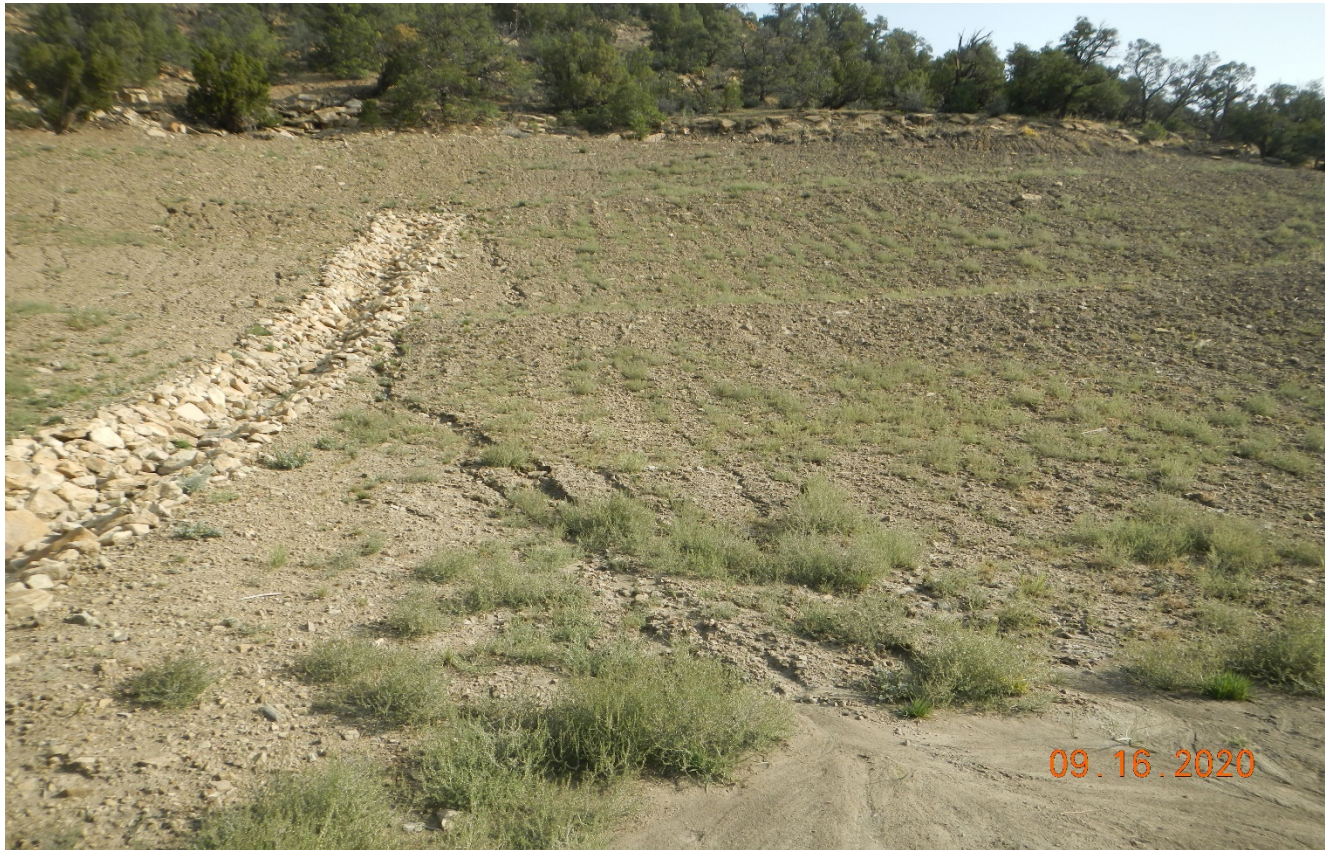
**Photo 6.** Facing north toward the location. There is some erosion occurring near the rock rip/rap. The rock rip/rap channel runs straight down the slope which may only accelerate concentrated flows and appears unnatural. Maintenance is needed to prevent erosion.

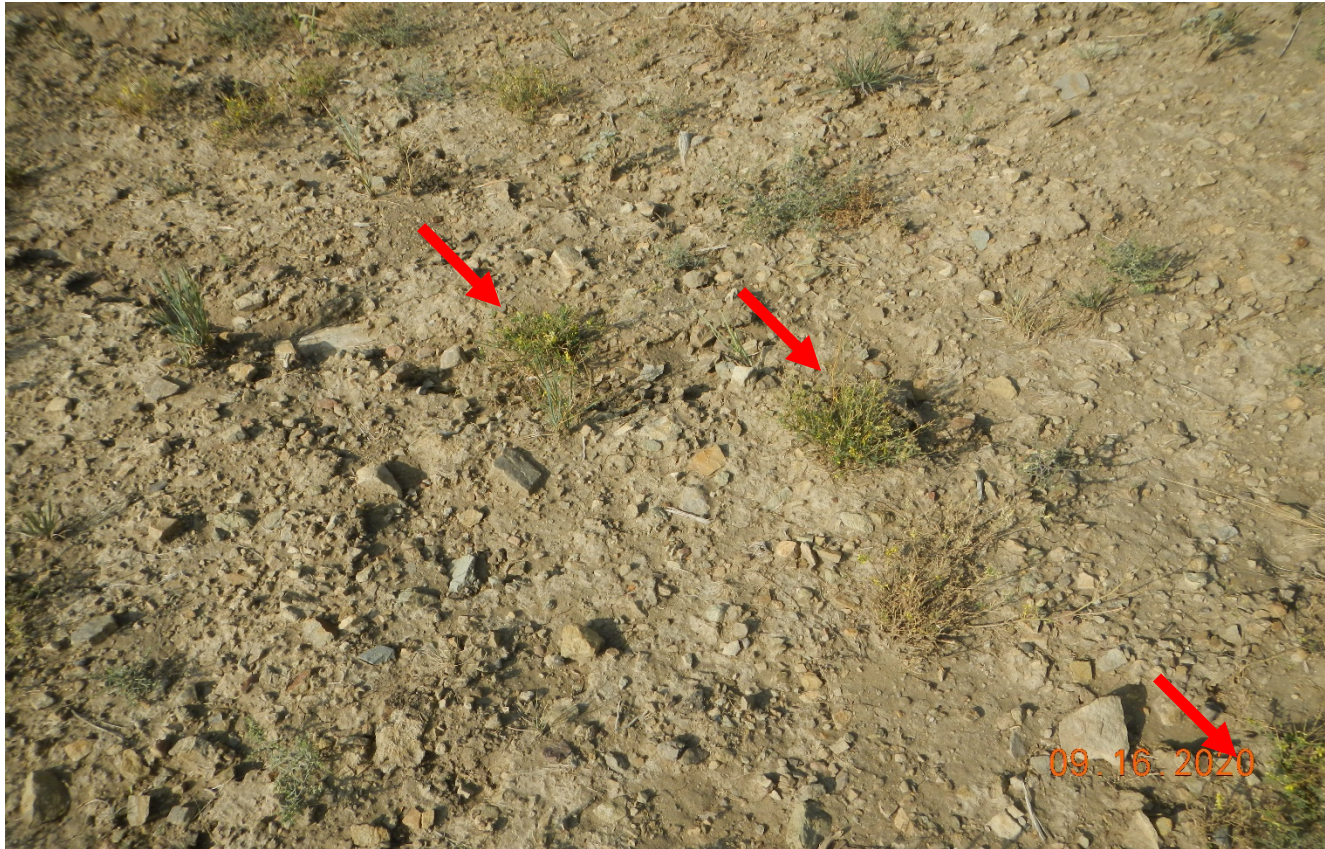
**Photo 7.** View of groundcover and vegetation observed. The arrow points to Yellow clover which is a non-native species that is not persistent and drought tolerant. The seeded vegetation should reflect the surrounding vegetation for long term stabilization.

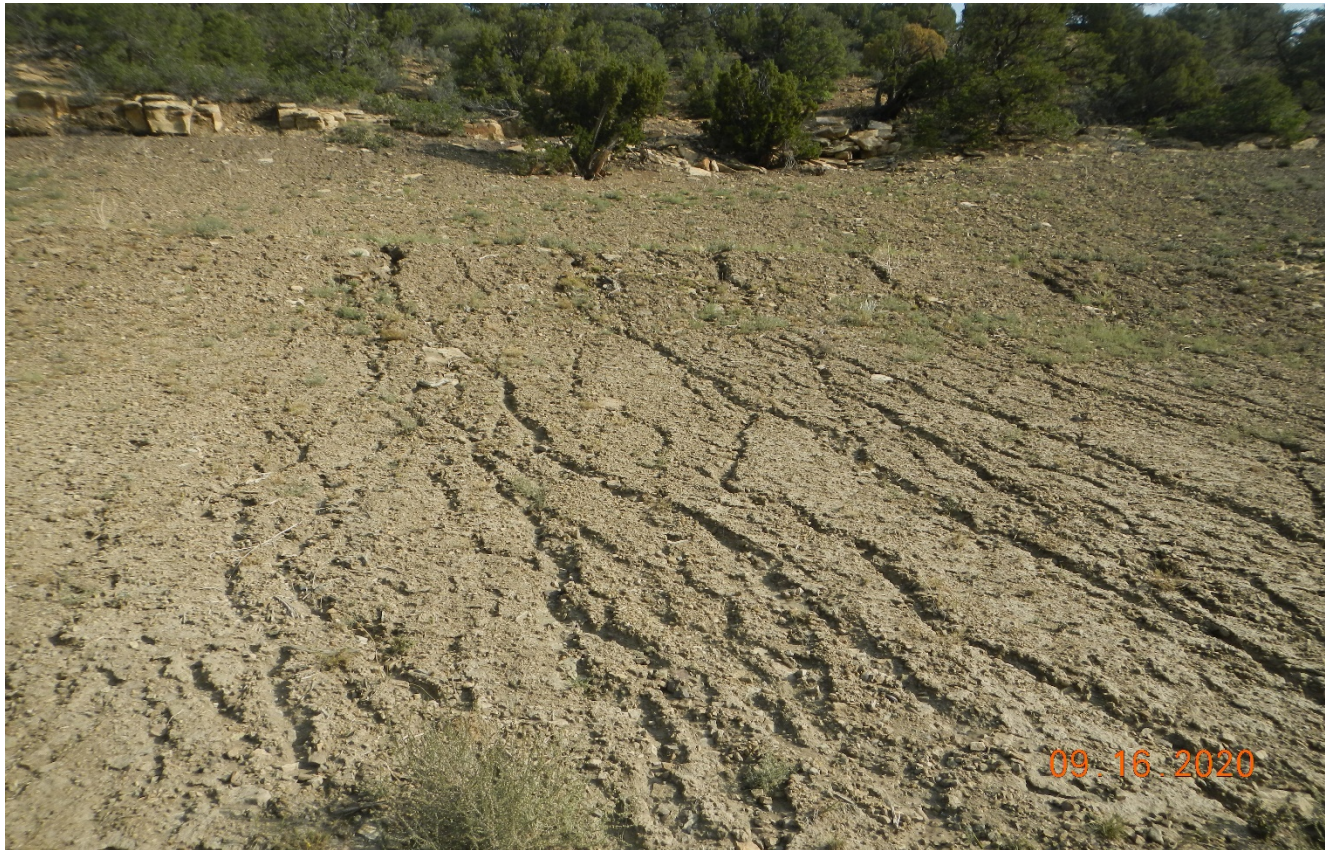
**Photo 8.** There are signs of rilling erosion along the slope which will need to be repaired.

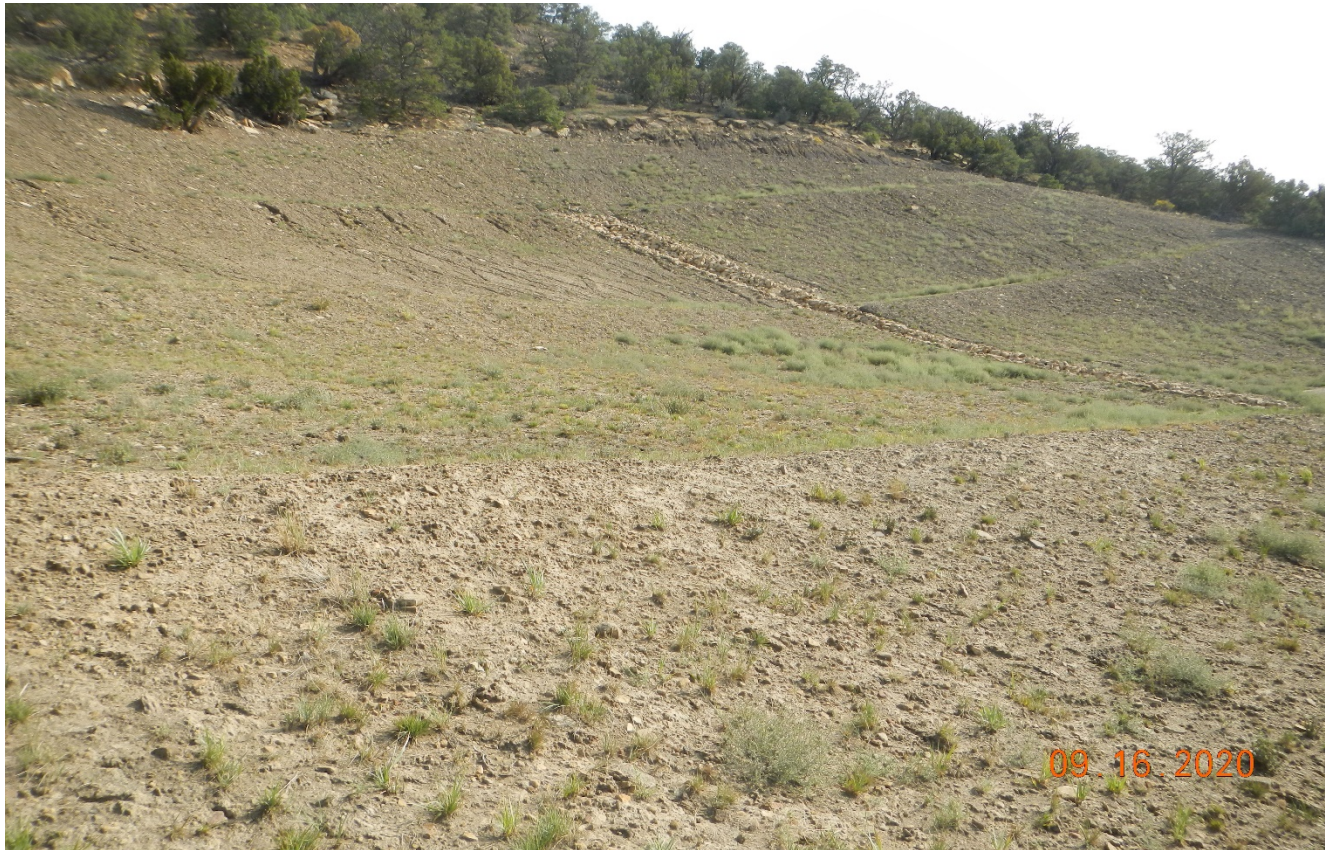
**Photo 9.** Facing northeast toward the location.

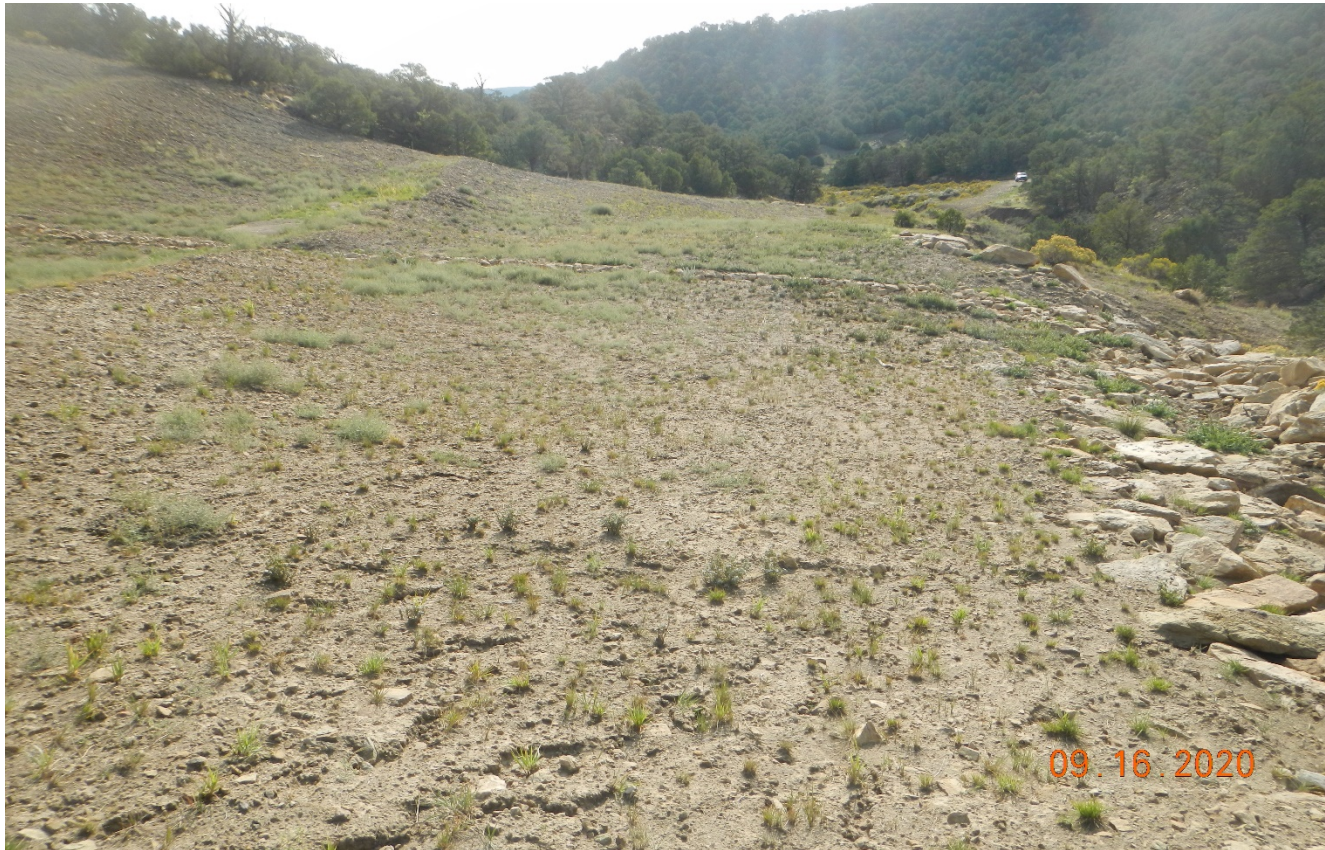
**Photo 10.** Facing southeast toward the location.

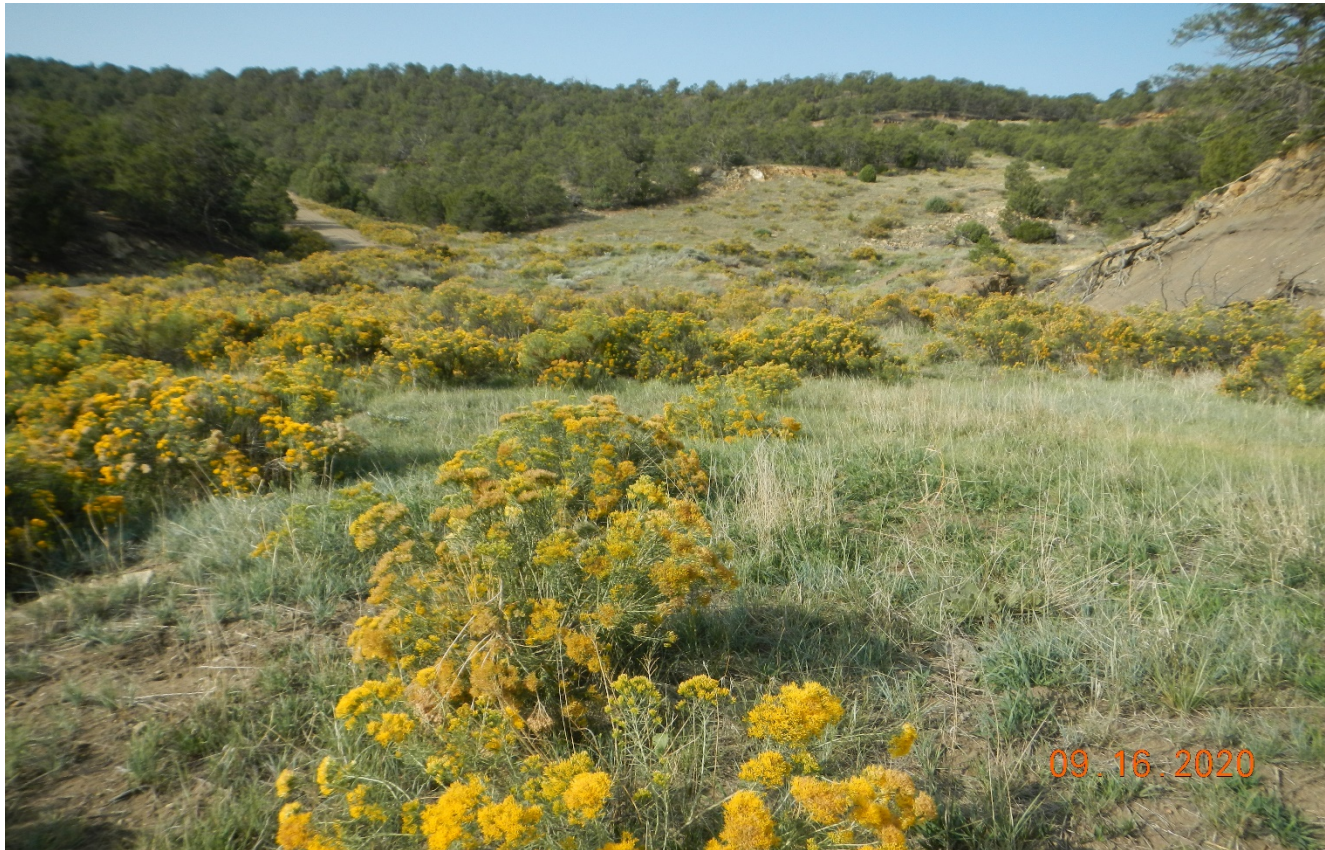
**Photo 11.** View of nearby pipeline vegetation which consists of many native species which are long term persistent vegetation consisting of Rubber rabbit brush, Sand dropseed, Western wheatgrass, Blue grama, among other species.
