## Inspection Photos

Location Name: MARALEX RESOURCES INC FEDERAL-68S98W /25NWSE

Location ID: 312513

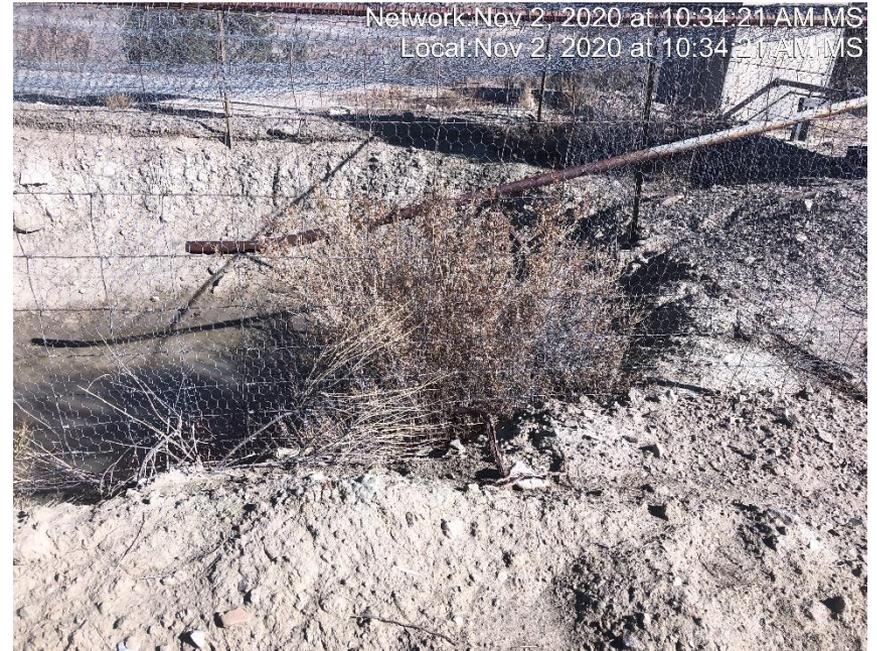
Photo #2153 Debris inside pit.

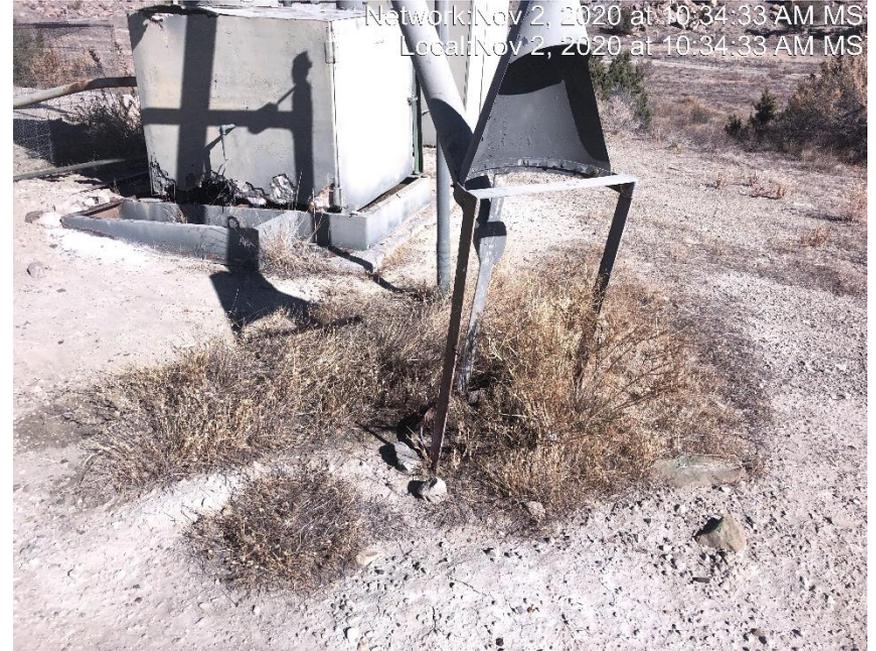
**Photo #2154 Debris around equipment.**
