Inspection Photos

API: 073-06774

Operator: KODA EXPLORATION LLC

Inspection Date: 11/5/2020

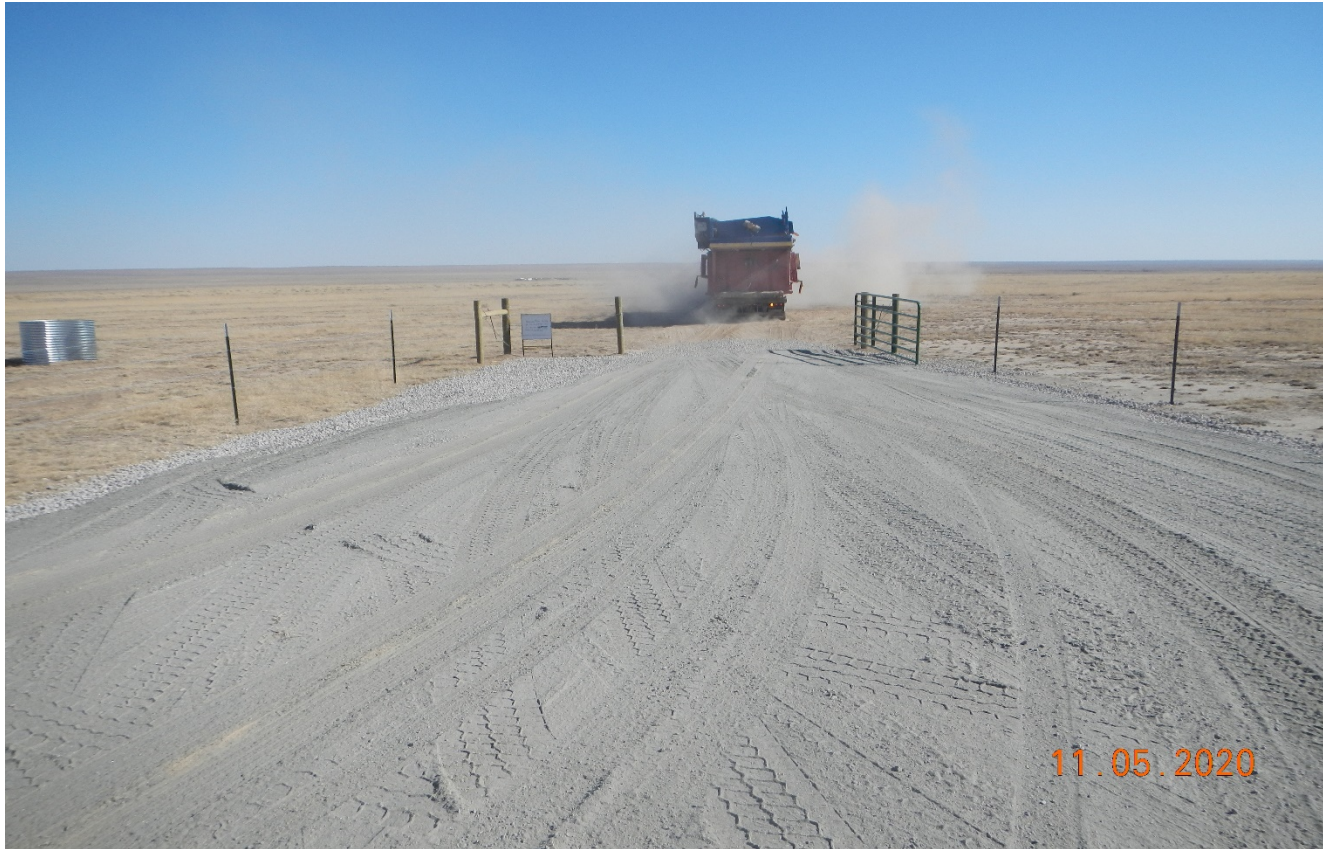
Photo 1. Facing east at the beginning of the access road. Equipment was being hauled to the site to begin drilling.

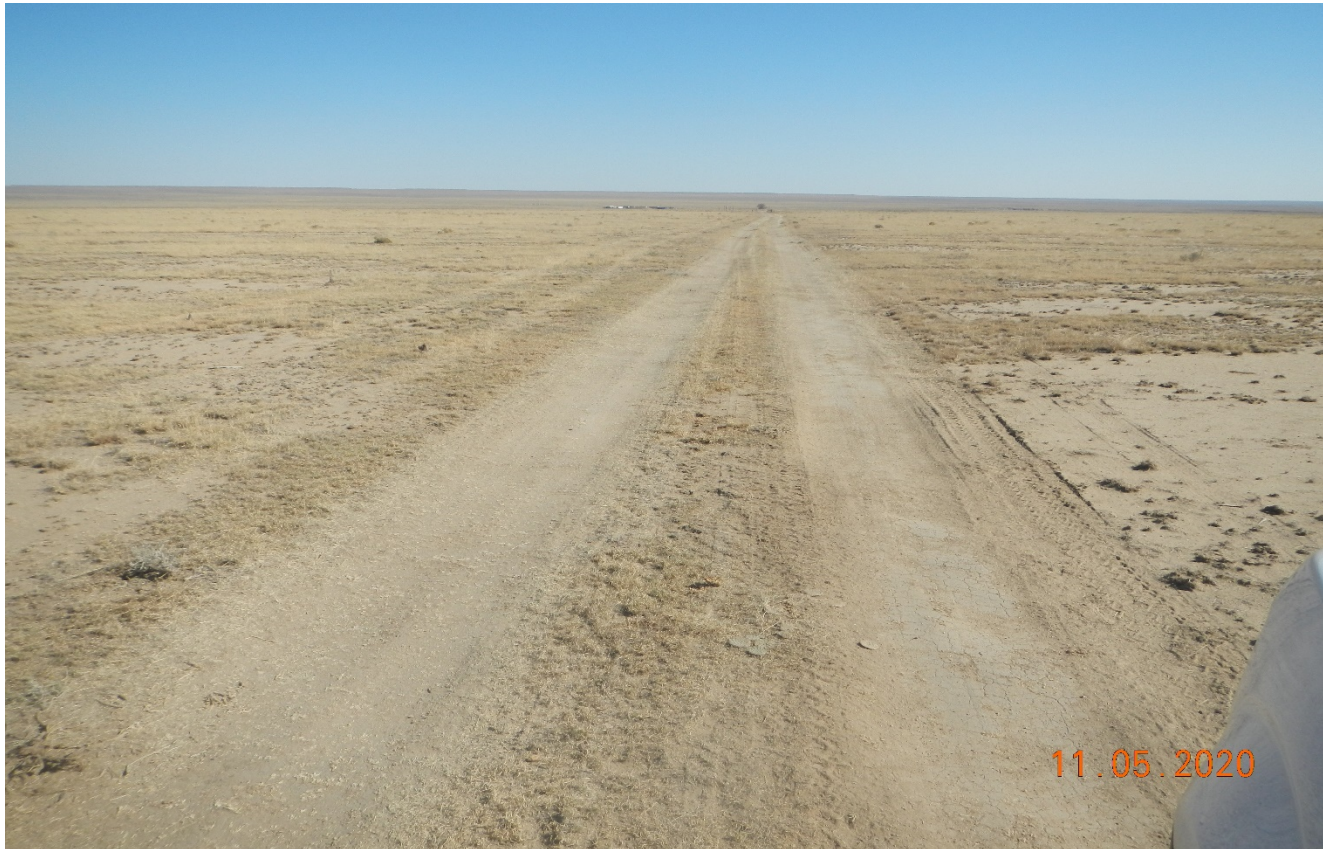
Photo 2. Facing east along the road used to access the site.

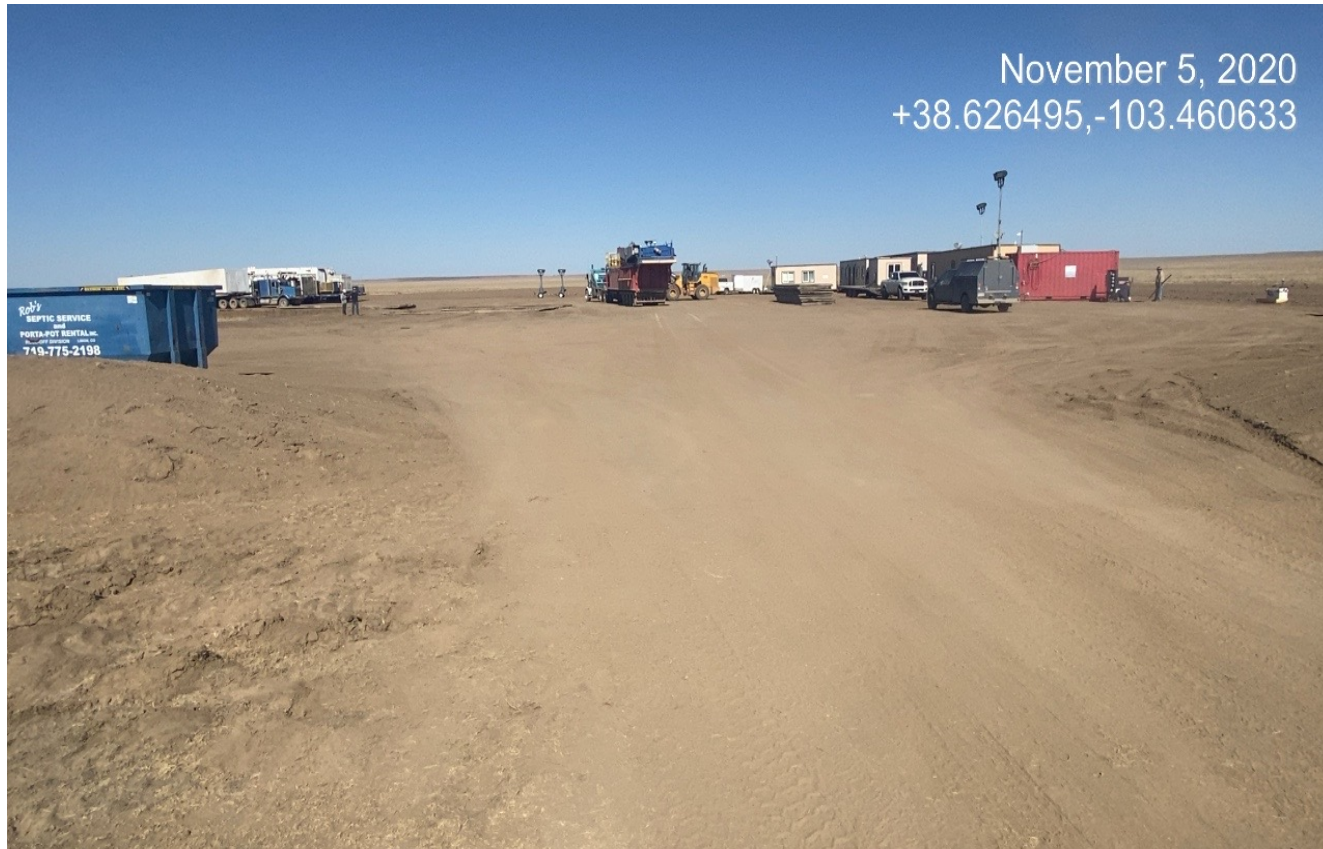
Photo 3. Facing north toward the location.

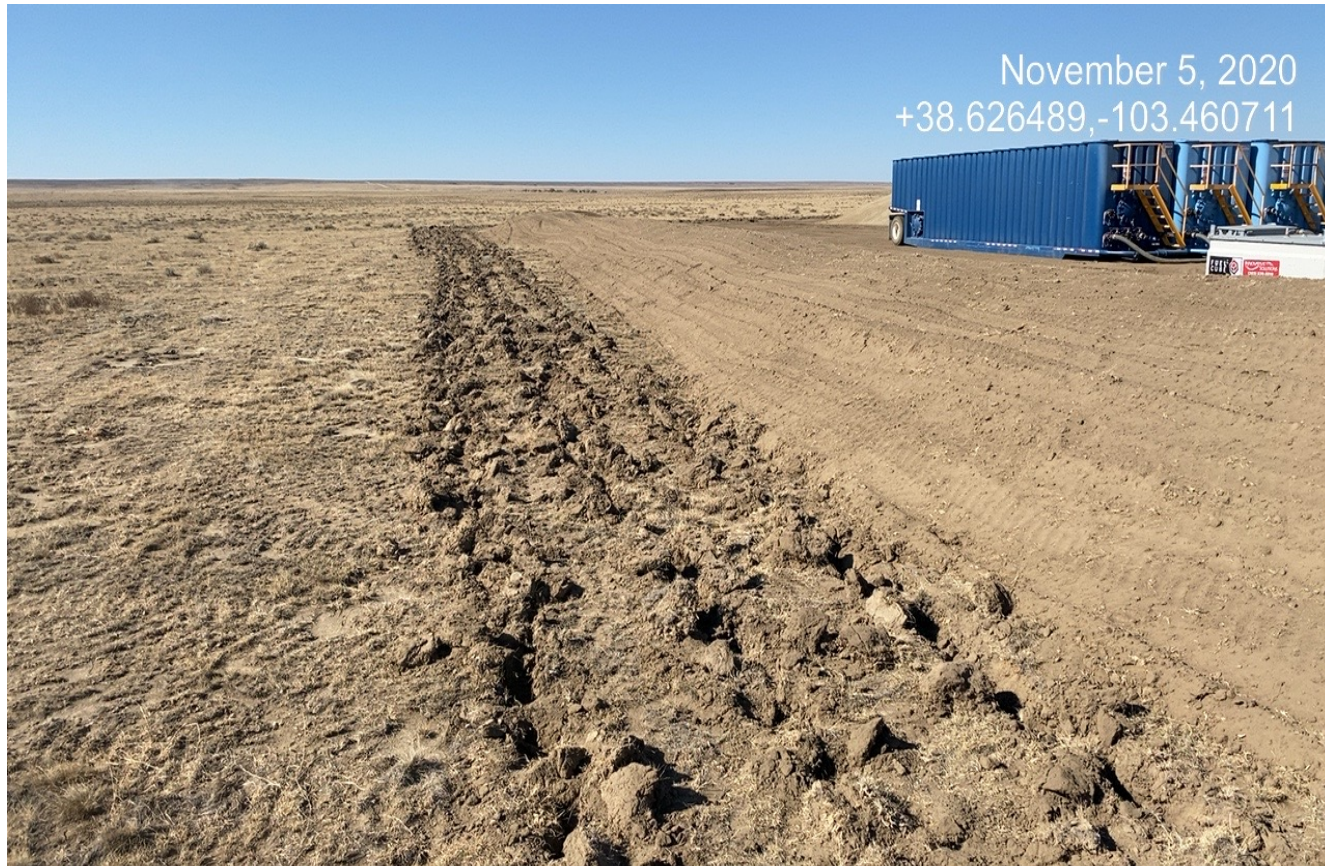
Photo 4. Facing northwest. Surface roughening has been performed around the location and a topsoil berm is placed around the perimeter of the location.

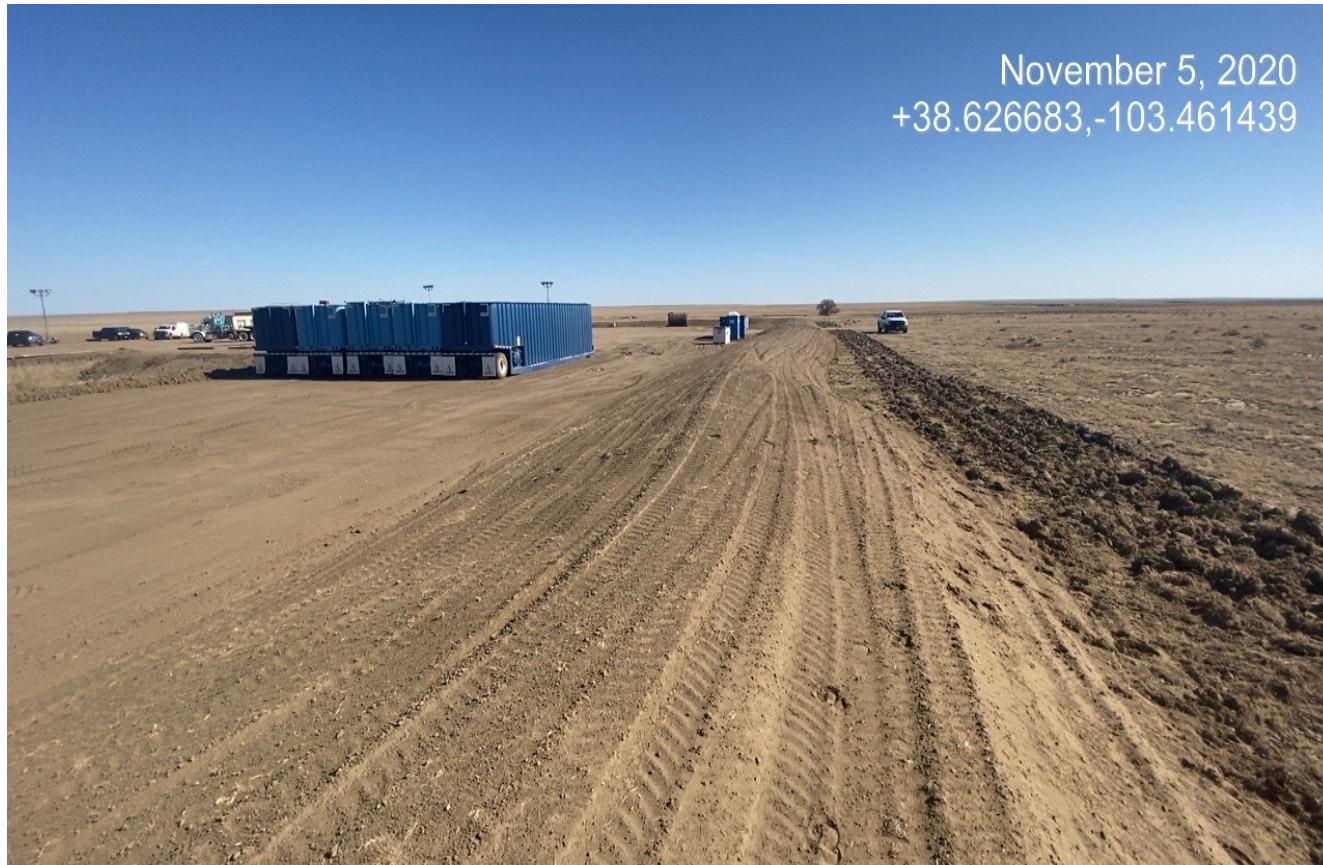
Photo 5. Facing east on top of the topsoil berm.

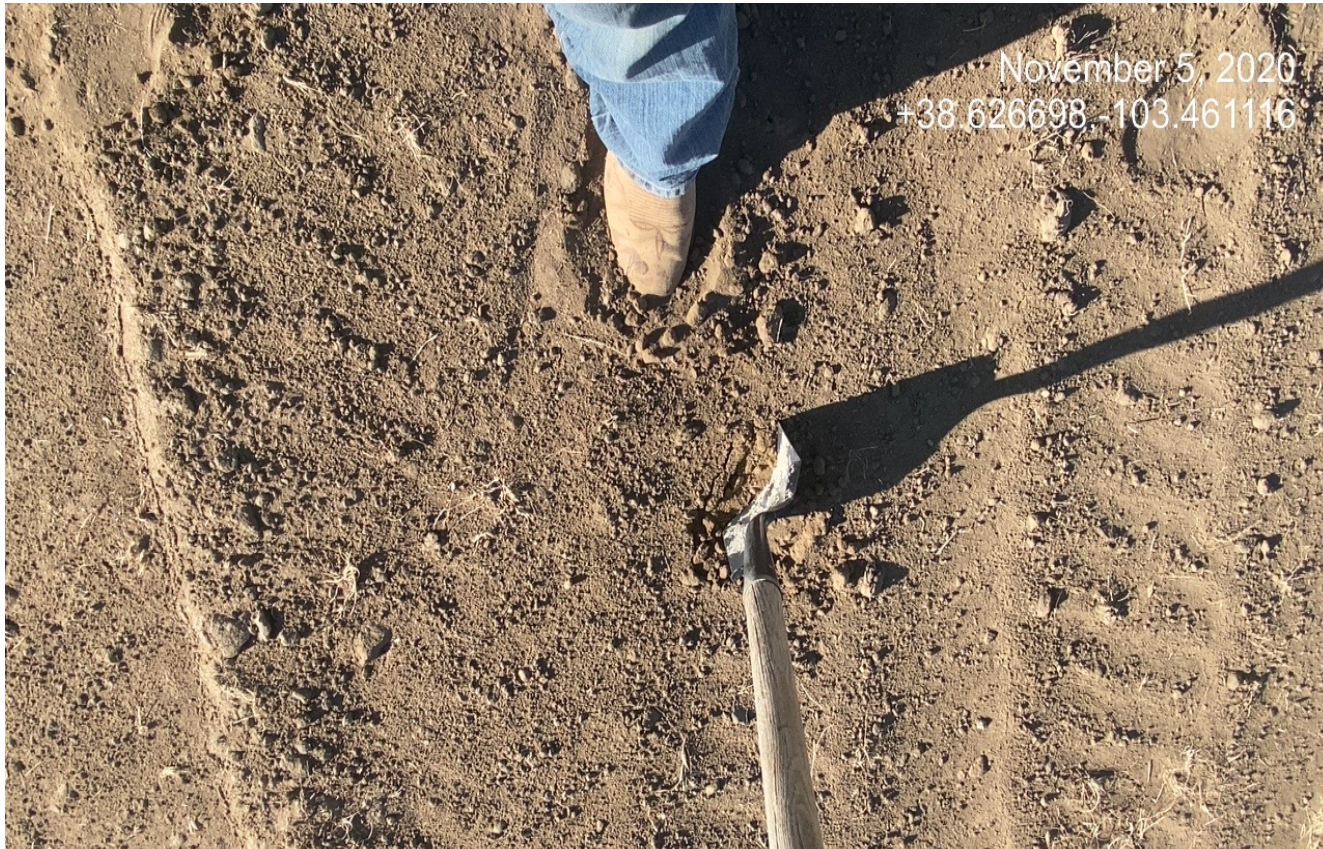
Photo 6. The topsoil pile has been tracked but is not sufficient to stabilize and maintain the topsoil pile. The topsoil is susceptible to erosion.

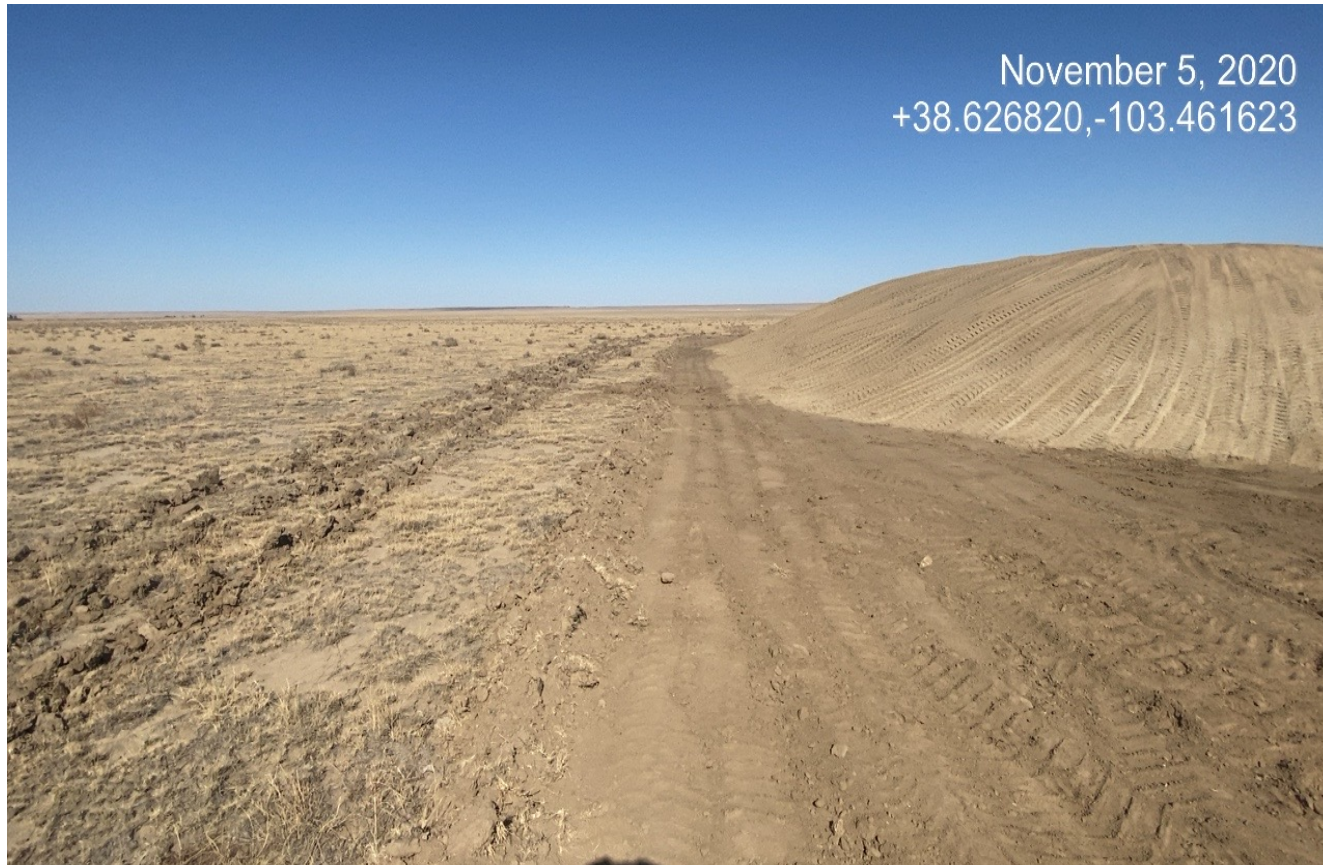
Photo 7. Facing north at the west side of the location.

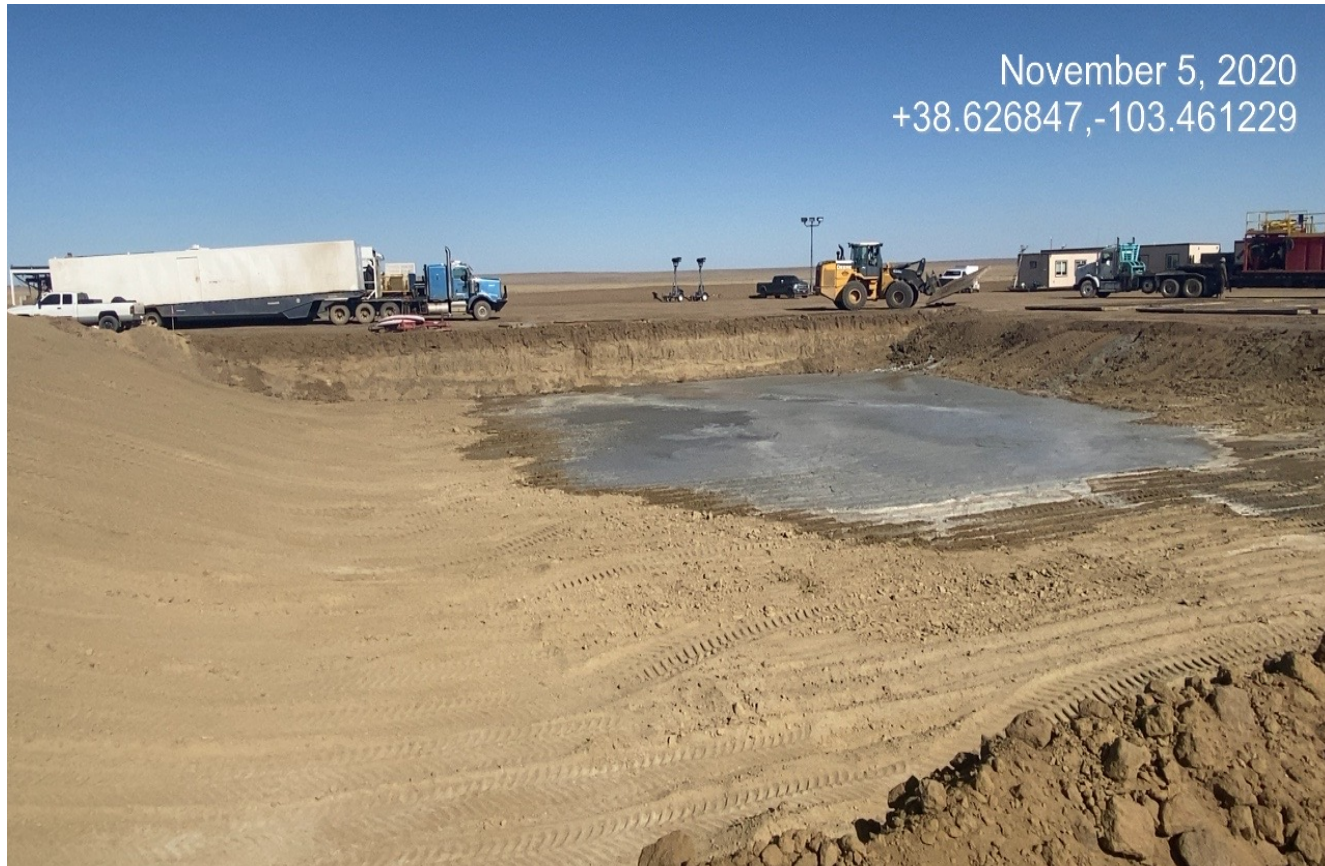
Photo 8. Facing toward the drilling pit.

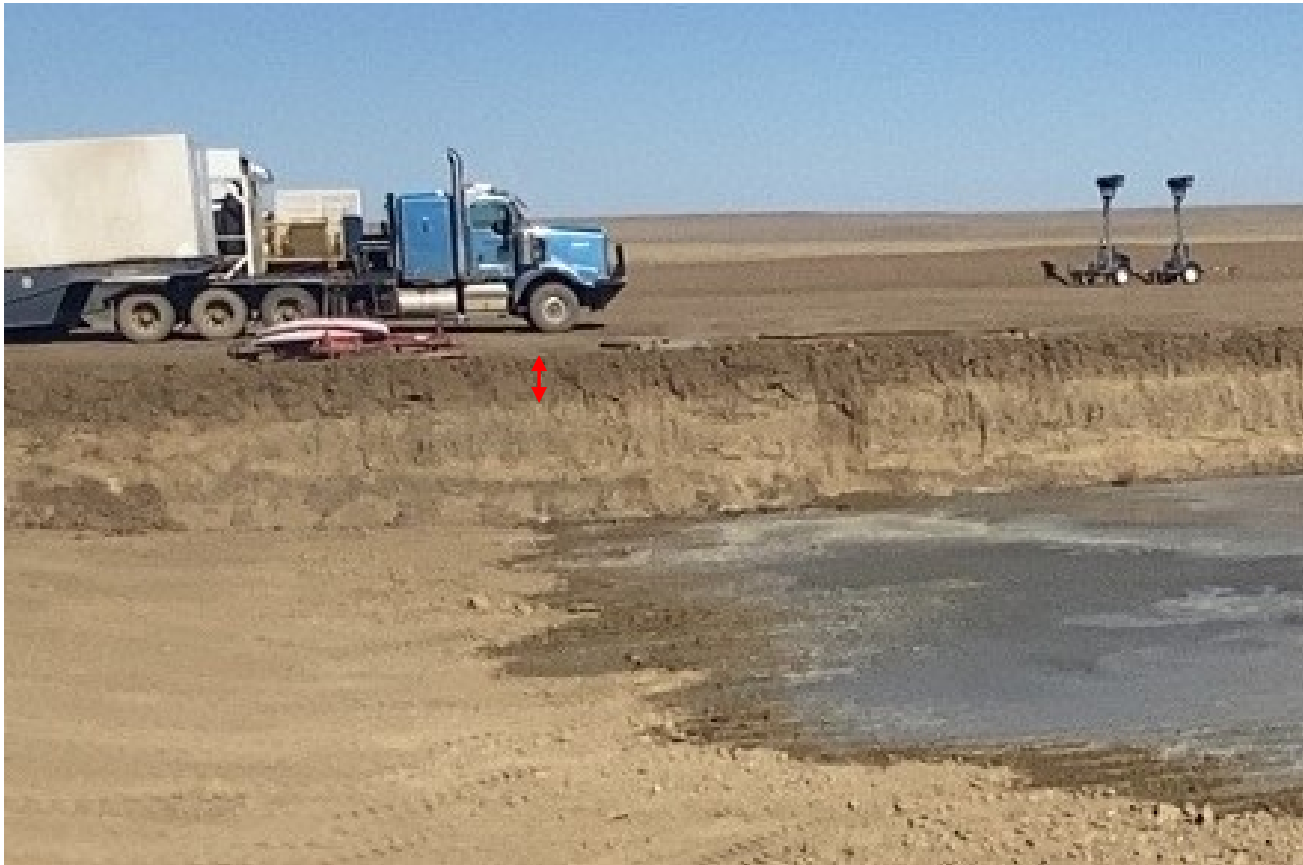
Photo 9. This photo is zoomed in to show the soil horizon in the excavated pit. There is a definitive color change in the soil indicating soil horizons. Additional topsoil (dark horizon) should have been salvaged.

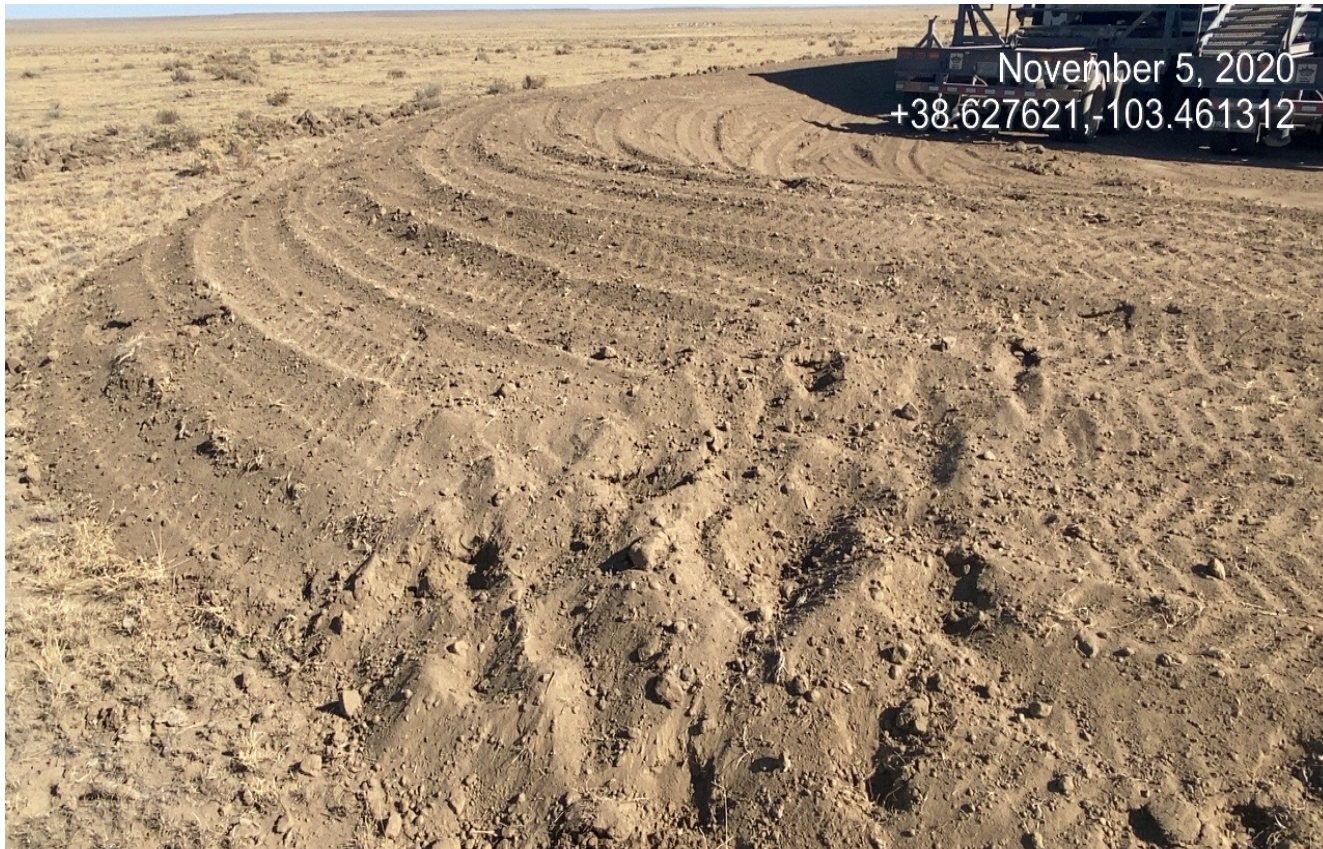
Photo 10. There is cattle tracks on the topsoil pile showing that the topsoil is loose and not stabilized.

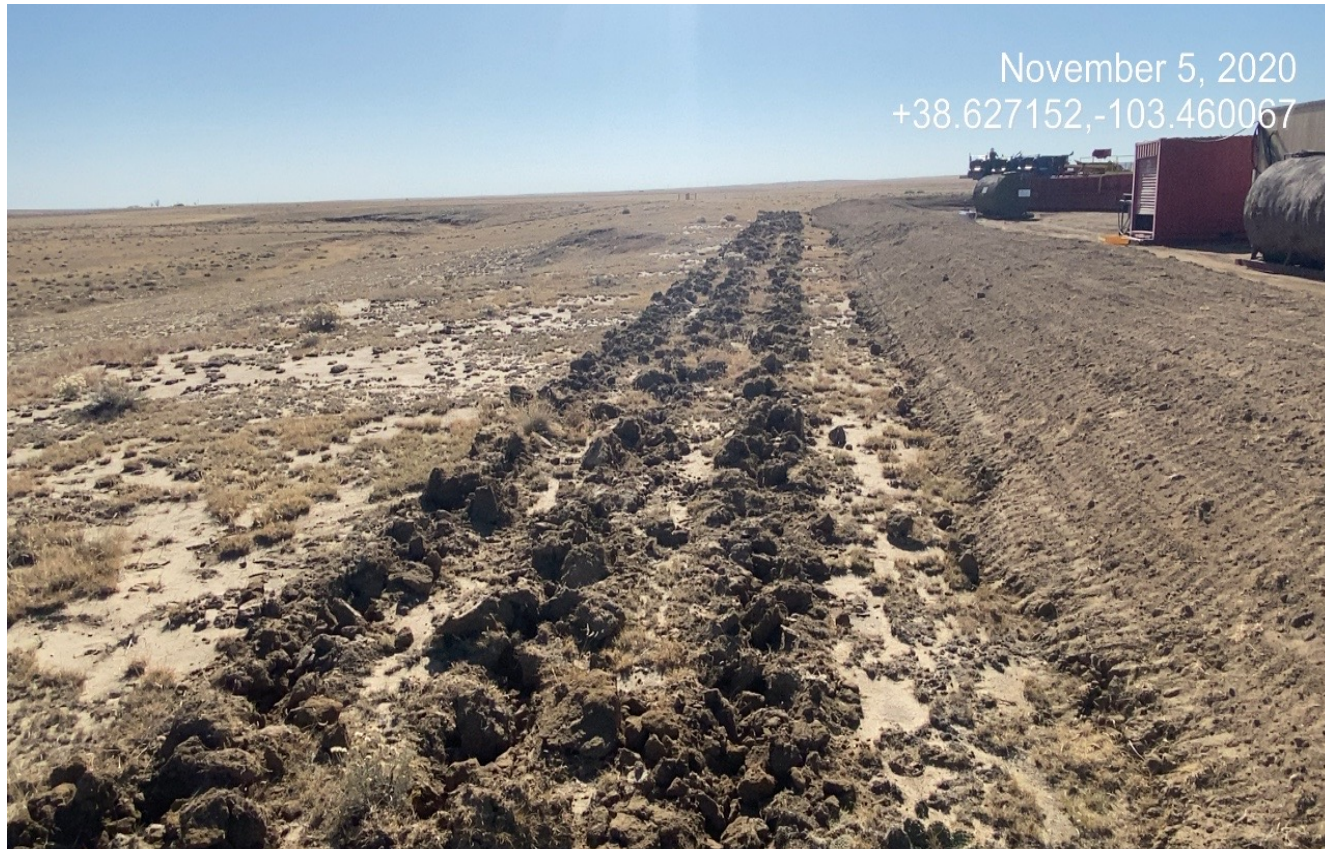
Photo 11. Facing south at the east side of the location.

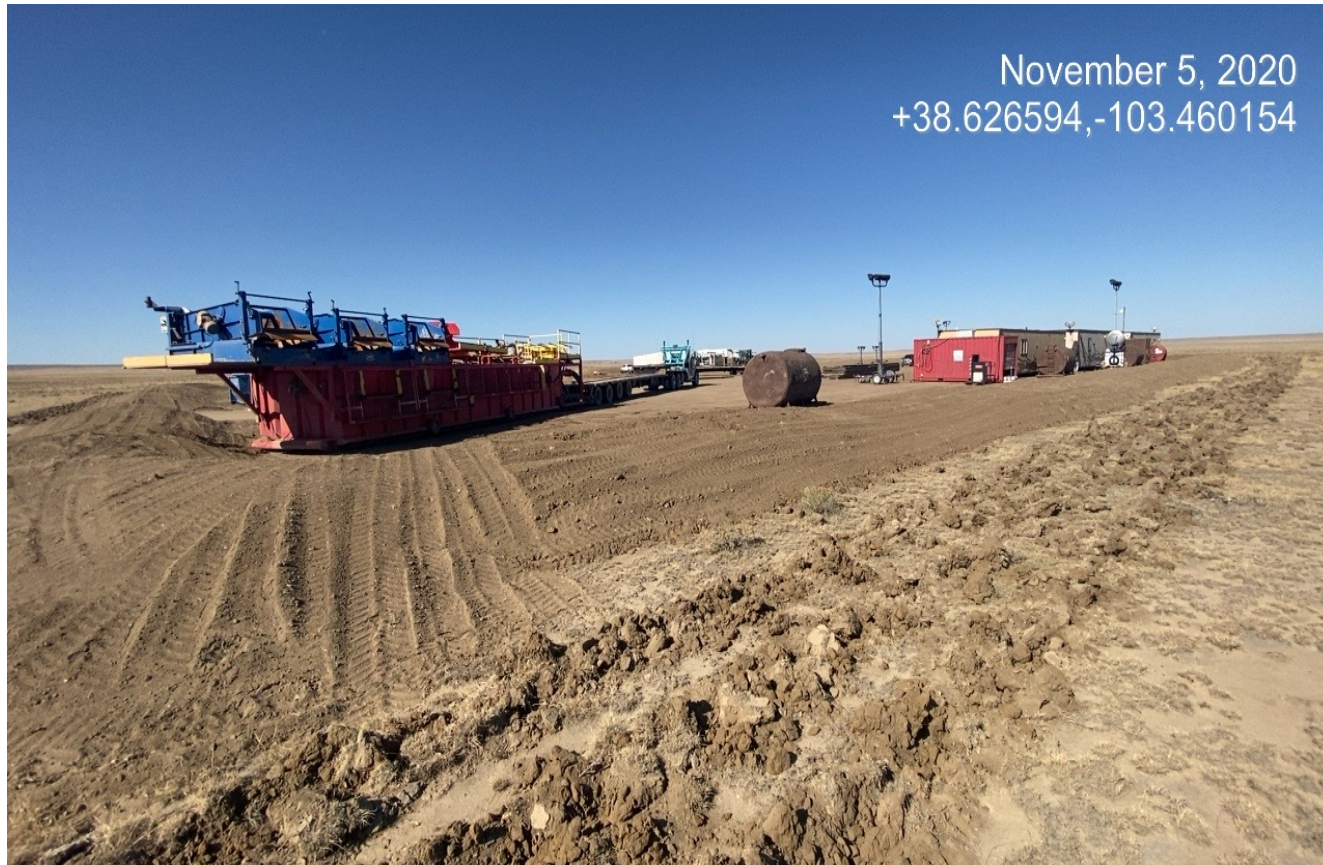
Photo 12. Facing northwest toward the location.
