Inspection Photos
Location Name: UPRR 43 PAN AM I#25
Location ID: 318383

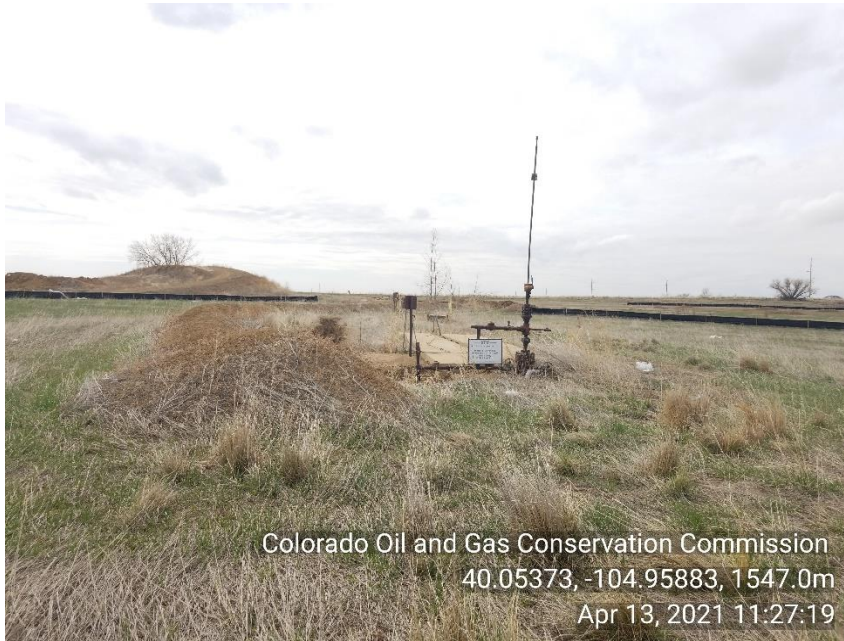
Photo 1 WH Debris: dead weeds on location and in ditch.

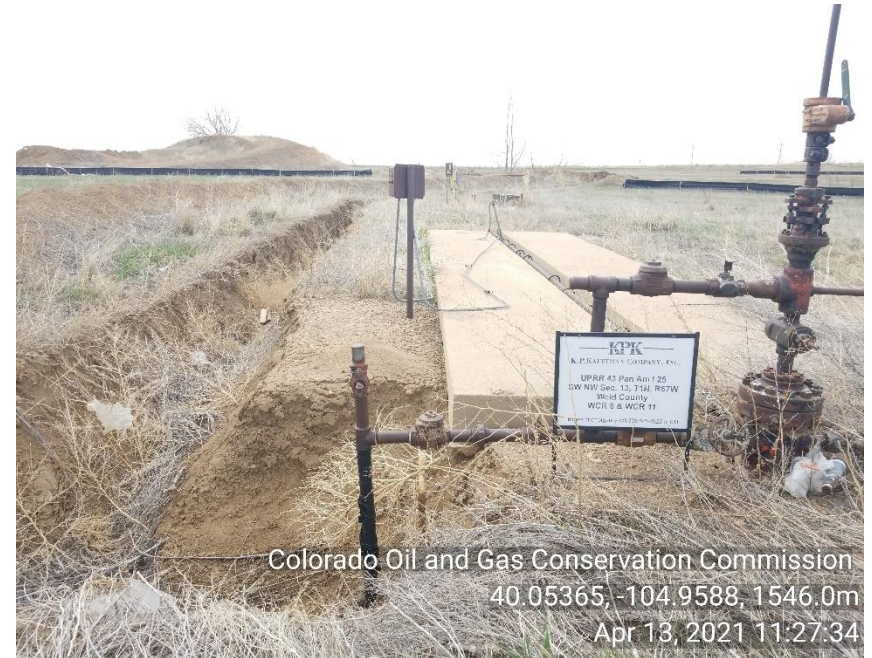
Photo 2 Unused equipment : Cement base, electric control box.

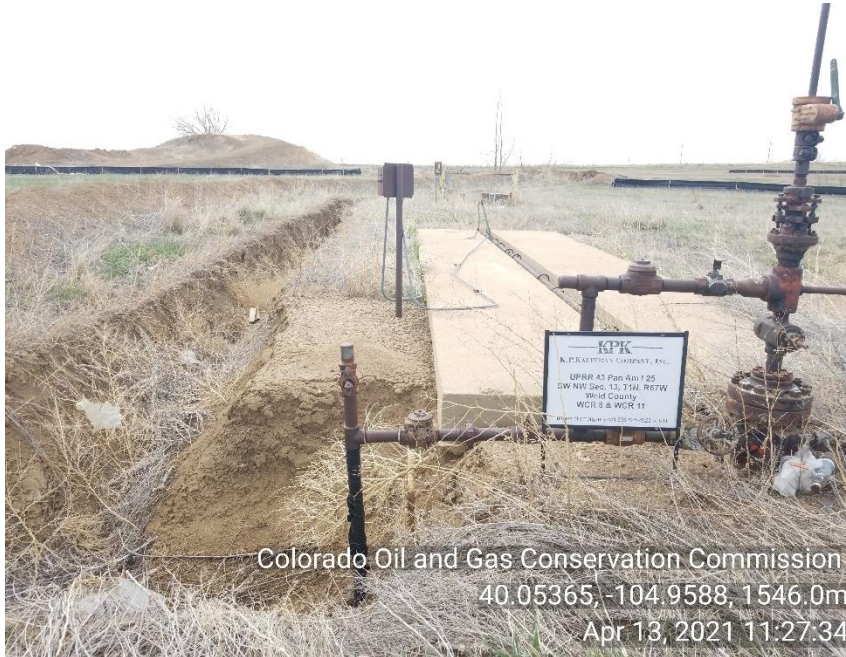
Photo 3 Site Remediation: Pipeline open excavation has been open since 4-4-18.

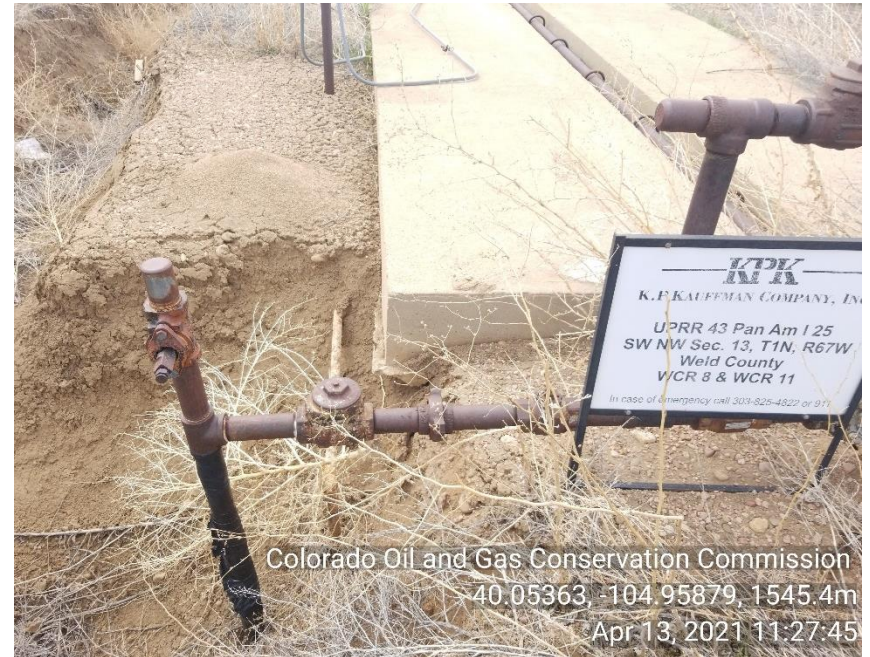
Photo 4 open excavation.

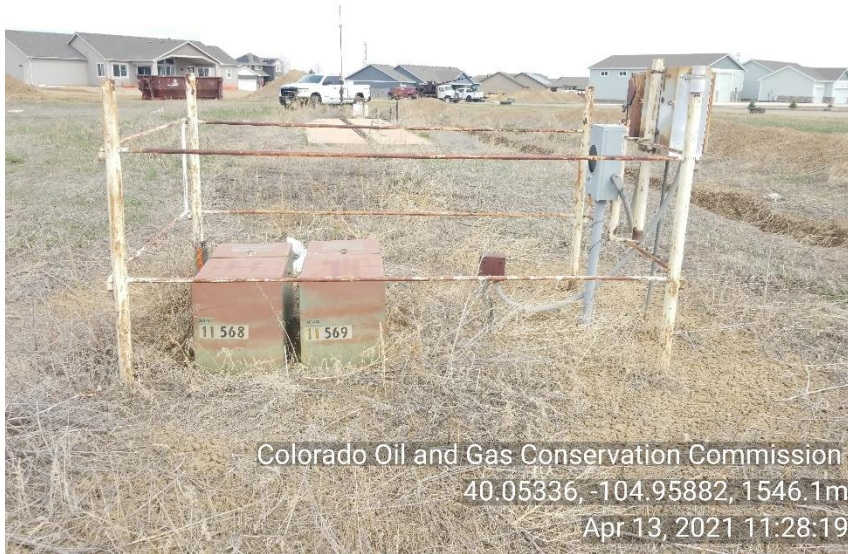
Photo 5 Unused equipment: electric panel, Meter has been removed.

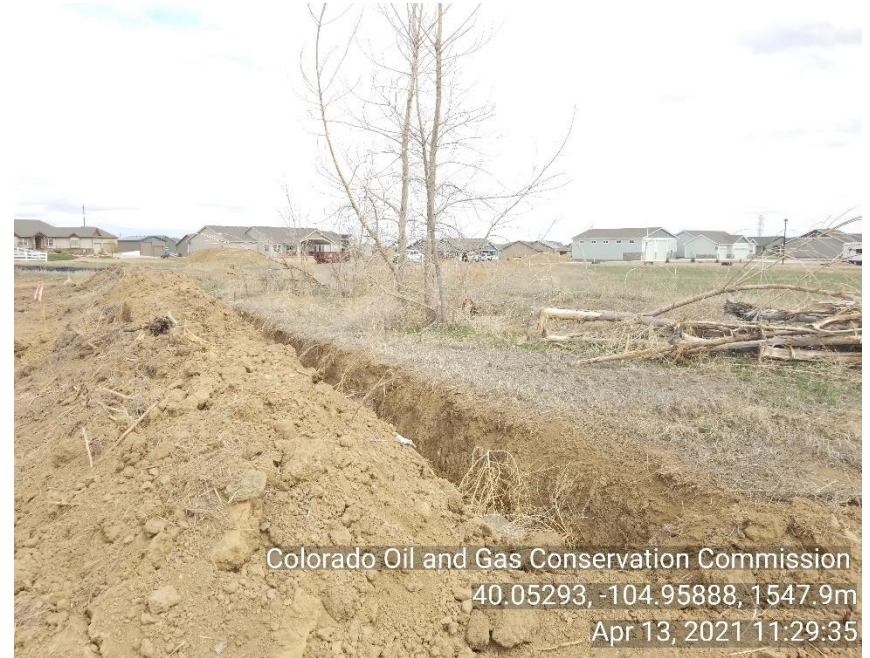
Photo 6 open excavation no BMP's.

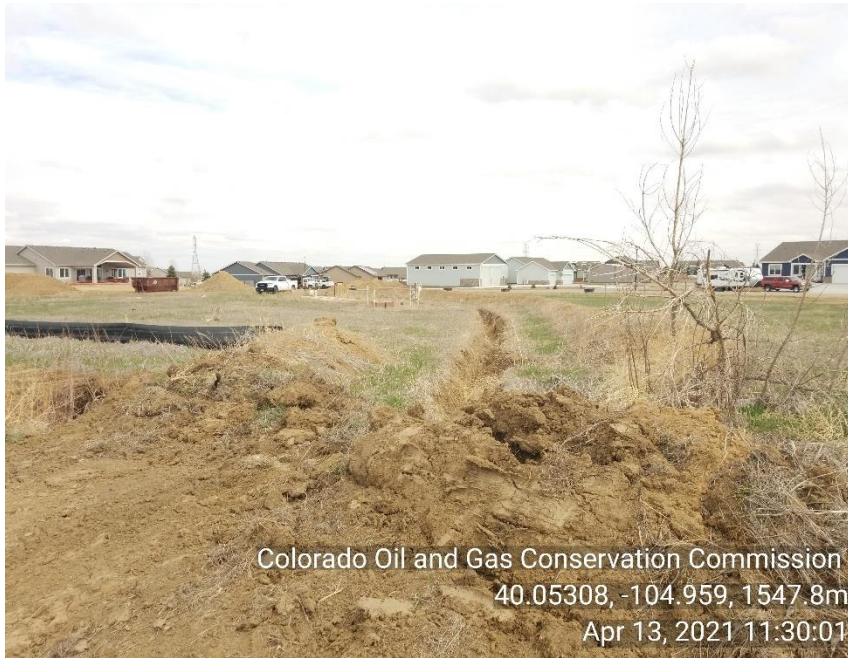
Photo 7 open excavation facing North. No fencing and or BMP's.

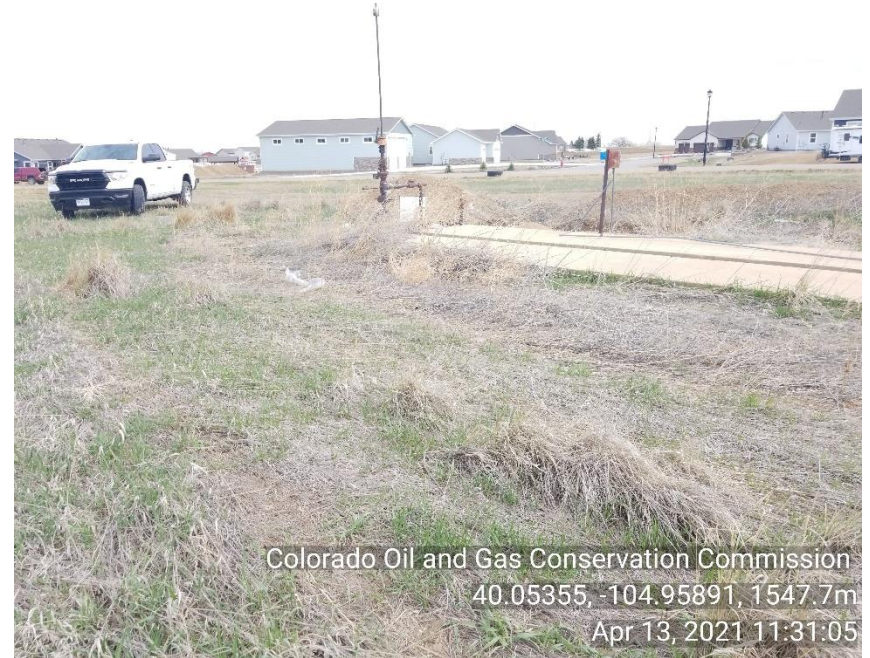
Photo 8 Debris: Dead weeds on location. Unused equipment Cement base and electric control box.

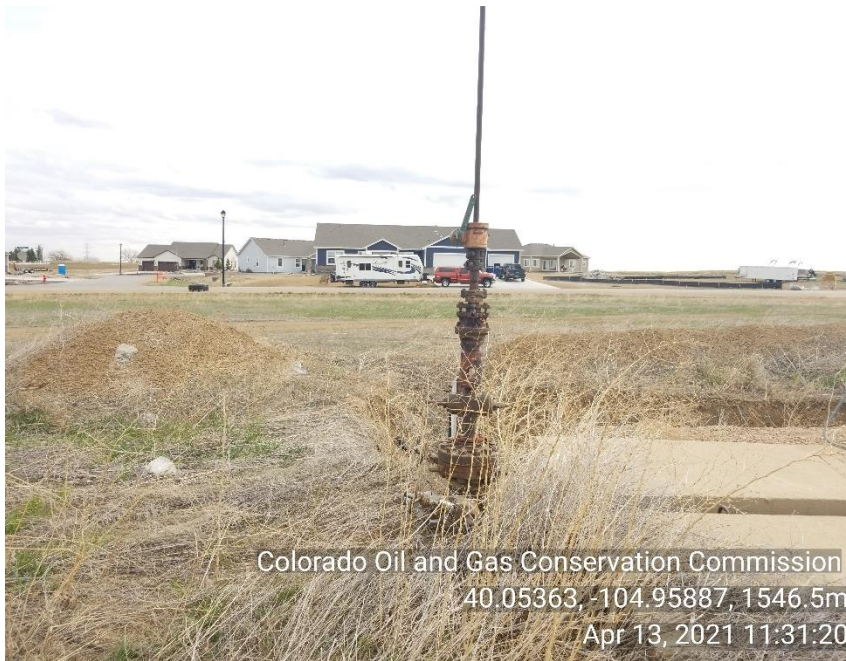
Photo 9 Well Head House facing North residents Home is approx..250 ft from WH. Debris: dead weeds on location.

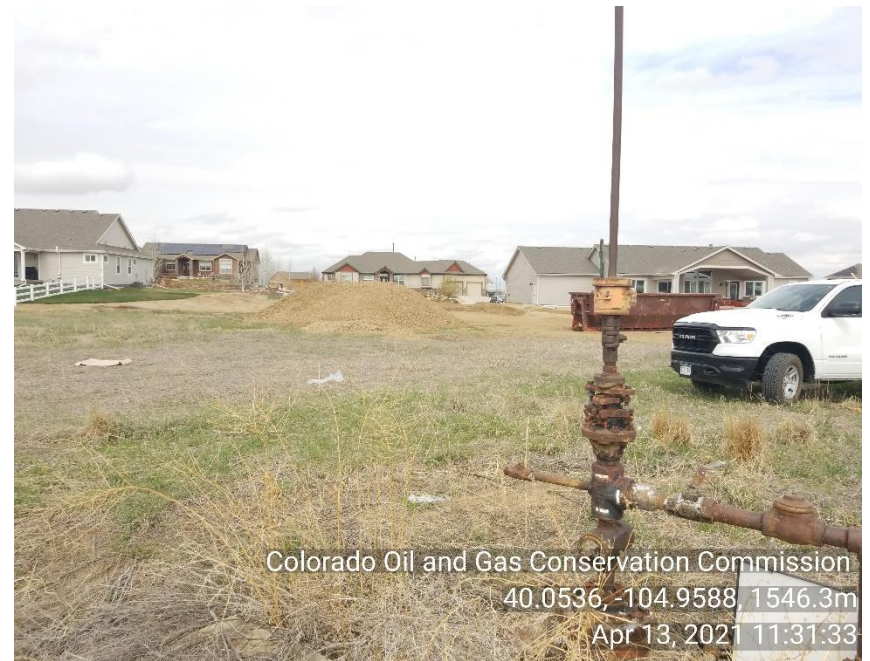
Photo 10 Well head facing North West Residents homes are approx. 195 ft from WH
