<b>FORM</b> <b>INSP</b> Rev X/20	<b>State of Colorado</b> <b>Oil and Gas Conservation Commission</b> 1120 Lincoln Street, Suite 801, Denver, Colorado 80203 Phone: (303) 894-2100 Fax: (303) 894-2109	   	Inspection Date: <u>03/17/2021</u> Submitted Date: <u>03/18/2021</u> Document Number: <u>700300112</u>																								
<b>FIELD INSPECTION FORM</b>																											
Loc ID <u>325310</u> Inspector Name: <u>LABOWSKIE, STEVE</u> On-Site Inspection <input type="checkbox"/> 2A Doc Num: _____		<b>Status Summary:</b> <input type="checkbox"/> THIS IS A FOLLOW UP INSPECTION <input type="checkbox"/> FOLLOW UP INSPECTION REQUIRED <input type="checkbox"/> NO FOLLOW UP INSPECTION REQUIRED																									
<b>Operator Information:</b> OGCC Operator Number: <u>31250</u> Name of Operator: <u>FRITZ &amp; DIGMAN INC</u> Address: <u>PO BOX 70024</u> City: <u>ALBUQUERQUE</u> State: <u>NM</u> Zip: <u>87197-</u>		<b>Findings:</b> 9    Number of Comments 3    Number of Corrective Actions <input checked="" type="checkbox"/> Corrective Action Response Requested

Facility ID: 214538    Type: WELL    API Number: 067-06141    Status: PR    Insp. Status: PR

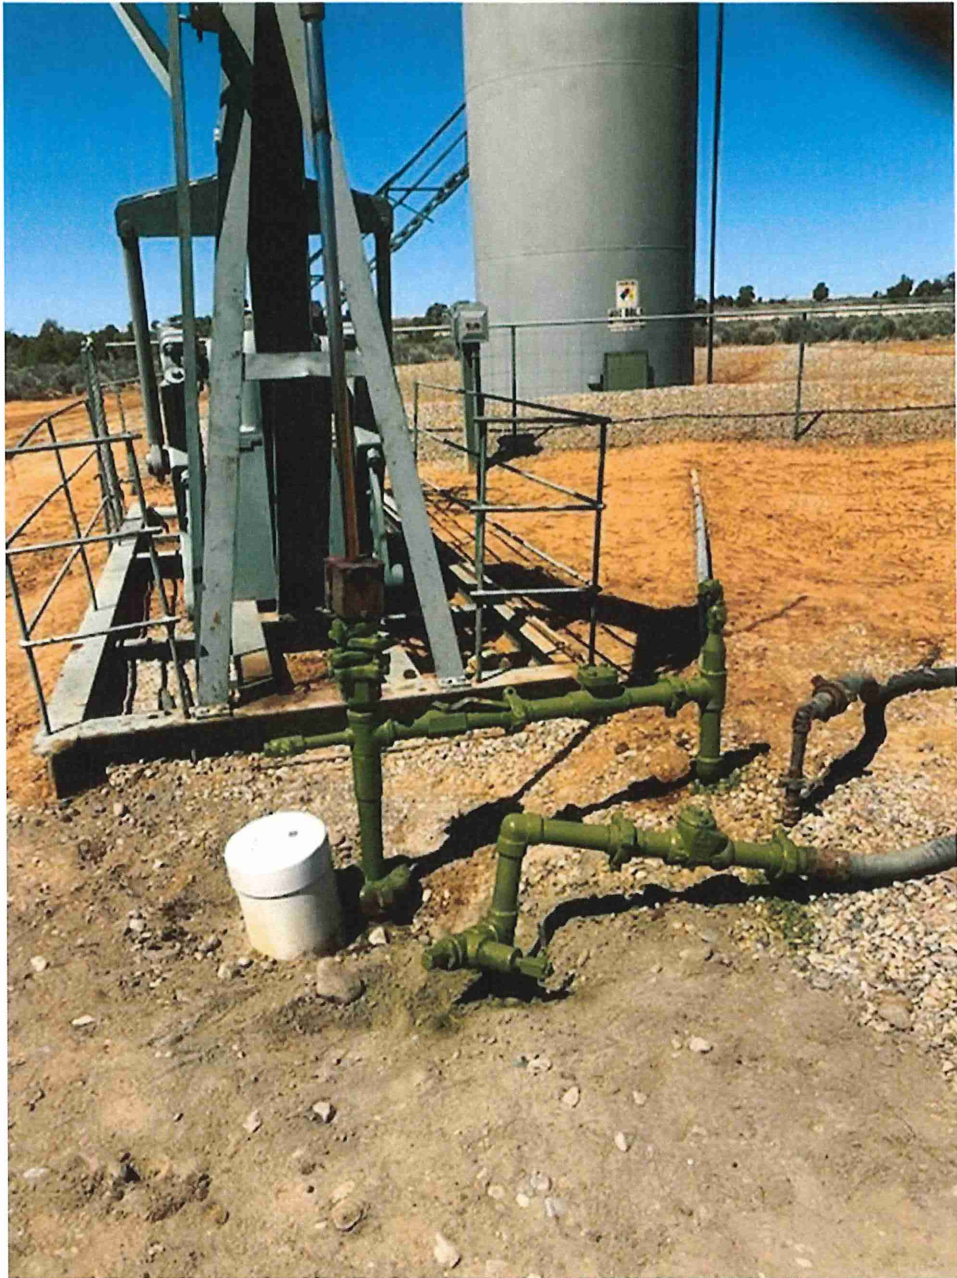
Type	WEEDS		
Comment:	no weeds or combustible materials observed near/around equipment or in tank berms		
Corrective Action:		Date:	
Type	OTHER		
Comment:	oil impacted material around wellhead, crude oil observed collecting on wellhead		
Corrective Action:	clean up impacted material and free oil, control stuffing box/wellhead leak per Rule 912.a and 1002.f(2)	Date:	03/23/2021

Corrective Action:		Date:	
Type: Bradenhead	# 0		
Comment:	No bradenhead access. Operator representative stated access, monitoring and annual testing was not required due to well construction, no correspondence or bradenhead test information in well file.		
Corrective Action:	Install appropriate fittings to allow bradenhead visual inspection as per Rule 419.a.(1), (2) Make bradenhead monthly monitoring reports available to COGCC per Rule 419.b.(5)	Date:	
Type: Deadman # & Marked	# 4		
Comment:			
Corrective Action:		Date:	
Type: Ancillary equipment	# 1		
Comment:			
Corrective Action:		Date:

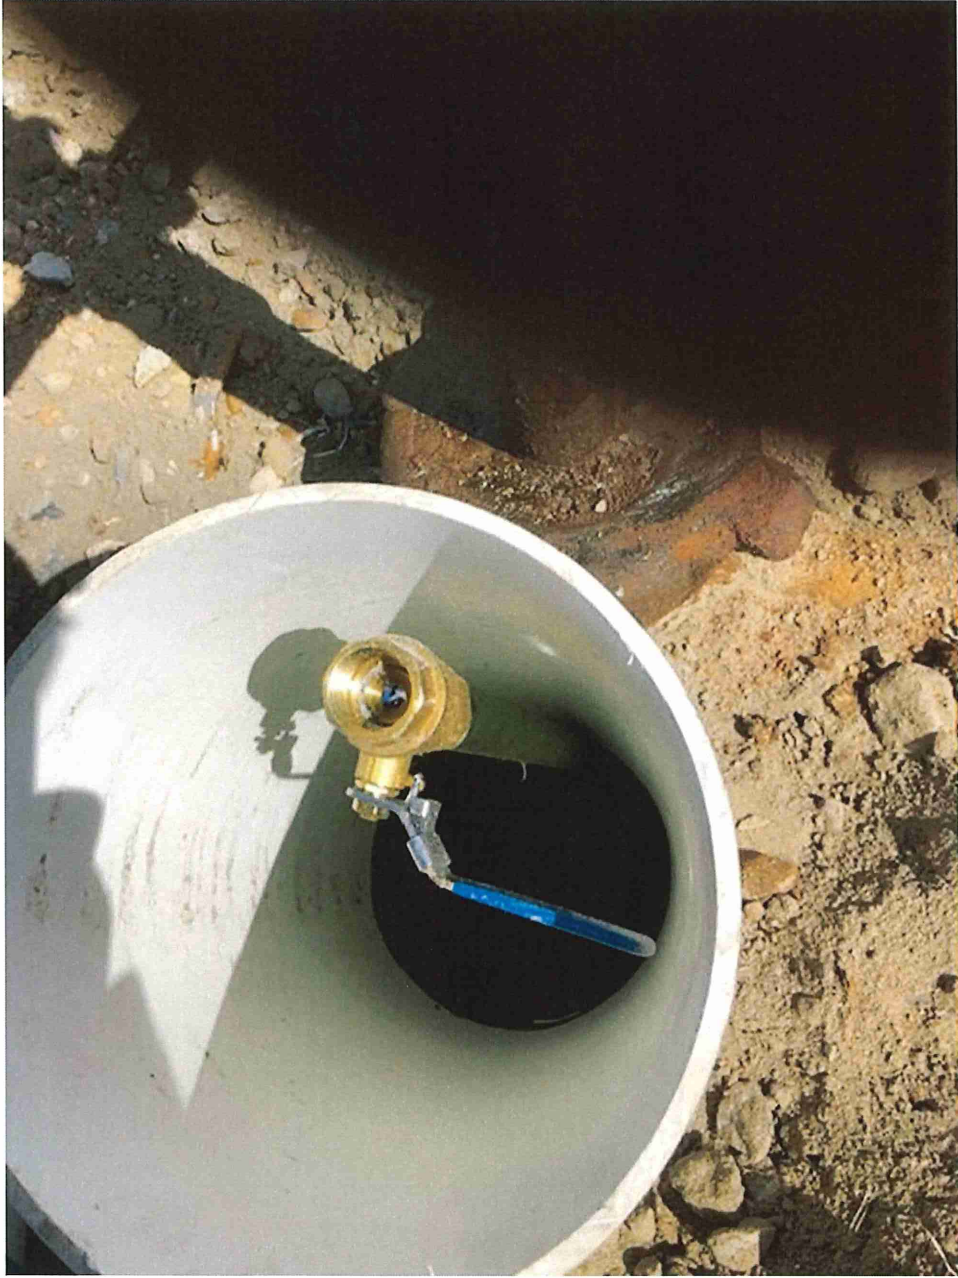
Yes/No	YES
Comment:	Casing head gas is beijg and vented and then combusted through converted fire tube, no annual sundry notice for vent/flare in well file.
Corrective Action:	Date:

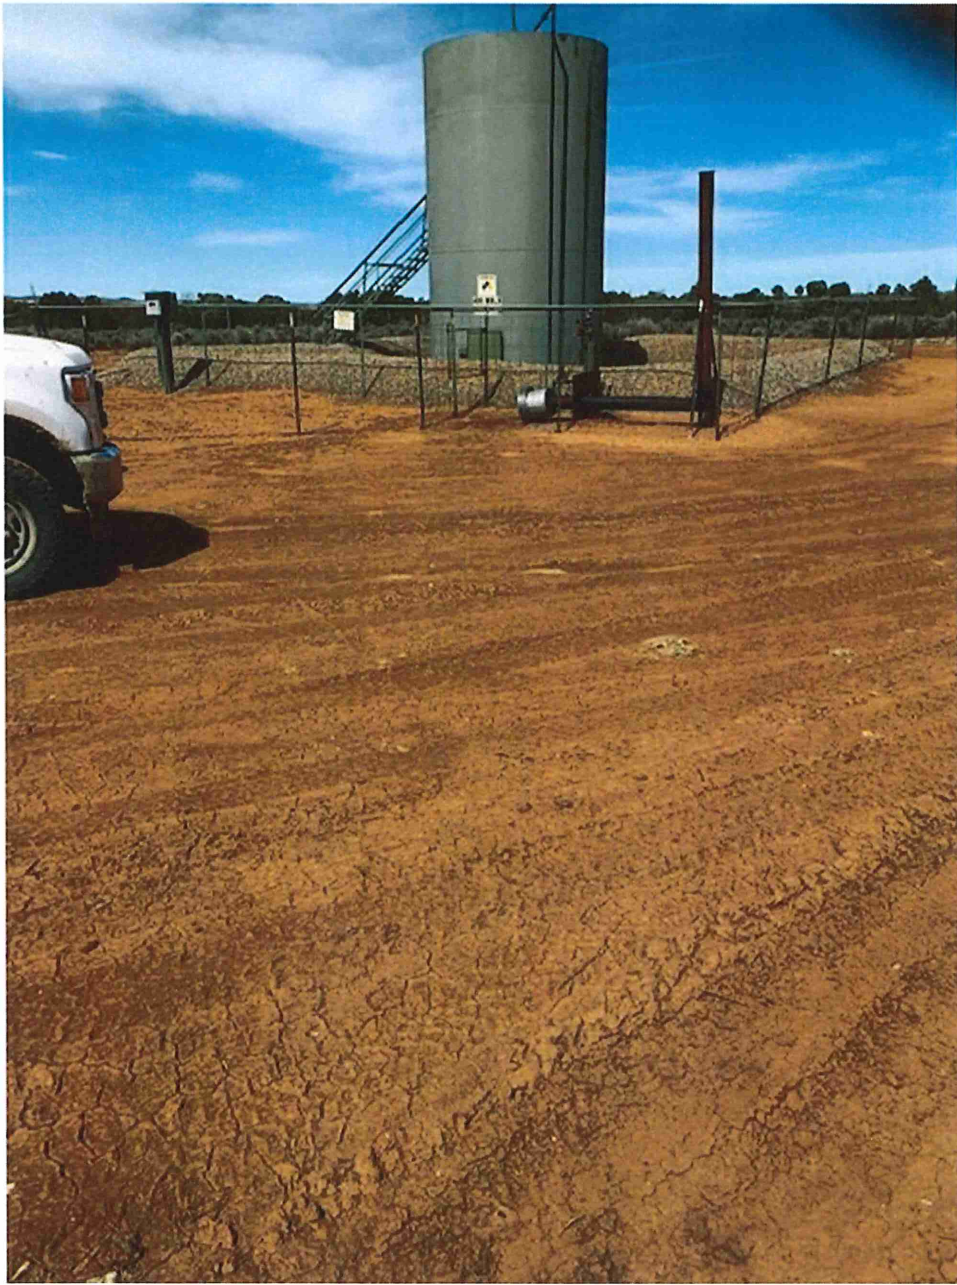
Contents	#	Capacity	Type	Tank ID	SE GPS
CRUDE OIL	1	400 BBLS	STEEL AST		
Comment:	tank venting gas through manually opened 2" valve (see attached FLIR footage) and enarto valve/PRV				
Corrective Action:					Date:

Comment: FLIR footage shows tank venting through manually opened 2" valve and PRV. Operator cited in previous inspections for same valve being open and/or thief hatch open.

Corrective Action: Only operate tank with properly sized and functioning PRV
