Inspection Photos  
Operator: Simcoe  
API: 067-07463  
Date: 4/22/2021

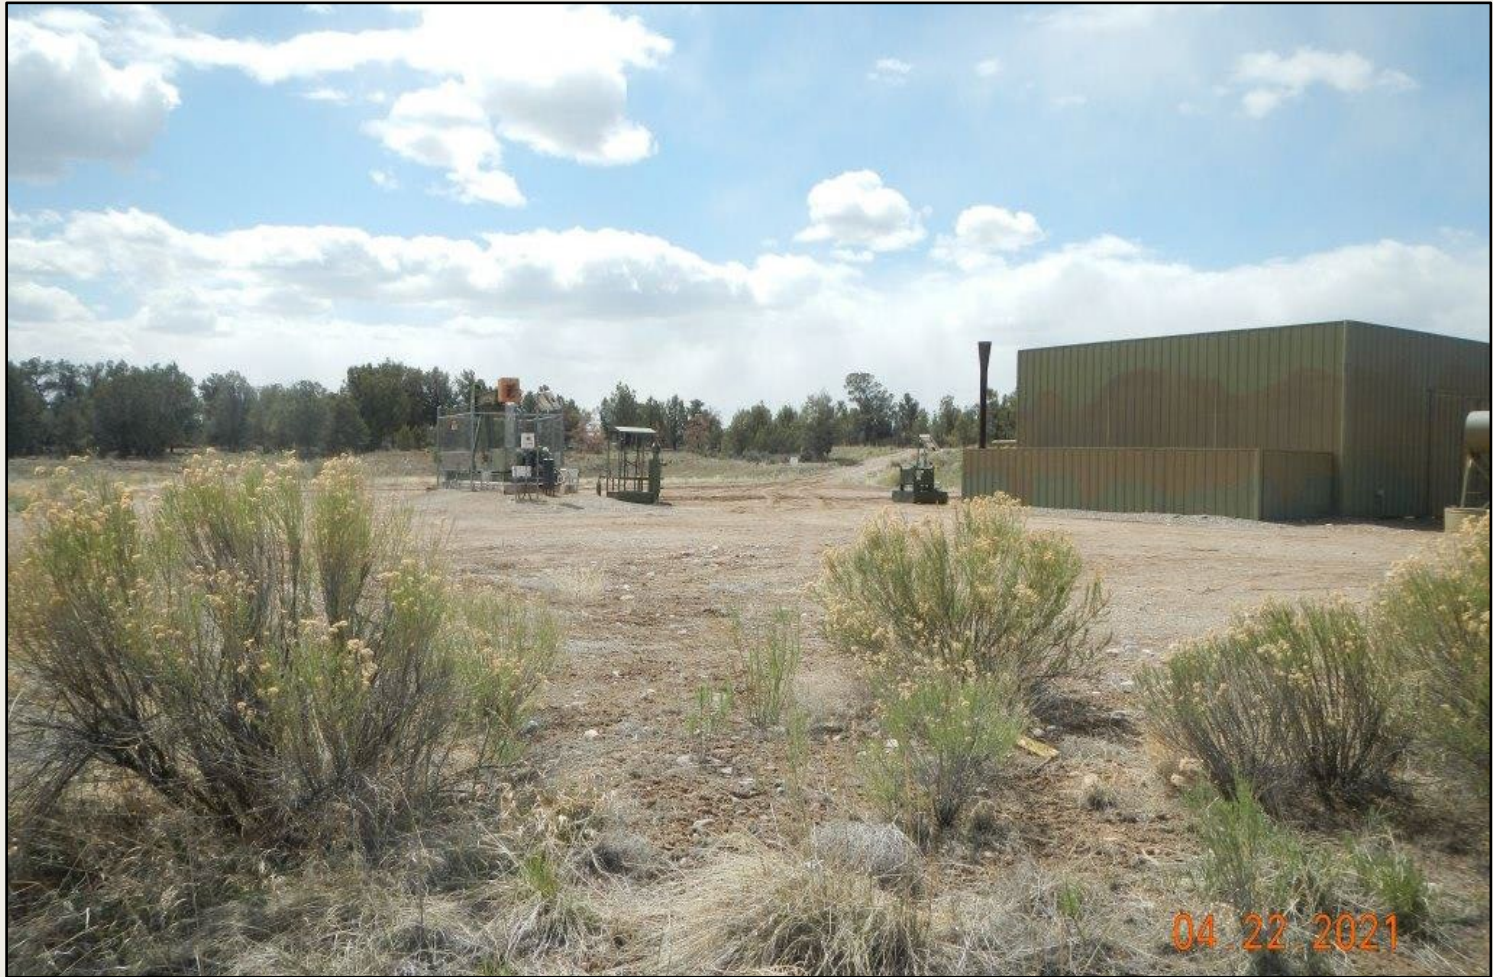
Photo 1. View of the project area from the northeastern corner facing center.

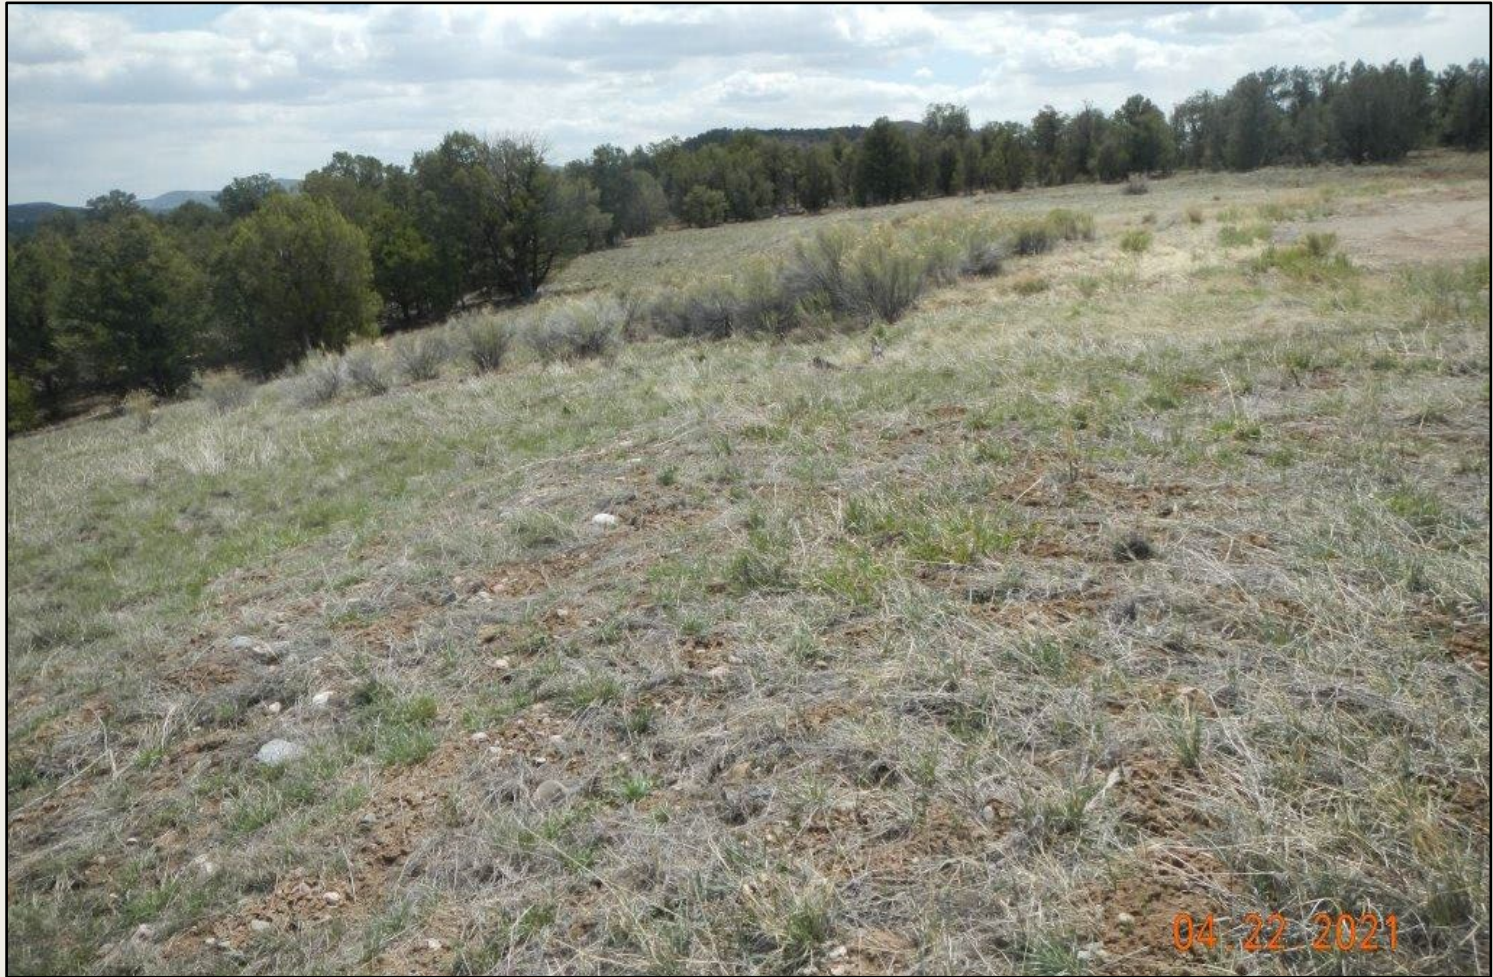
Photo 2. View of the eastern project area from the northwestern corner facing eastward. Revegetation is progressing with western wheatgrass, crested wheatgrass, and rubber rabbitbrush.

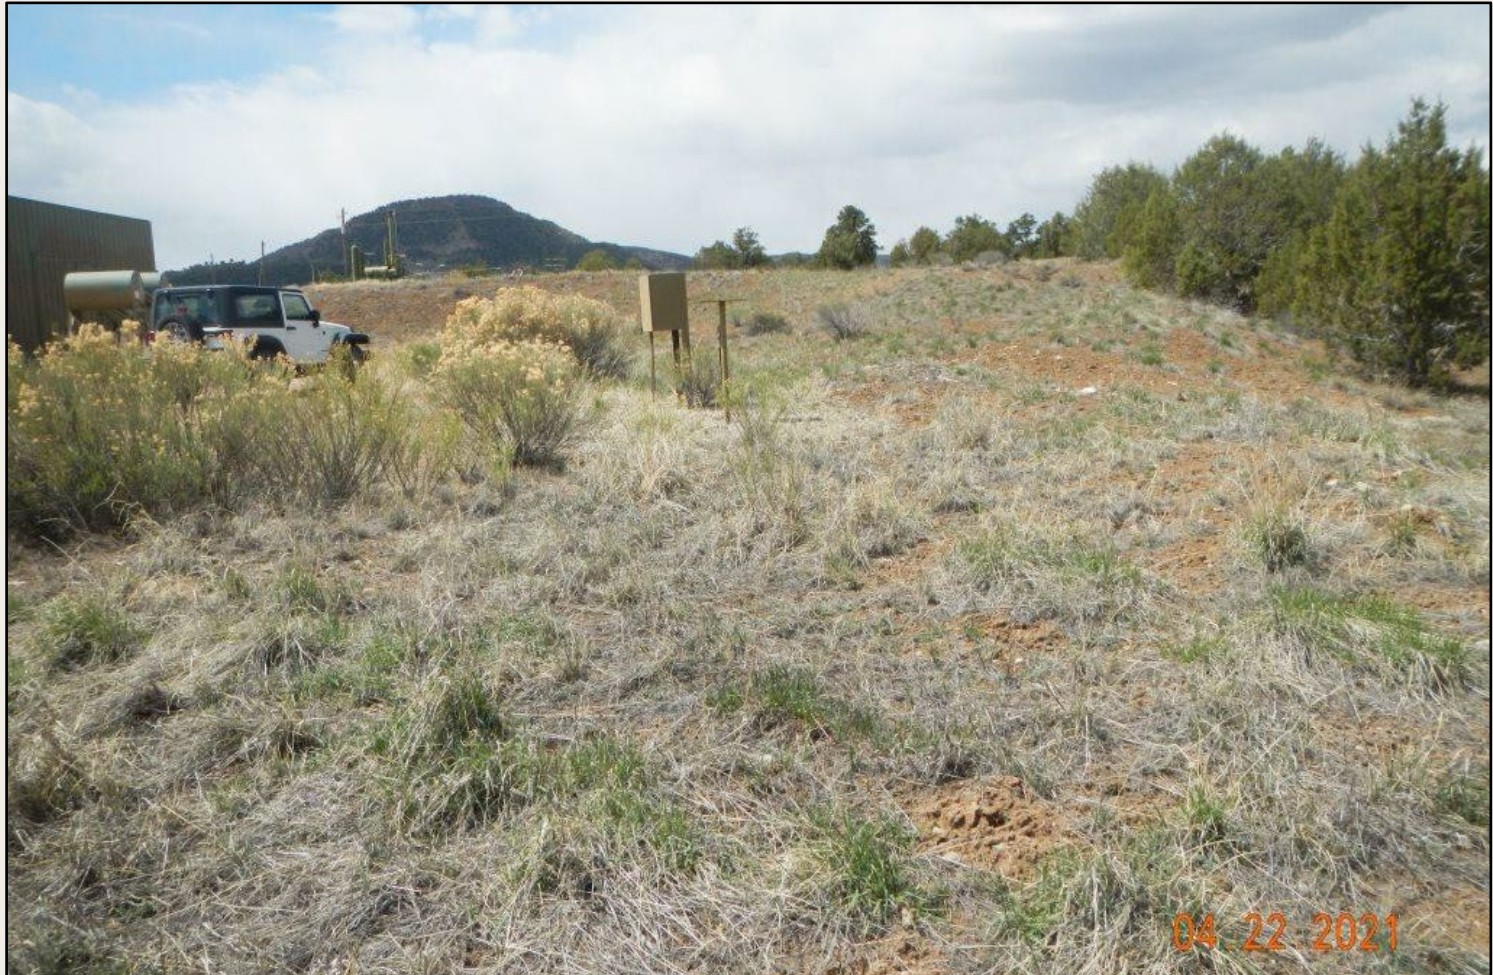
Photo 3. View of the northern project area from the northeastern corner facing westward.

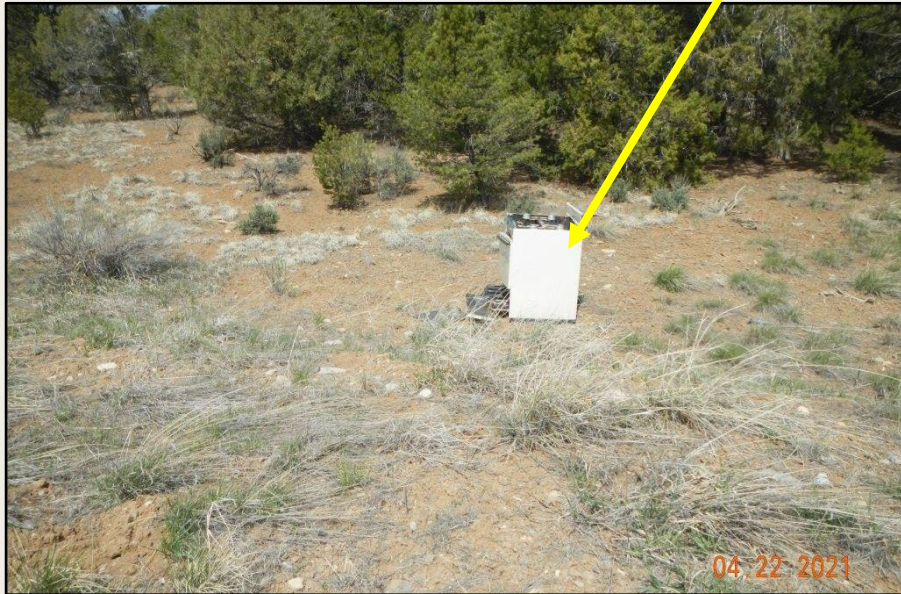
Debris

Photos 4/5. View of appliance dumped off of the northern edge of the well pad (left), and musk thistles observed within the interim reclamation area (right).
