Inspection Photos

Operator: Paradox Upstream
API: 113-06120
Date: 6/9/2021

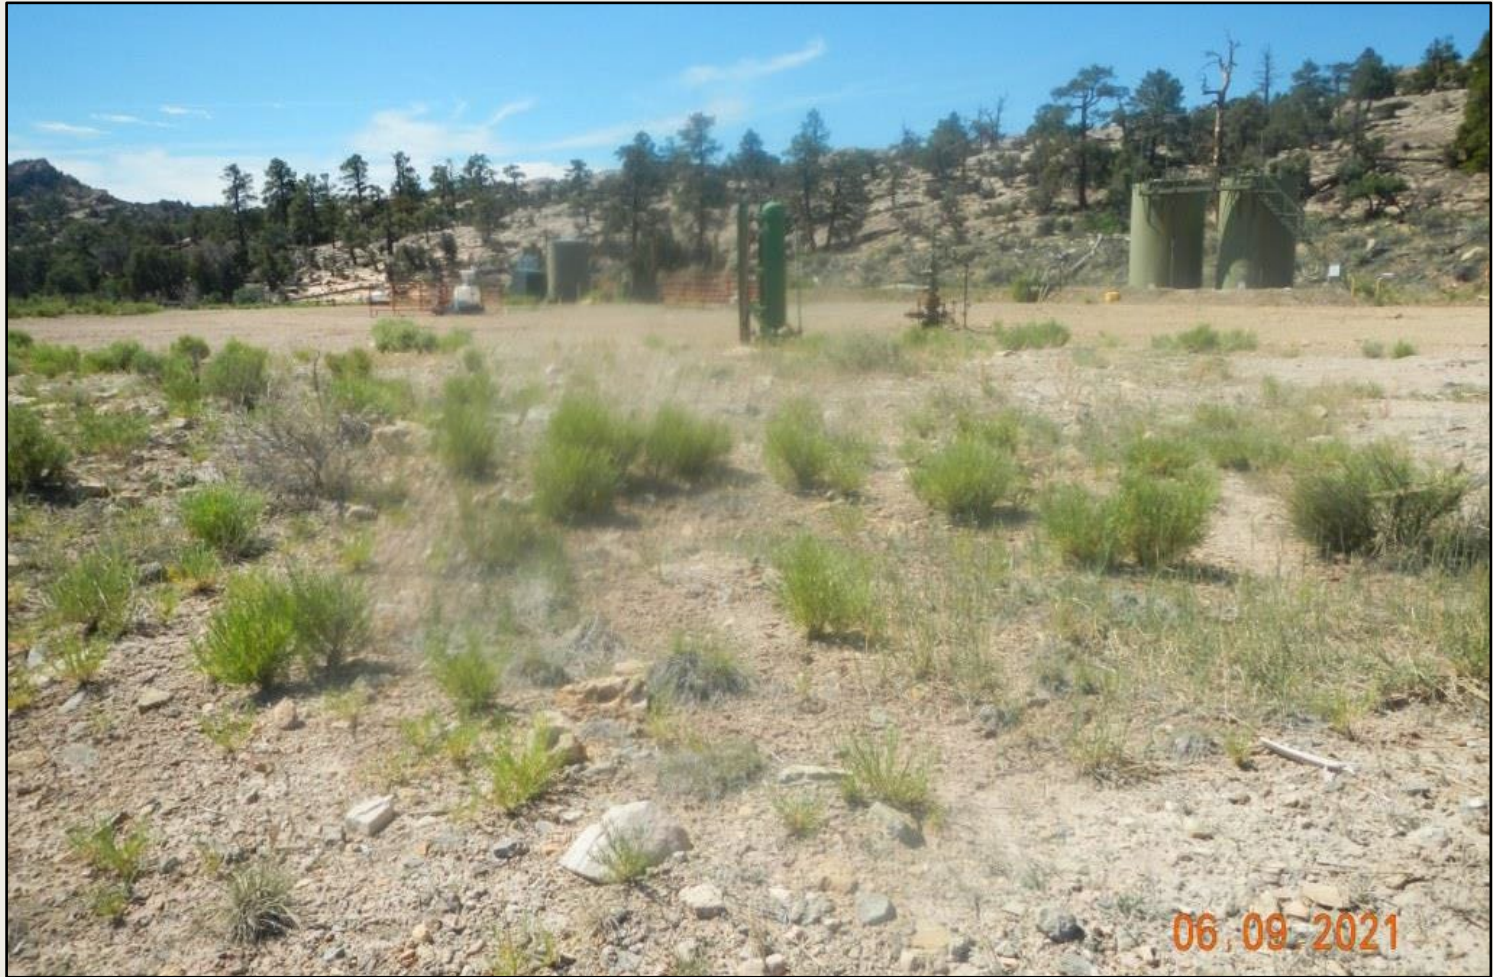
Photo 1. View the project area from the northwestern corner facing center.

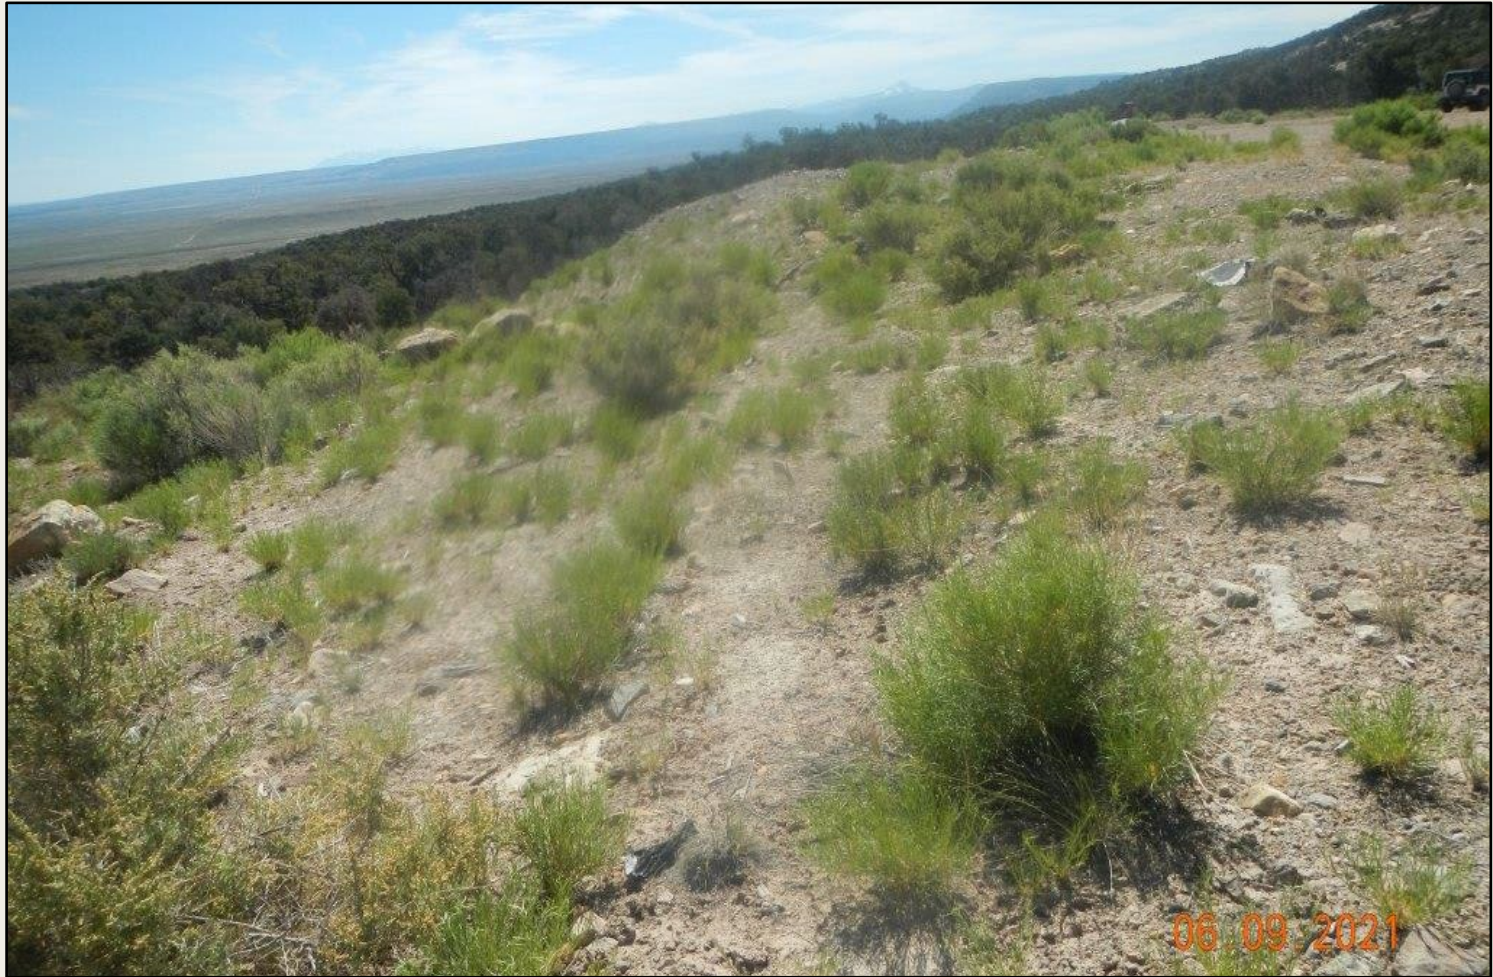
Photo 2. View of the northern project area from the northwestern corner facing eastward. Revegetation is progressing with rubber rabbitbrush, fourwing saltbush, squirreltail, and Indian ricegrass.

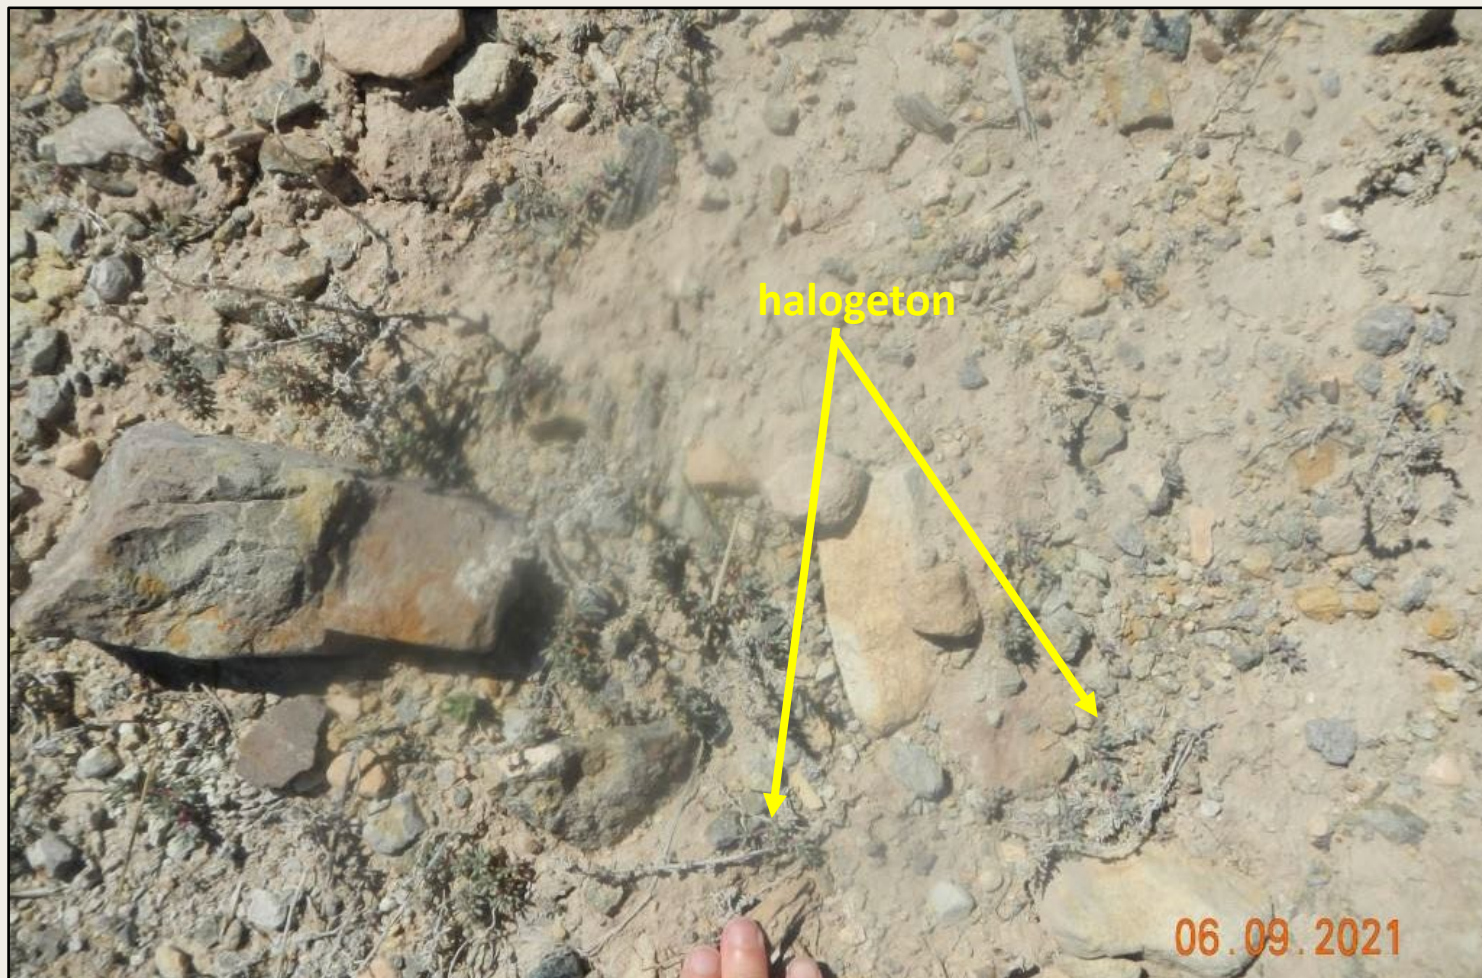
Photo 3. View of halogeton seedlings on the well pad. Approximately 5000 individuals observed on the well pad and access road.

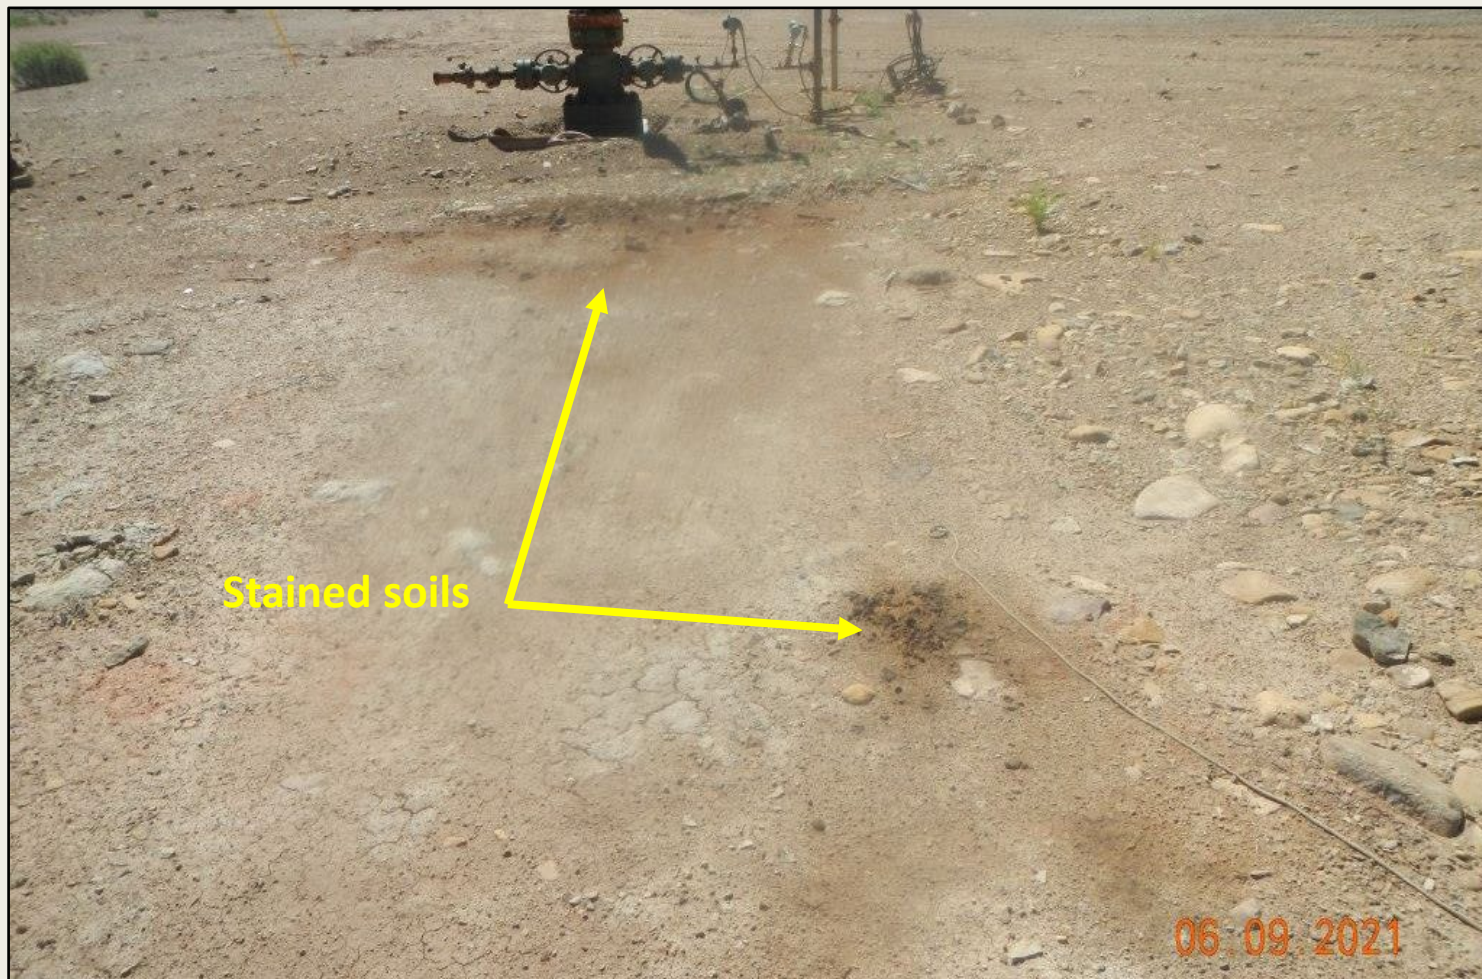
Photo 4. View of stained soils observed around the wellhead.

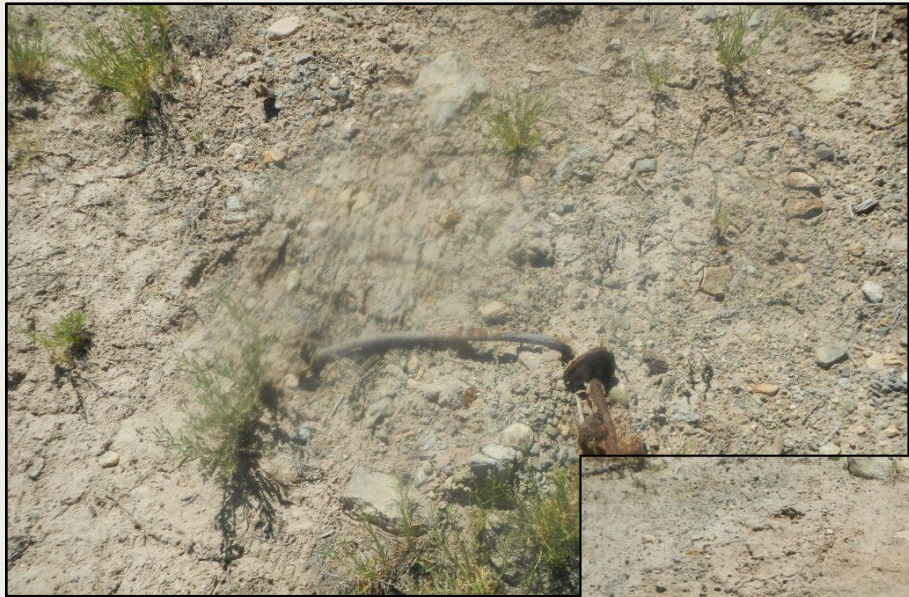
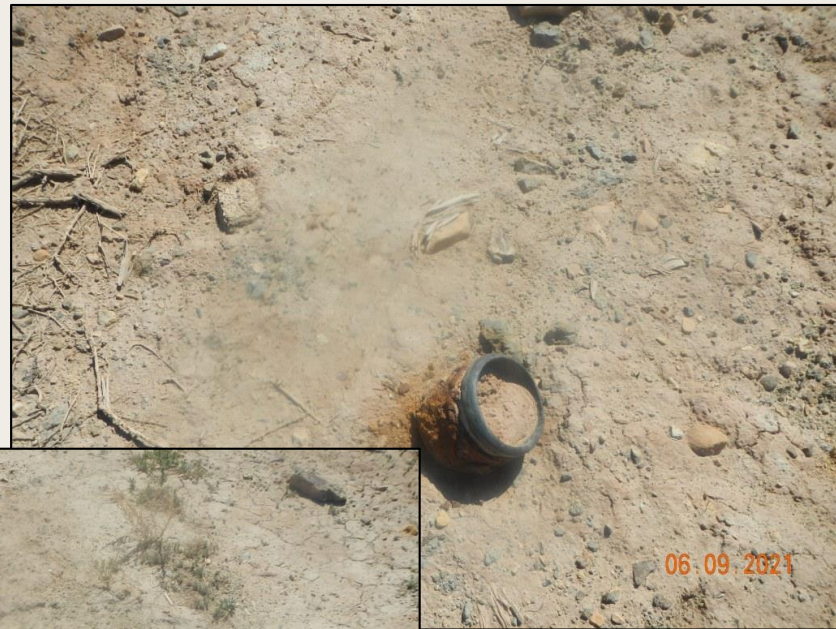
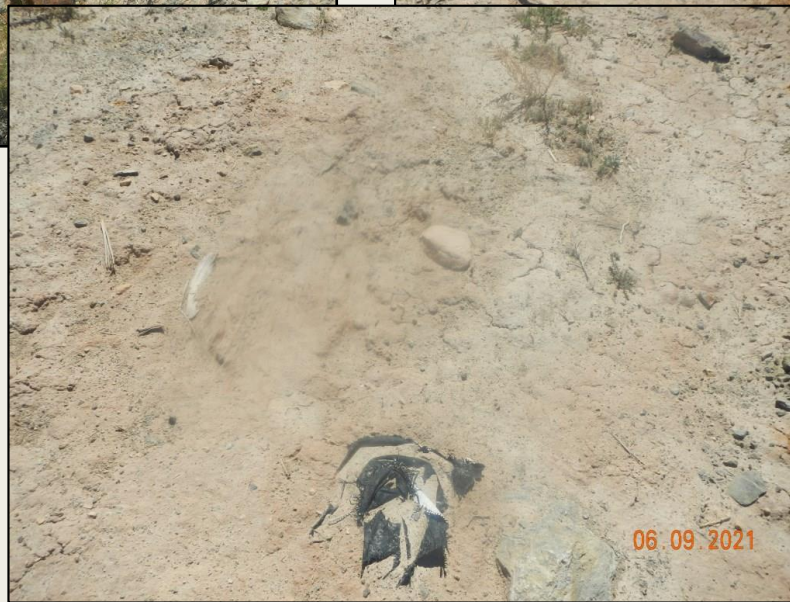
Photos 5-7. View of debris observed within the project area. Scattered debris observed scattered around the project area.

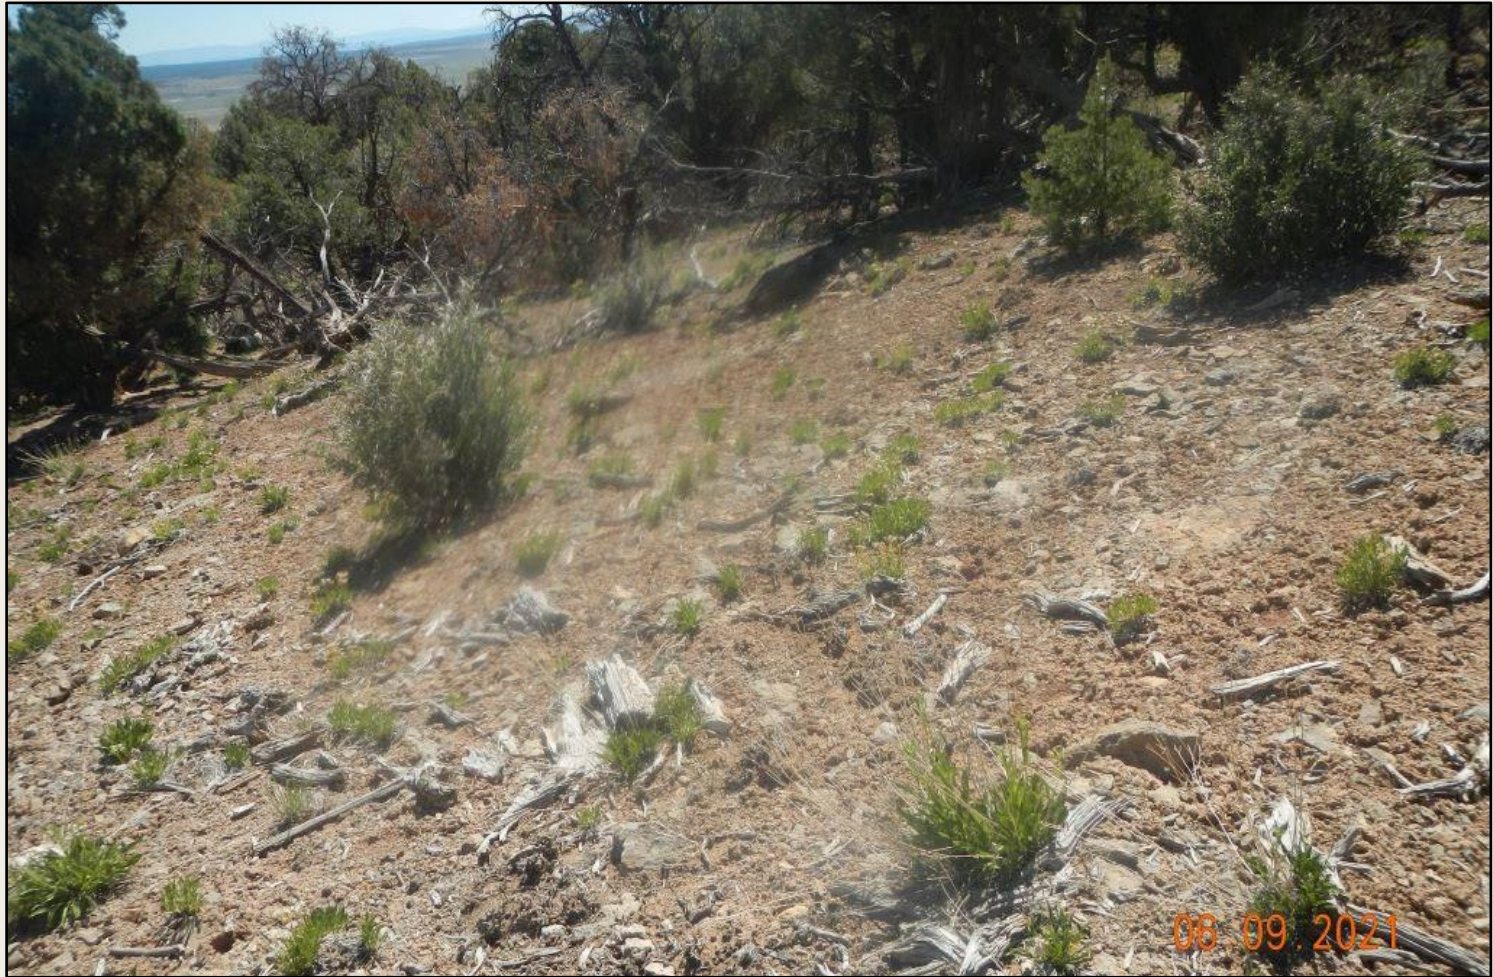
Photo 8. View of reference area comprised of pinyon and juniper woodland with an understory of mountain mahogany, *Tetrandeum* sp., ephedra, yucca, and Indian ricegrass.
