Inspection Photos

7/12/2021

Operator: NONSUCH NATURAL GAS INC #
10163

Location ID: 453726
Garfield County, CO

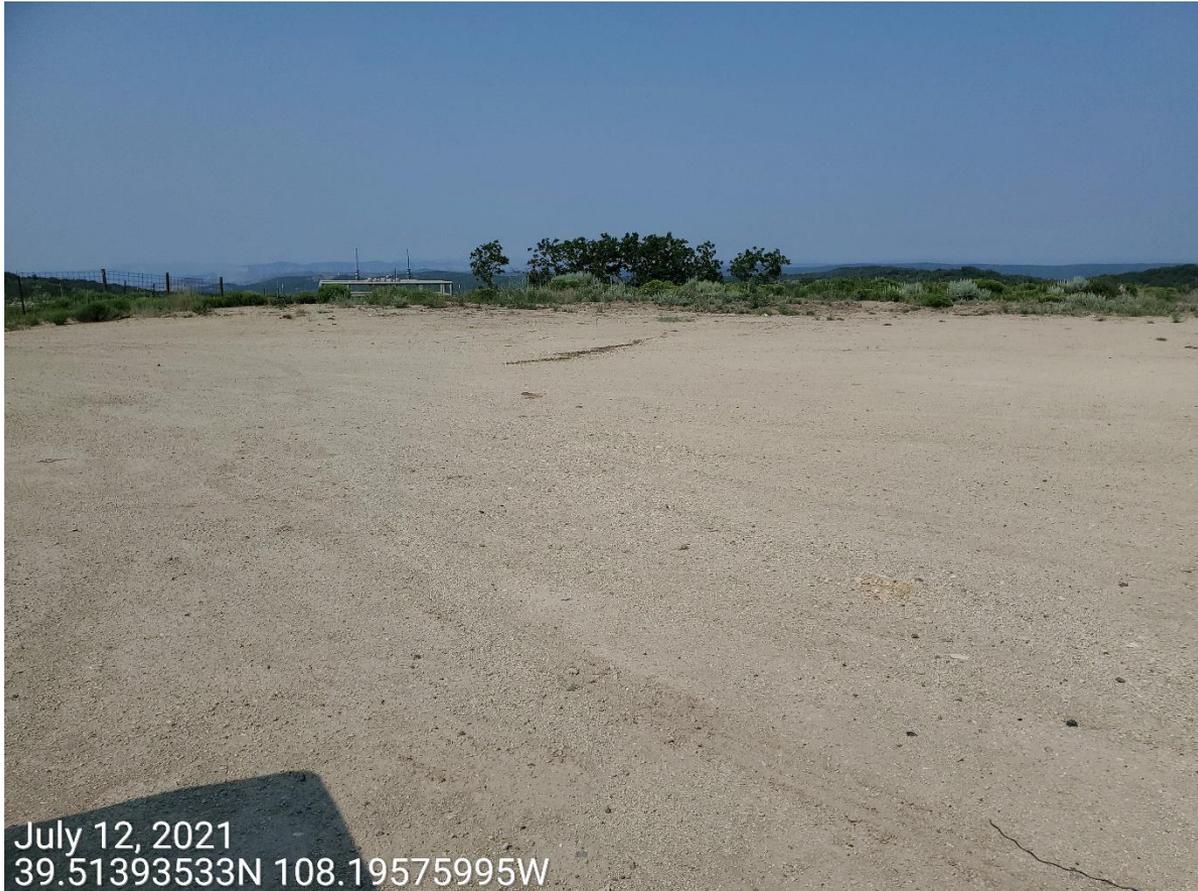
Photo 1: Photo taken from the east end of the Location, facing south. Photos 1-3 provide an overview of the Location from south, west to north.

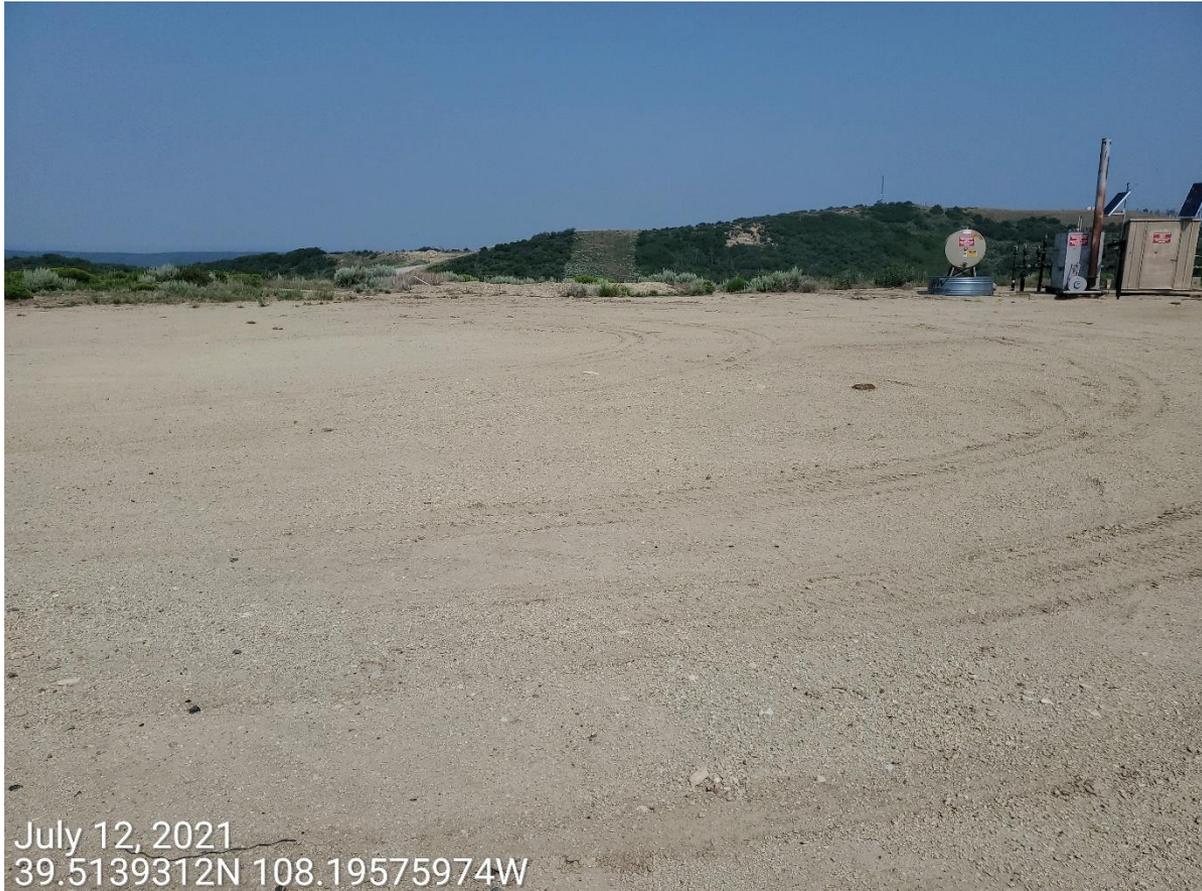
Photo 2: See comments under photo 1.

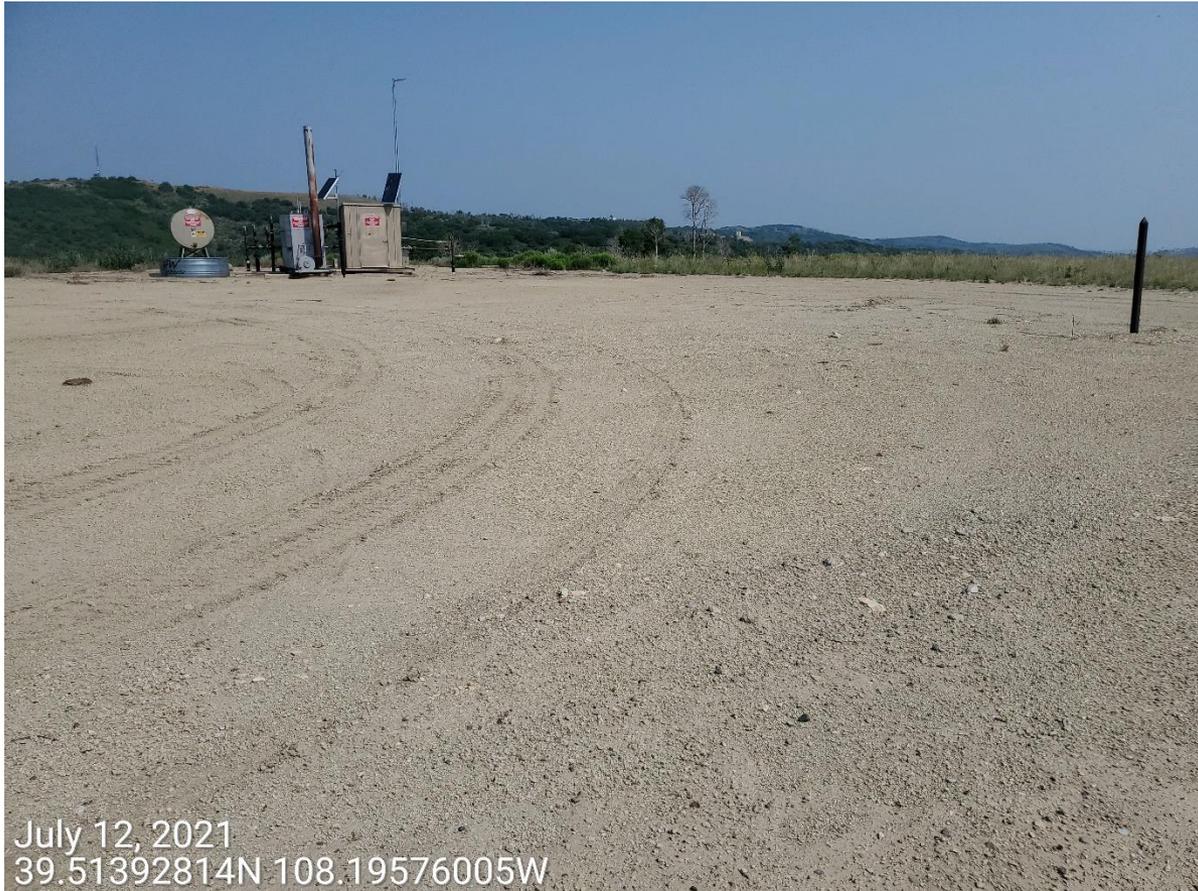
Photo 3: See comments under photo 1.

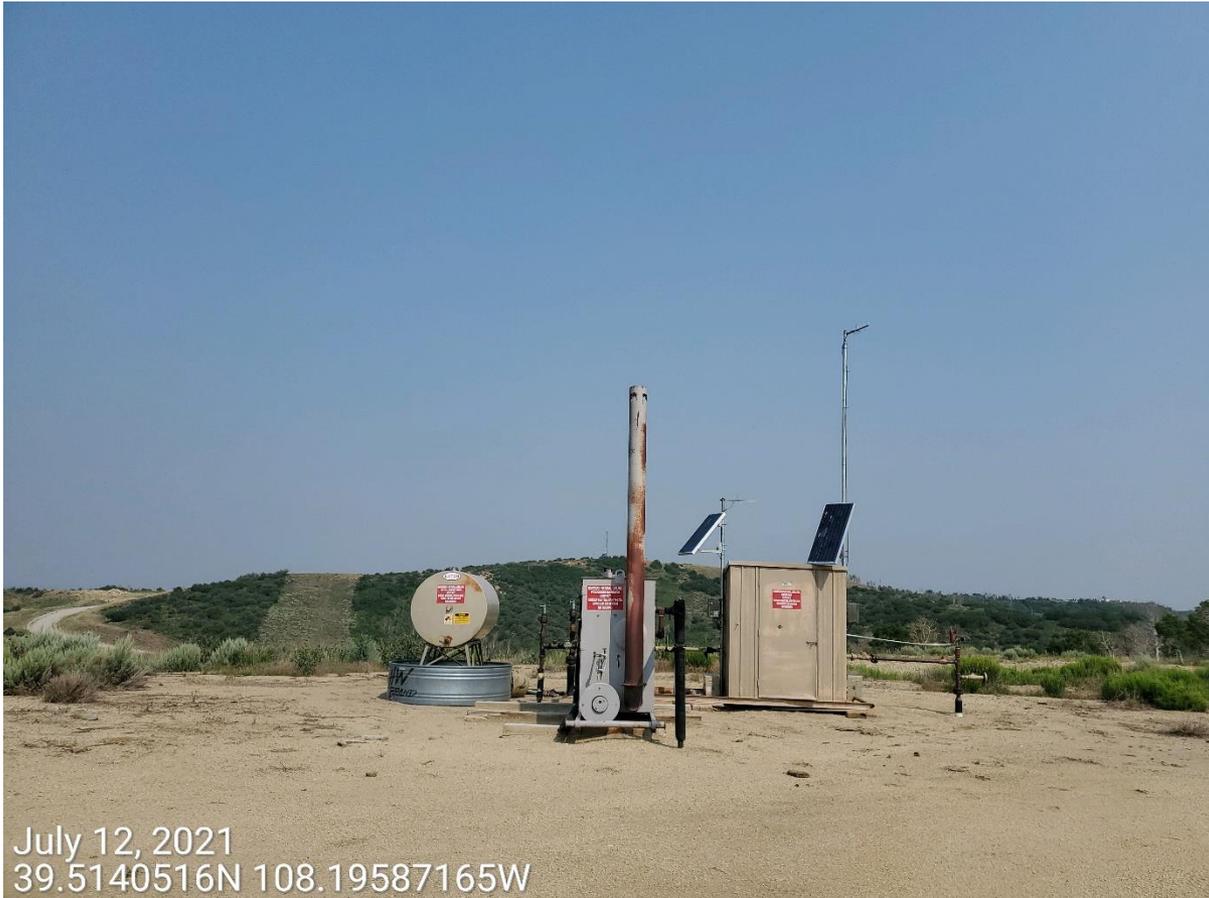
Photo 4: Photo facing west. Photo shows metershed, separator equipment and methanol tank. Photo also shows bird protector equipment appears to be missing from top of the separator.

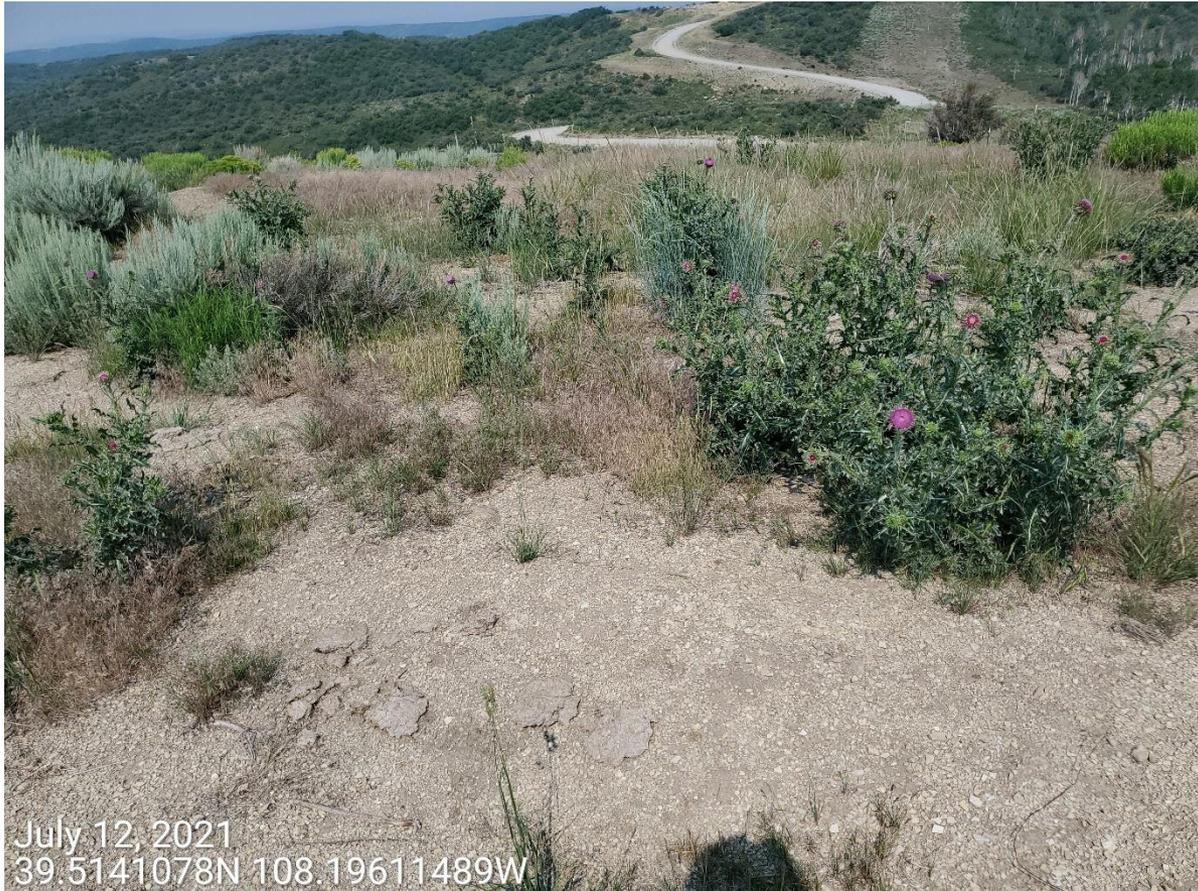
Photo 5: Photo taken from the west end of the Location, facing southwest. Photo shows example of noxious weeds (Musk thistle) observed on the location and access road.

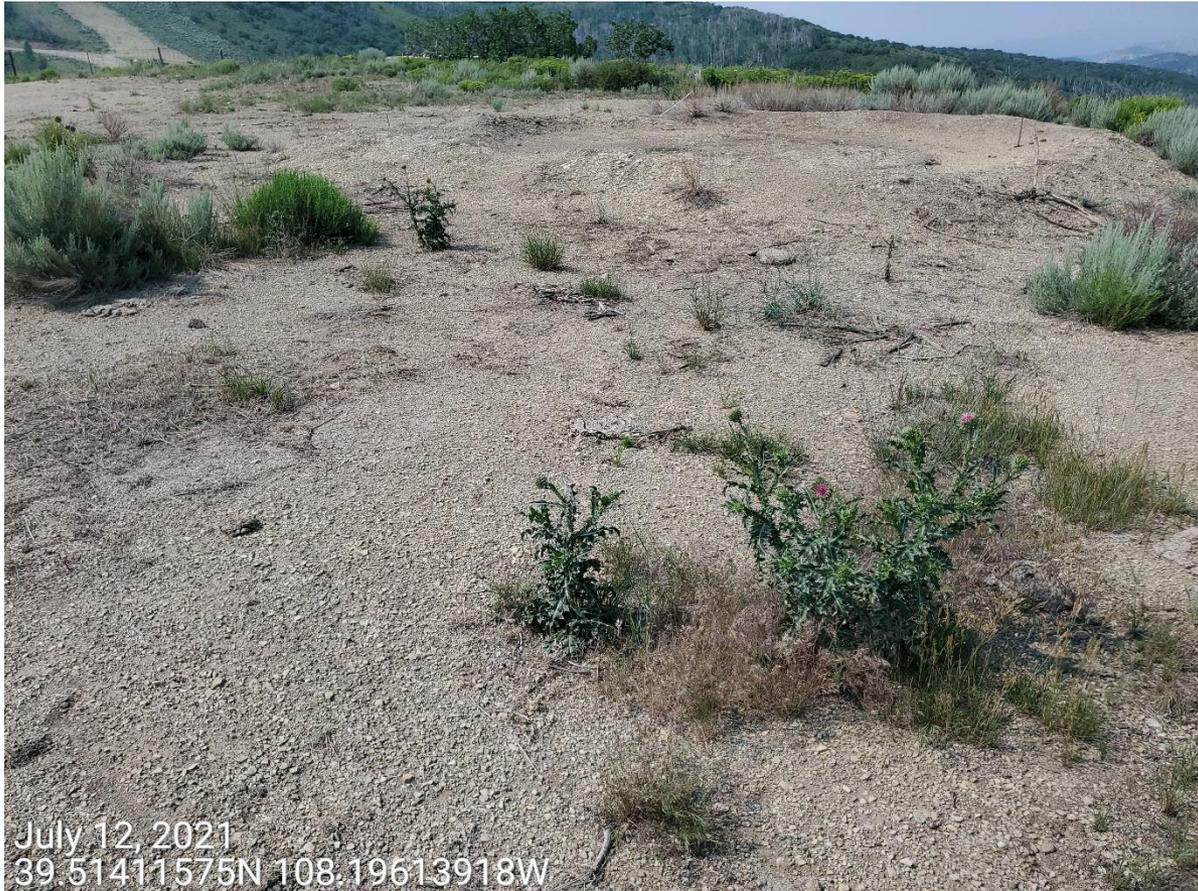
Photo 6: Photo taken from the west end of the Location, facing southeast. Photo shows example of noxious weeds (Musk thistle) observed on the location and access road.

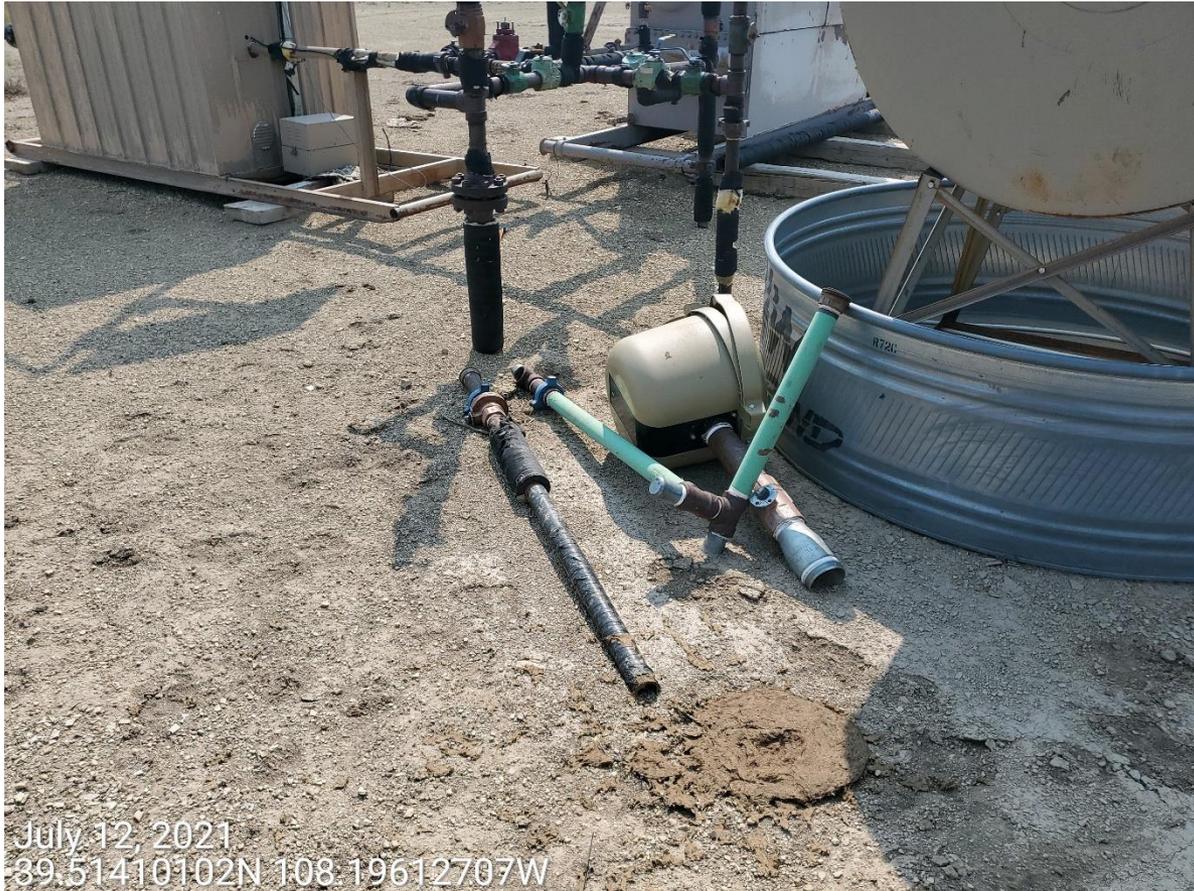
Photo 7: Photo taken from the west end of the Location, facing northeast. Photo shows various pipe equipment remain improperly stored behind the methanol tank. Photo also shows that wildlife protection equipment, such as netting, to prevent wildlife access to the tanks secondary containment BMP is missing.

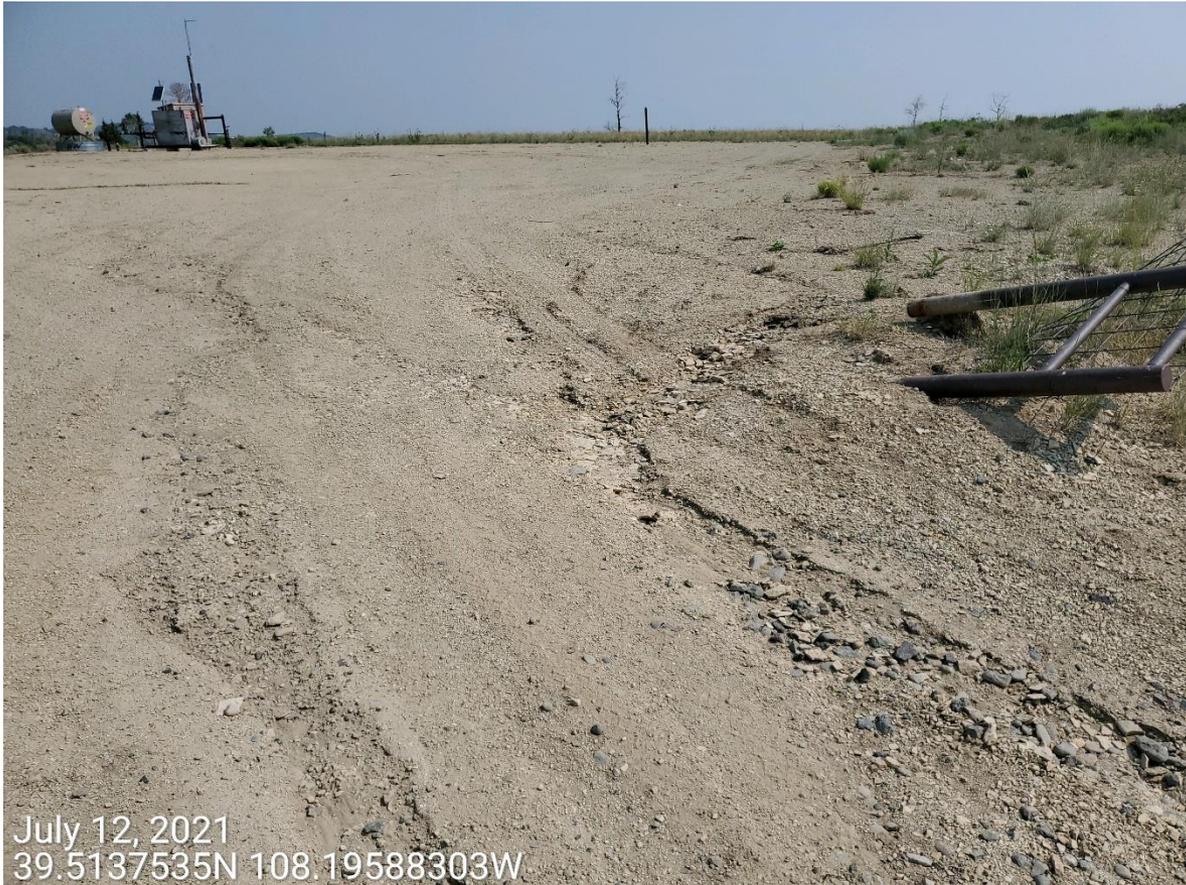
Photo 8: Photo taken from the Location entrance (south end of the Location), facing north. Photo shows erosion degradation due to stormwater runoff from the pad; stormwater runoff has resulted in erosion degradation and offsite sediment discharge at Location entrance and access road.

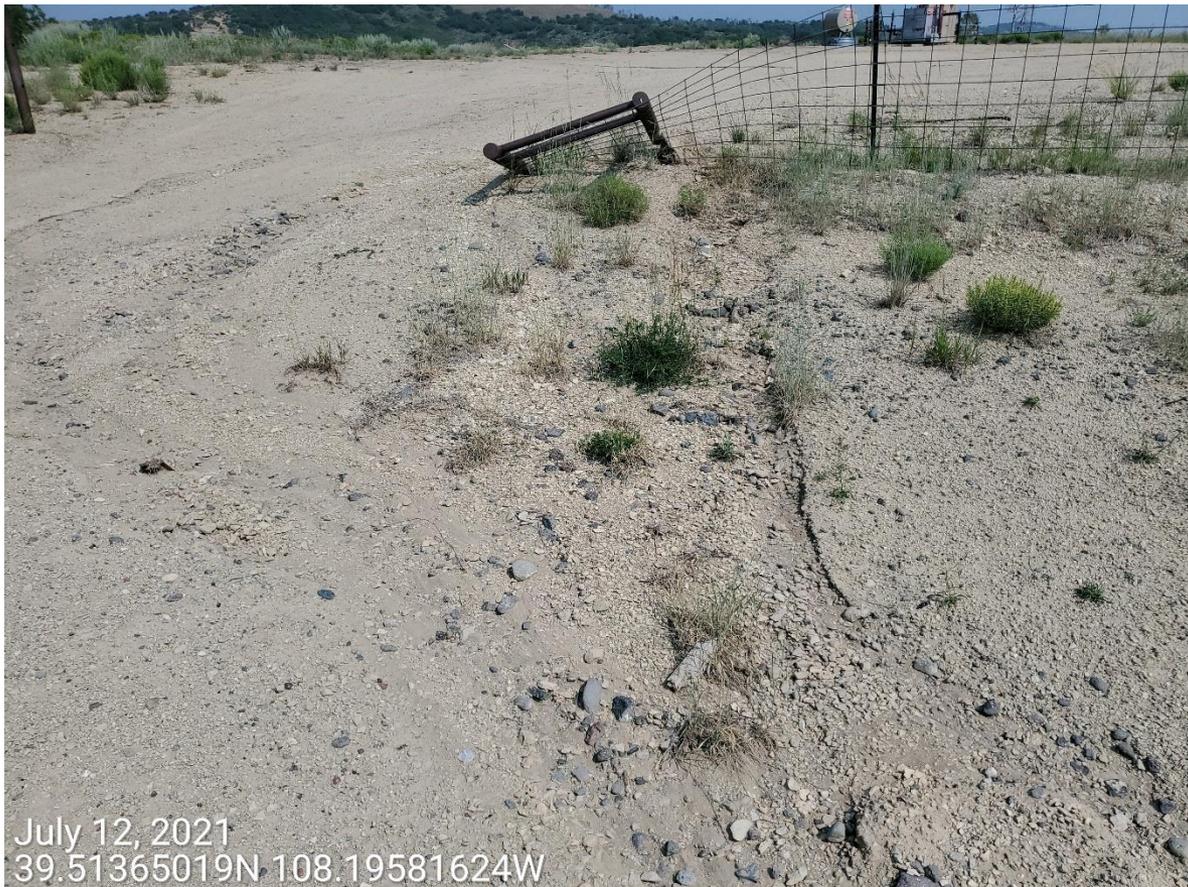
Photo 10: Photo taken from the Location entrance (south end of the Location), facing north. Photo shows erosion degradation due to stormwater runoff from the pad

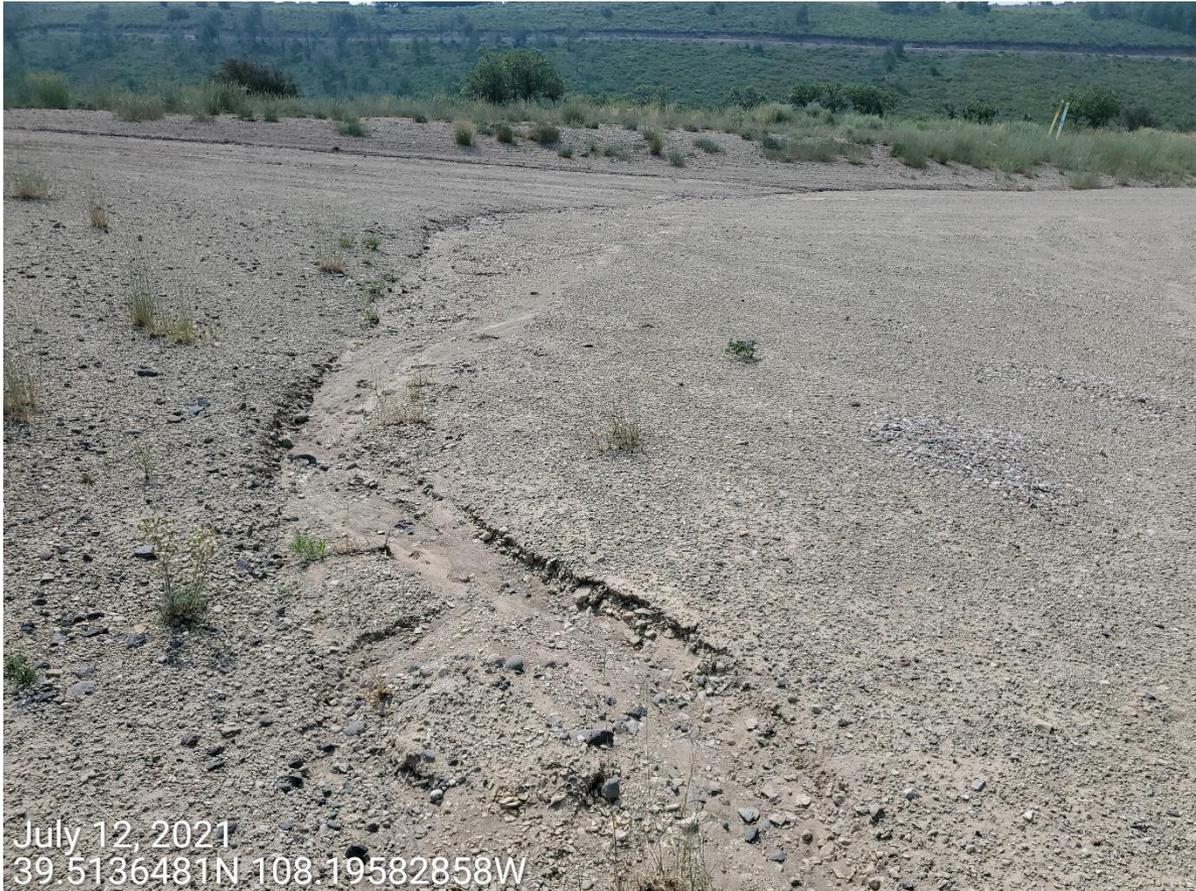
Photo 11: Photo taken from the Location entrance (south end of the Location), facing southeast. Photo shows stormwater runoff from the Location has resulting in erosion degradation on the access road, and off-site sediment transport.

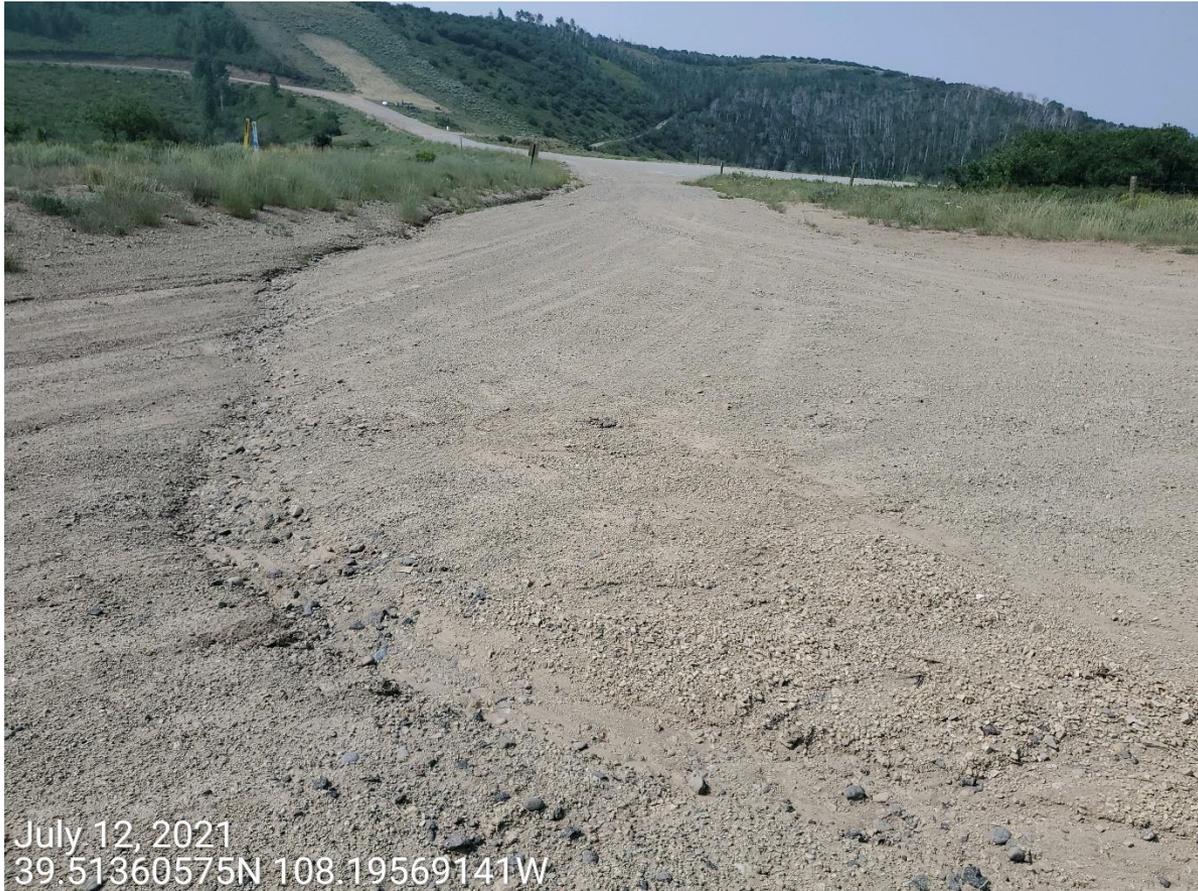
Photo 12: Photo taken from the access road, south of the Location. Photo shows stormwater erosion degradation on access road due to runoff from the Location.

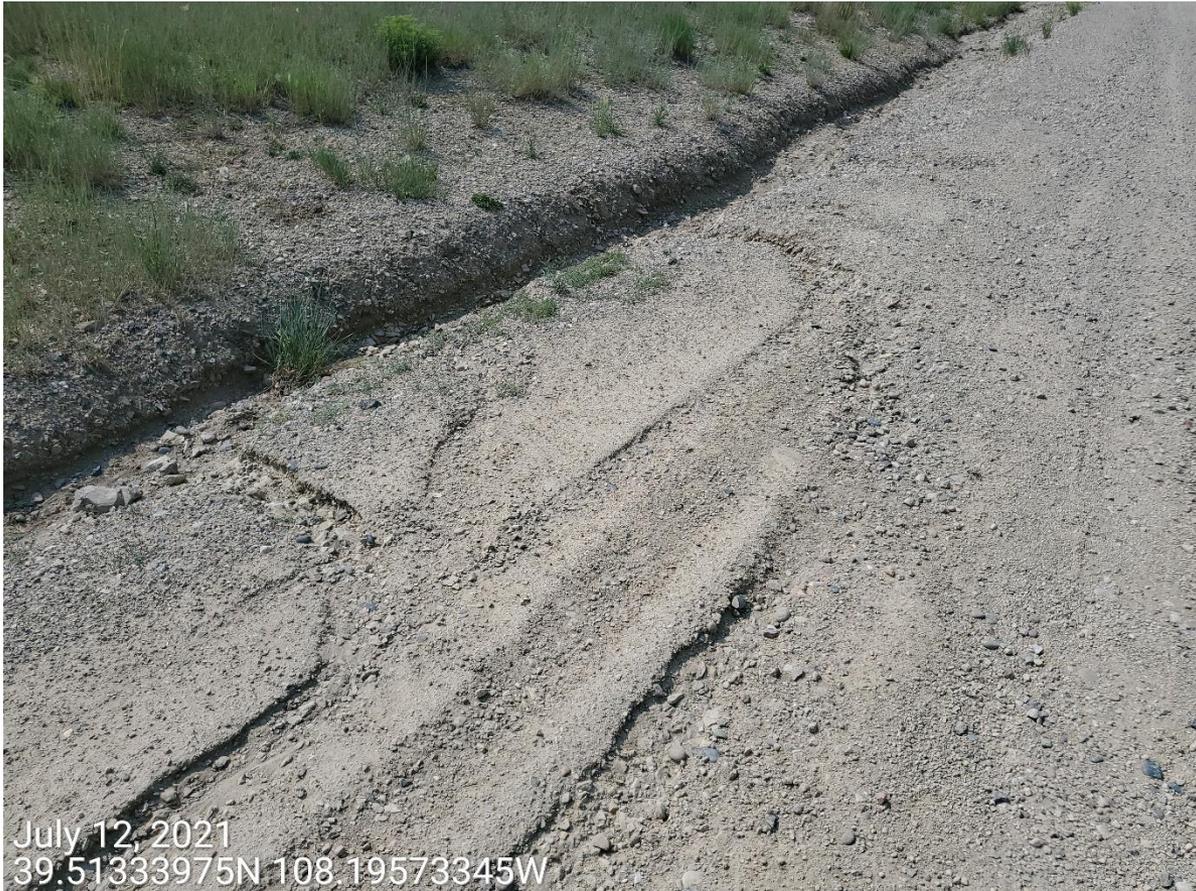
Photo 13: Stormwater erosion on access road.

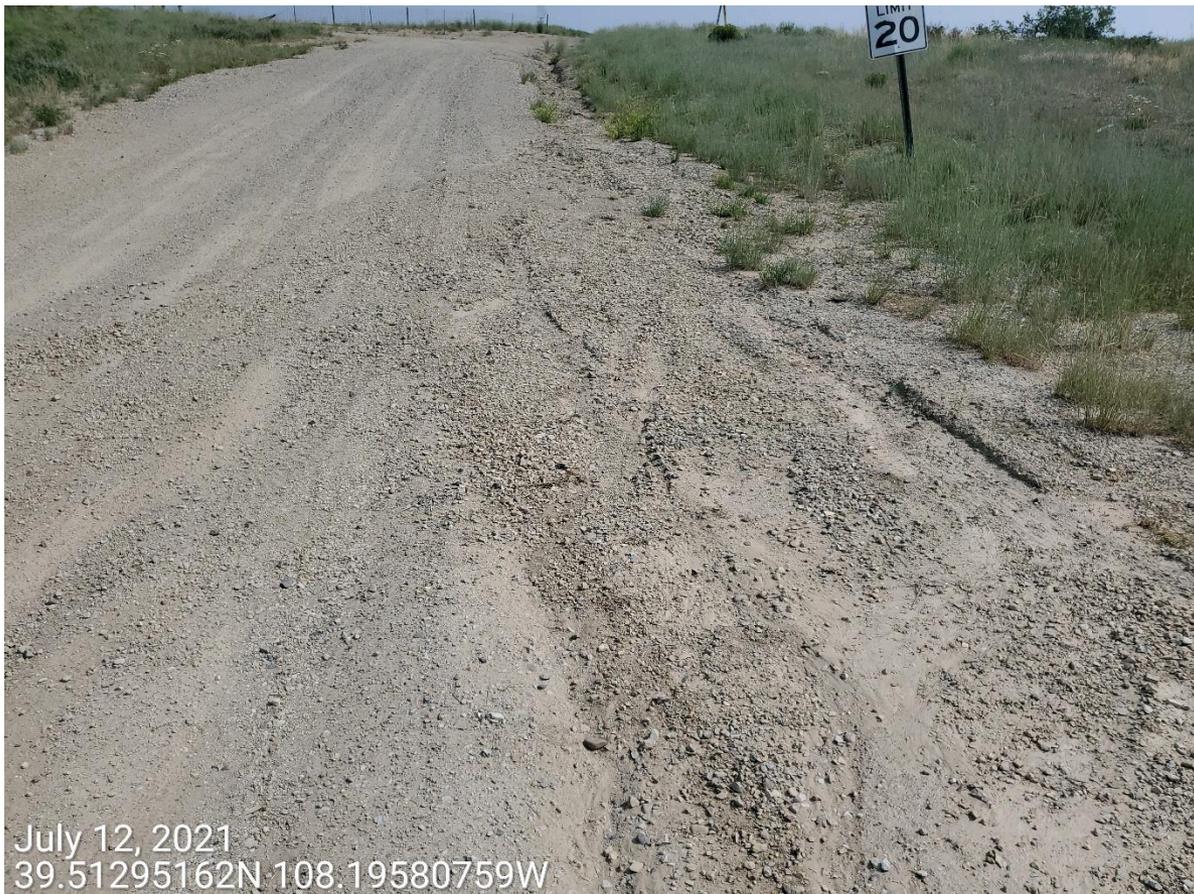
Photo 14: Photo taken from the access road. Photo shows sediment deposition resulting from stormwater runoff from the Location and erosion degradation.
