Inspection Photos
Operator: Simcoe
API: 067-06969
Date: 7/29/2021

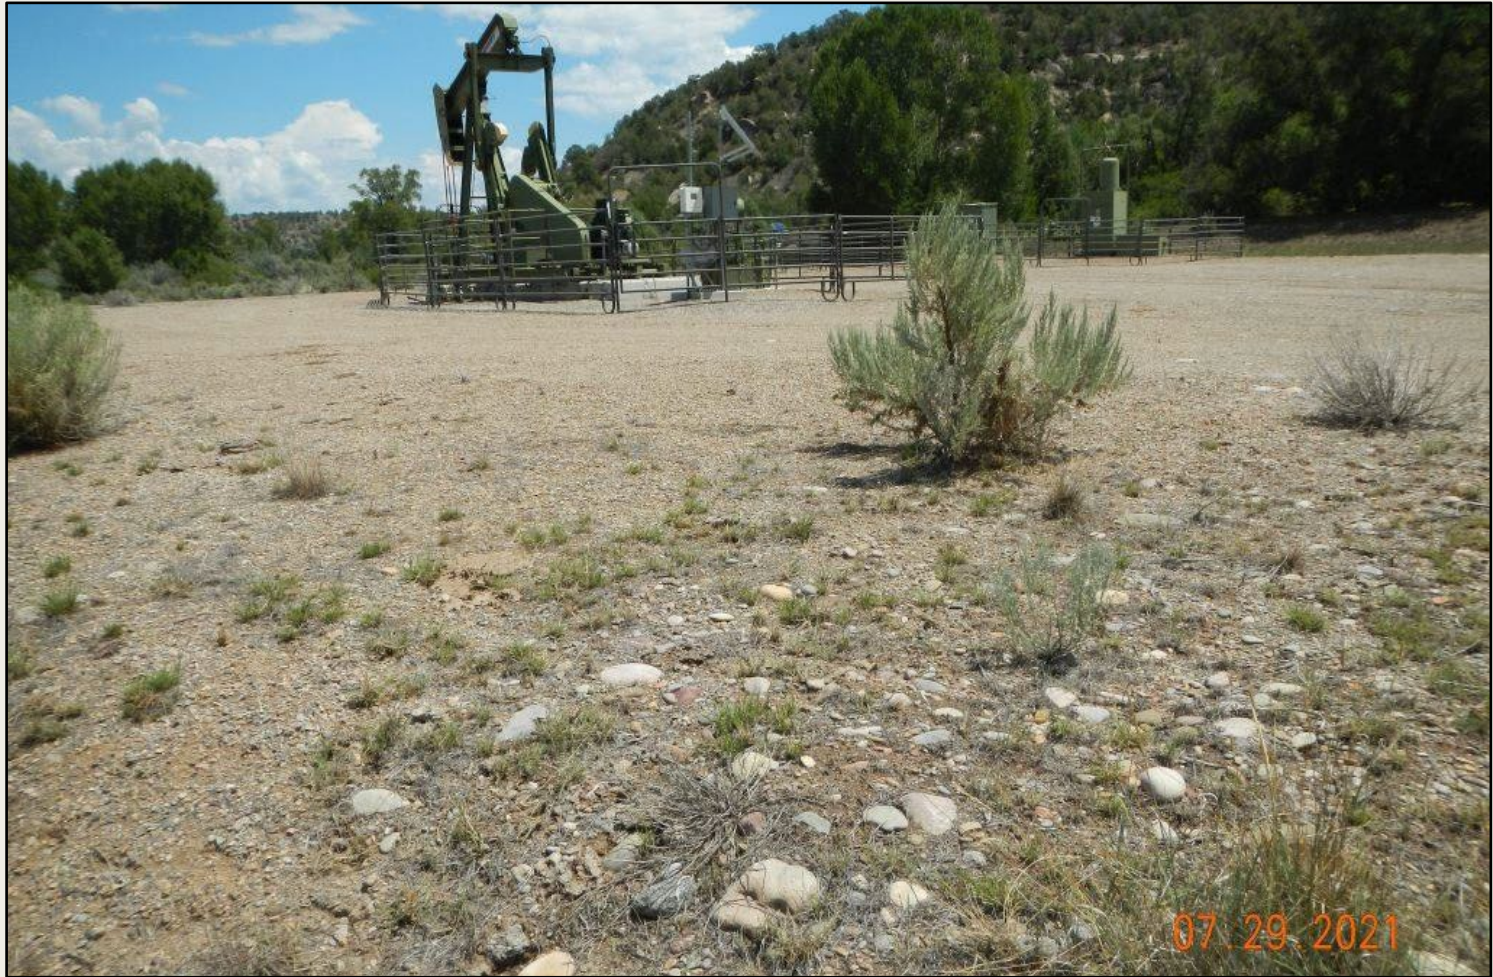
Photo 1. View of the project area from the well pad entrance facing center.

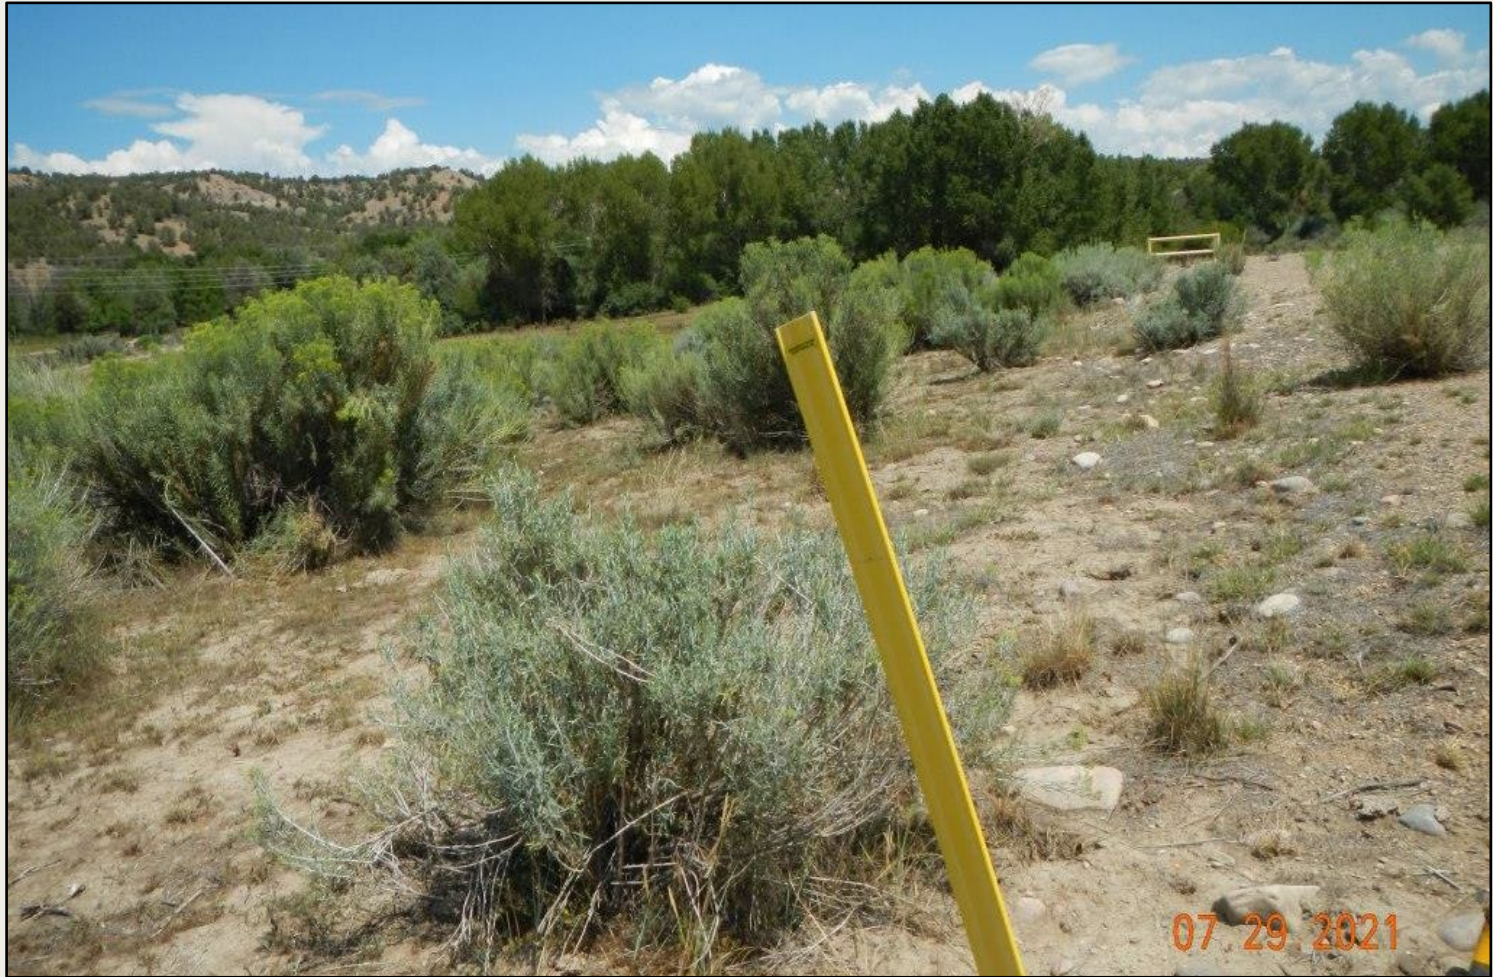
Photo 2. View of the northern project area from the northwestern corner facing eastward. Revegetation is progressing within the project area with crested wheatgrass, western wheatgrass, and rubber rabbitbrush.

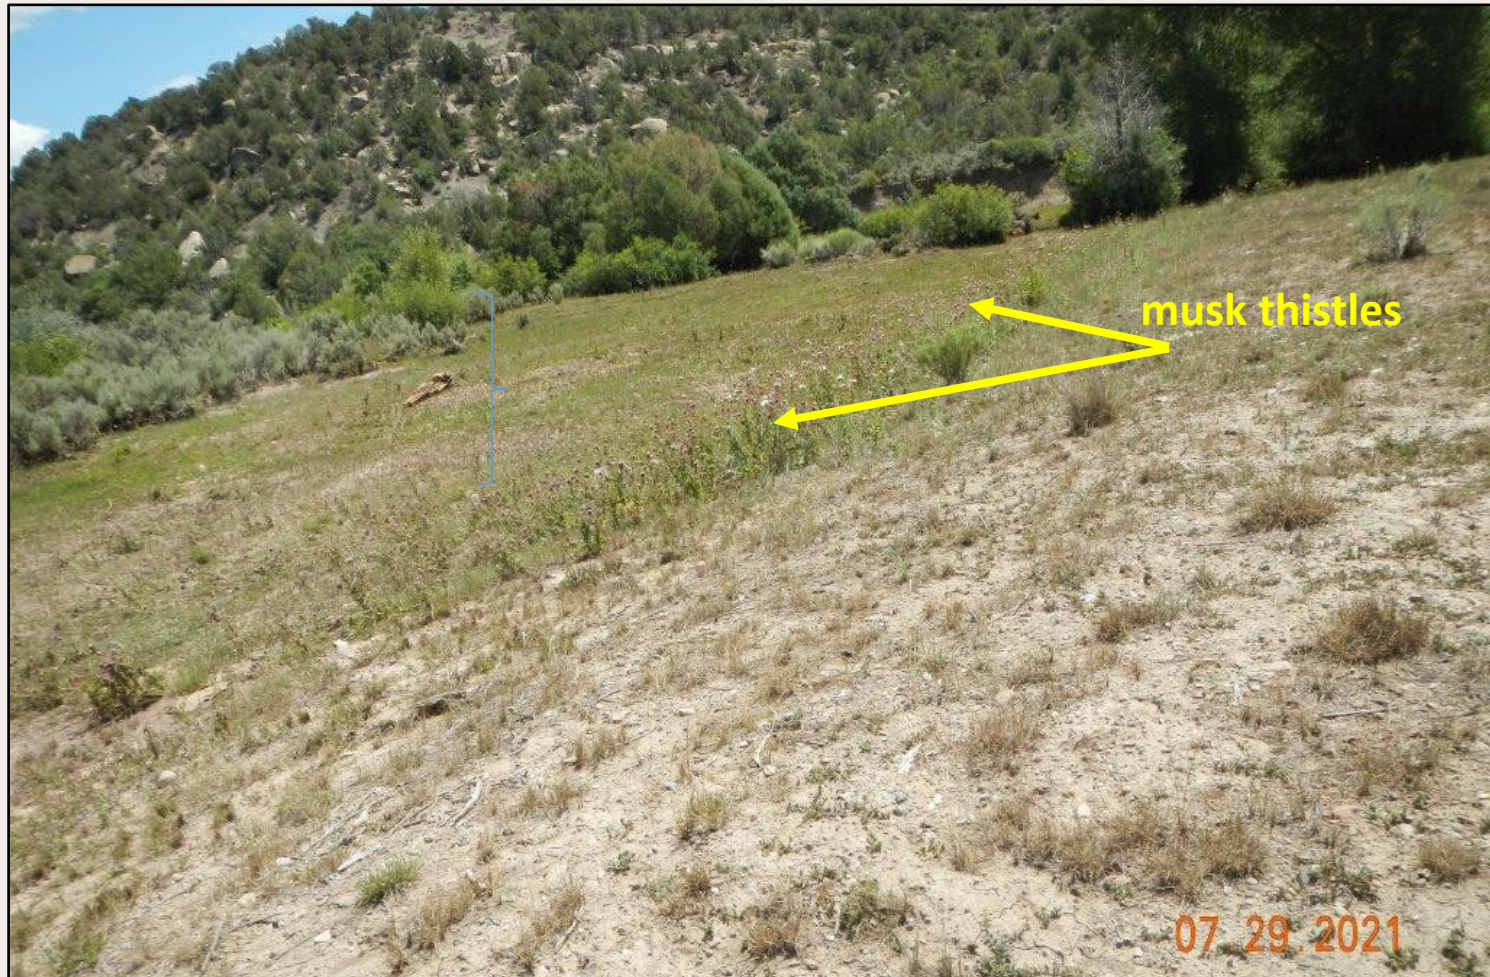
Photo 3. View of the eastern project area from the northeastern corner facing southward. Approximately 100 musk thistles observed along the eastern edge of the project area.

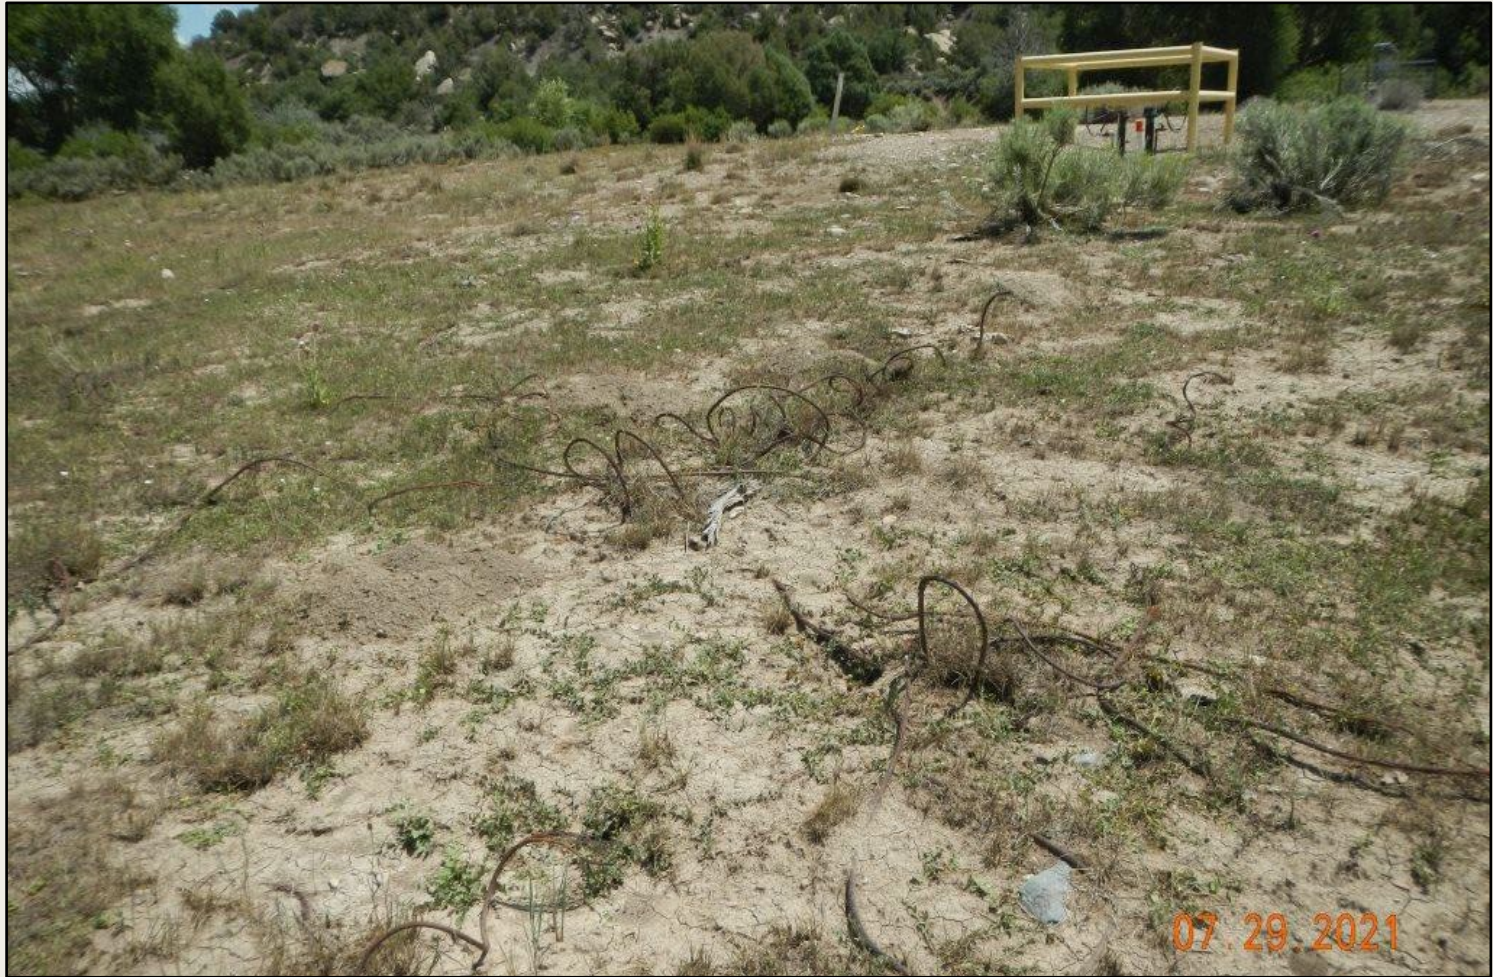
Photo 4. View of cable debris observed within the northern project area.

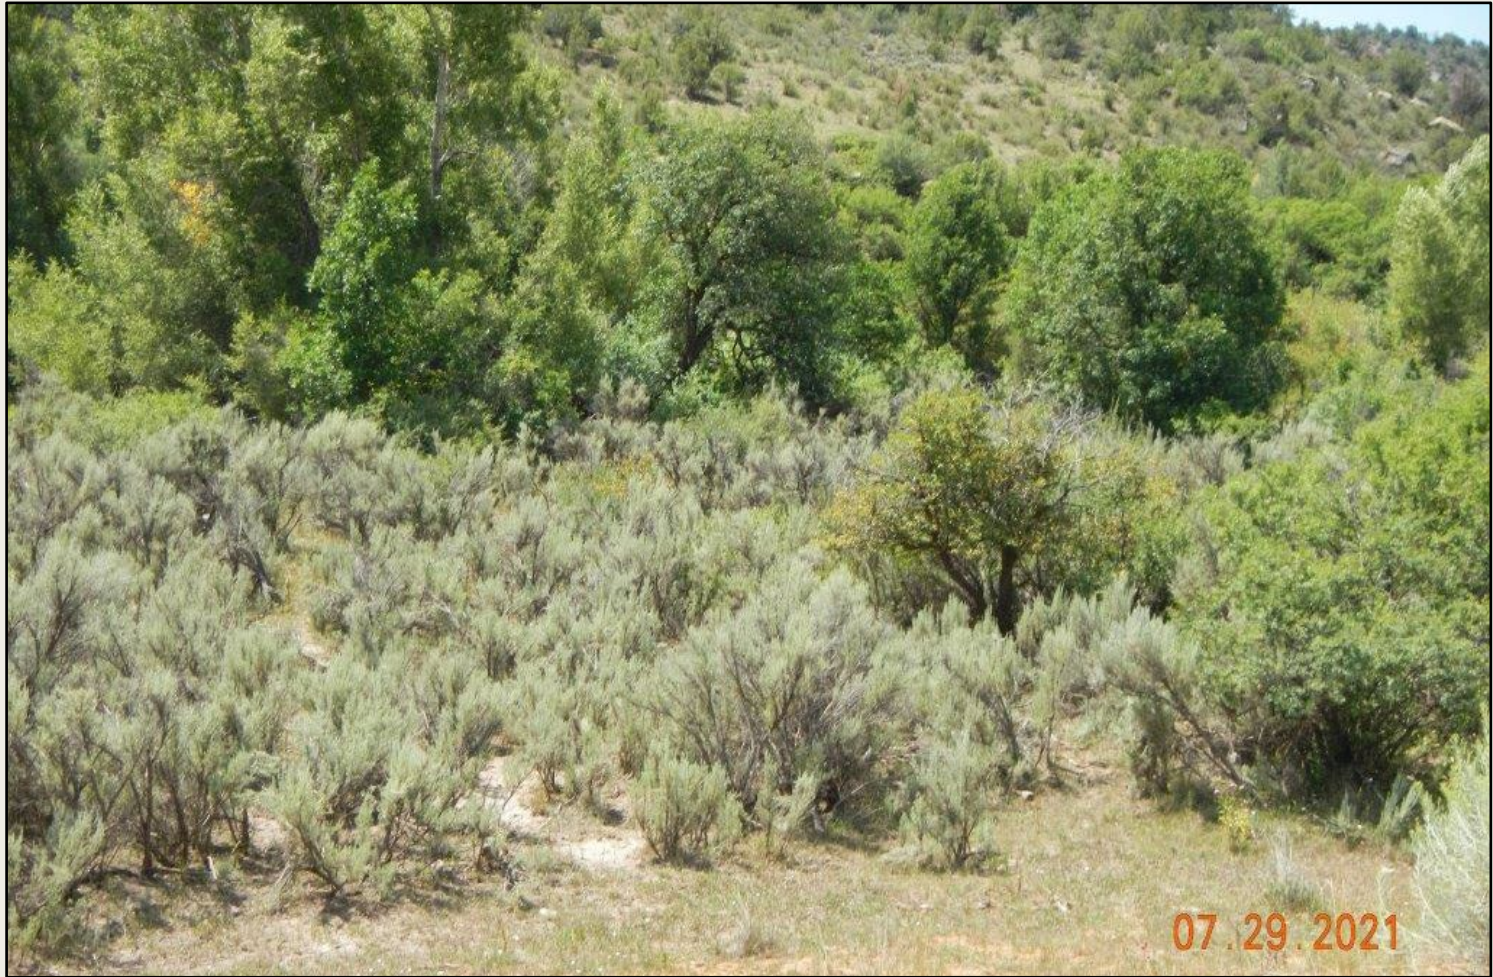
Photo 5. View of the reference area comprised of big sagebrush mosaic with narrow leaf cottonwoods, western wheatgrass, and gambel oaks.
