Inspection Photos

API: 025-06021

Operator: VAL ENERGY INC

Inspection Date: 8/23/2021

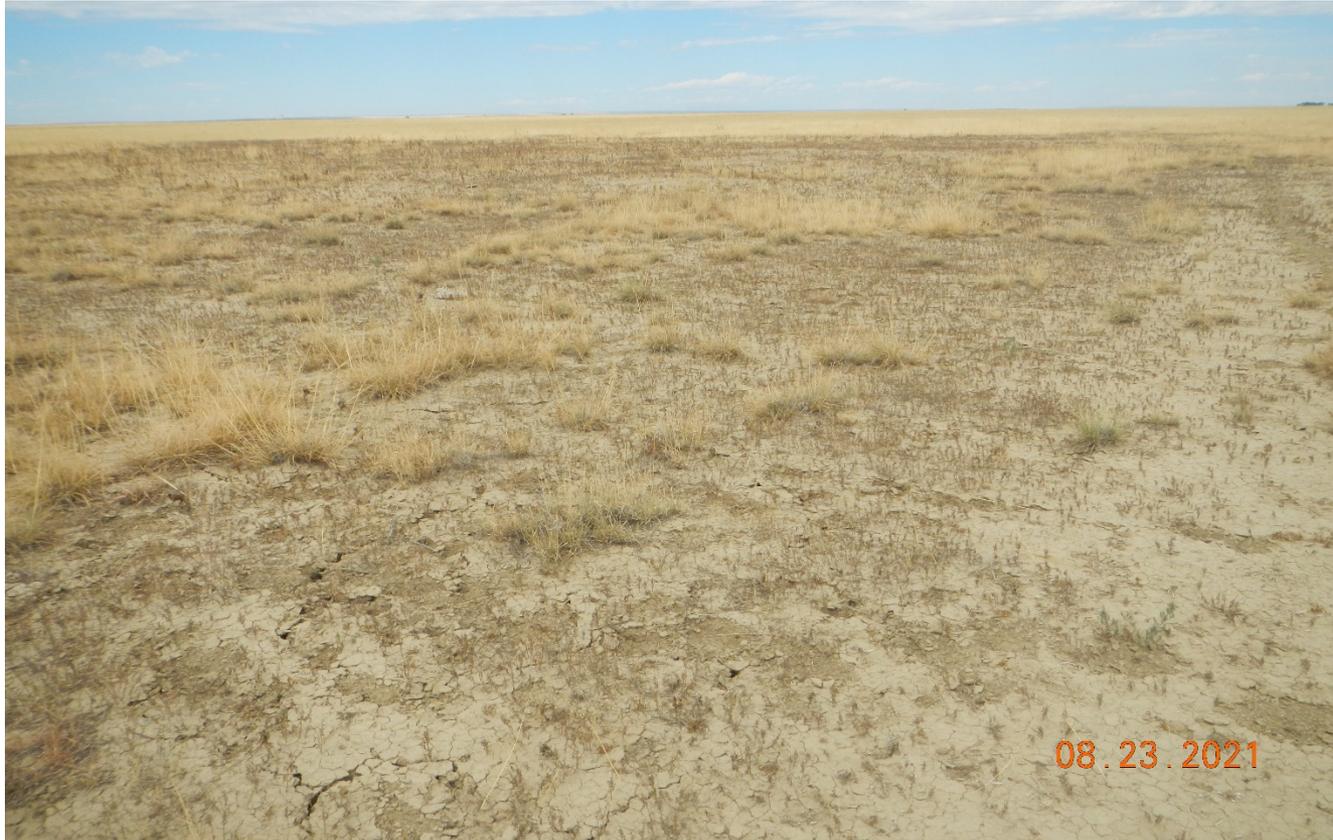
Photo 1. Facing west toward the location. The perennial vegetation has not re-established to a 80% of reference area levels.

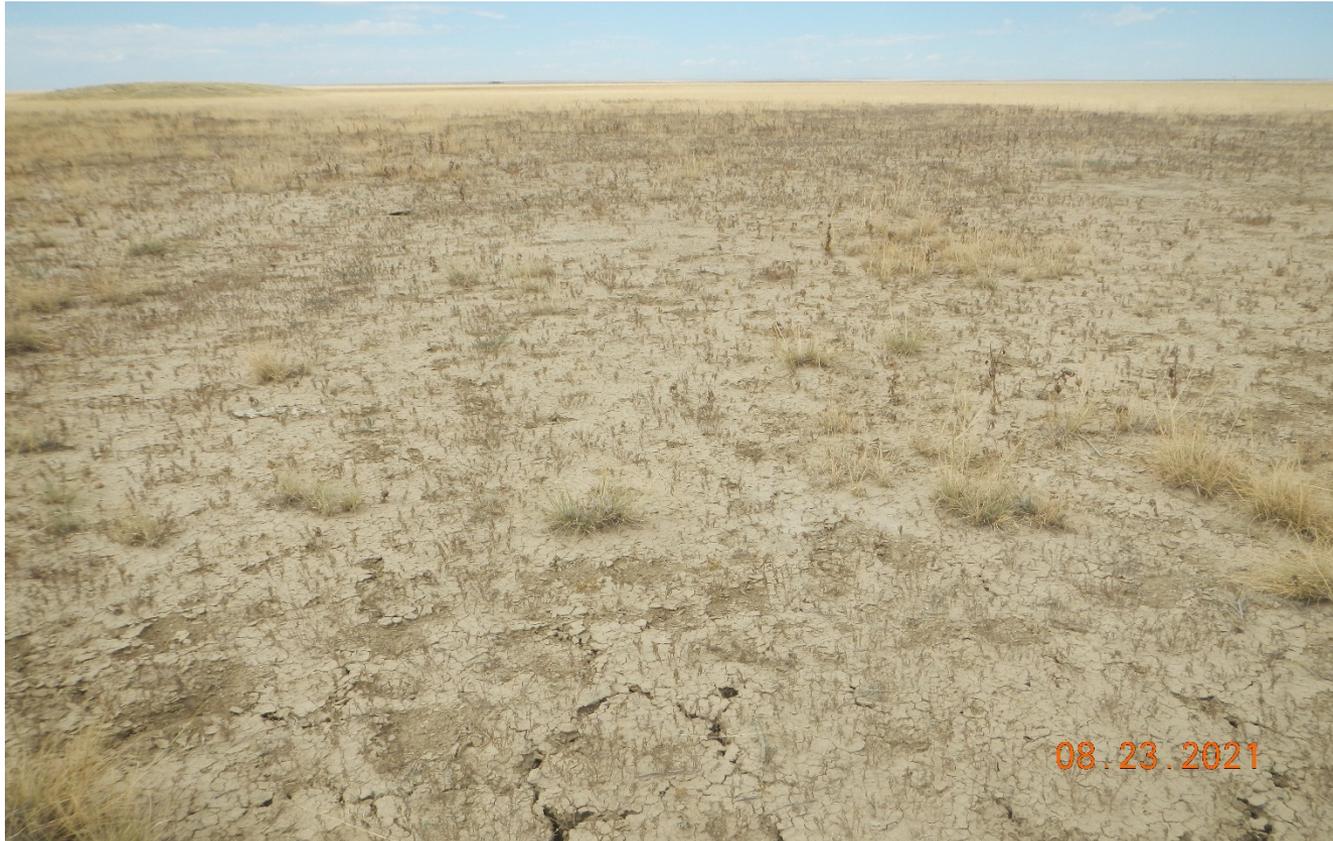
Photo 2. Facing west at the north side of the location. This area is approximately 300' x 200' of mostly bare soil. The location needs to be reclaimed to re-establish perennial vegetation cover.

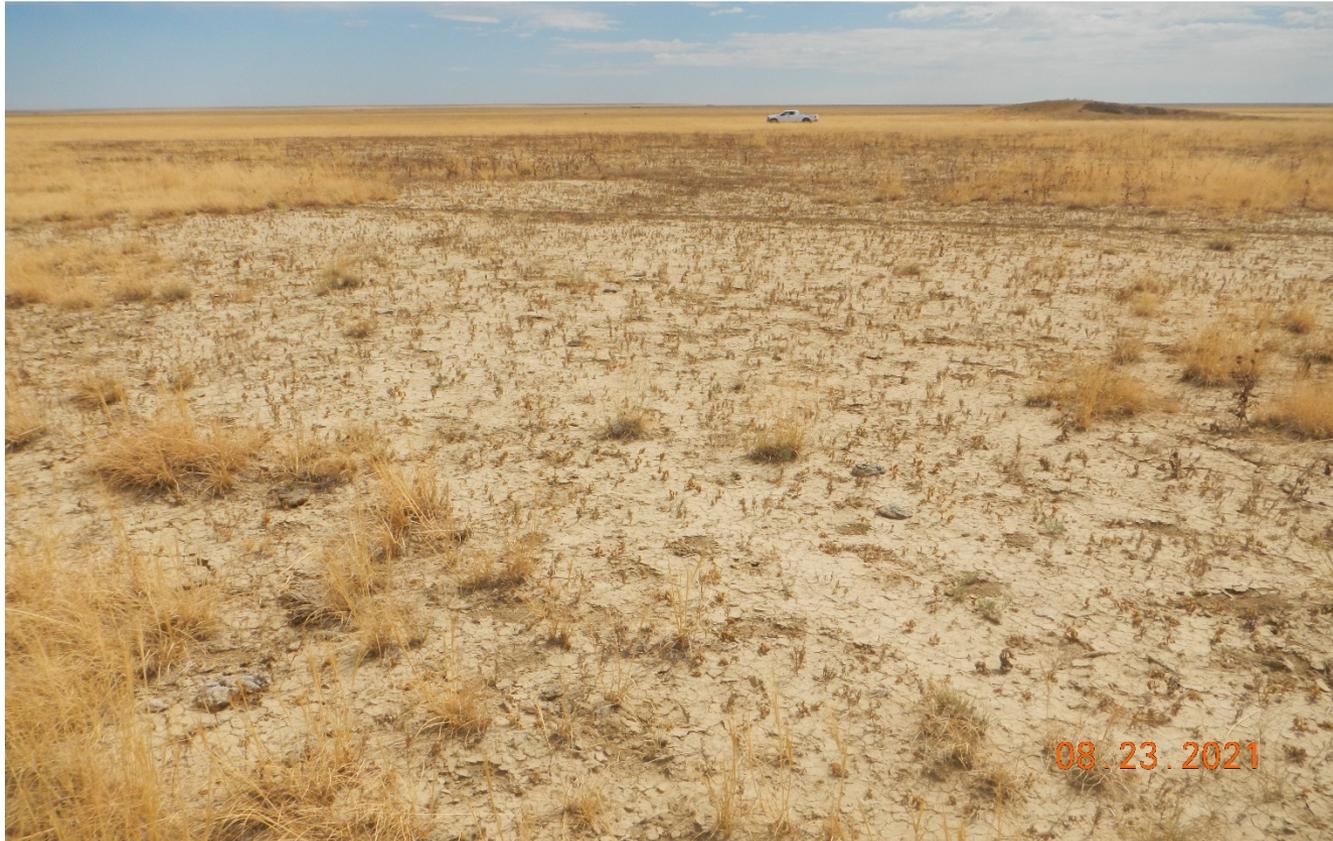
Photo 3. Facing east at the west side of the location.

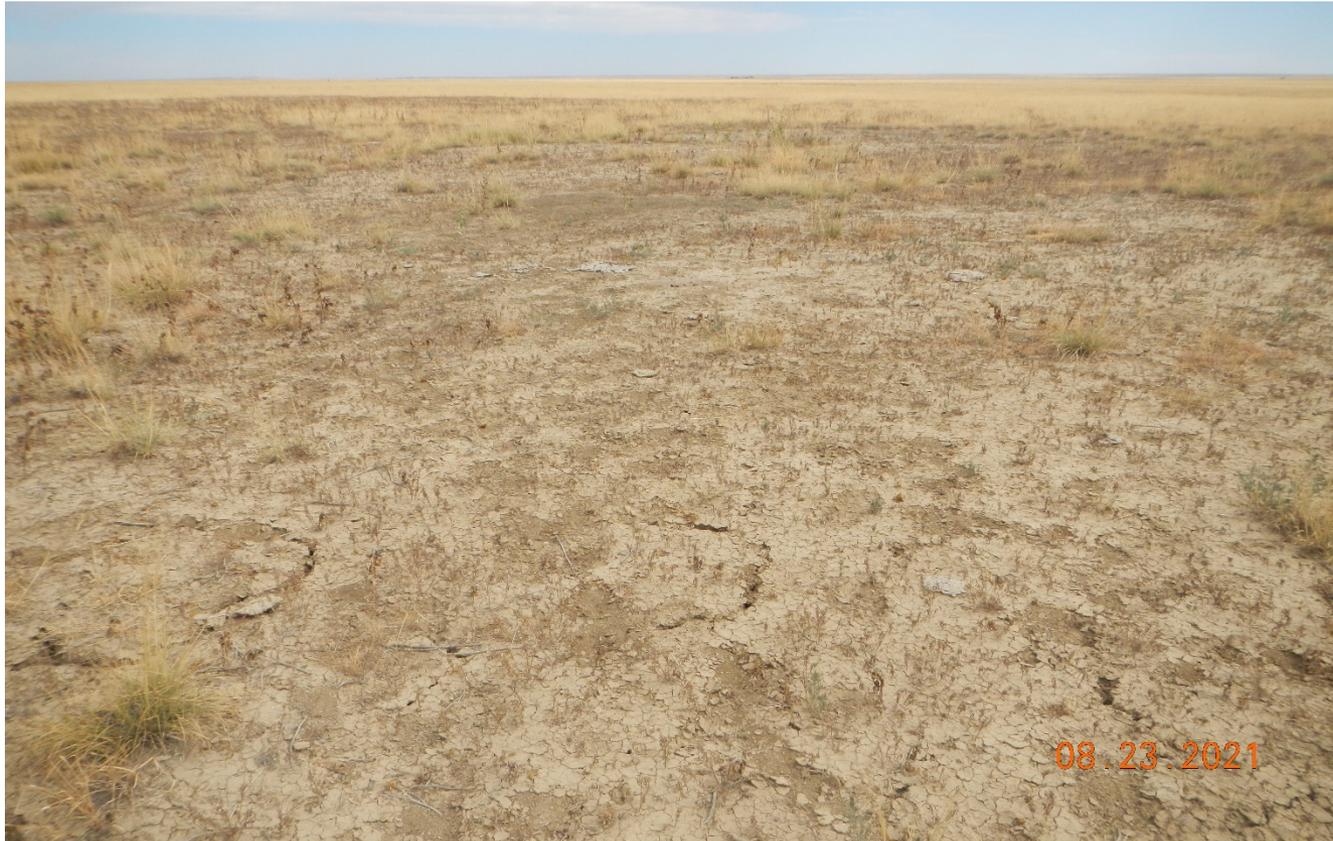
Photo 4. Facing north at the south side of the location.

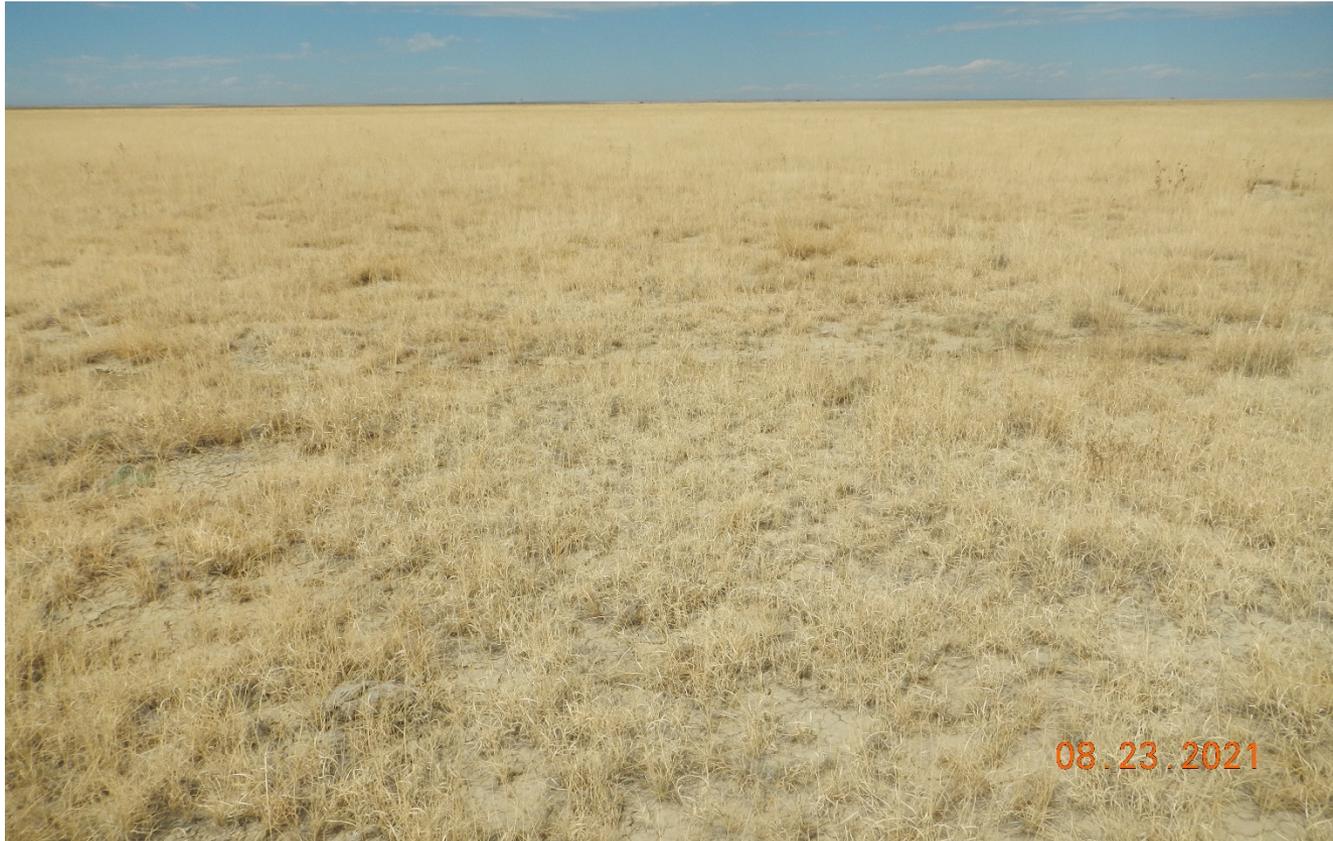
Photo 5. Facing west toward the surrounding undisturbed pasture which consists of a uniform native vegetation cover.
