Inspection Photos
Operator: Petrox
API: 007-06099
Date: 9/13/2021

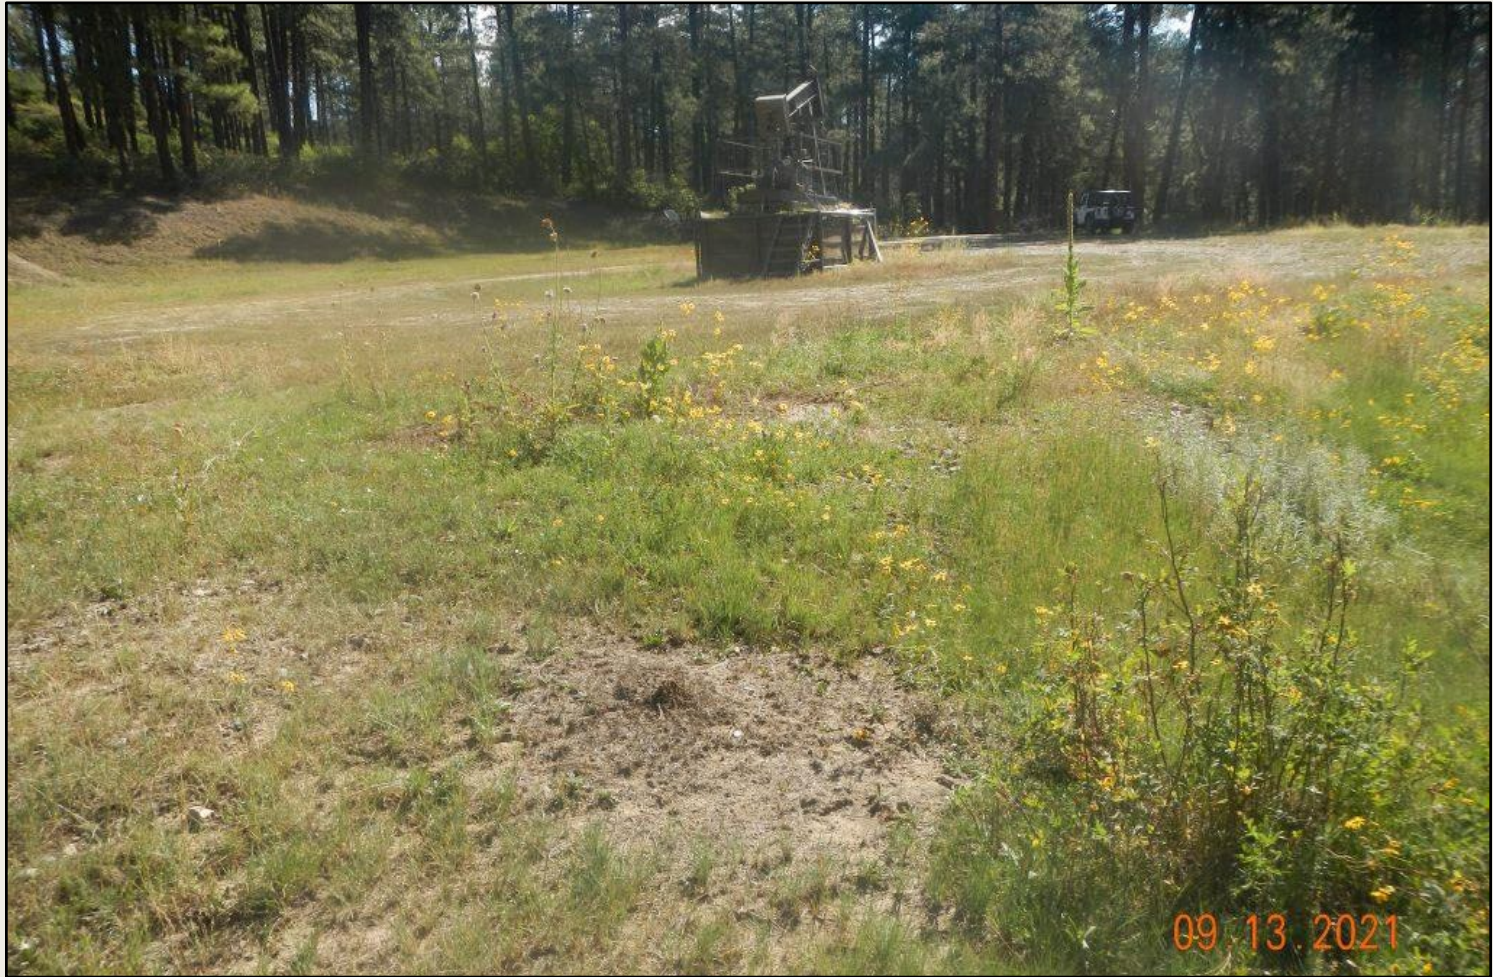
Photo 1. View of the project area from the southwestern corner facing center.

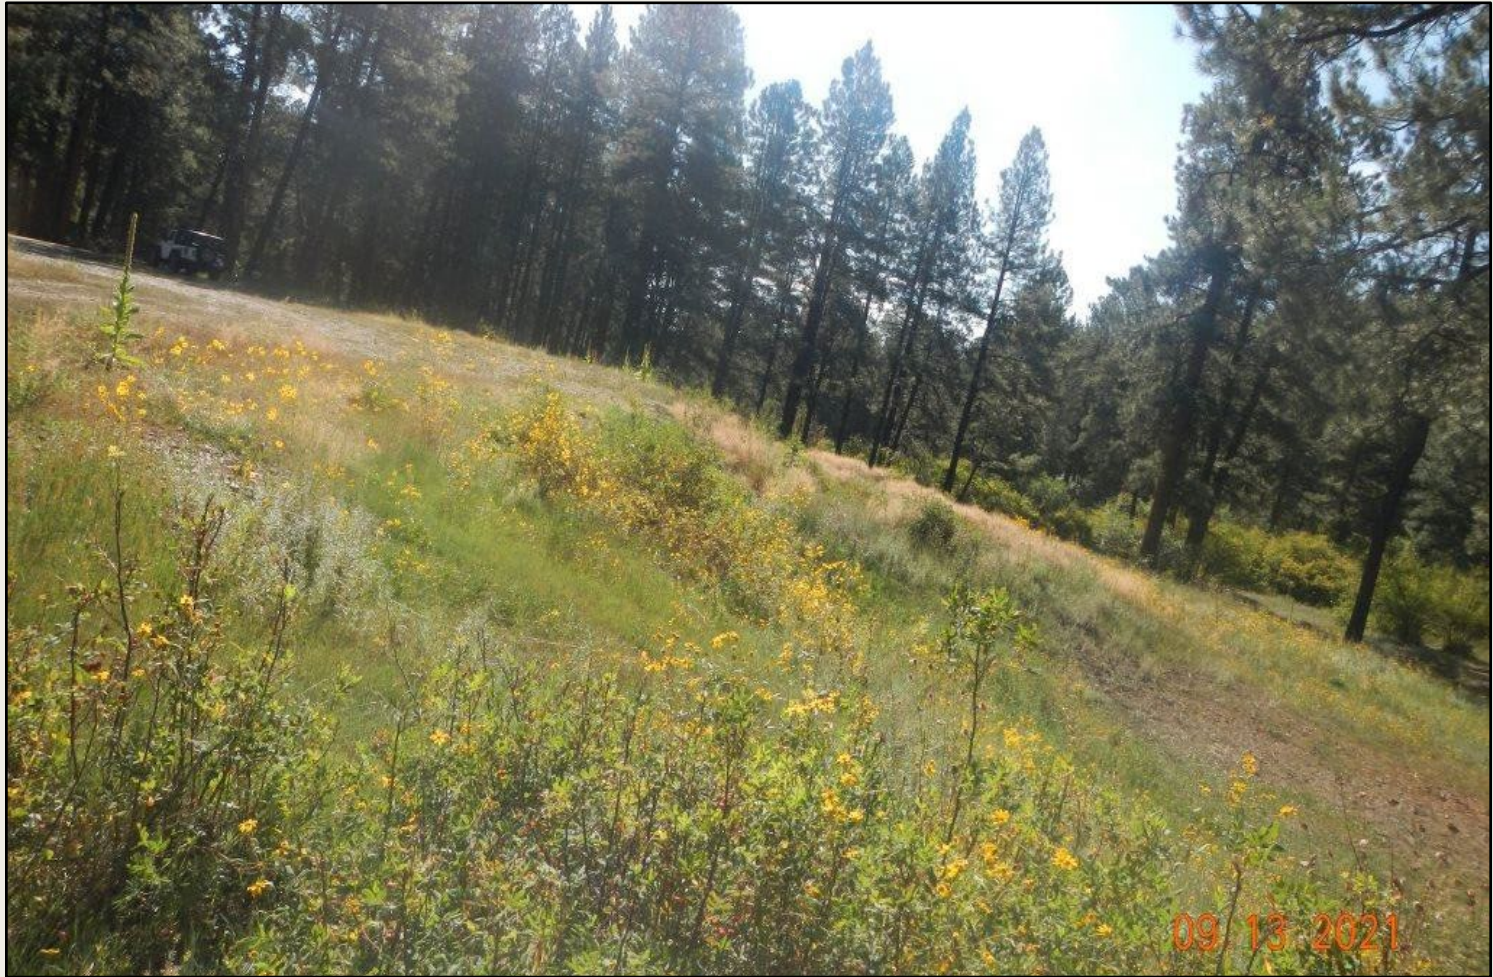
Photo 2. View of the southern project area from the southwestern corner facing eastward. Revegetation is progressing with western wheatgrass, gambel oak, Woods rose, and mugwort.

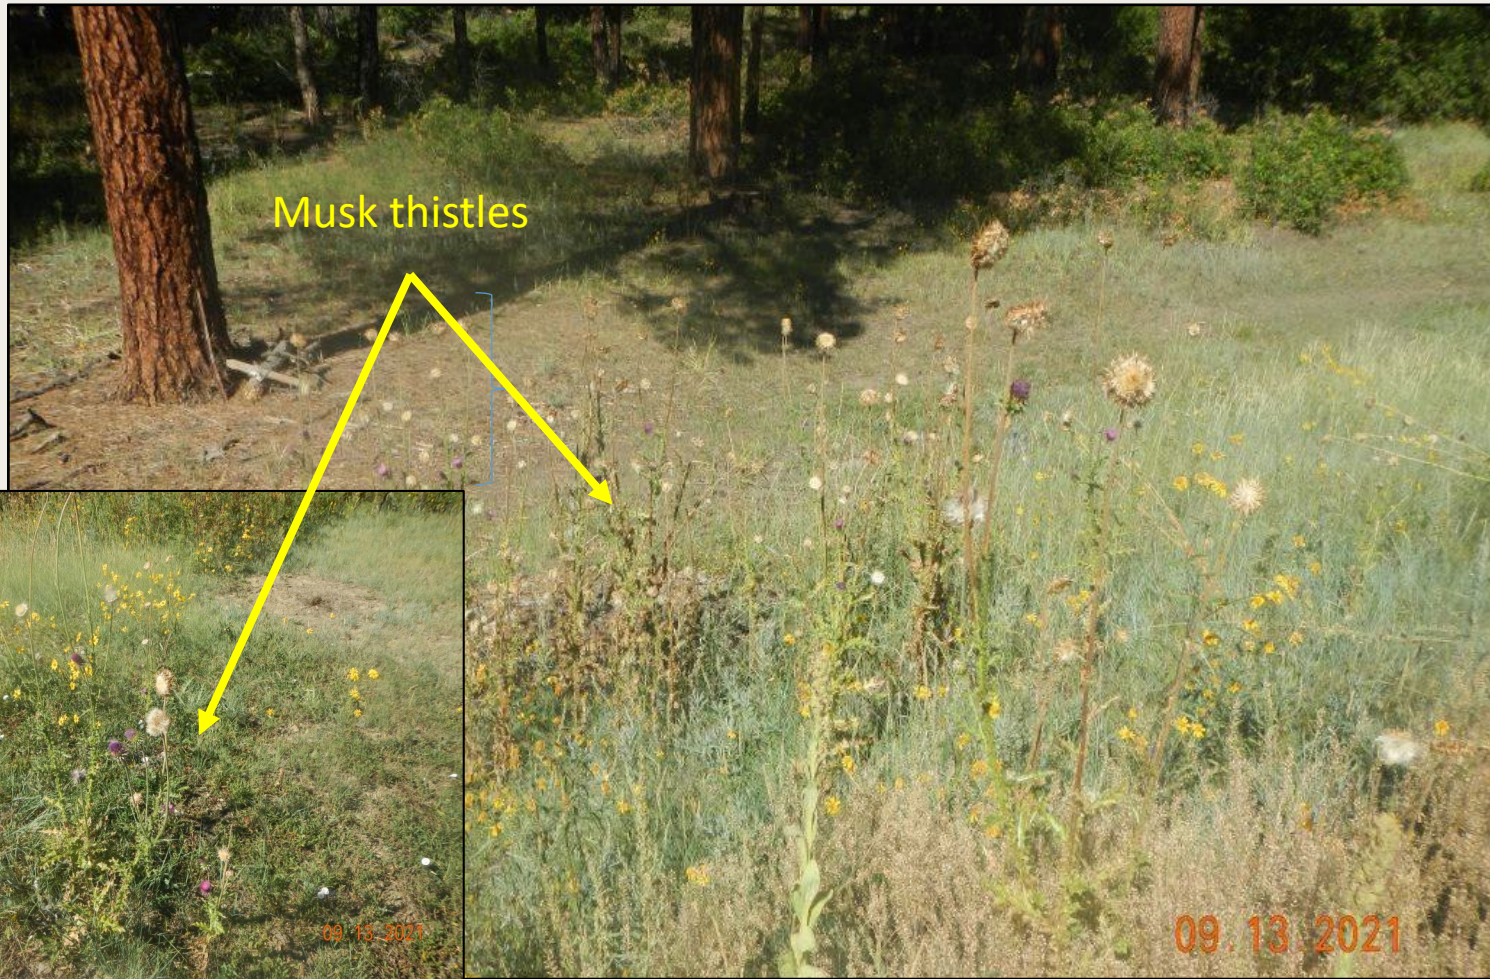
Photo 3. View of musk thistles within the southern project area. Approx. 100 individuals observed.

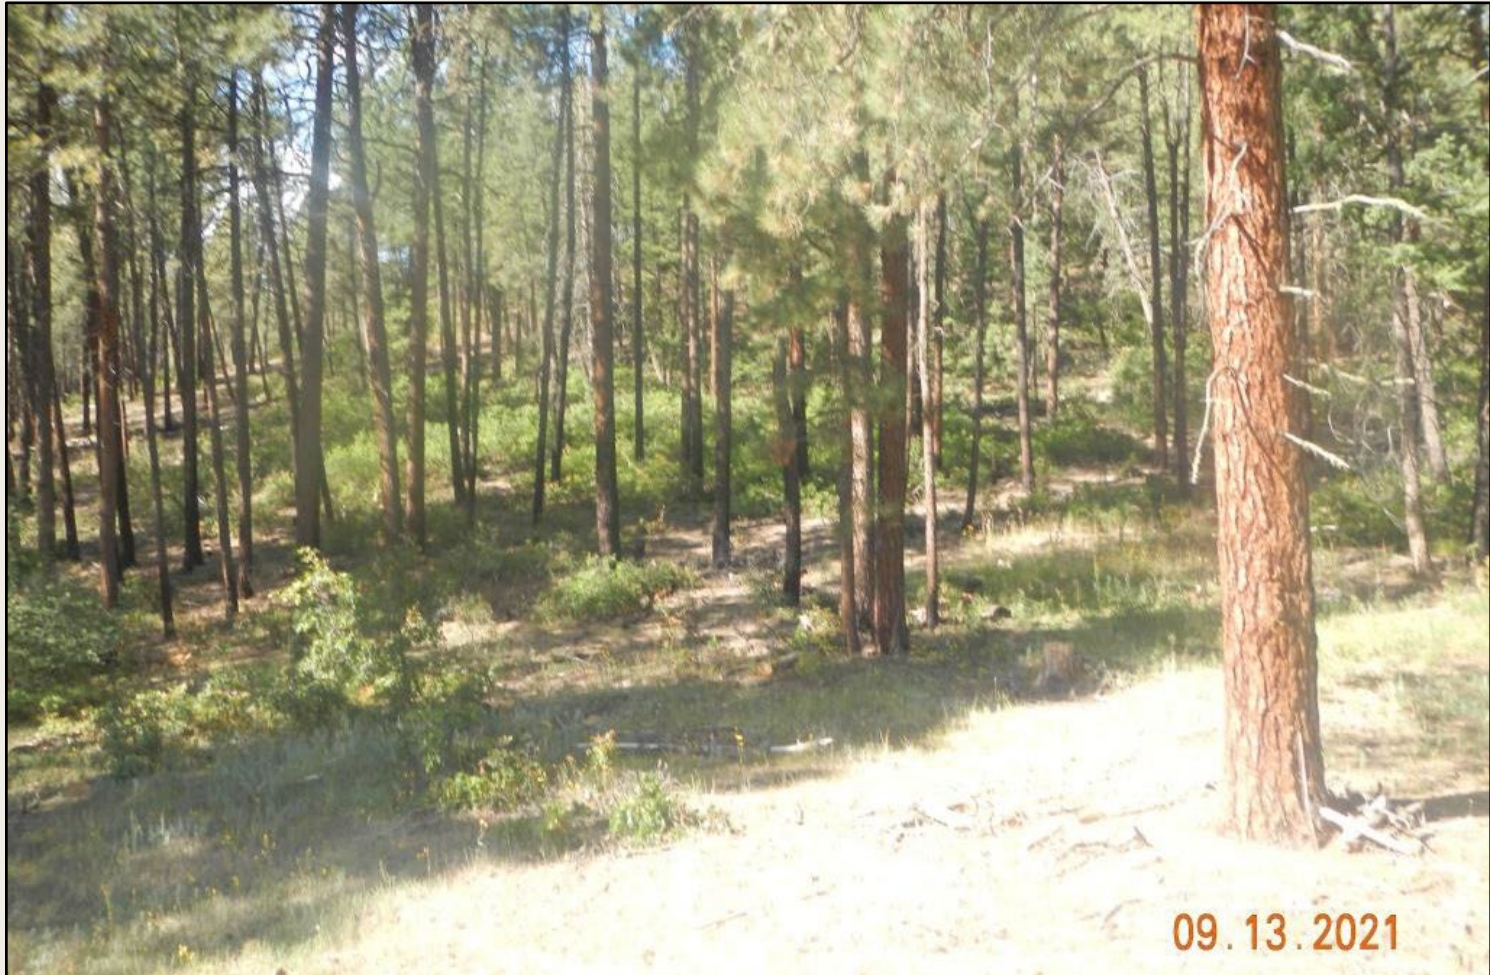
Photo 4. View of the reference area comprised of ponderosa pine forest with understory of gambel oak, Sandberg bluegrass, and serviceberry.
