APACHE CANYON 06-14 API# 05-071-08321 – OGRIS OPERATING
OGCC OPERATOR NUMBER 10758 - DATE: APRIL 14, 2021
CORRECTIVE ACTIONS COMPLETED REGARDING COGCC FIR DOCUMENT # 690201355

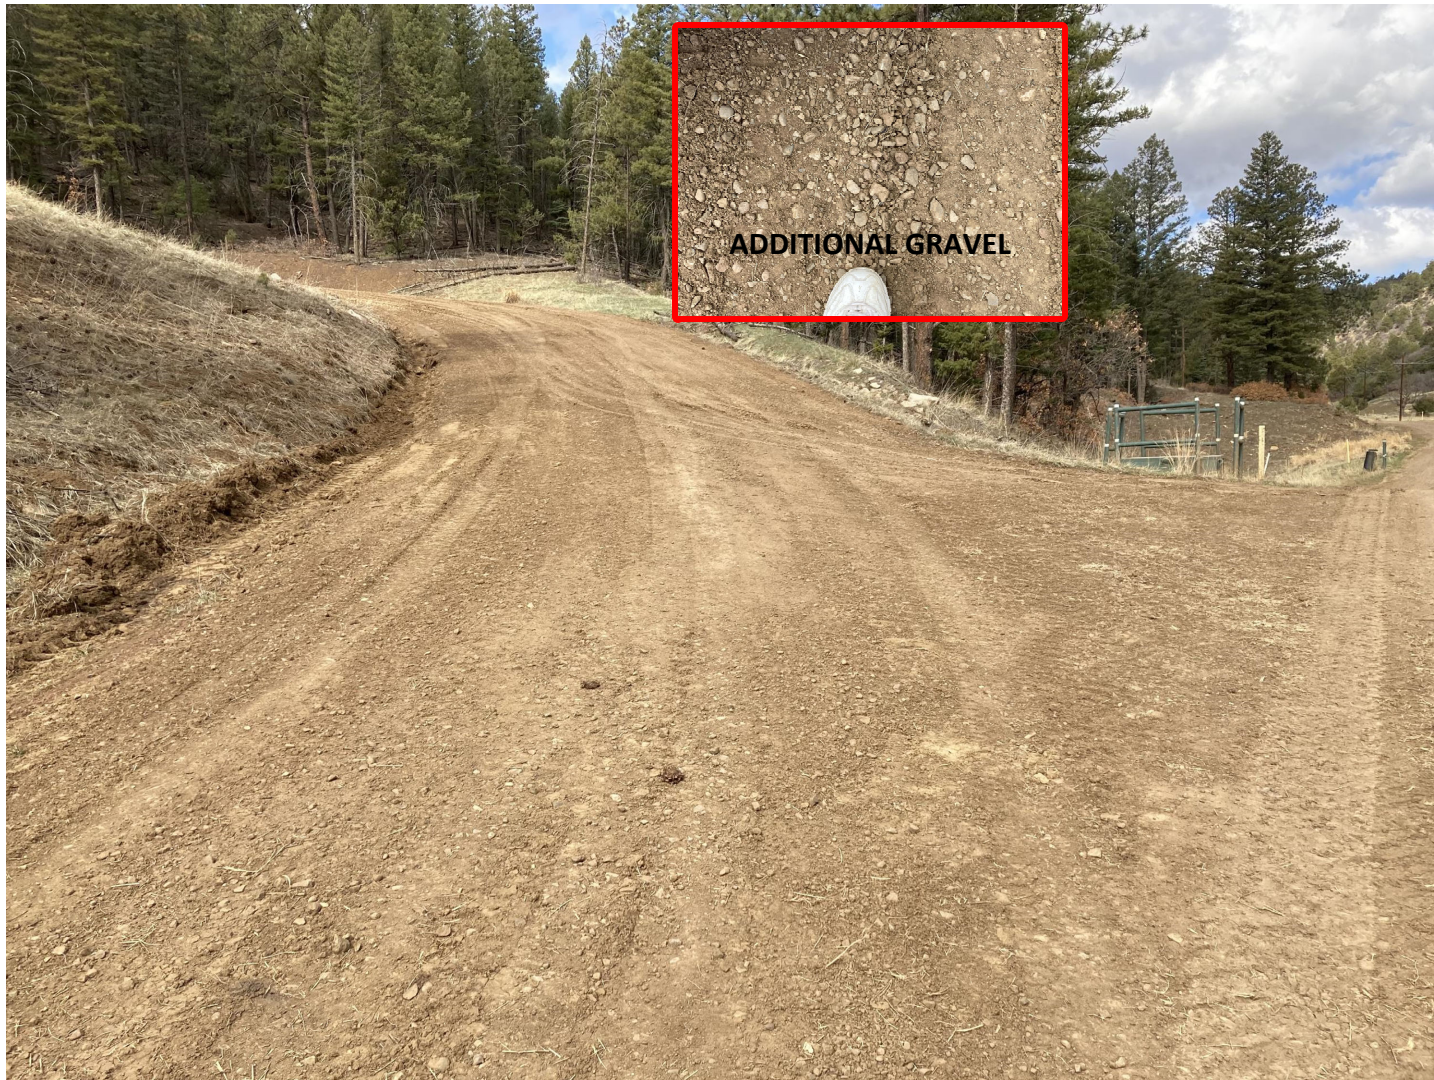
PHOTO 1: THE ROAD SURFACE WAS CROWNED TO CREATE SHEET FLOW AND ELIMINATE THE TIRE RUTS. ADDITIONAL GRAVEL WAS ADDED TO THE ROADWAY SURFACE FOR STABILIZATION.

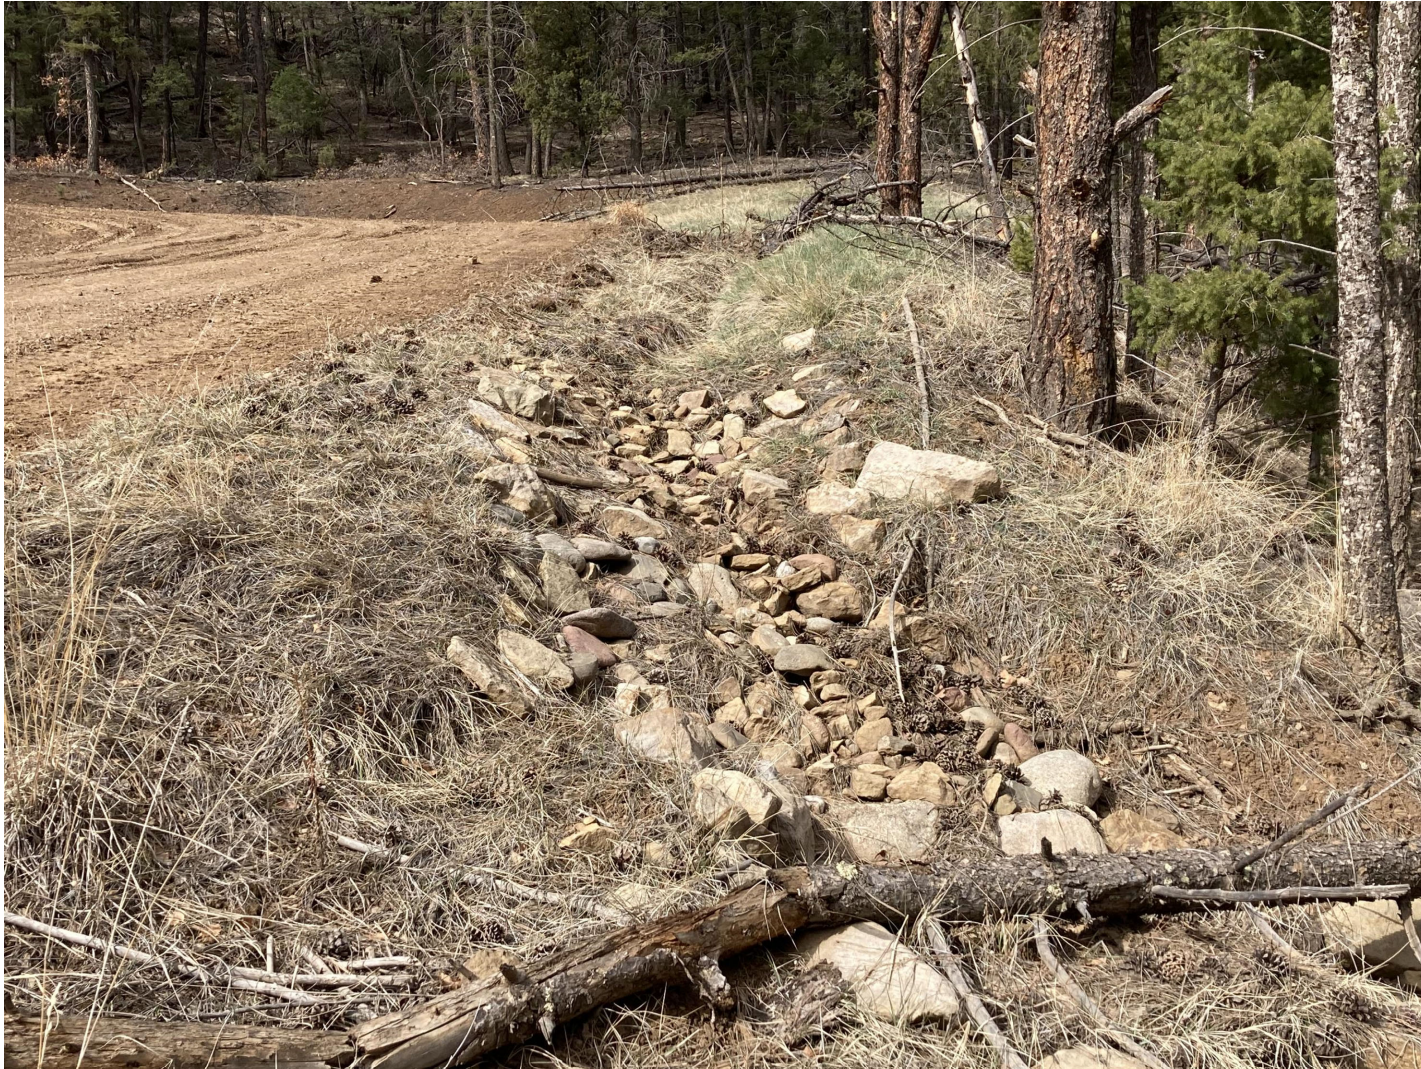
PHOTO 2: THE ROAD SURFACE WAS CROWNED TO CREATE SHEET FLOW AND ELIMINATE THE TIRE RUTS. STORMWATER RUN OFF FROM THE ACCESS ROAD IS DIRECTED TO THE EXISTING ARMORED CALL OUT WHICH IS UPGRADIENT OF A CULVERT ON THE MAIN ROAD.

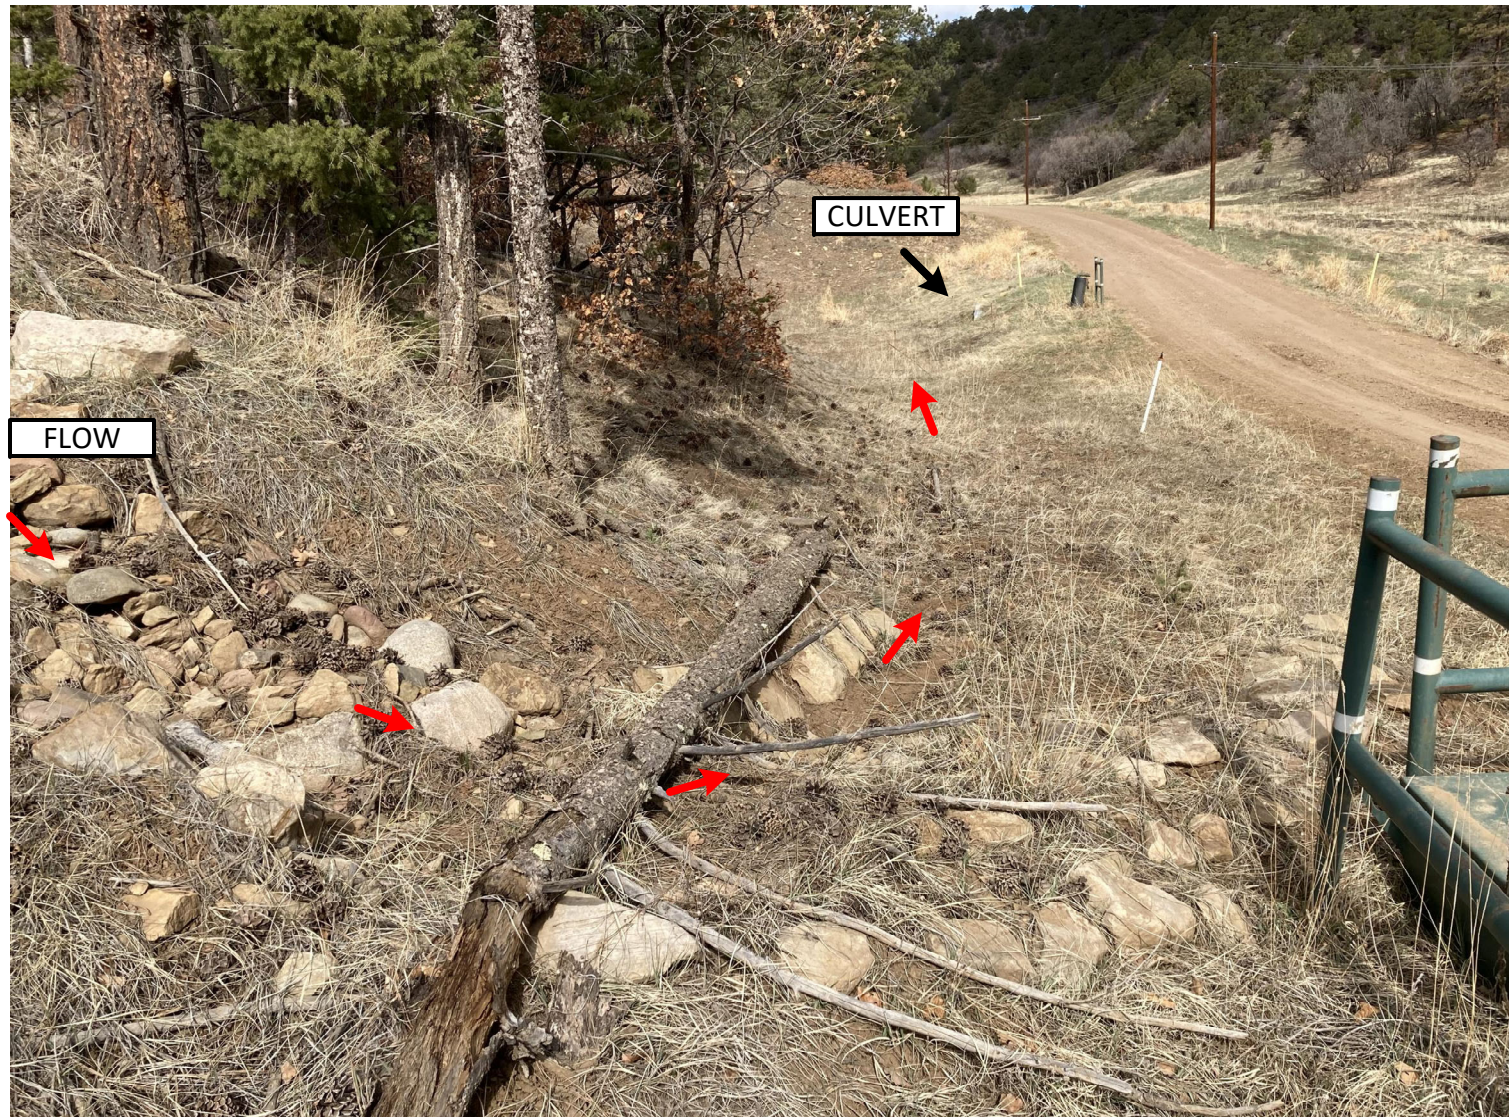
PHOTO 3: THE ARMORED CALL OUT DIRECTS RUN OFF FROM THE WELL PAD ACCESS ROAD TO A GRASSY SWELL WHICH WILL ALLOW SEDIMENT TIME TO DROP OUT. AFTER PONDING, RUN OFF WILL THEN ENTER A GALVANIZED CULVERT THAT CROSSES THE MAIN LEASE ROAD IN ALAMOSITO CANYON.

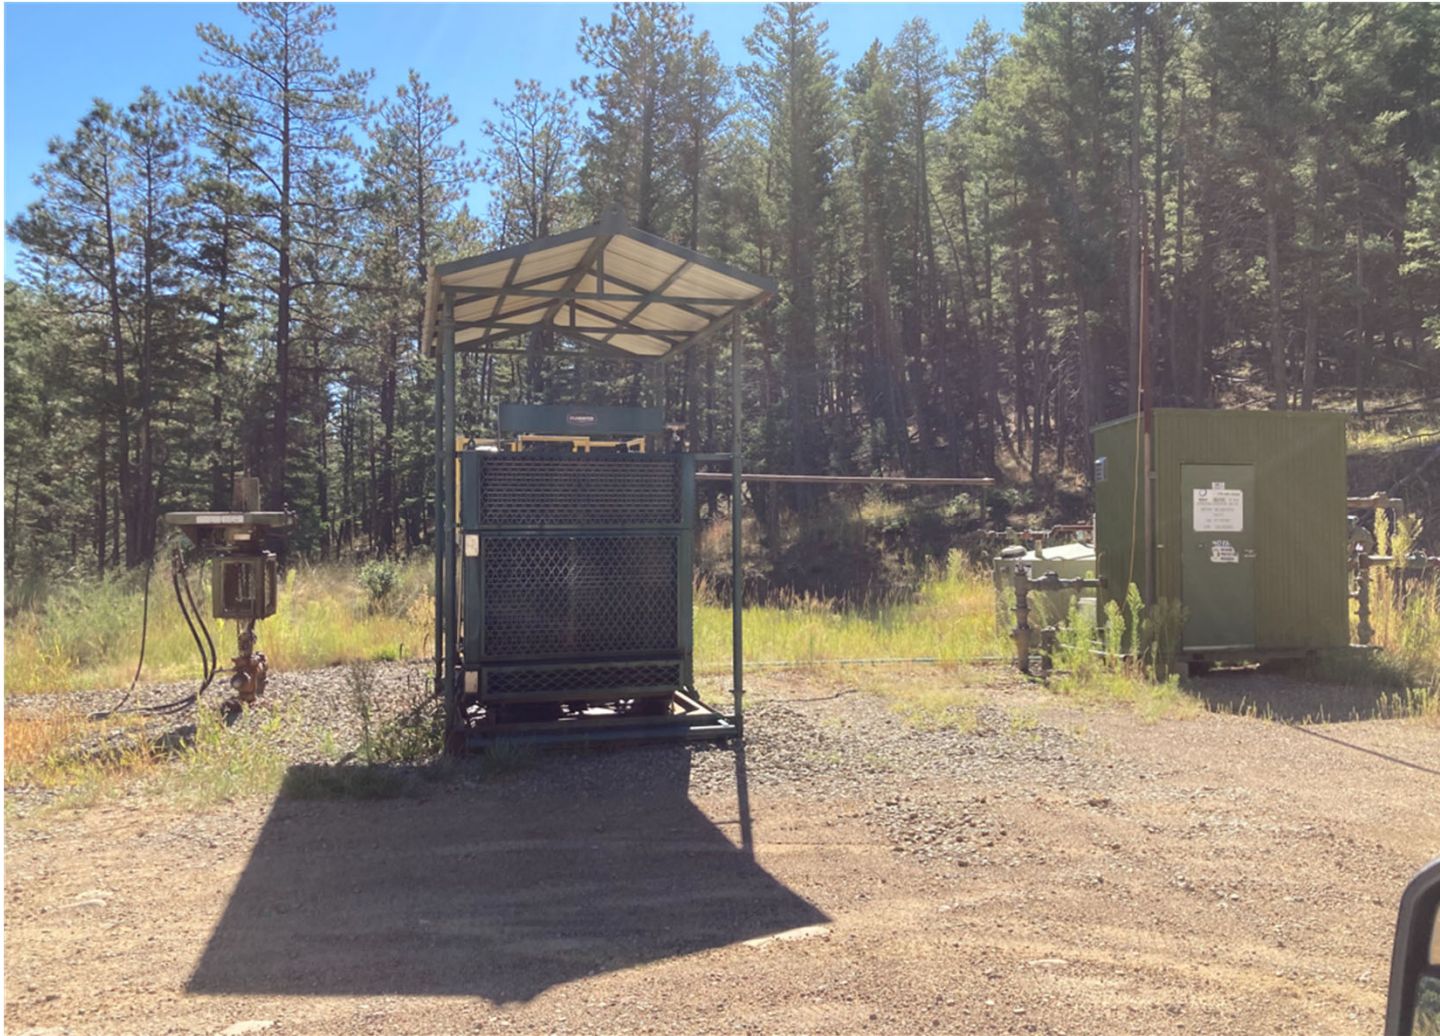
PHOTO 4: THE LEAK ON THE LIQUID RING COMPRESSOR WAS REPAIRED. THE SKID AND THE IMPACTED SOIL WAS CLEANED UP AND REMOVED FROM LOCATION. THE SELF-INSPECTION PROCESS HAS BEEN REVIEWED.
