Inspection Photos

API: 071-06508

Operator: EVERGREEN NATURAL RESOURCES

Inspection Date: 10/8/2021

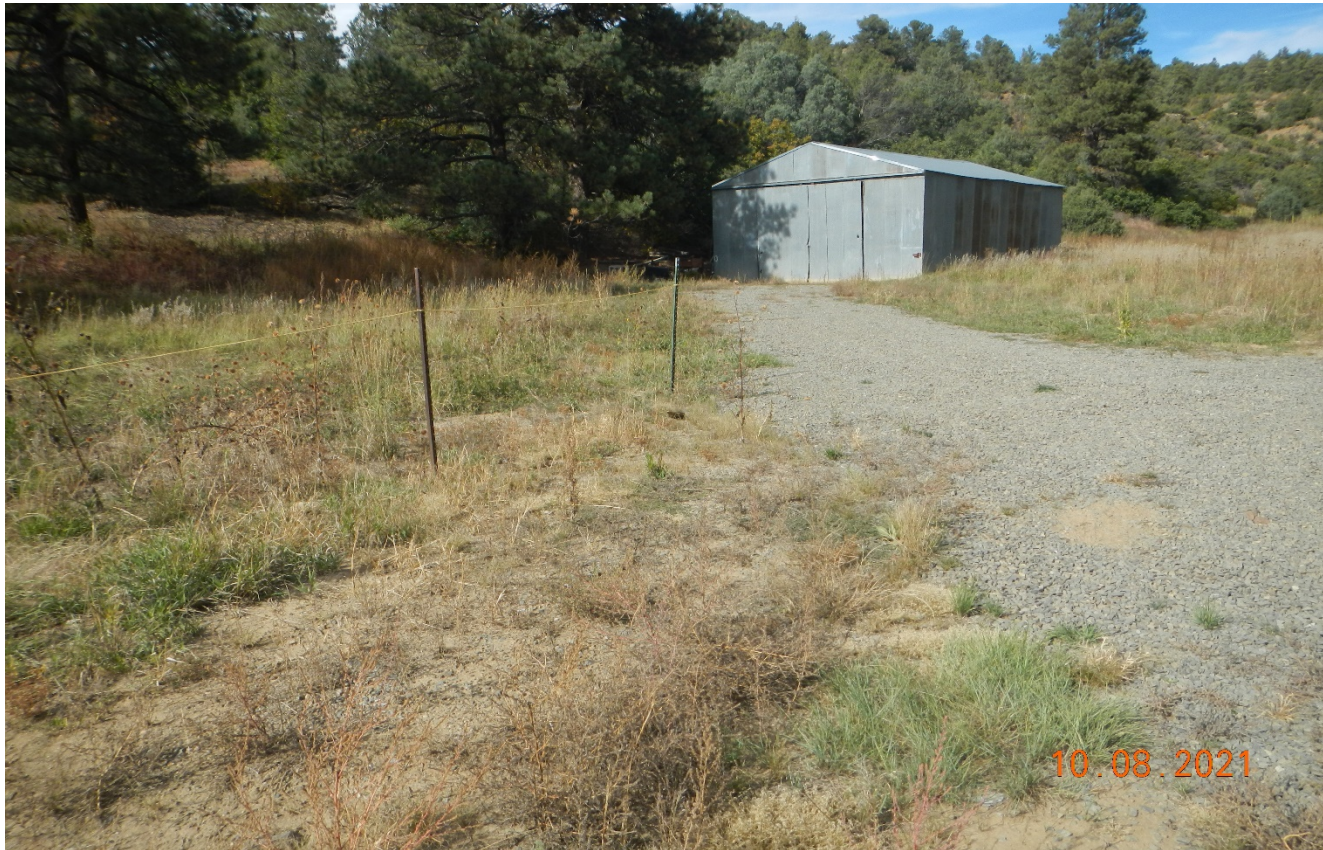
Photo 1. There is a steel building along the access road where landowner has observed oil and gas vehicle parking off the designated road way blocking this building. All oil and gas vehicles must stay within access road boundary.
Lat/Long:37.23550,-104.69878

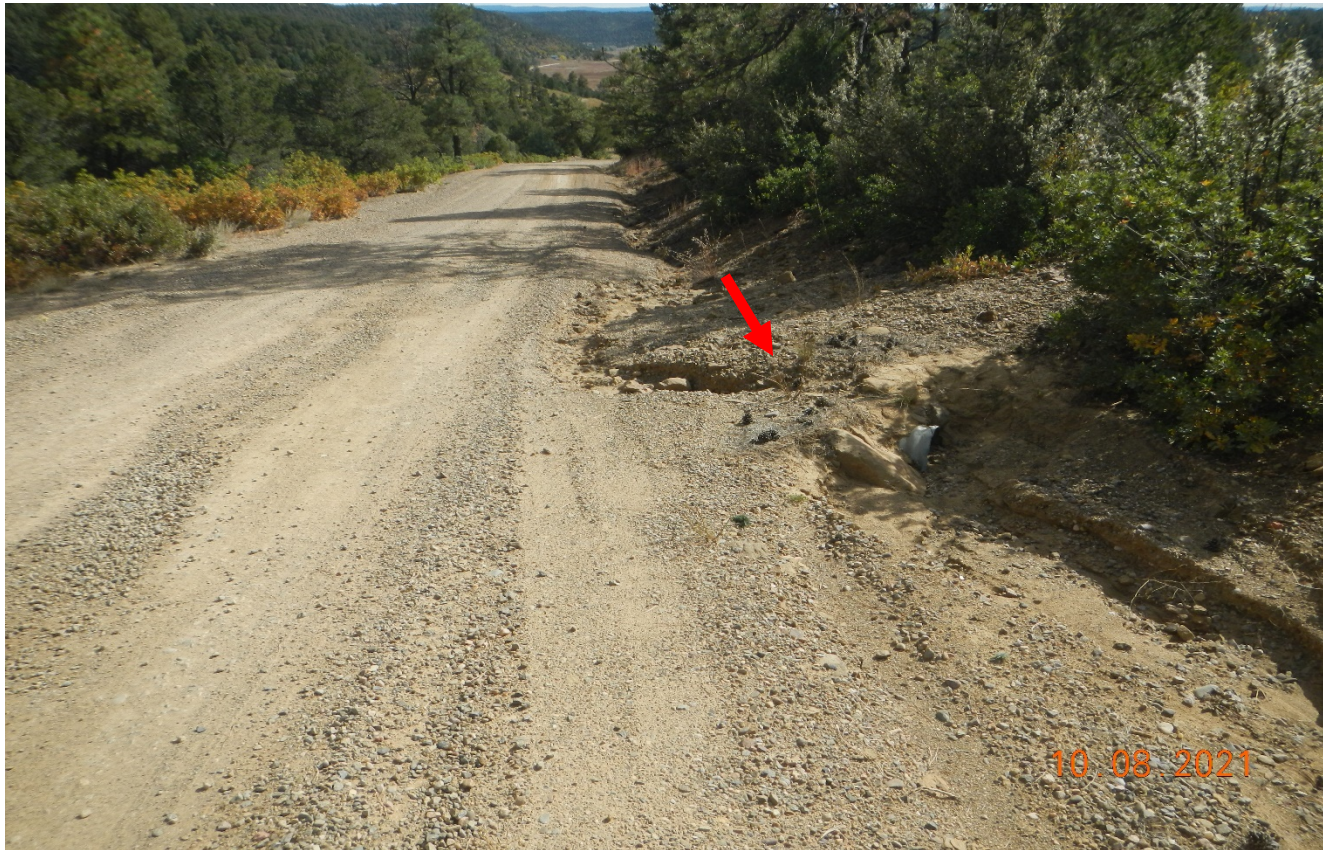
Photo 2. Further along the road toward the location are areas of erosion that need to be repaired. Stormwater is flowing past the culvert shown at red arrow.
Lat/Long:37.23760,-104.69906.

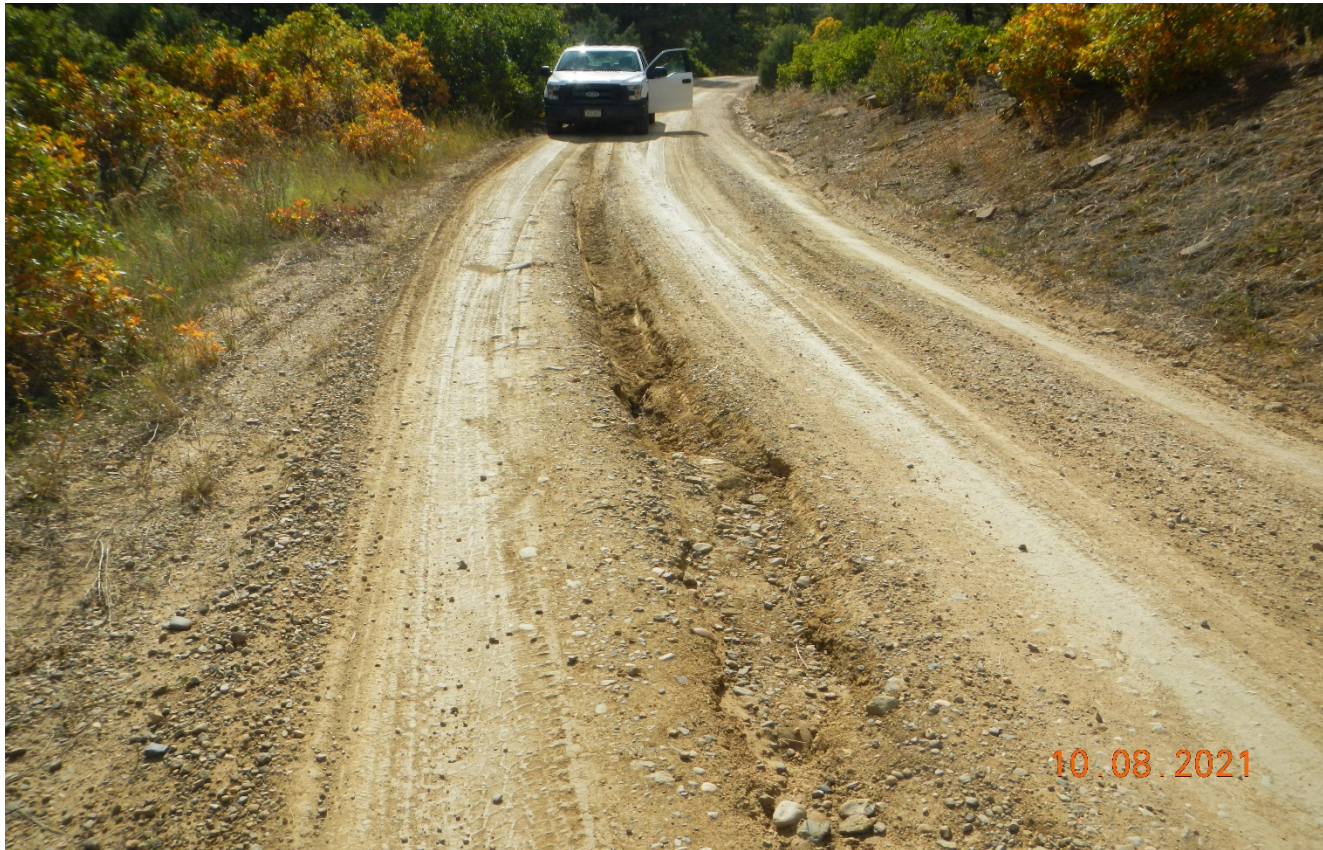
Photo 3. Further along the road is erosion channeling along the center of the road. Areas of erosion and vehicle rutting need to be repaired and stabilized.

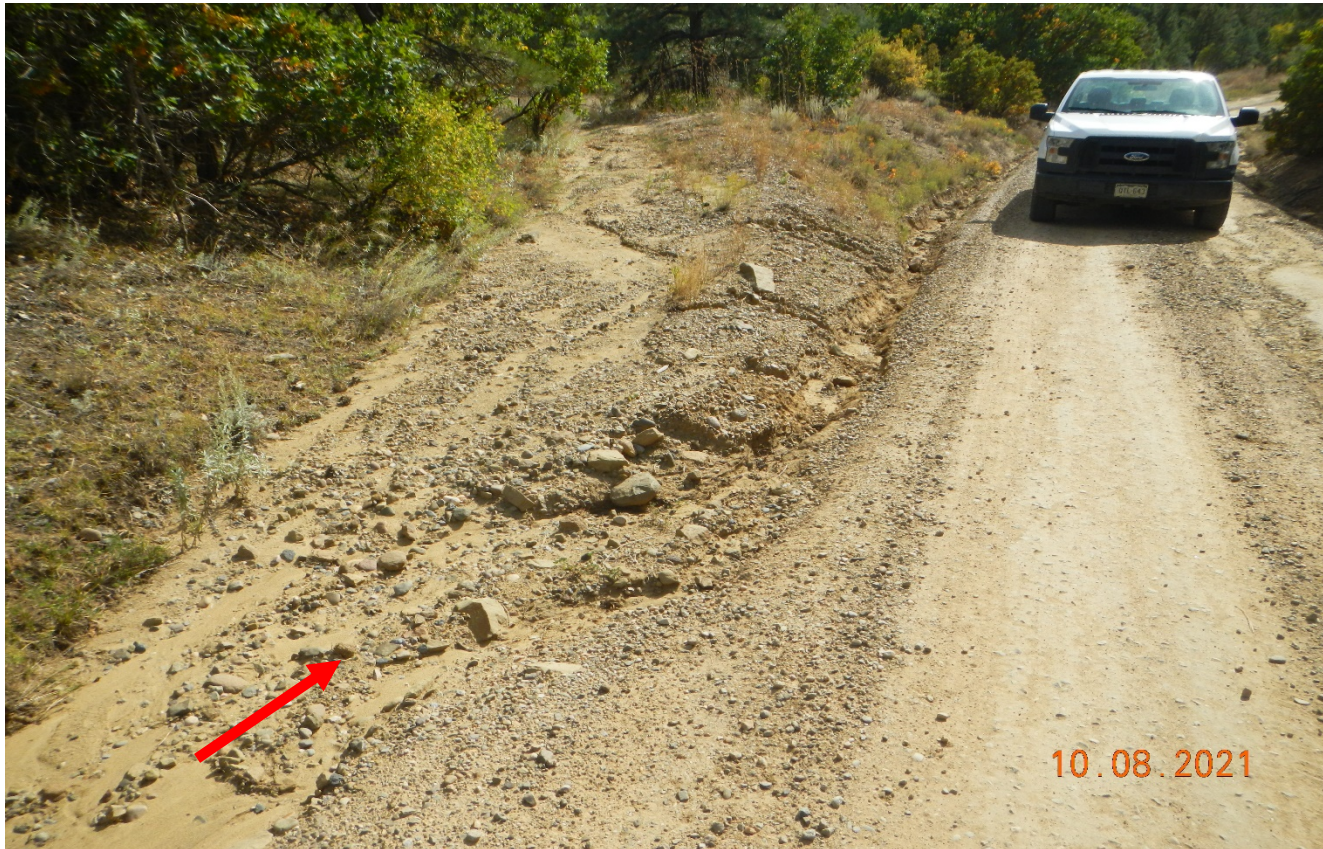
Photo 4. This area of stormwater diversion has filled in with sediment causing erosion to occur down the road side shown at red arrow. The stormwater diversion needs to be repaired with proper BMP installation such as a sediment trap.

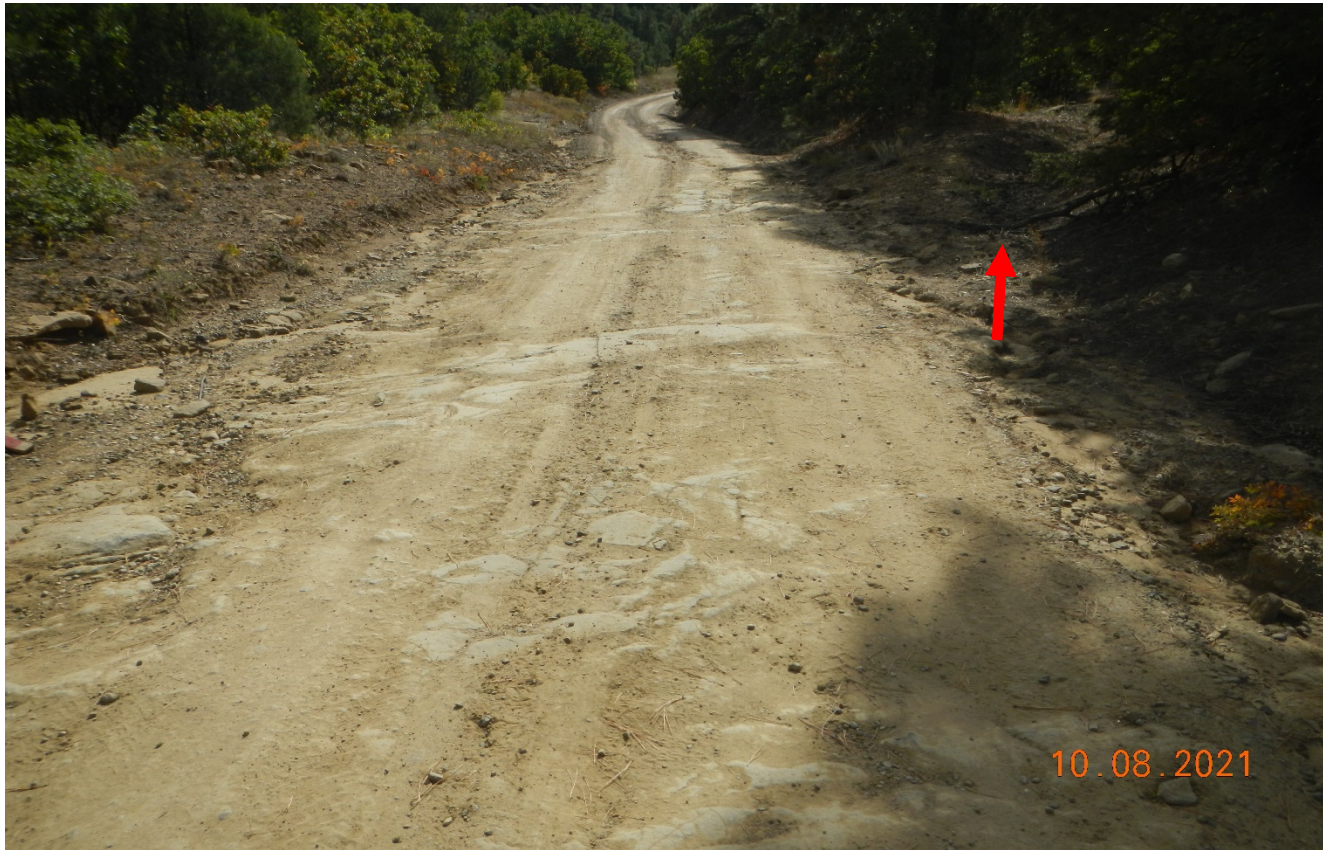
Photo 5. Similarly to previous photo, stormwater is not properly diverted at red arrow. This area of the road is not stabilized.

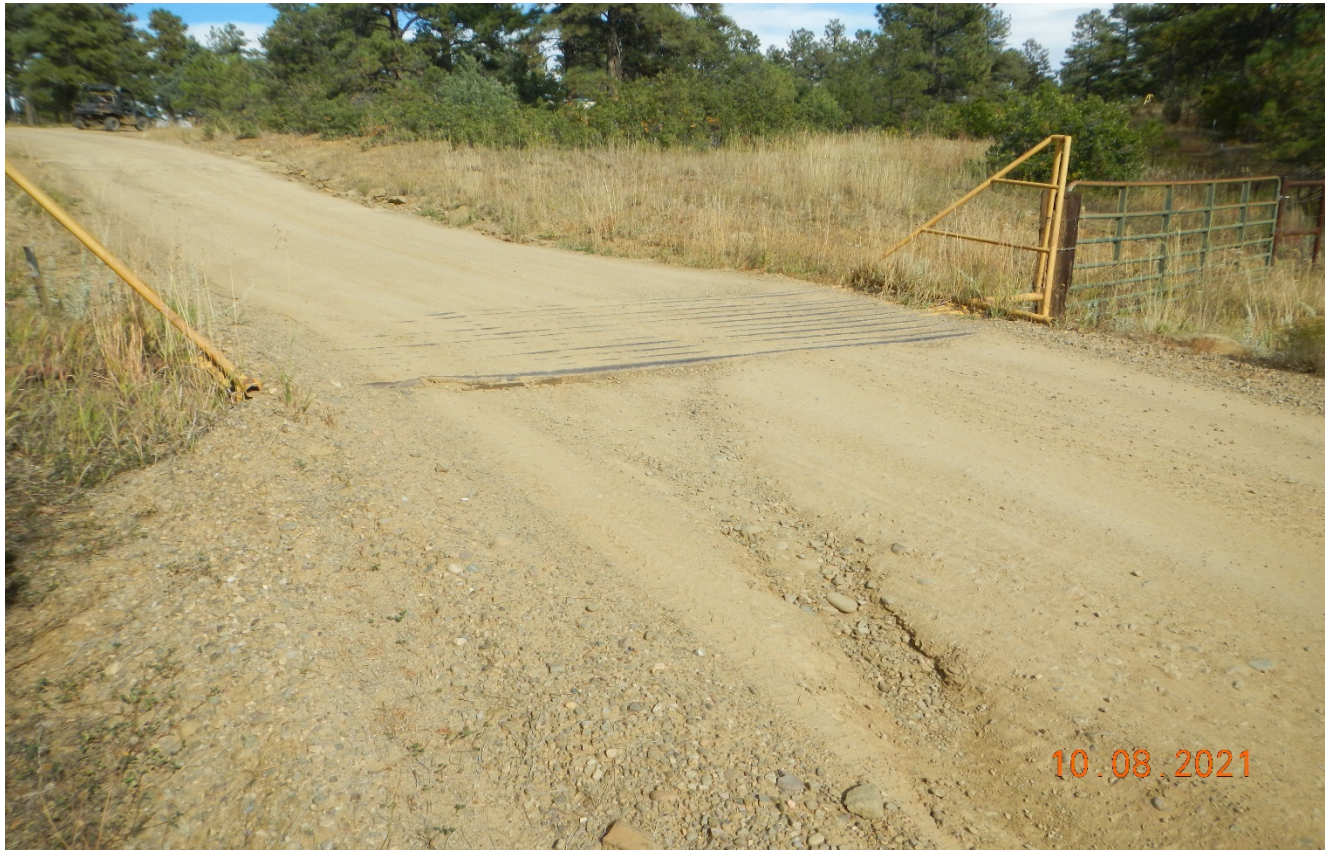
Photo 6. There is a cattleguard that is filled in with sediment at Lat/Long: 37.24379,-104.68923.

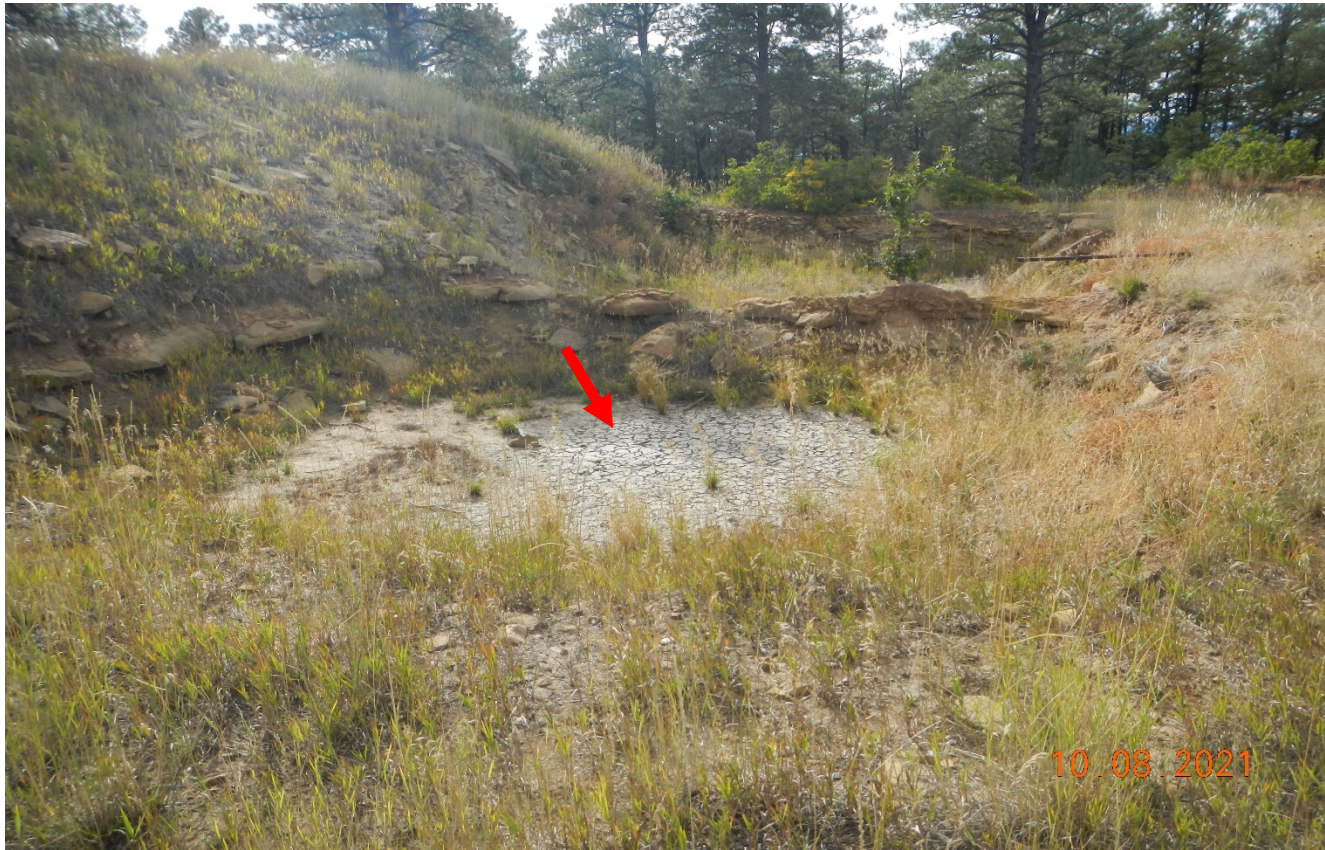
Photo 9. Facing toward the pit. The portion of the pit shown at red arrow appears to be drilling mud in the pit that needs to be cleaned up.
