Inspection Photos  
Operator: Simcoe  
API: 067-09506  
Date: 10/27/2021

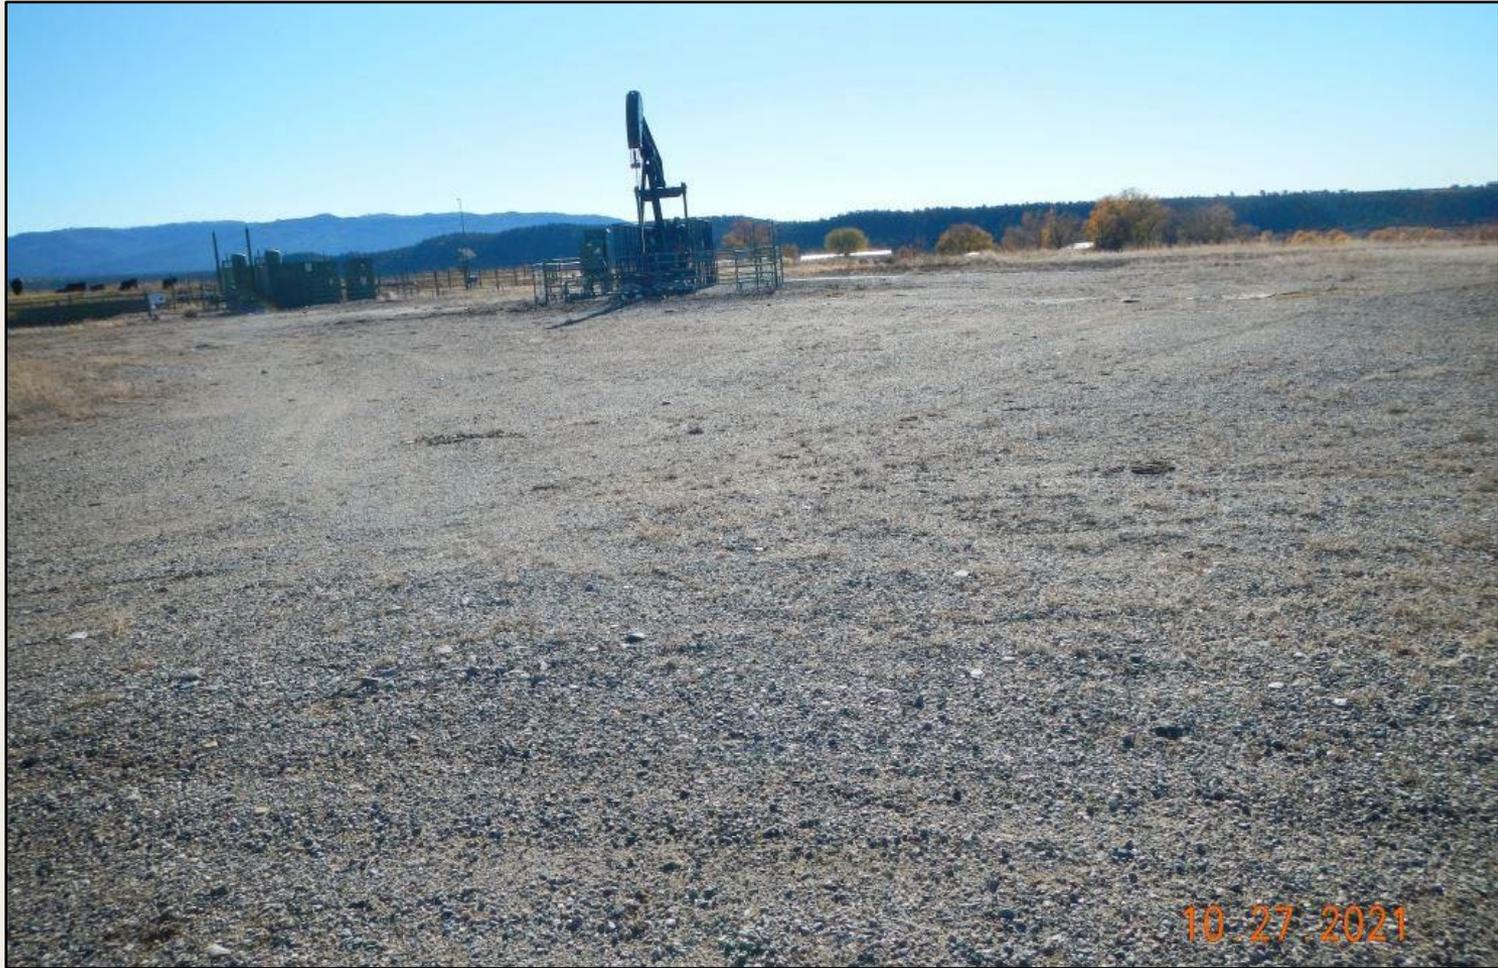
Photo 1. View of the project area from the well pad entrance facing center.

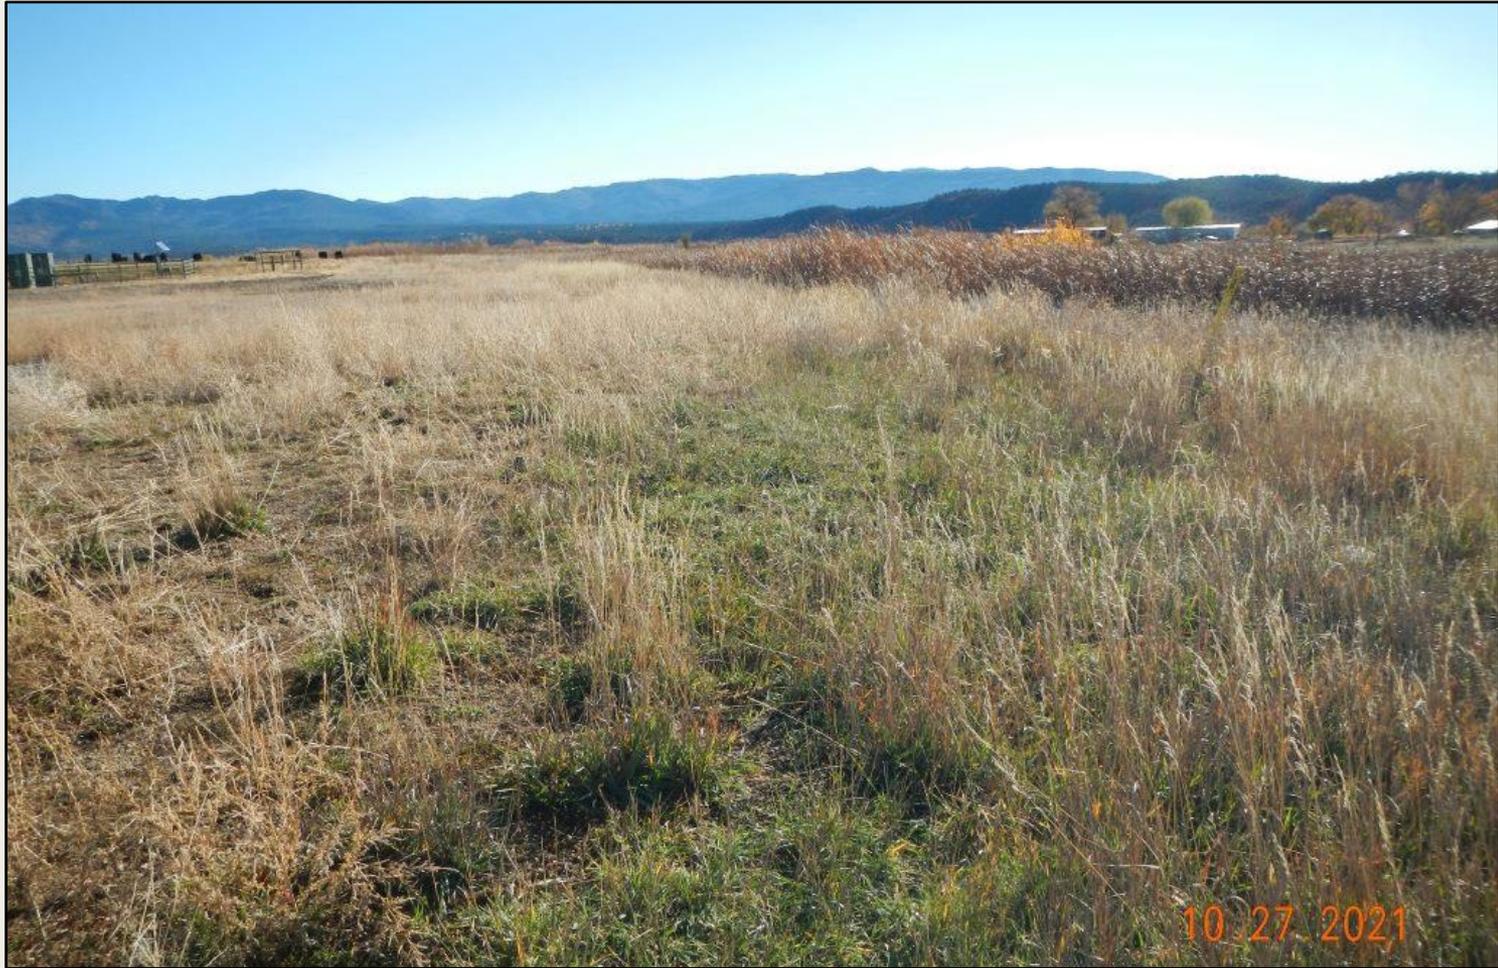
Photo 2. View of the western project area from the northwestern corner facing southward. Revegetation is progressing with a mixture of wheatgrasses.

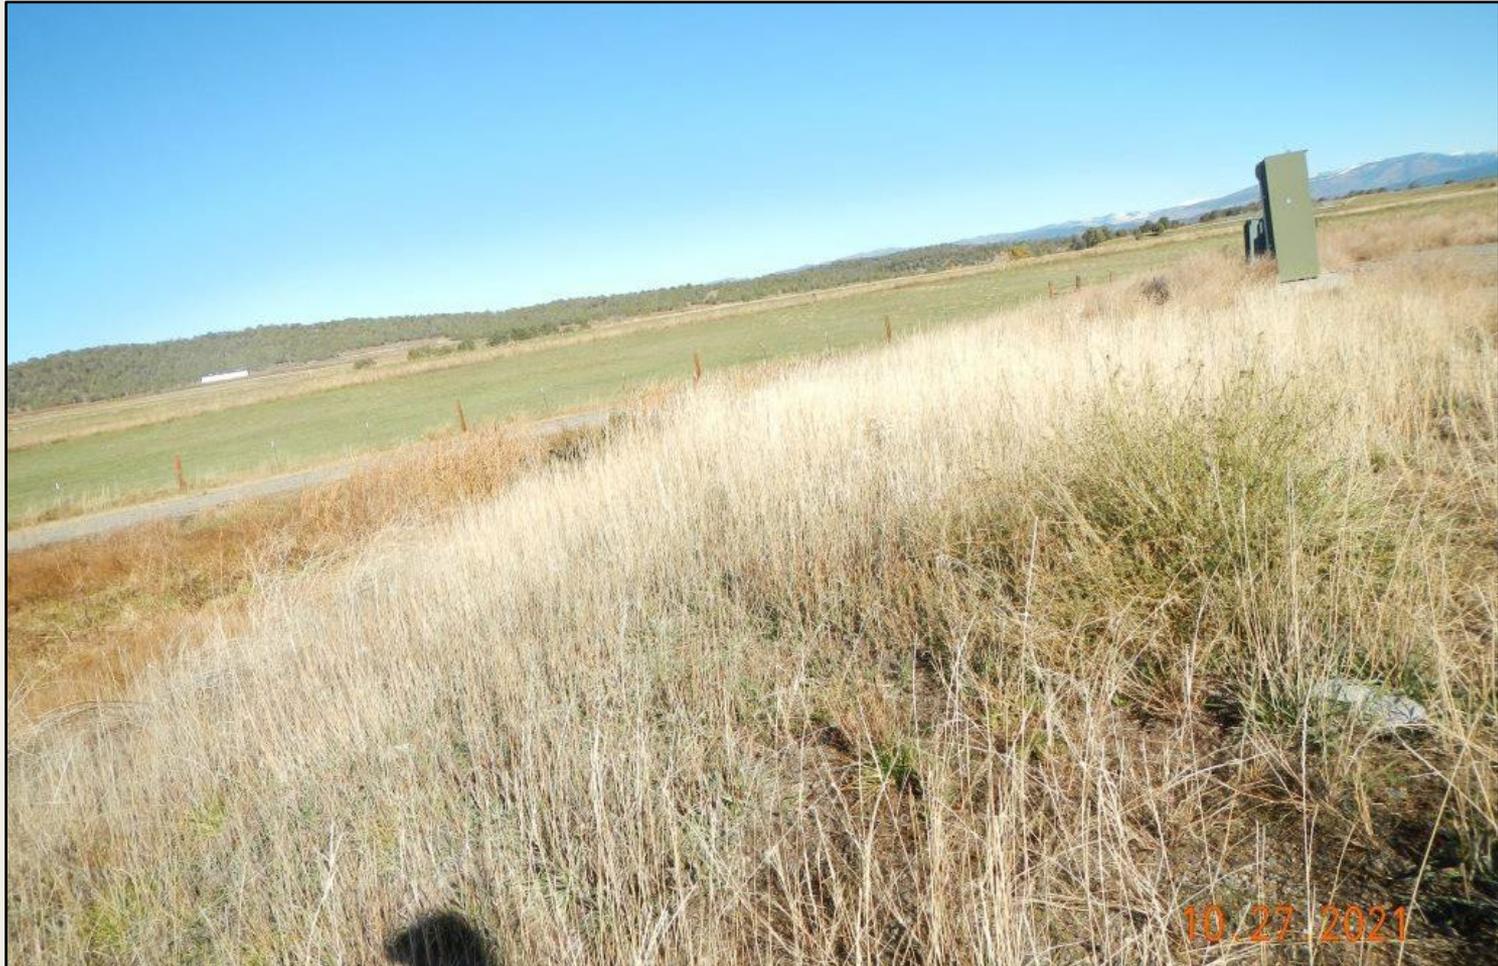
Photo 3. View of the northern project area from the northwestern corner facing eastward.

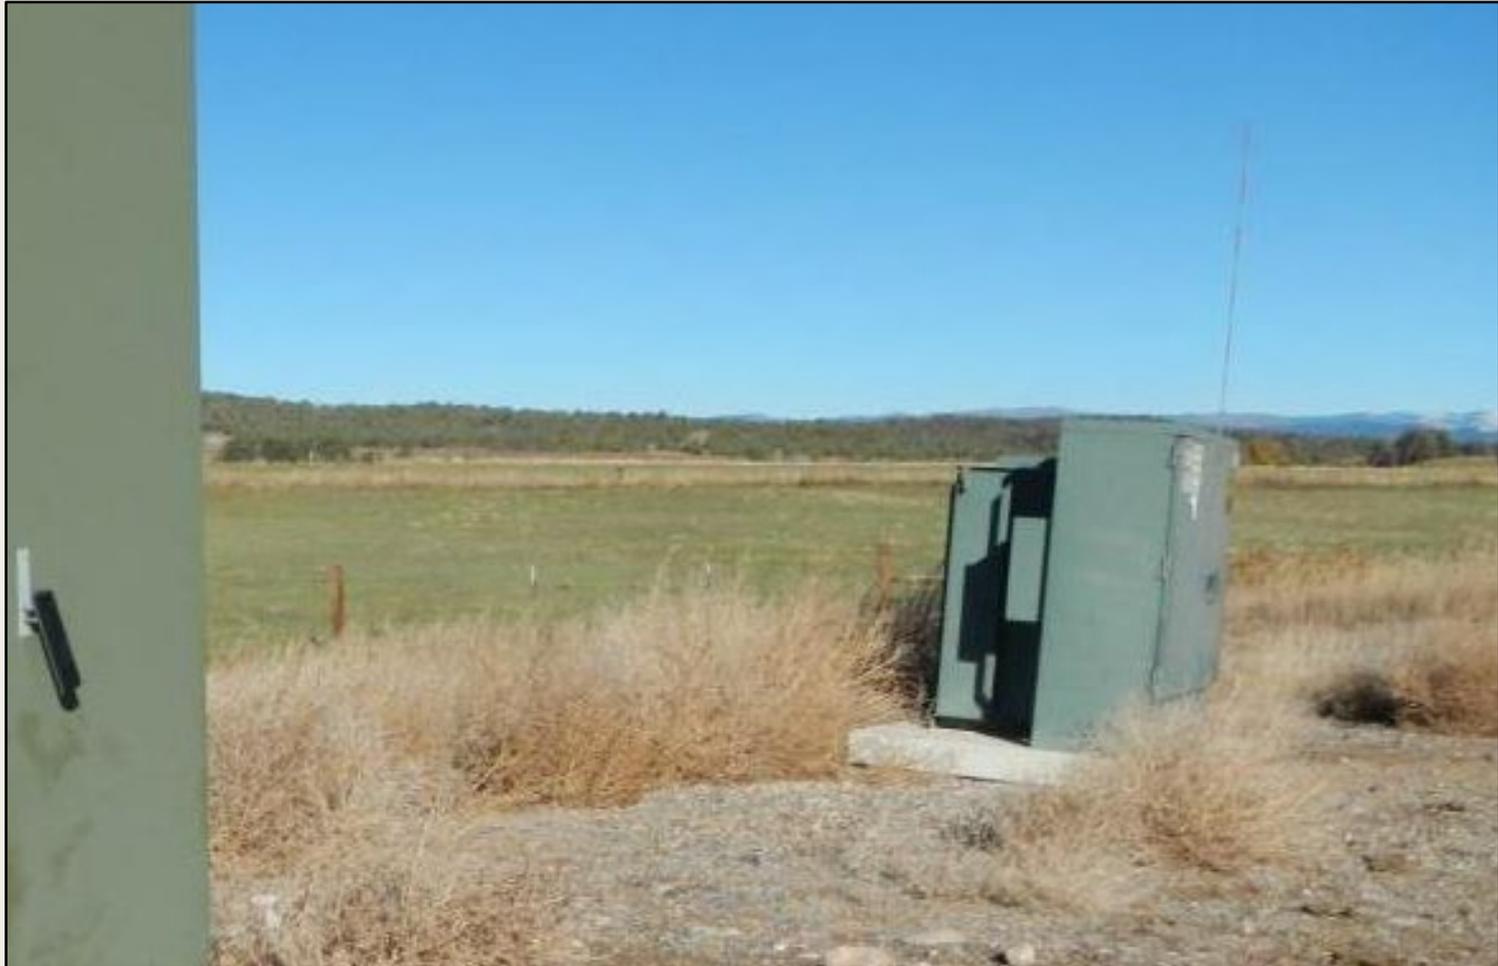
Photo 4. View of dense kochia debris within the western project area, needs to be removed.

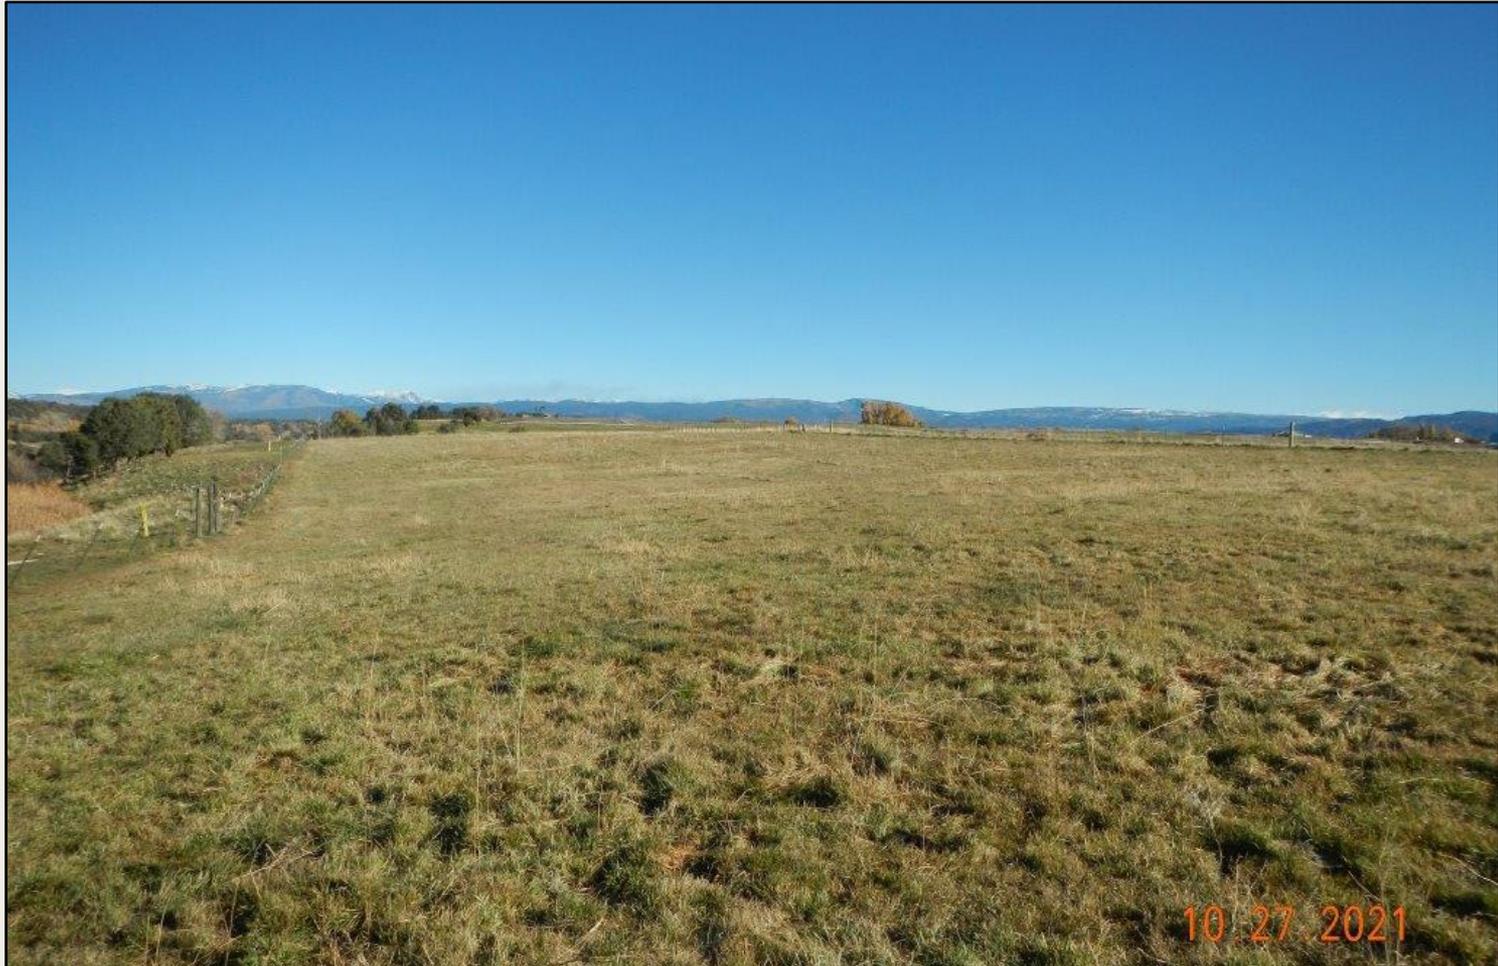
Photo 5. View of the reference area comprised of irrigated grass field with grasses such as meadow brome, orchard grass, perennial rygrass, and tall fescue.
