Inspection Photos

Location Name: Thompson-Price 2

Location ID: 320156

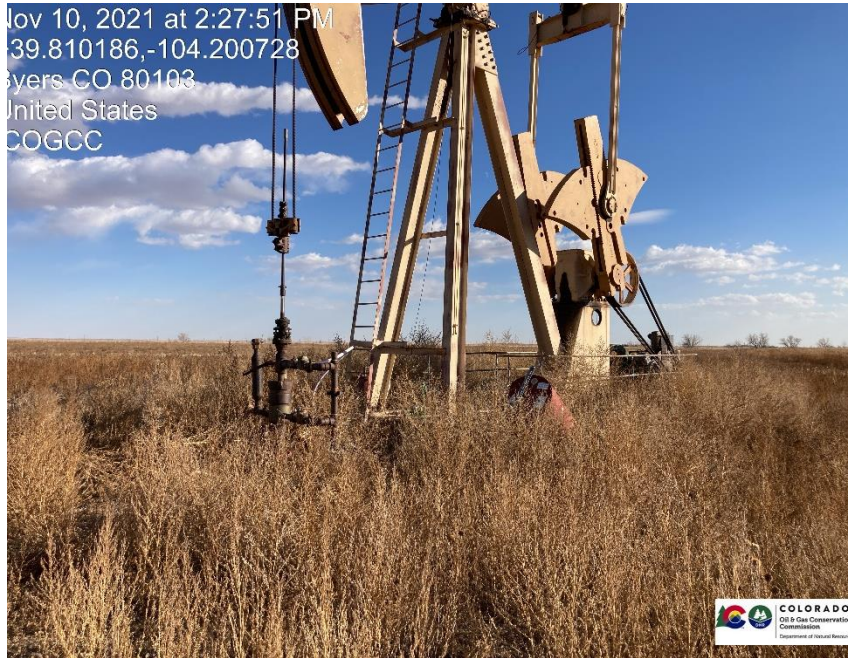
Pic 1 wellhead, weeds unmanaged.

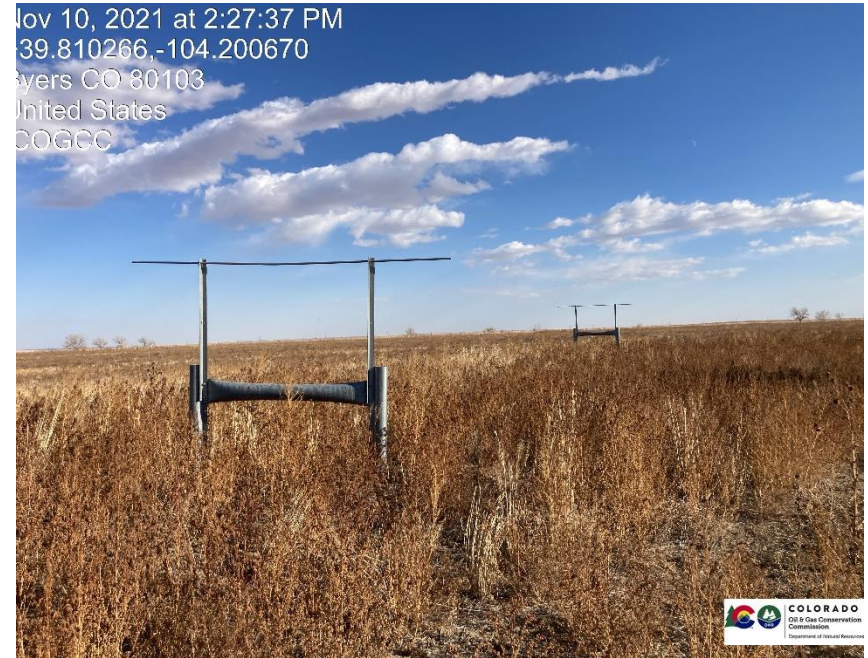
Pic 2 unused equipment by pump jack weeds unmanaged

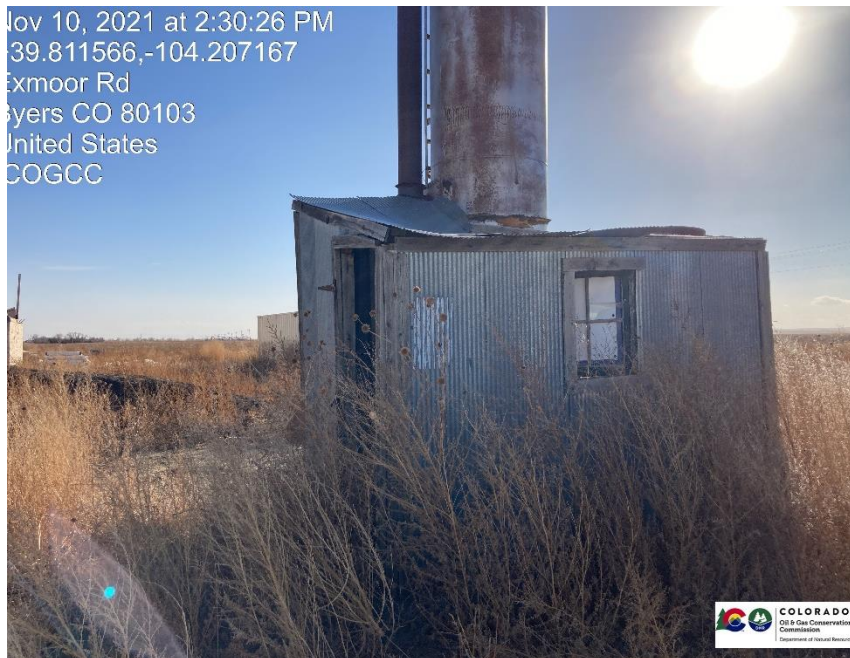
Pic 3 separator house weeds unmanaged

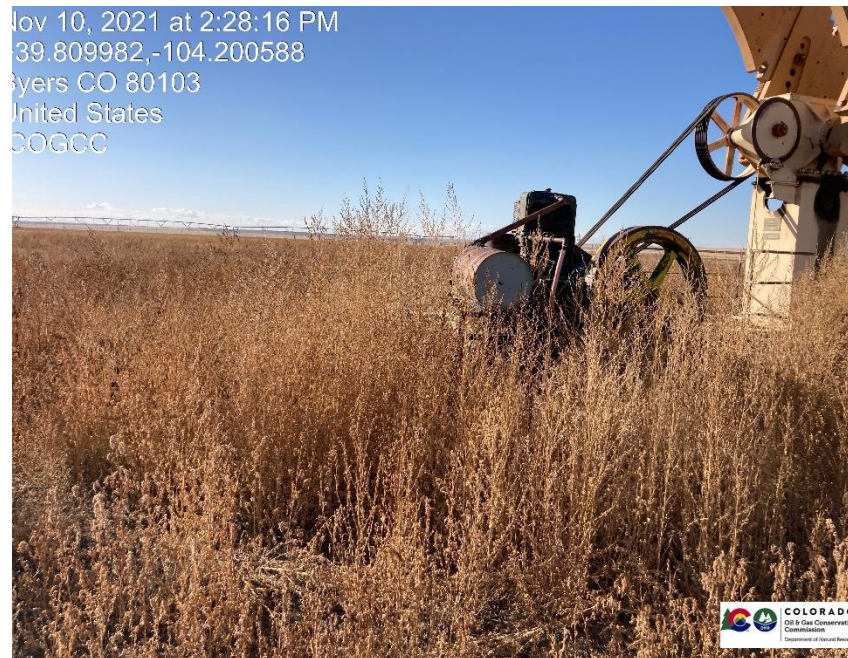
Pic 4 pumpjack motor, weeds unmanaged.

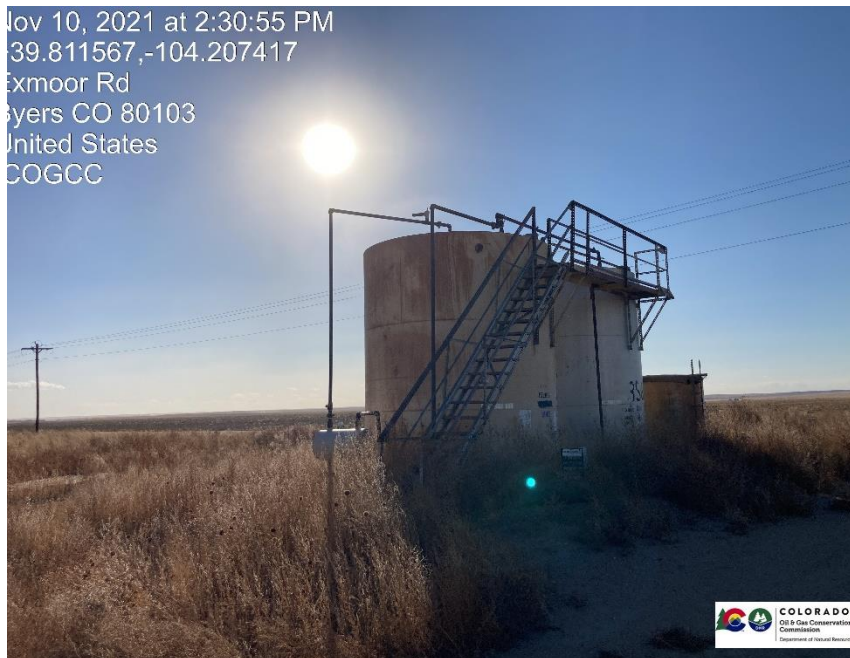
Pic 5 tanks, unable to inspect berms due to weed growth

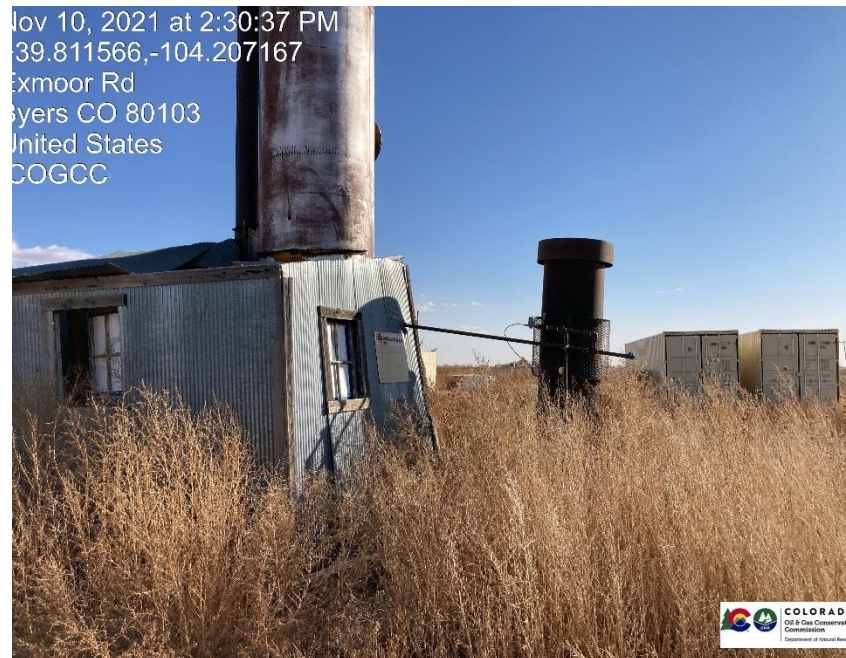
Pic 6 separator/ECD weeds unmanaged on location.
