Inspection Photos
Location Name: Argenta 33-10 #4-3
API: 05-067-08322

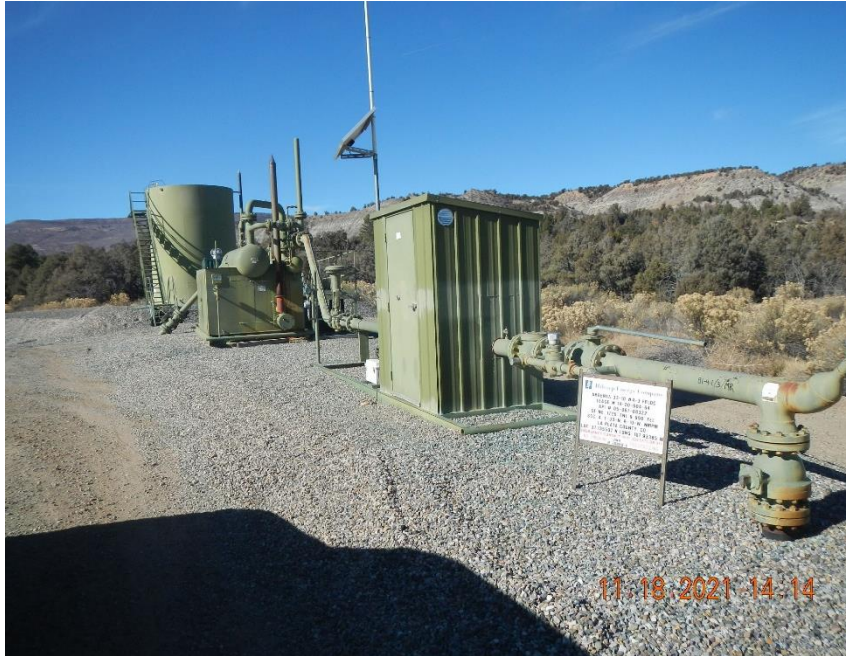
Argenta 33-10 #4-3 production equipment.

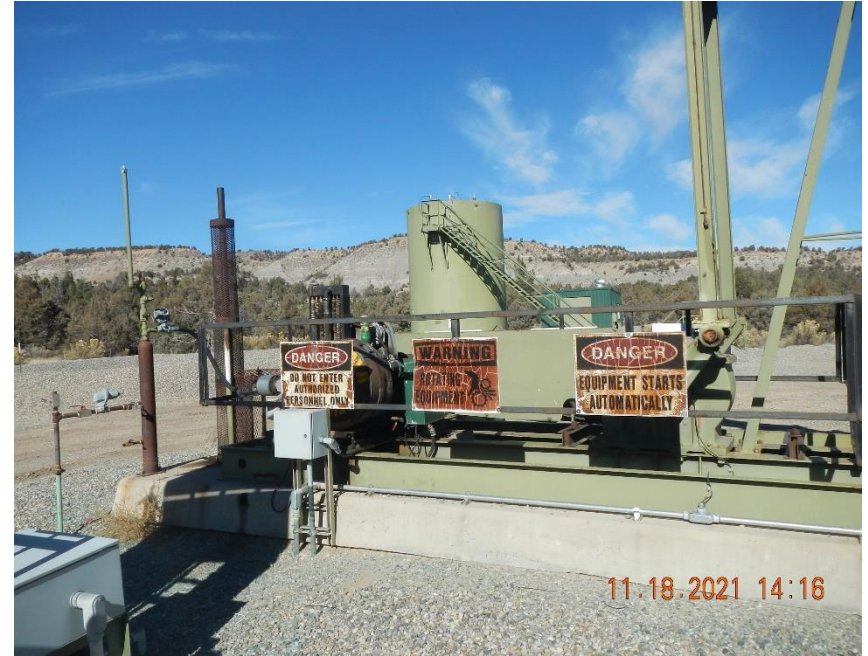
Regulator on prime mover supply gas was broken and had an audible leak.

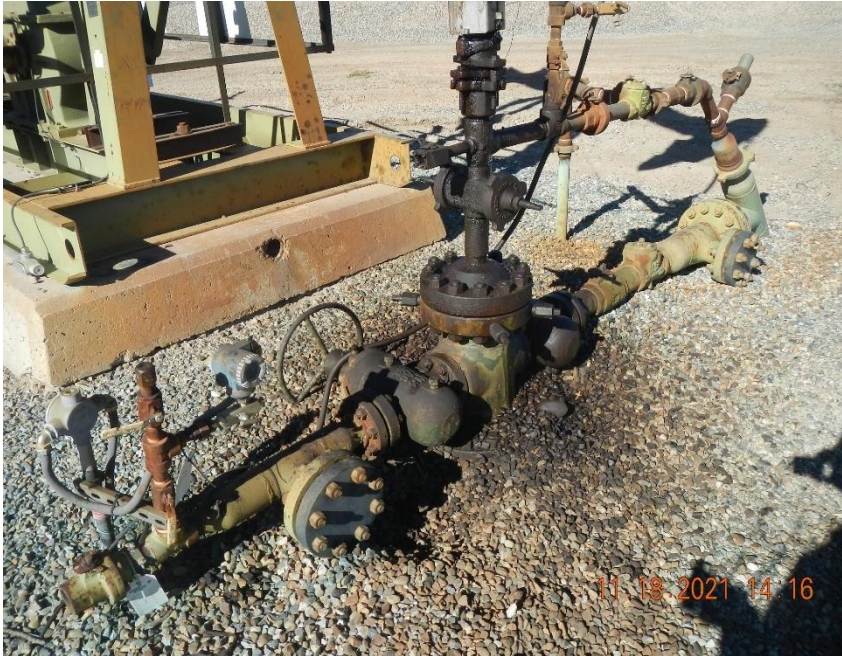
Well head and surrounding area are wet and stained.

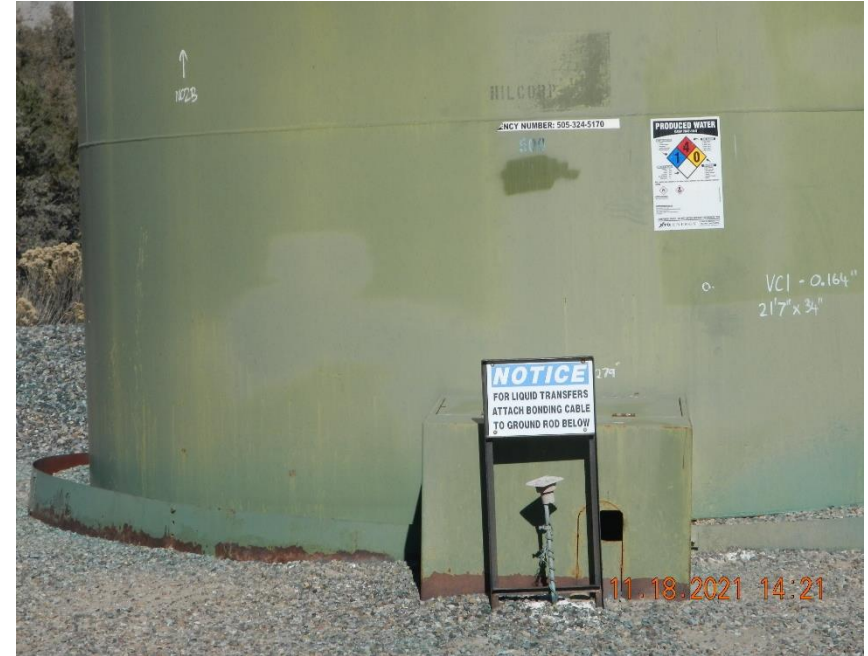
AST signage is not compliant with Rule 605.h.
