Inspection Photos
Location Name: GE 19-15
Location ID: 308844

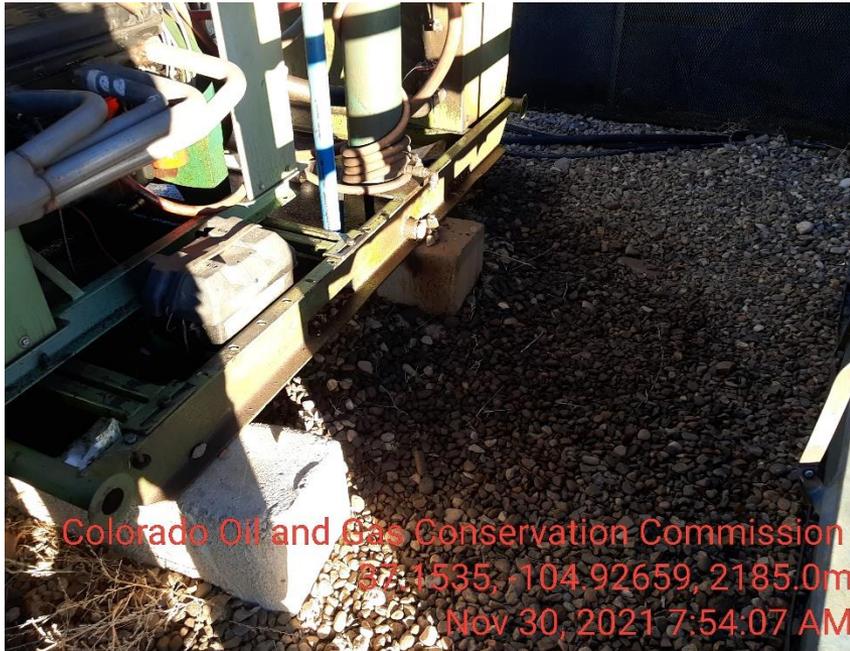
Photo 2 stained soil around HYD skid
