# Inspection Photos

Loc ID: 321098

Operator: INVESTMENT EQUIPMENT LLC

Inspection Date: 11/30/2021

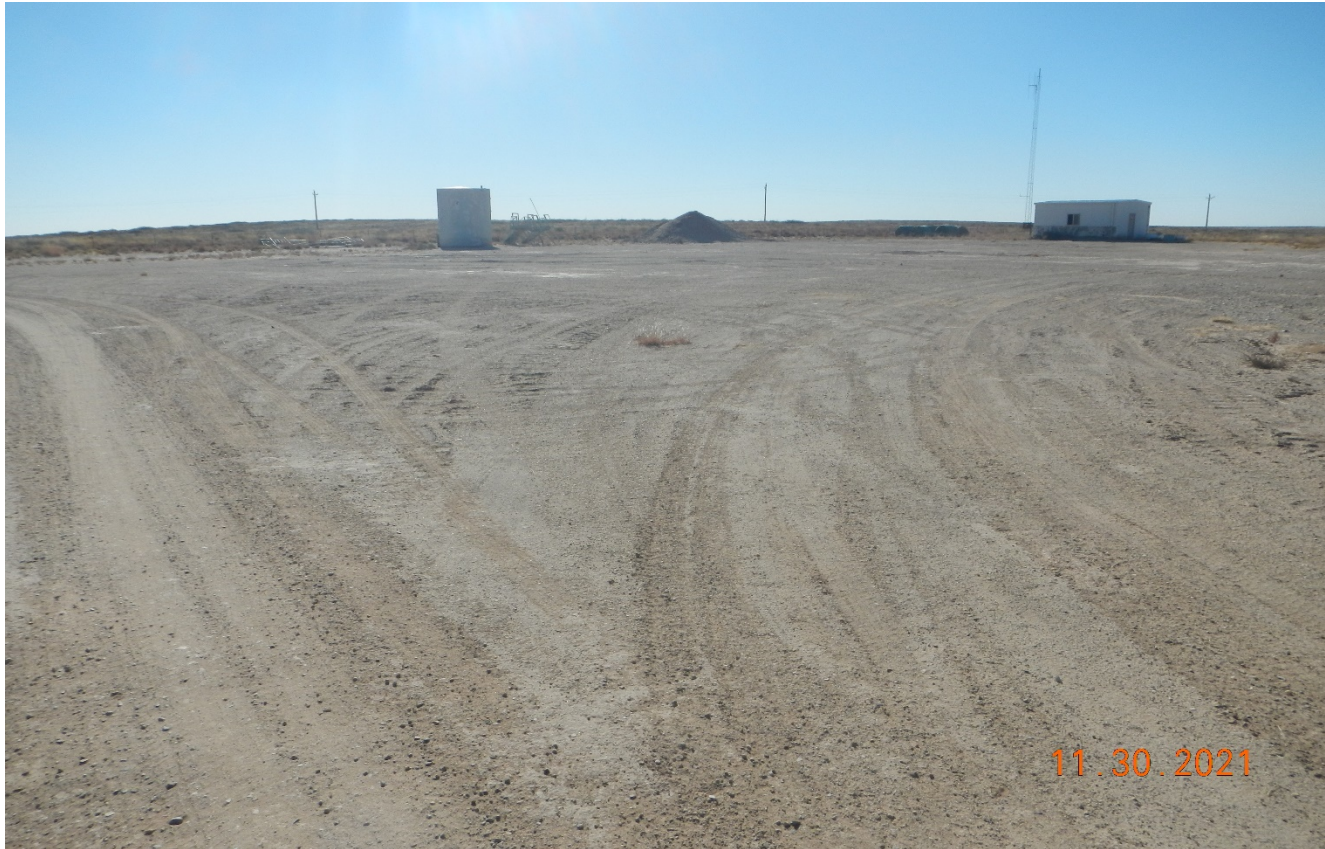
**Photo 2.** Facing southwest toward the abandoned facility and well site which is approximately 3 acres in size.

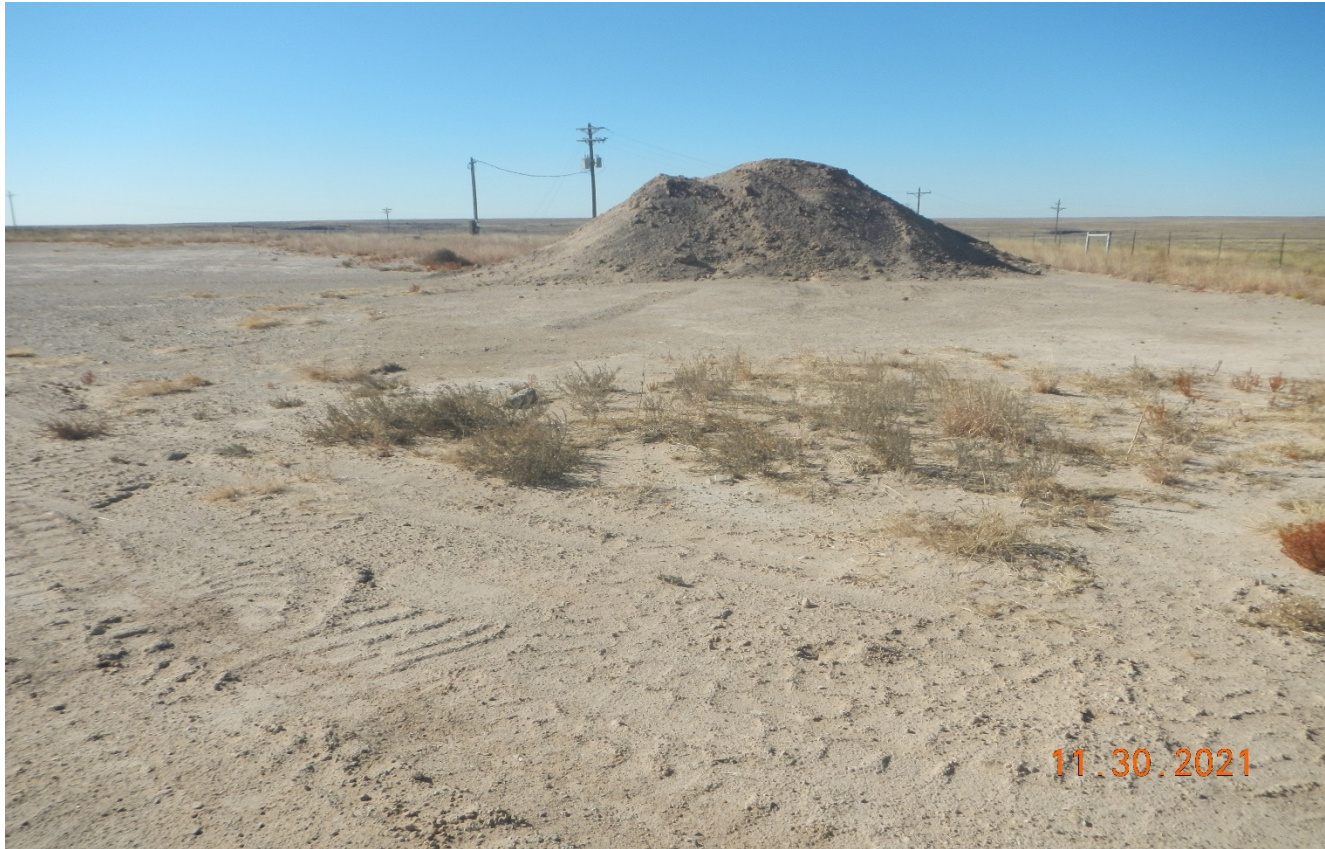
**Photo 3.** There is a soil material pile that remains at the north side of the location.

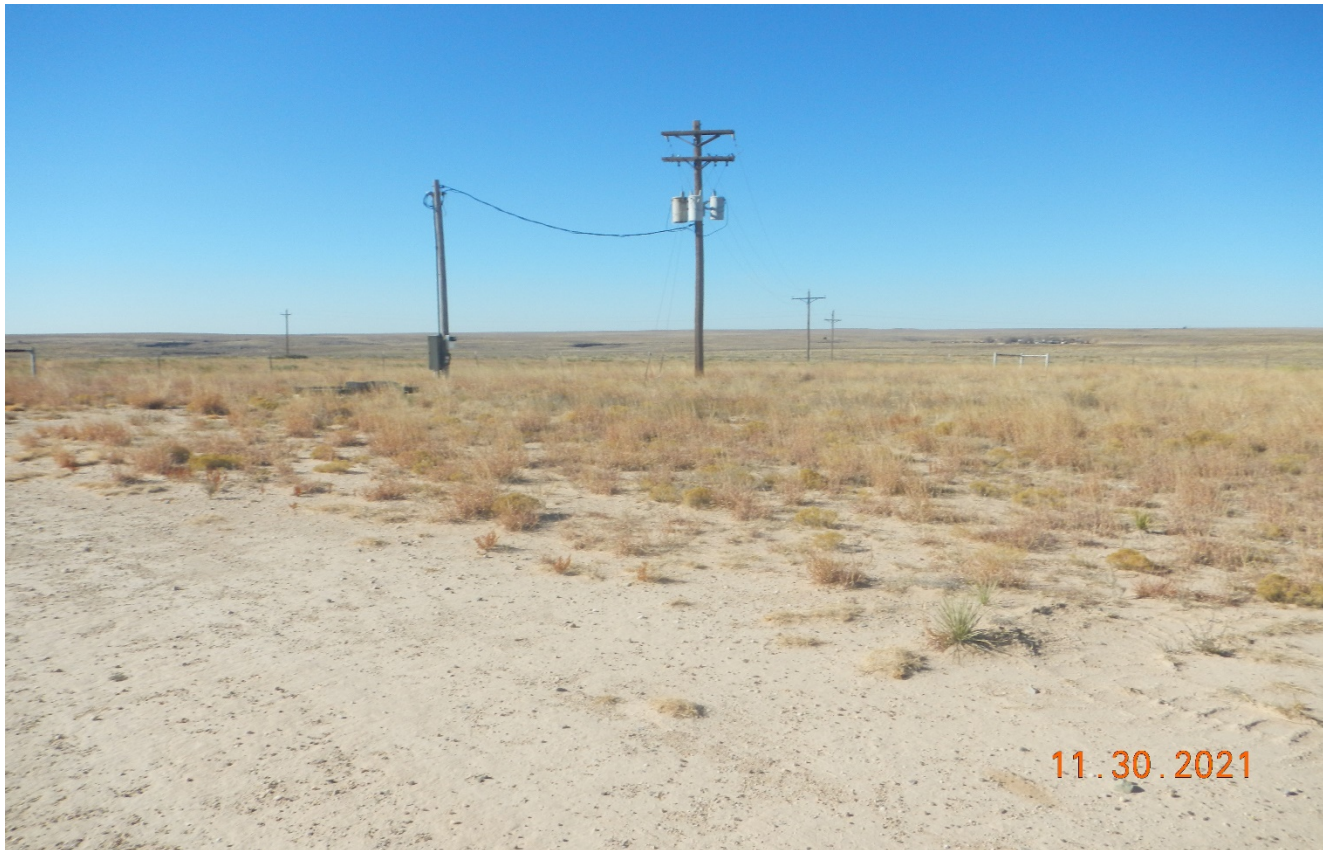
**Photo 4.** The electric powerline utilities remain at the location.

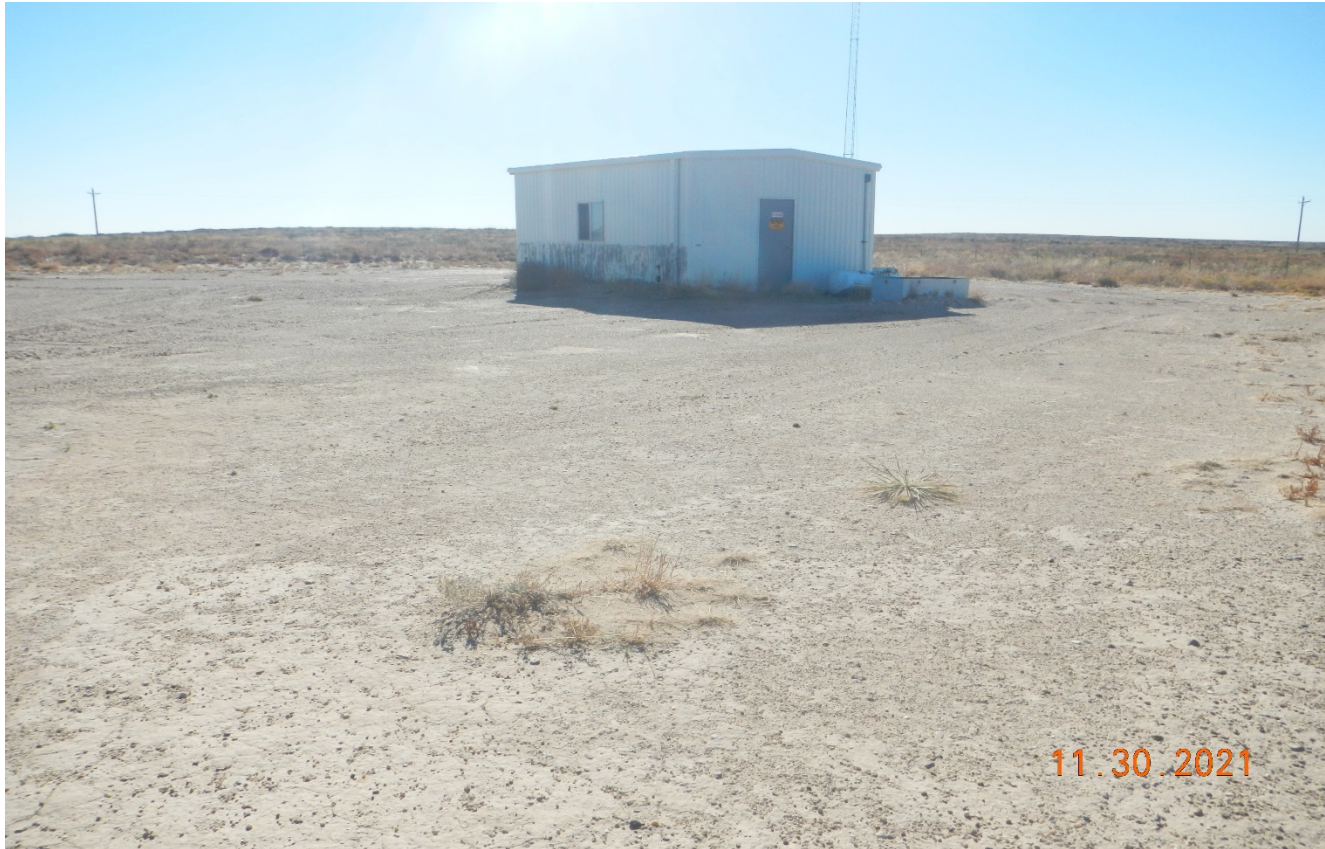
**Photo 5.** There is a metal shed that remains at the west side of the location.

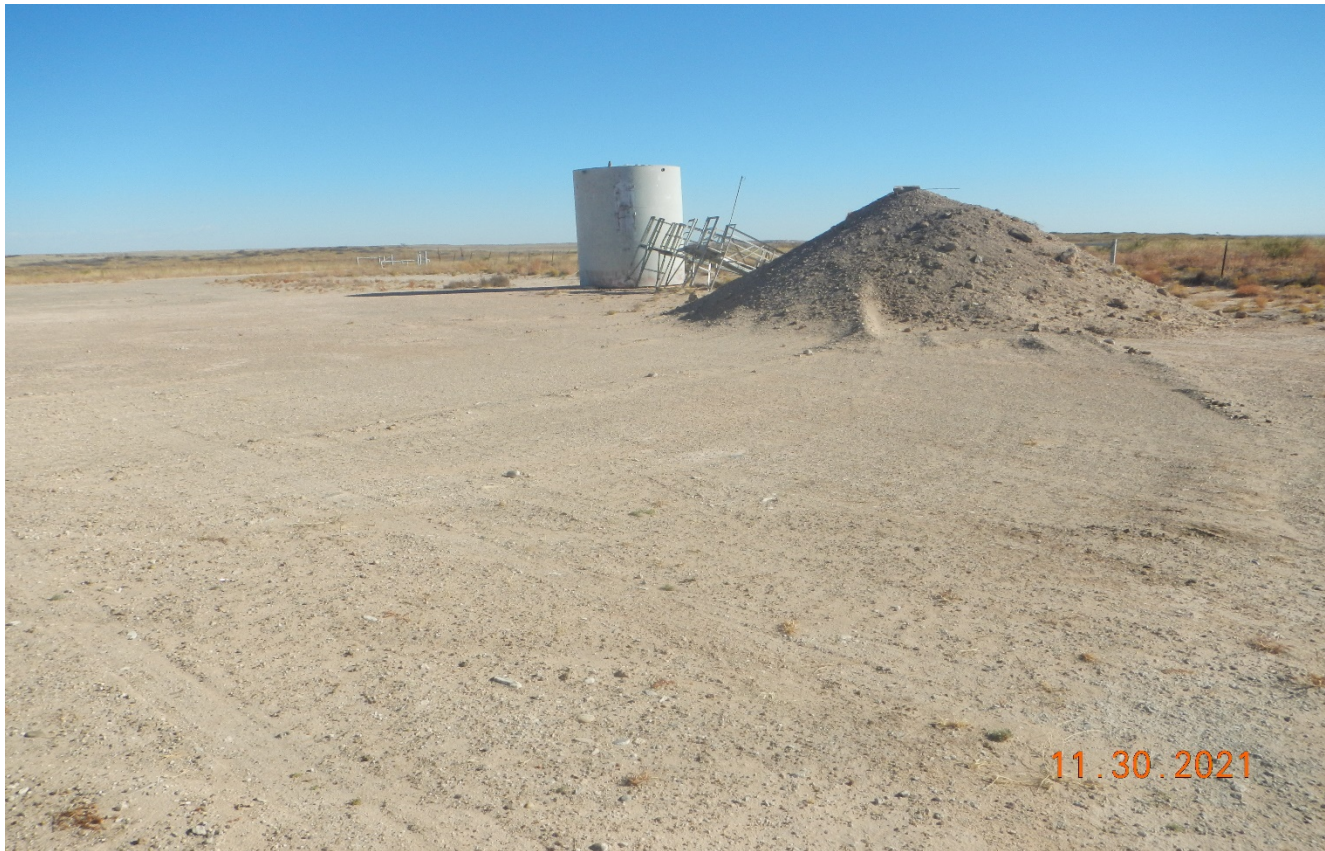
**Photo 6.** Another soil material pile that remains at the south side of the location. There is a steel tank that remains.

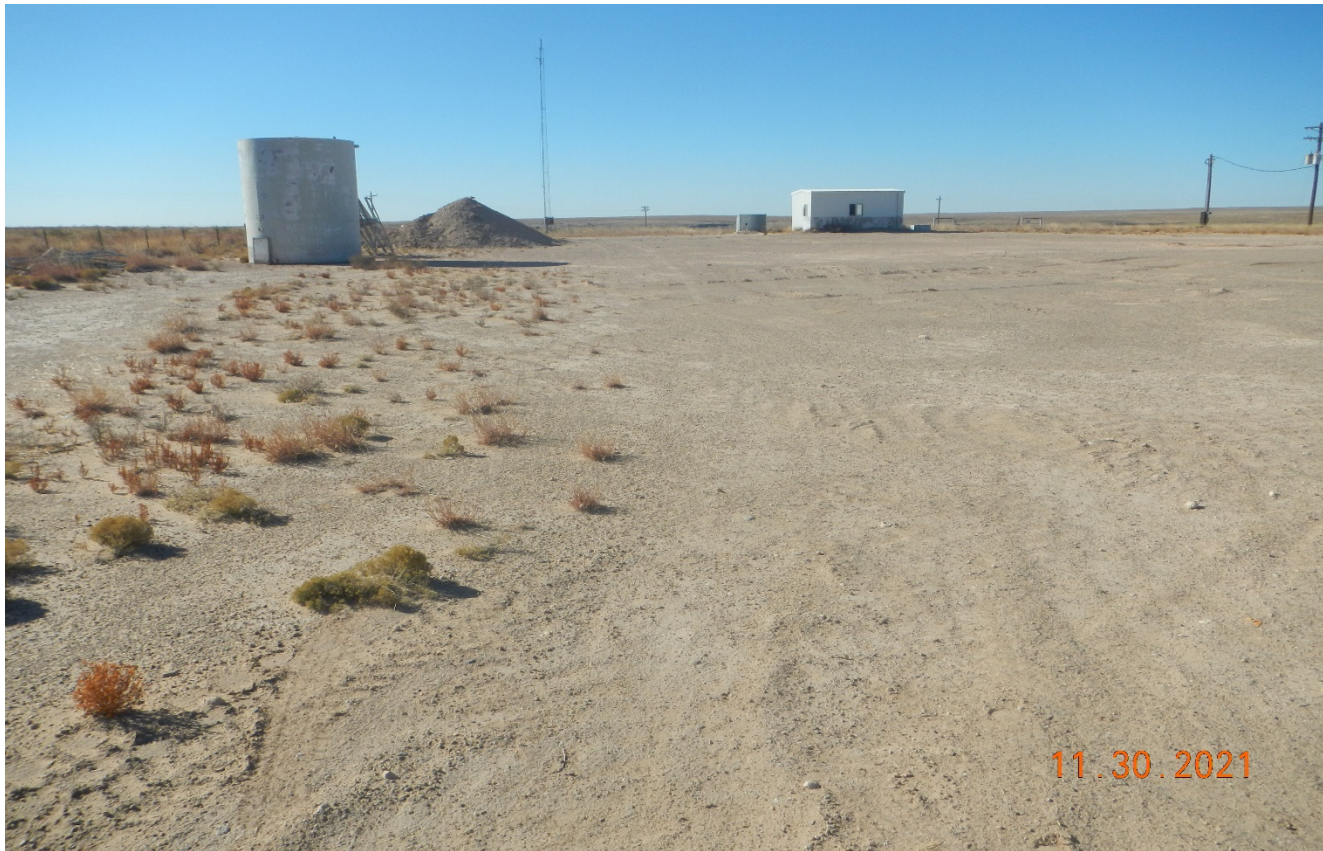
**Photo 7.** East side of the location facing southwest.
