Inspection Photos
Location Name: Montoya 10-2
Location ID: 326289

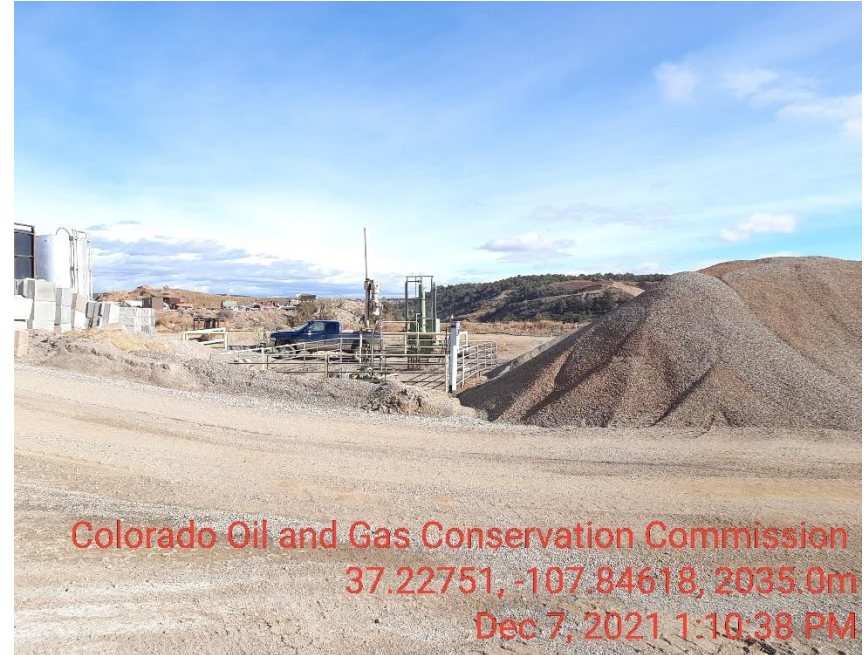
Photo 2 WH. Gravel piles blocking access to well head.

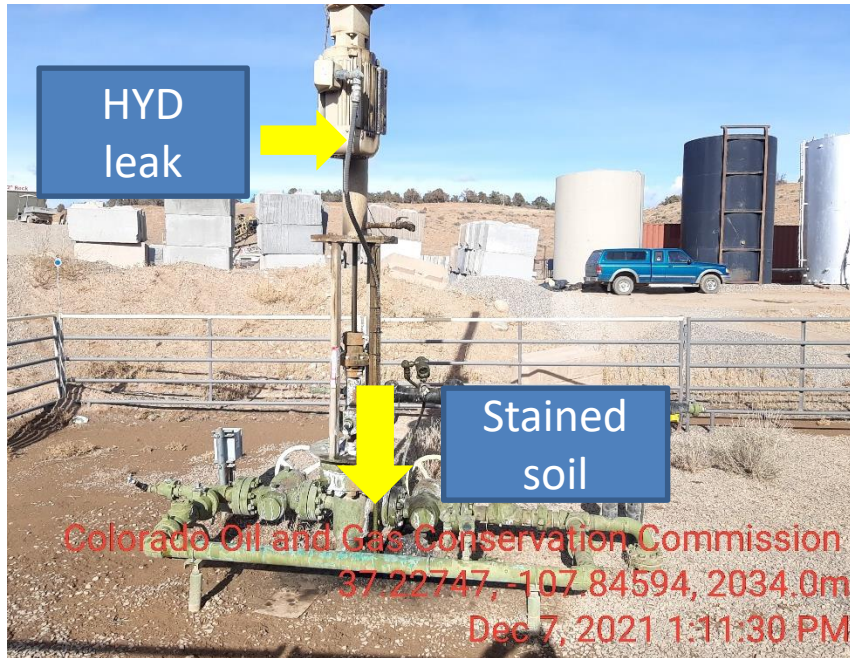
Photo 3 Mechanical issue and stained soil

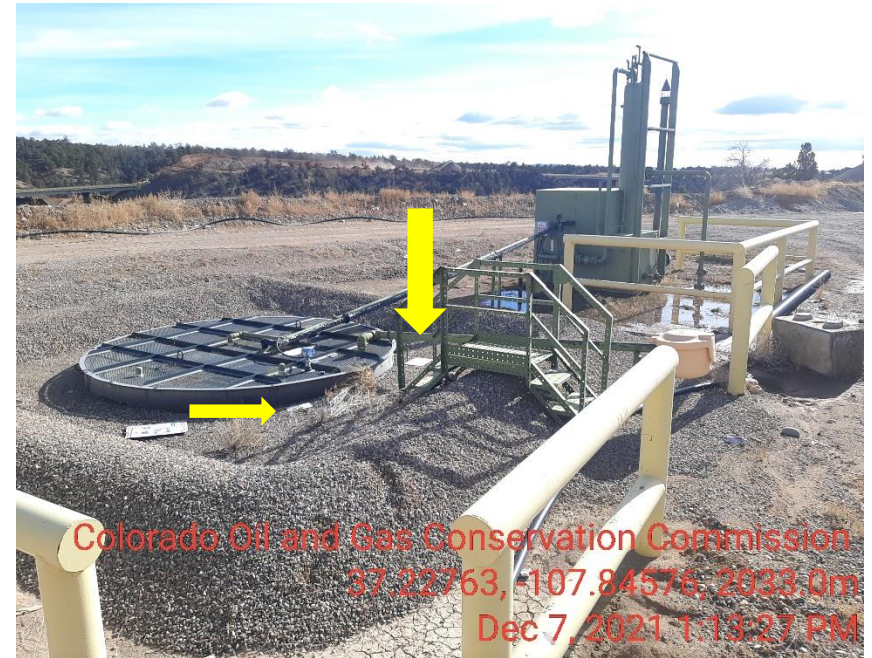
Photo 4 all signs have come off tank and are laying on ground.

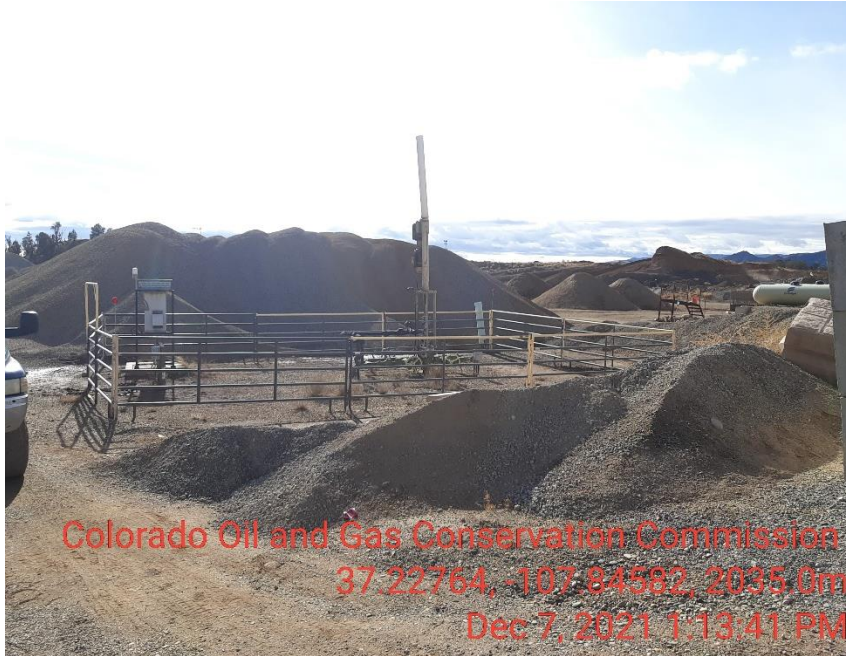
Photo 5 Access blocked to well head

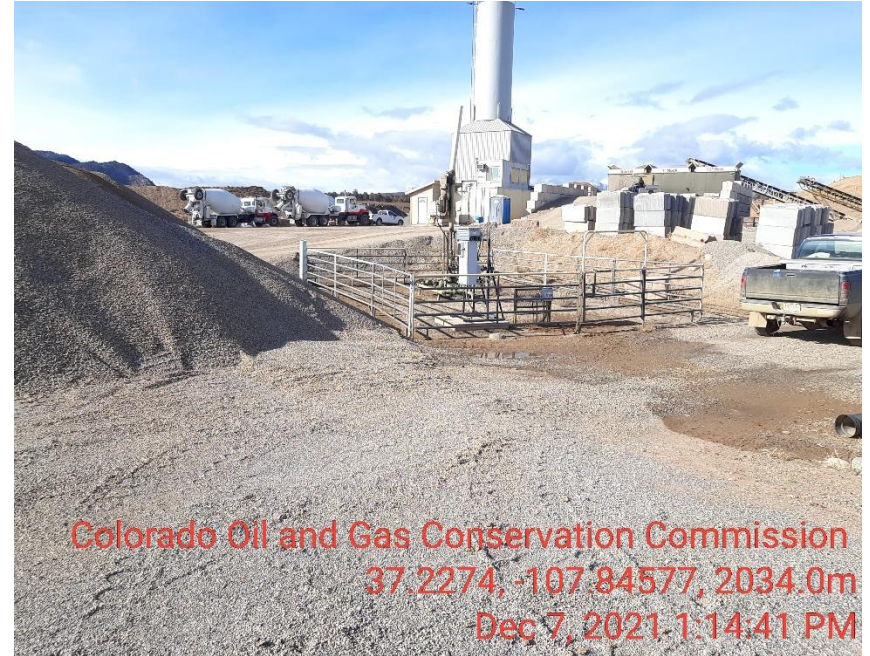
Photo 6 Only open side to well head.

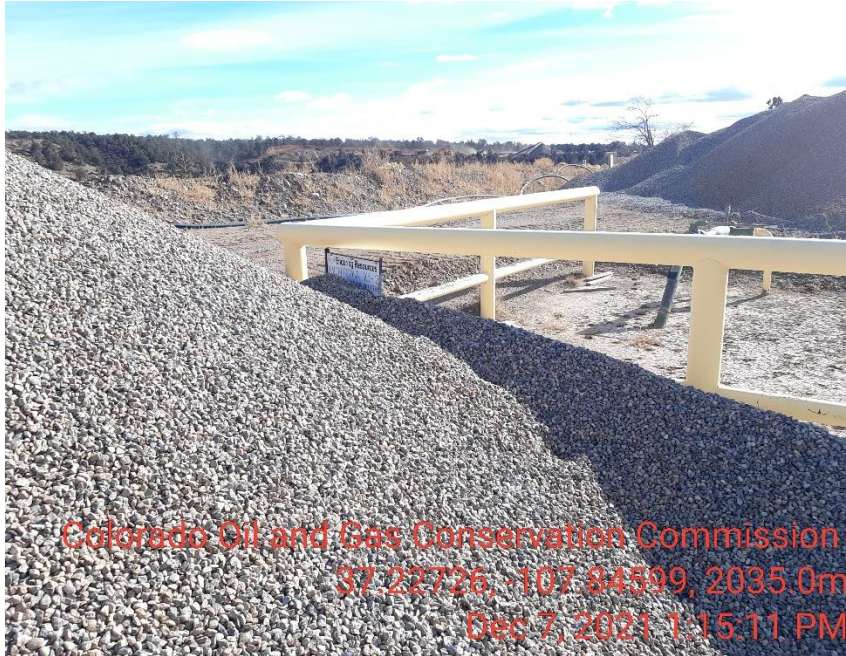
Photo 7 Well sign buried by gravel pile.
