Inspection Photos

Location Name: CAERUS PICEANCE LLC G. JONES-67S96W /35SESE

Location ID: 334355

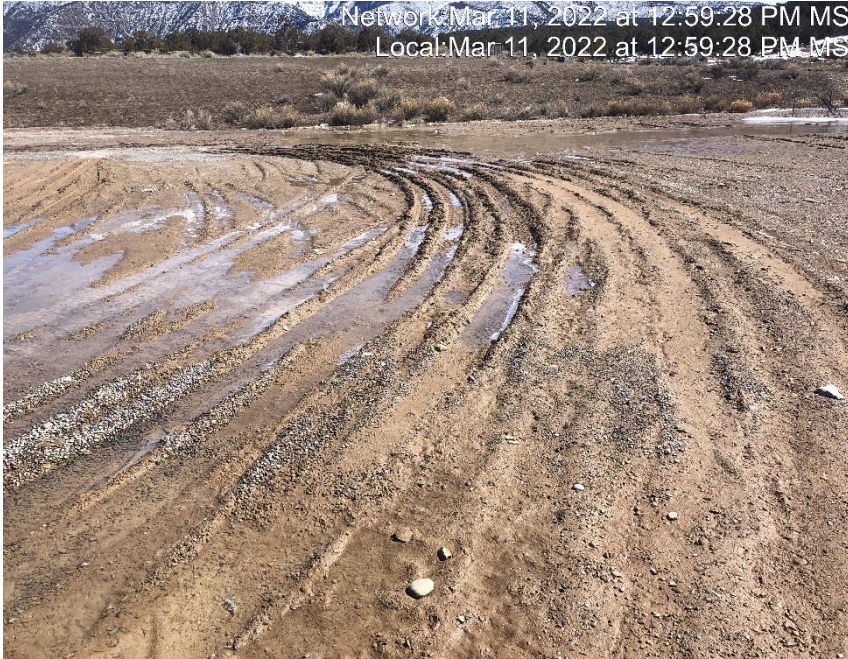
Photo #6153 Location lacks stabilization.

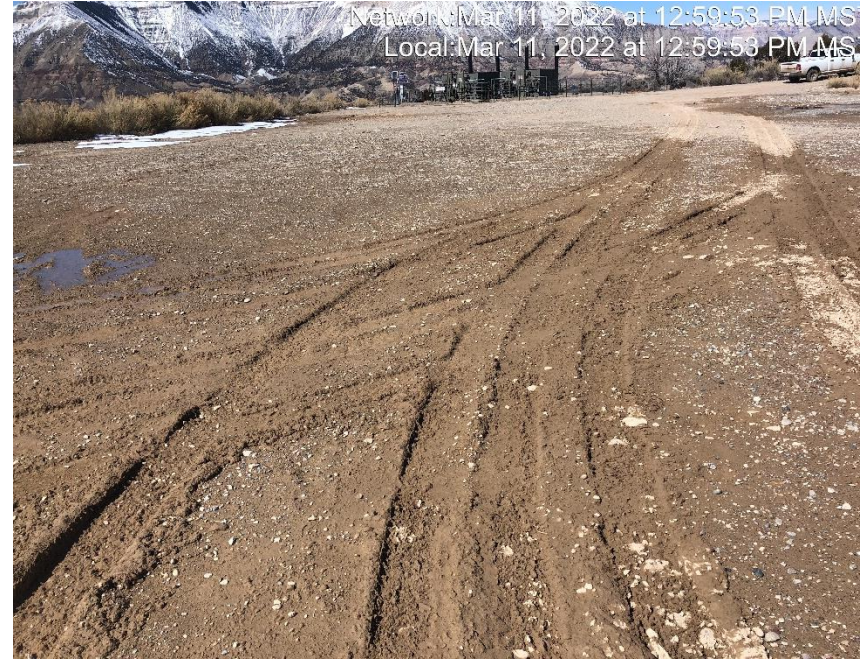
Photo #6154 Location lacks stabilization.

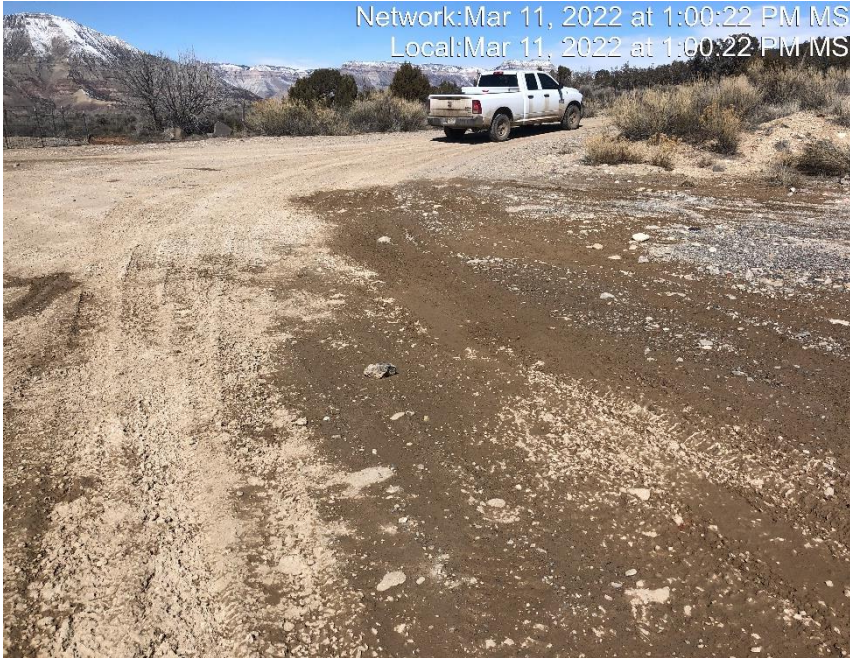
Photo #6155 Insufficient tracking controls at entrance to location.
