Inspection Photos
Location Name: UPRR 43 Pan AM I #3
Location ID: 318134

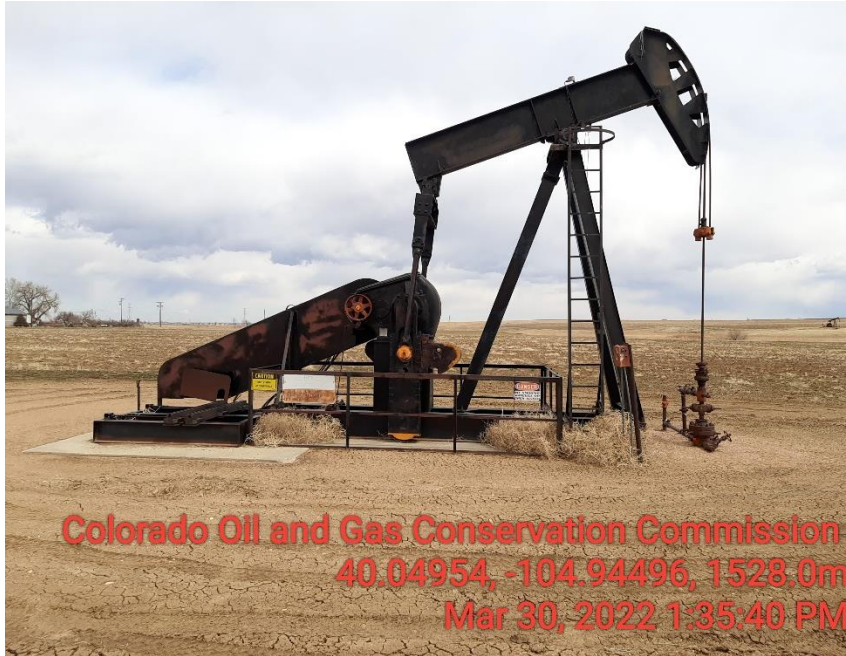
Photo 1 WH sign faded not legible

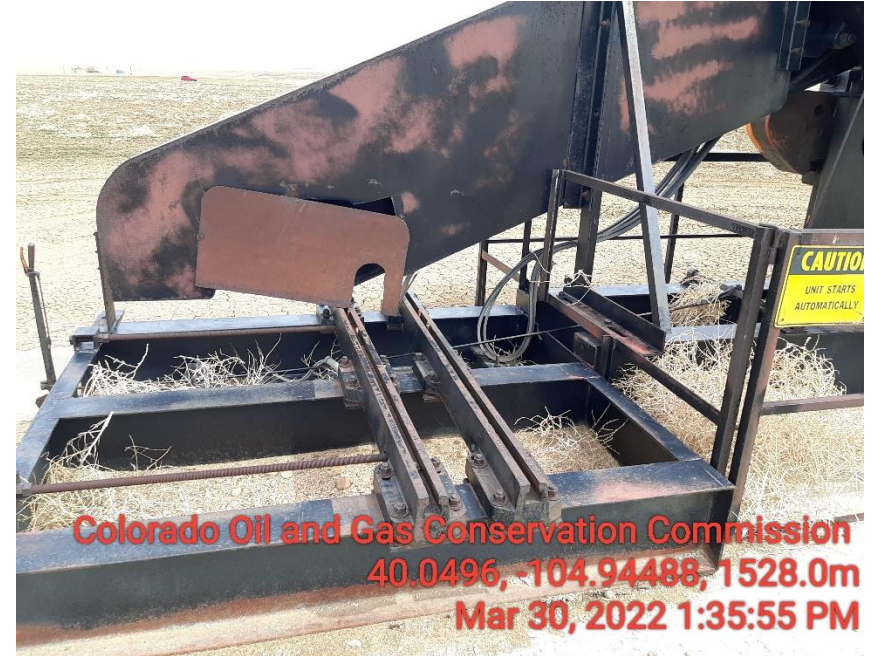
Photo 2 mechanical issue not motor.
