Inspection Photos

API: 055-06101

Operator: MANZANO LLC

Inspection Date: 4/6/2022

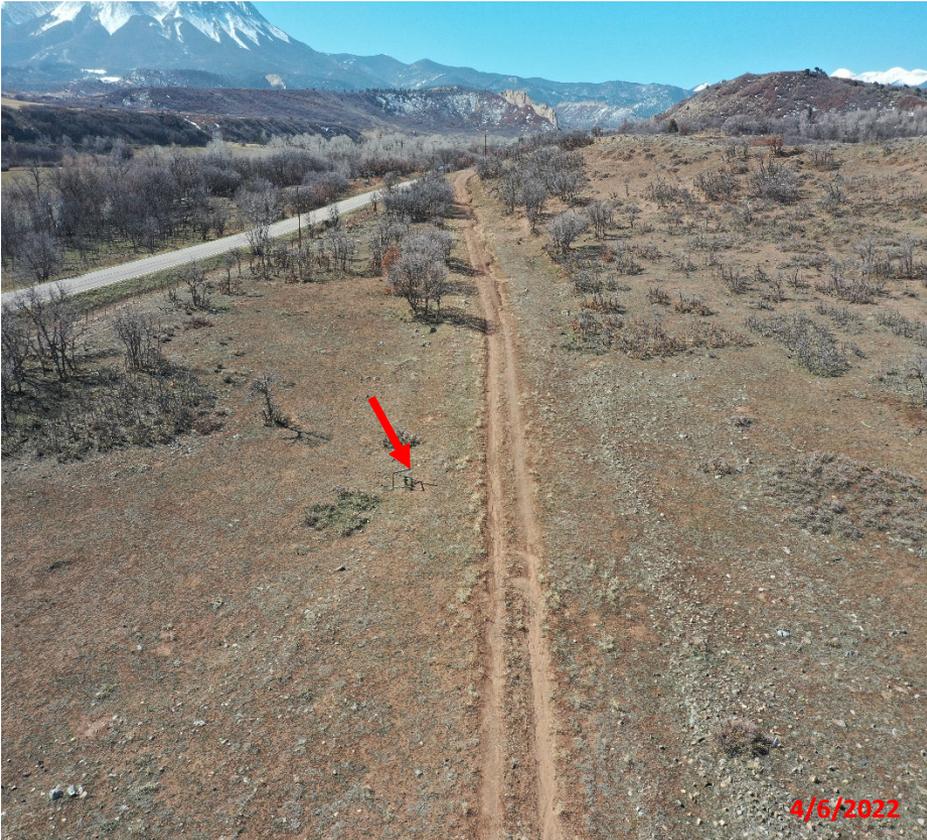
Photo 1. Drone aerial photo facing southwest along the access road. A pipe riser remains at the red arrow. The access road has not been reclaimed and the location is shown at the yellow arrow.

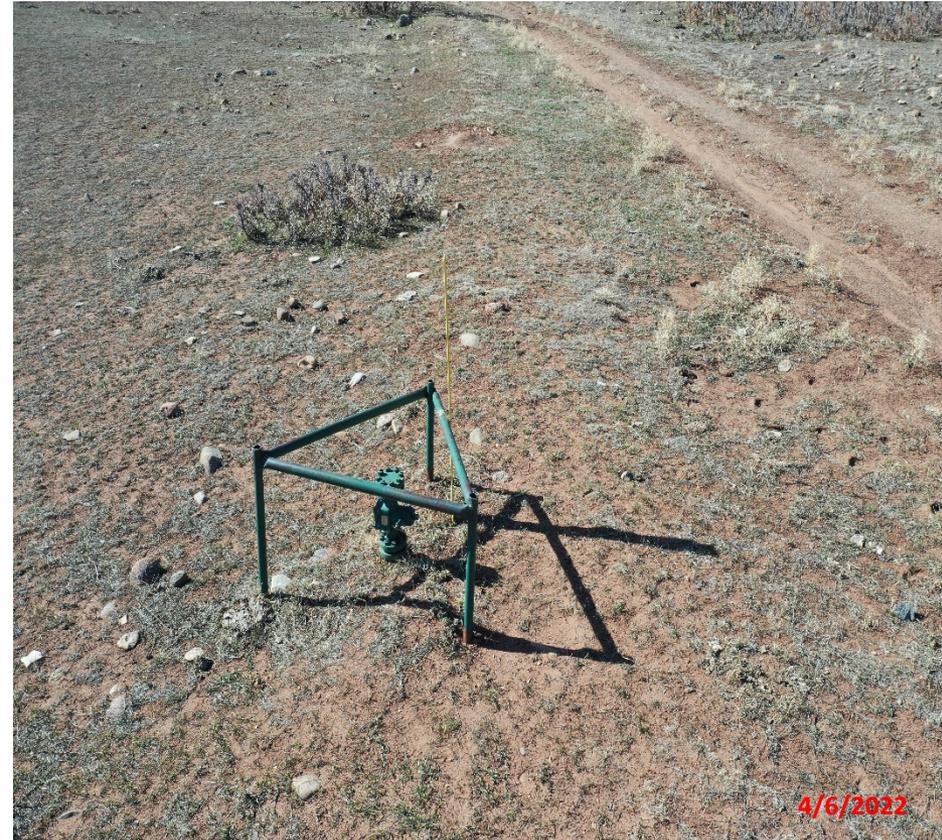
Photo 2. Close up view of the pipeline riser found along the access road. Pipeline riser has not been abandoned per 1100 Rules.

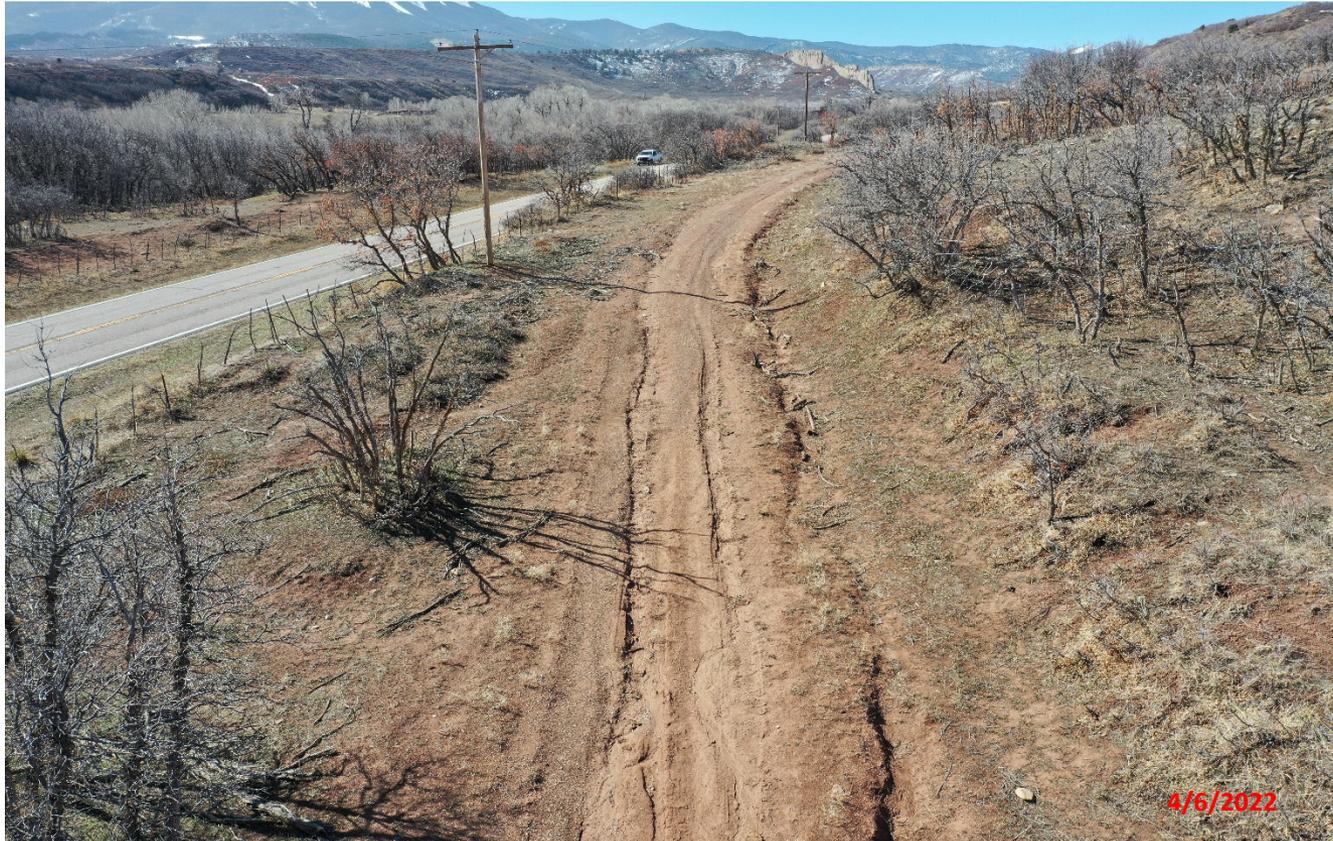
Photo 3. Drone aerial photo facing southwest along the access road. There is erosion occurring along the road which has not been repaired and stabilized.

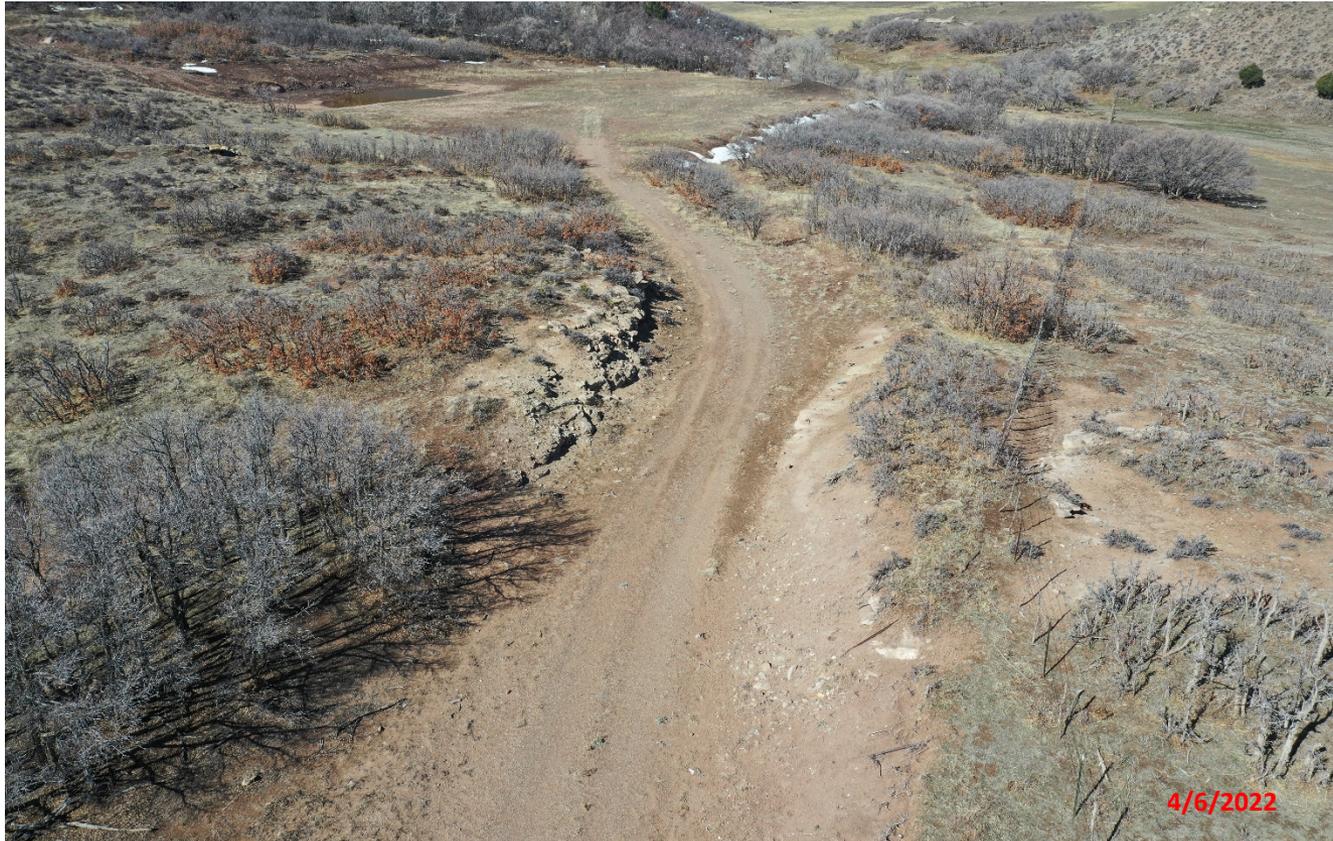
Photo 4. Drone aerial photo facing northwest along the access road. The access road has not been recontored and reclaimed.

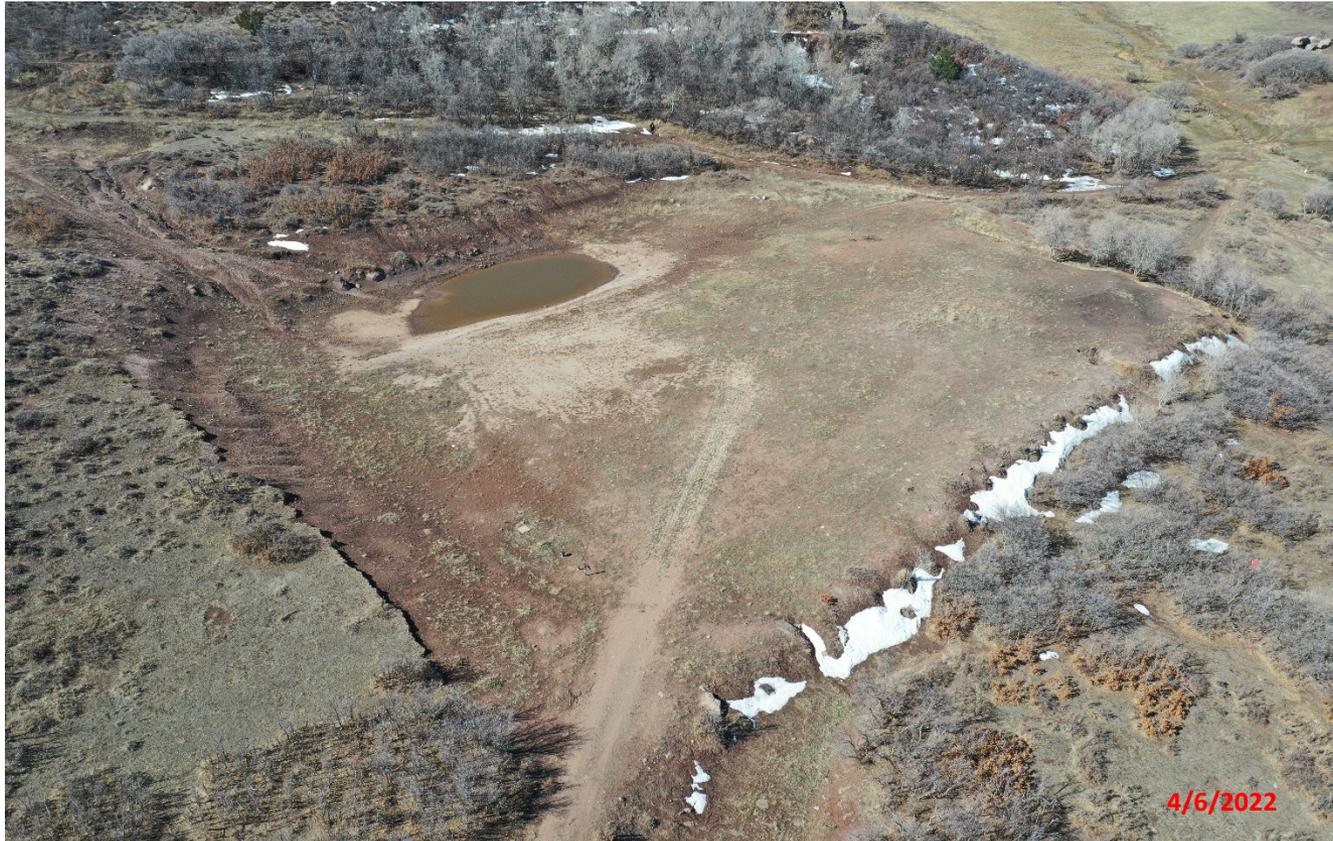
Photo 5. Drone aerial photo facing northwest shows the location has not been recontoured and reclaimed. The location disturbance is approximately 3.3 acres.

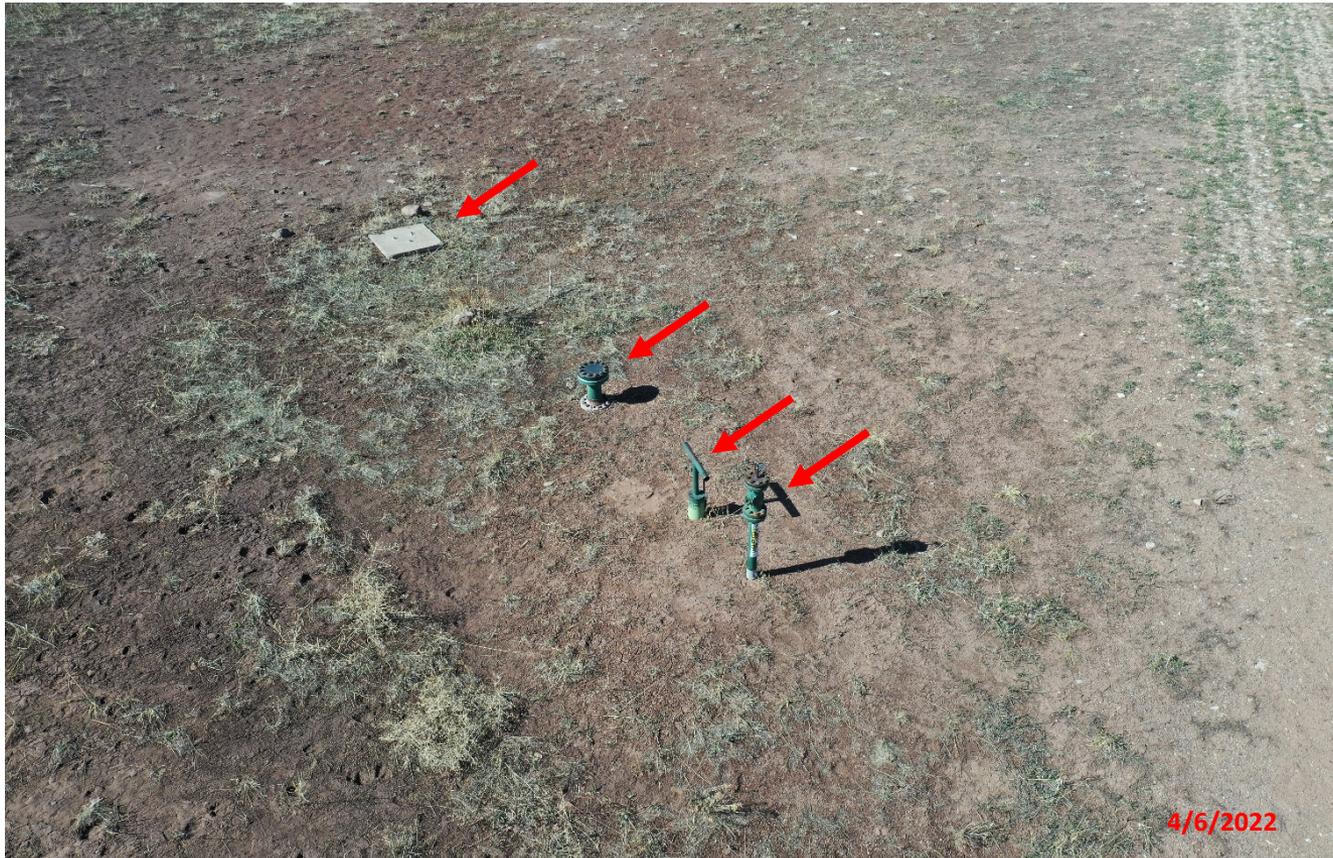
Photo 6. The pipeline risers still remain at the location shown at red arrows. Pipeline riser should have been abandoned per 1100 Rules.

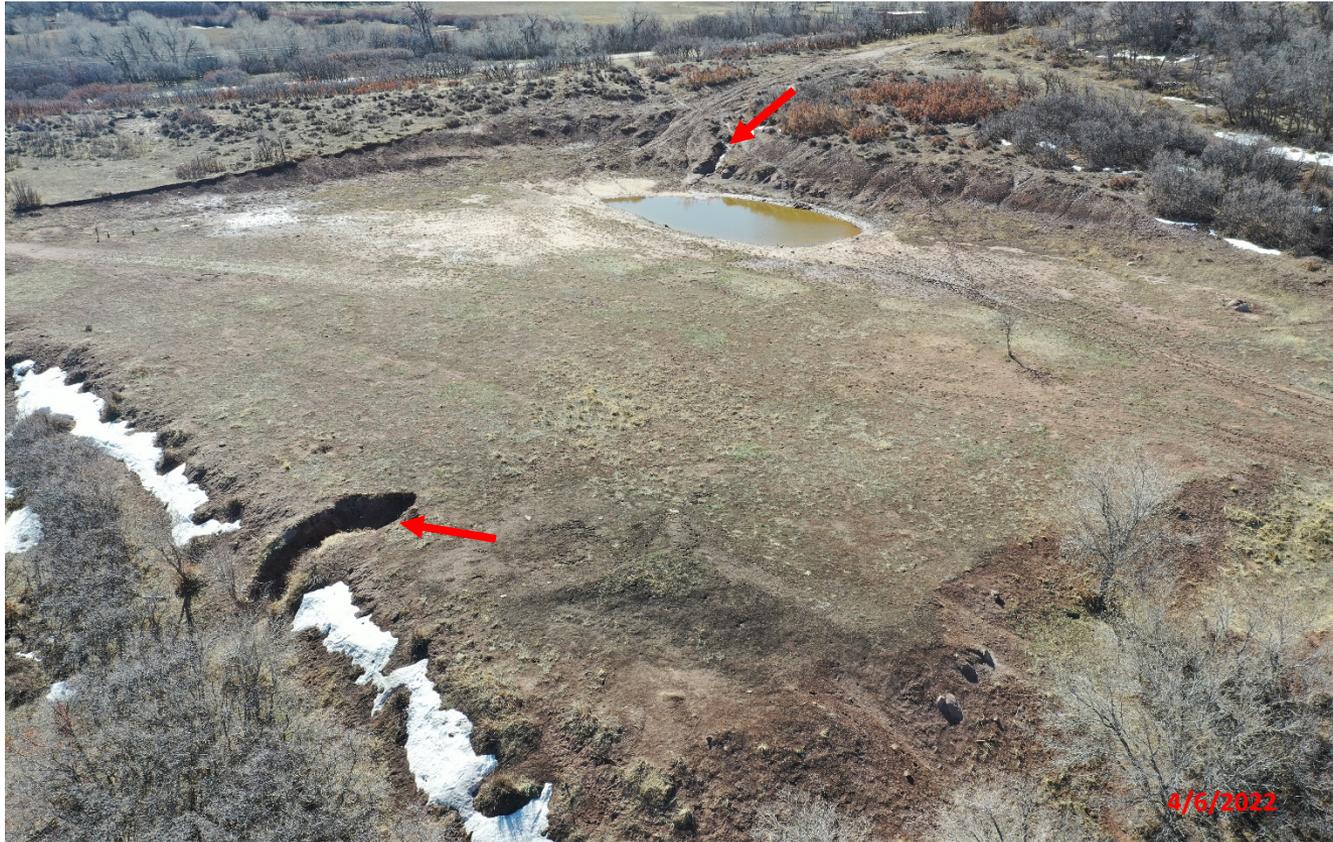
Photo 7. Facing southwest overlooking the location. There are multiple areas of significant gully erosion along the cut and fill slopes shown at red arrows.

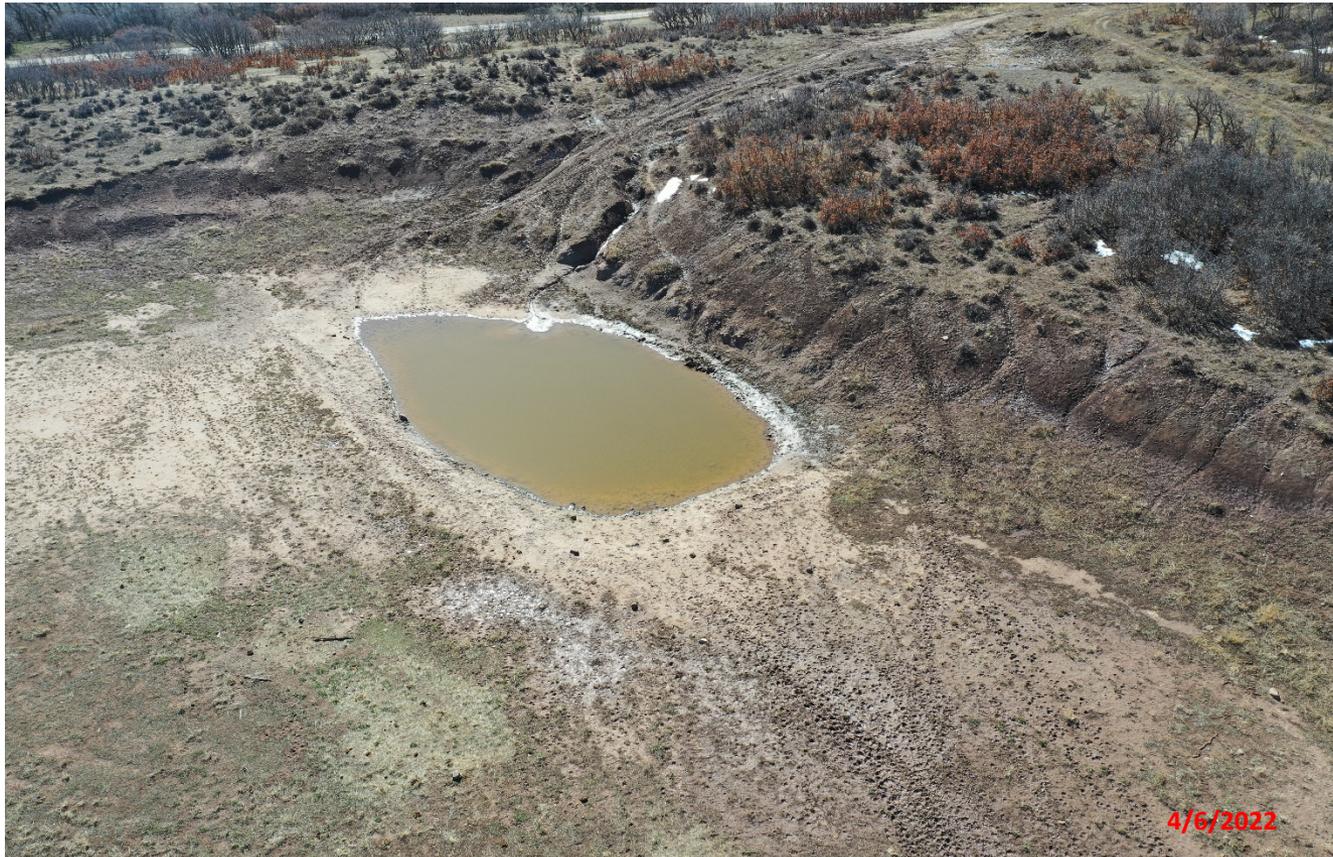
Photo 8. The pit was never backfilled and reclaimed.

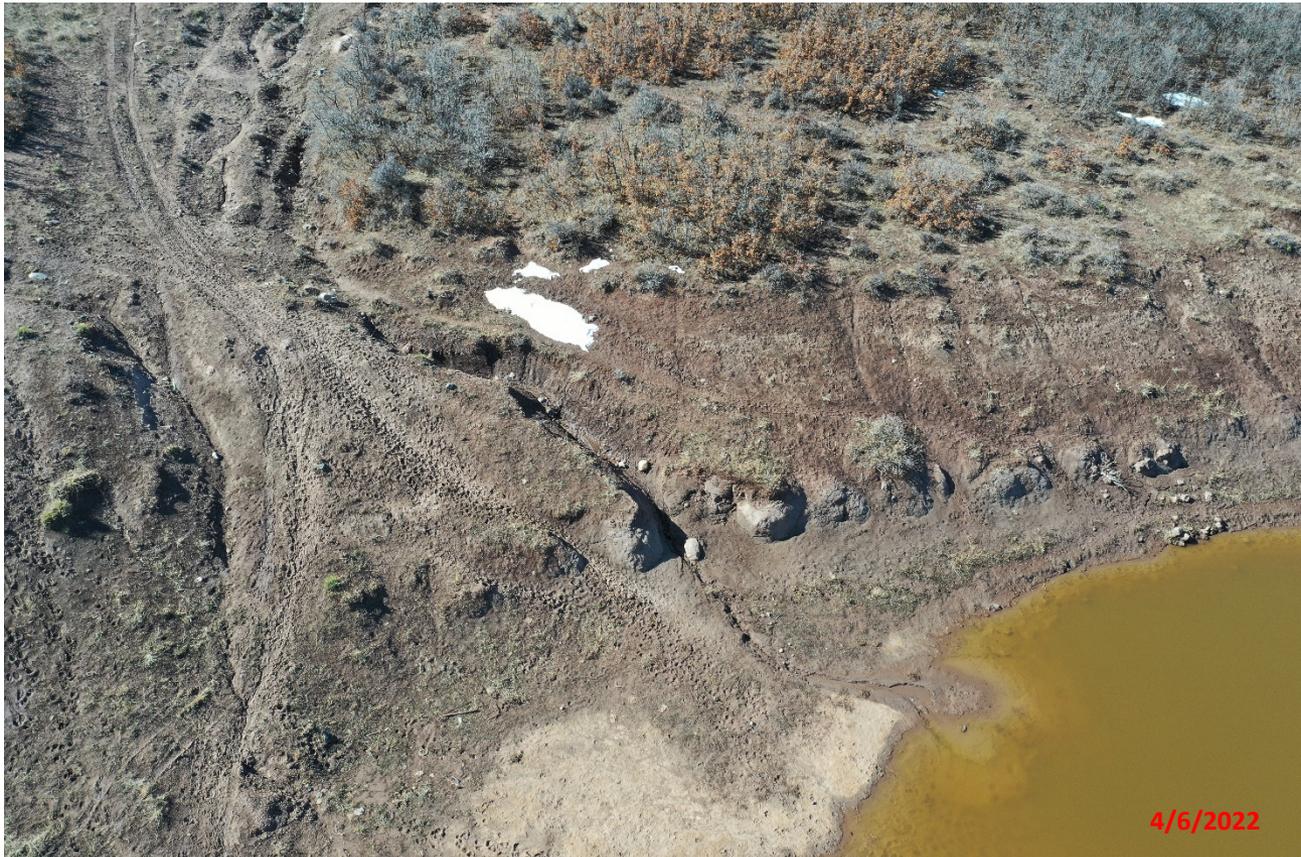
Photo 9. This photo shows the significant erosion along the cut slope.

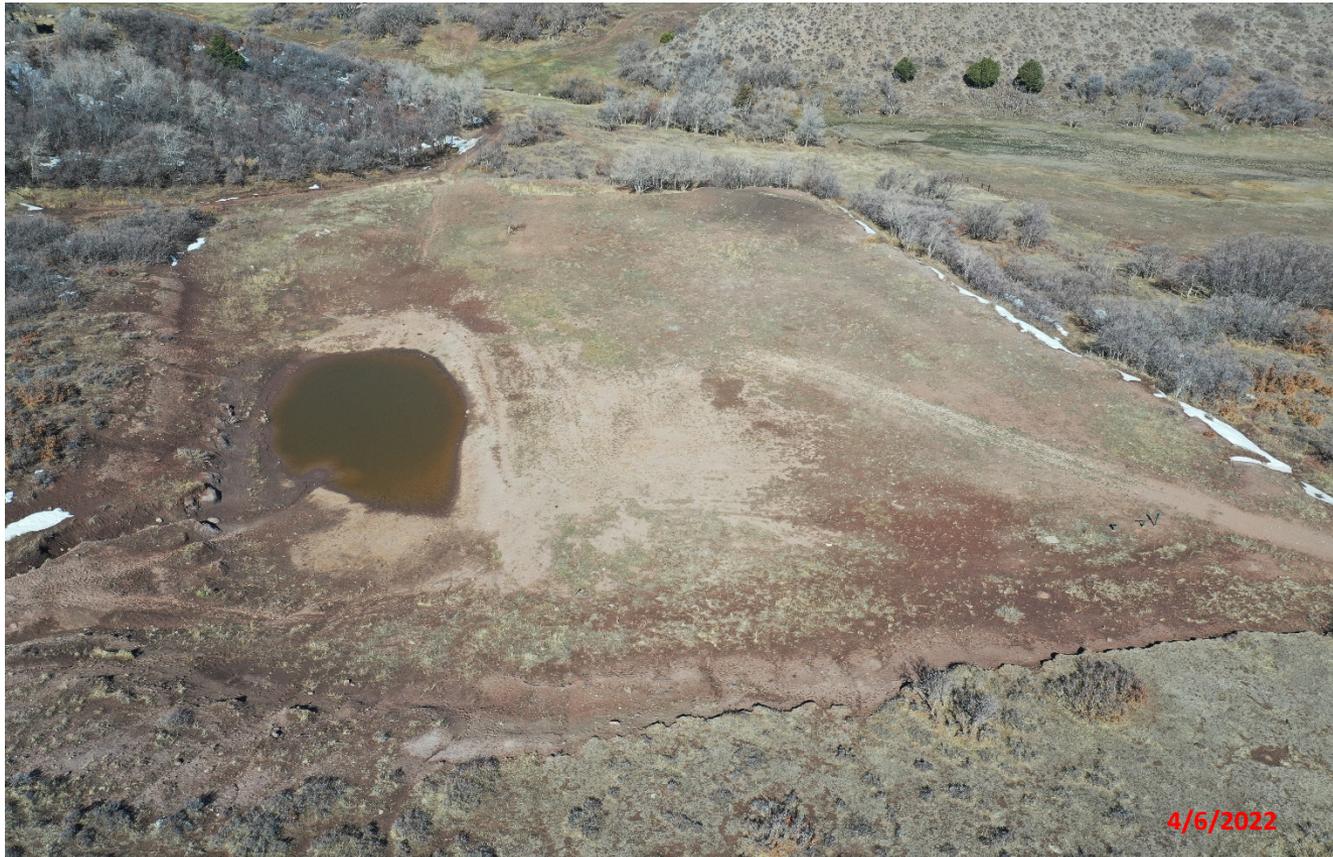
Photo 10. Facing southeast toward the location. The location disturbance is approximately 3.3 acres.
