Site Inspection Report

Site: COSSLETT #3
04/20/2022

SITE/LOCATION	DATE	TIME	INSPECTOR
COSSLETT #3	04/20/2022	02:55 PM	COGCC Contractor
Comments	No changes since last site inspection		
Work Activity Notes	None		
Changes since previous inspection?	No	Drive by inspection	No
Actively being worked?	No		
Fieldwork Oversight Performed?	No	Oversite Type	N/A
Were Oversight Samples Collected?	No	Sample Details	N/A

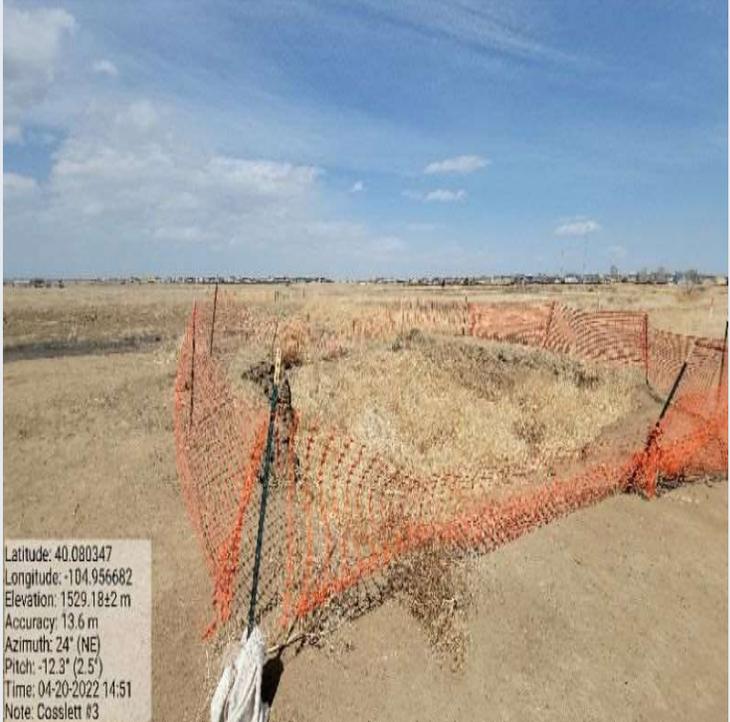
Photo
<p>Question: Open excavation? Approximate size (Length x Width x Depth, ft)</p> <p>Response: Yes 37x38x5</p> <p>Notes:</p>

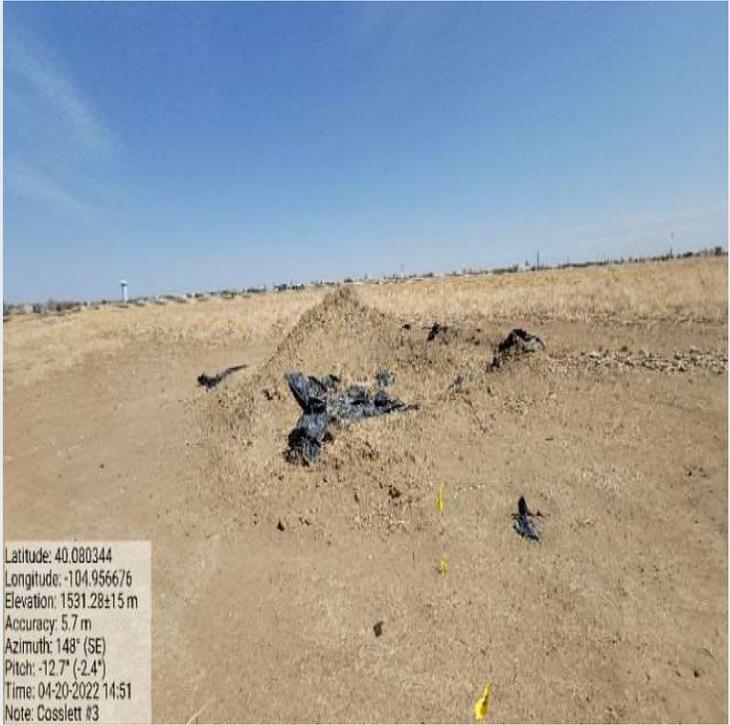
Photo
<p>Question: Stockpiled waste and approximate volume (cubic yards) Response: Yes 33 Cu. Yds. Notes: No stormwater BMPs in place.</p>

Notes: Install stormwater erosion control measures and BMPs immediately. Remove weeds and trash throughout site.

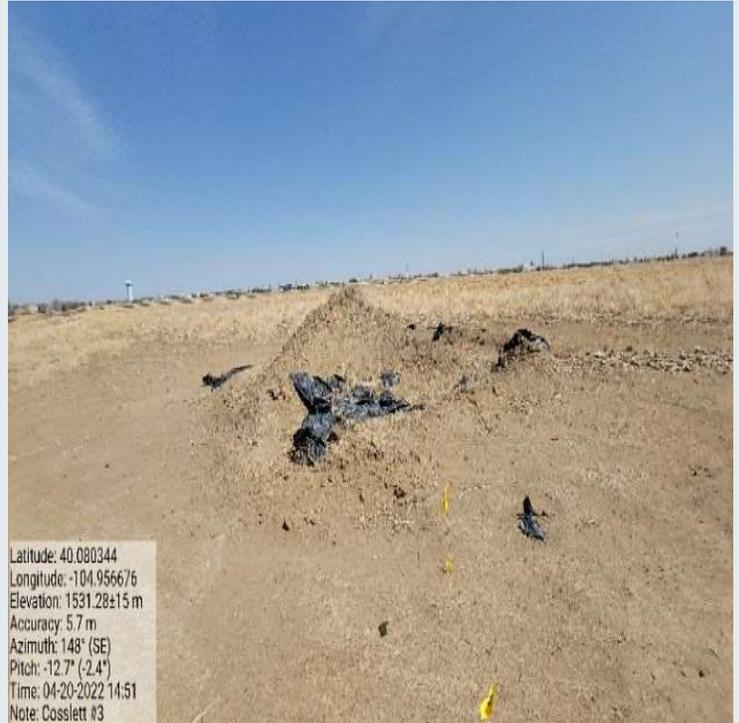
Question: Waste signage present, legible is accurate and up to date (in accordance with rule 913.b.(5)B.iv)?

Response: No

Notes: Soil stockpile has no waste signage.

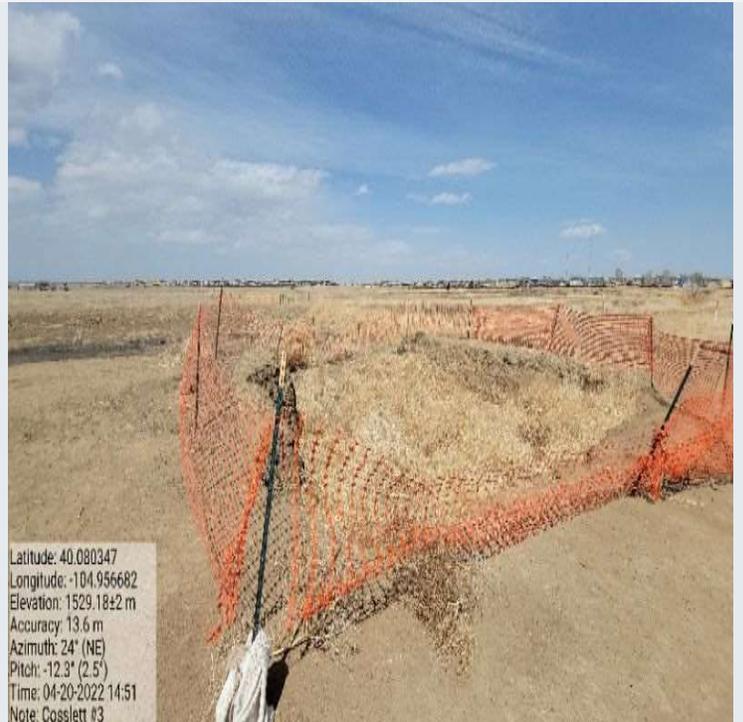
Question: Site properly fenced (in accordance with rule 913.b.(5)B.i)?

Response: No.

Notes: Orange construction fence installed inadequately.

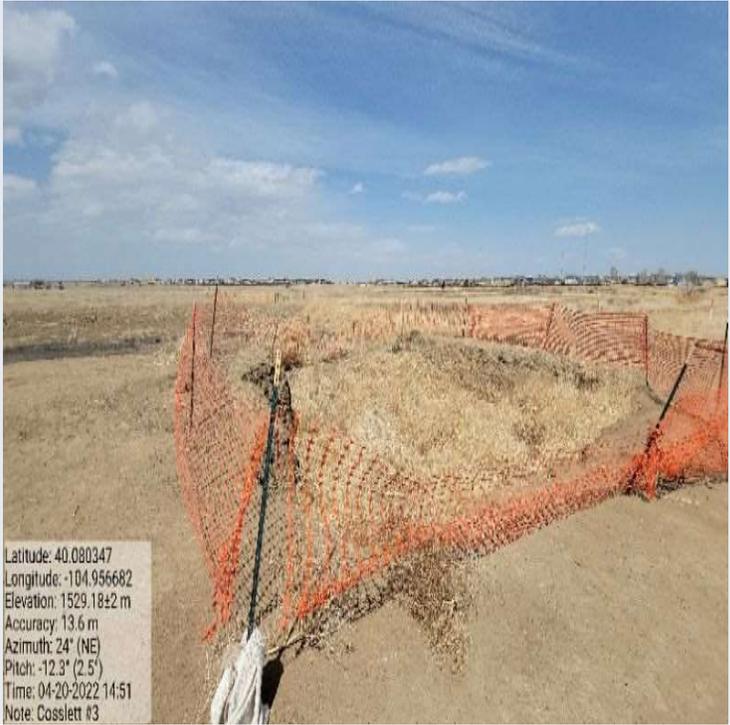
Photo
<p>Question: Is fencing adequate/appropriate for site and well maintained? Response: No. Notes: Orange construction fence installed inadequately.</p>

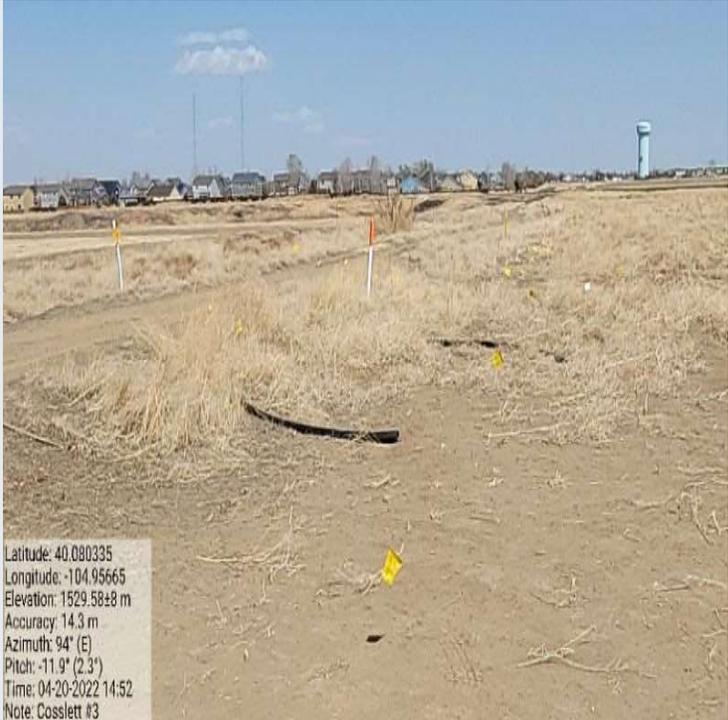
Photo
<p>Question: All stormwater erosion control measures and BMPs are present and in good/working condition? Response: N/A Notes: Trackout control has been installed, no other BMPs in place.</p>	<p>No Photo</p>
<p>Question: Site is free of debris/trash? Response: No. Notes: Trash throughout site.</p>

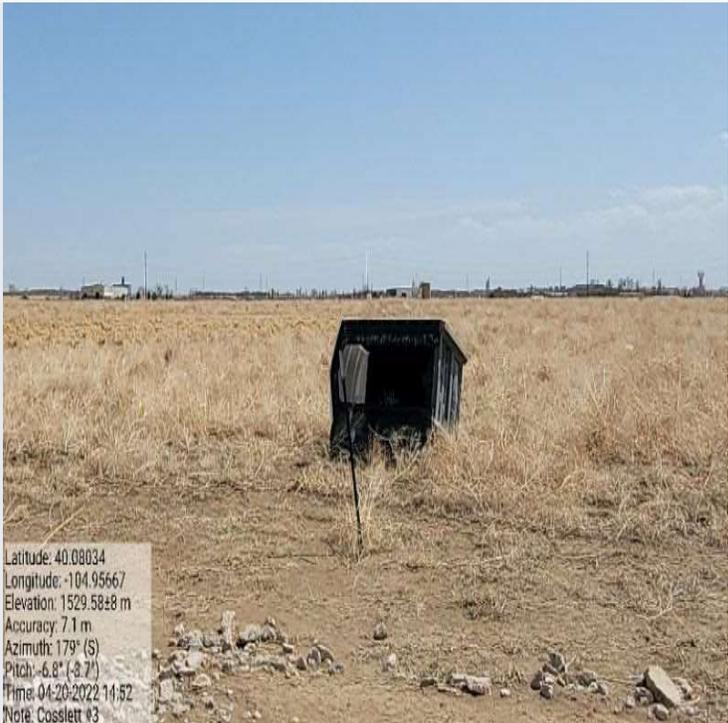
<p>Latitude: 40.080335 Longitude: -104.95665 Elevation: 1529.58±8 m Accuracy: 14.3 m Azimuth: 94° (E) Pitch: -11.9° (2.3°) Time: 04-20-2022 14:52 Note: Cosslett #3</p>
<p>Question: Site is free of debris/trash? Response: No. Notes:</p>

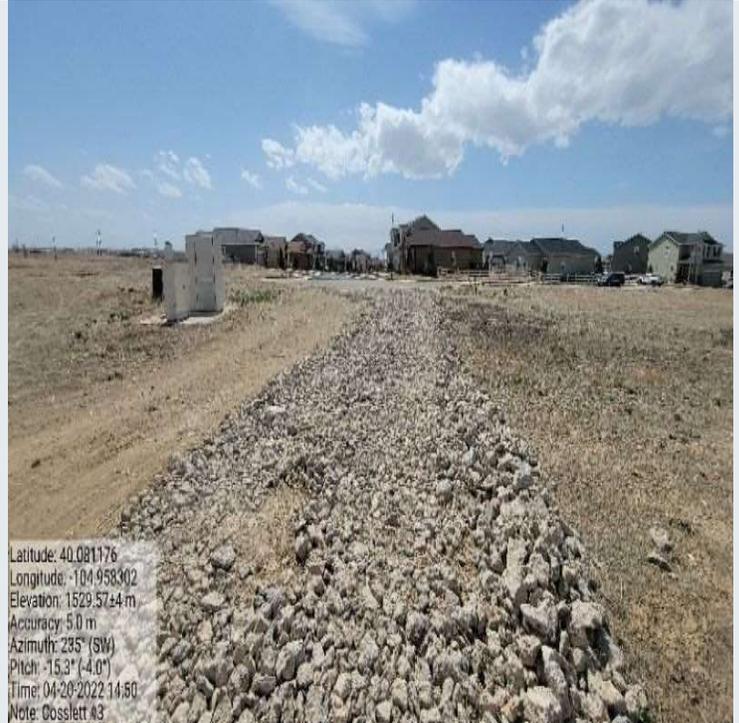
Question: Potential pollutants (trash, material stockpiles) are properly contained?

Response: No.

Notes: No BMPs in place around stockpiles or site perimeter.
