Inspection Photos

API: 073-06736

Operator: MURFIN DRILLING COMPANY

Inspection Date: 5/16/2022

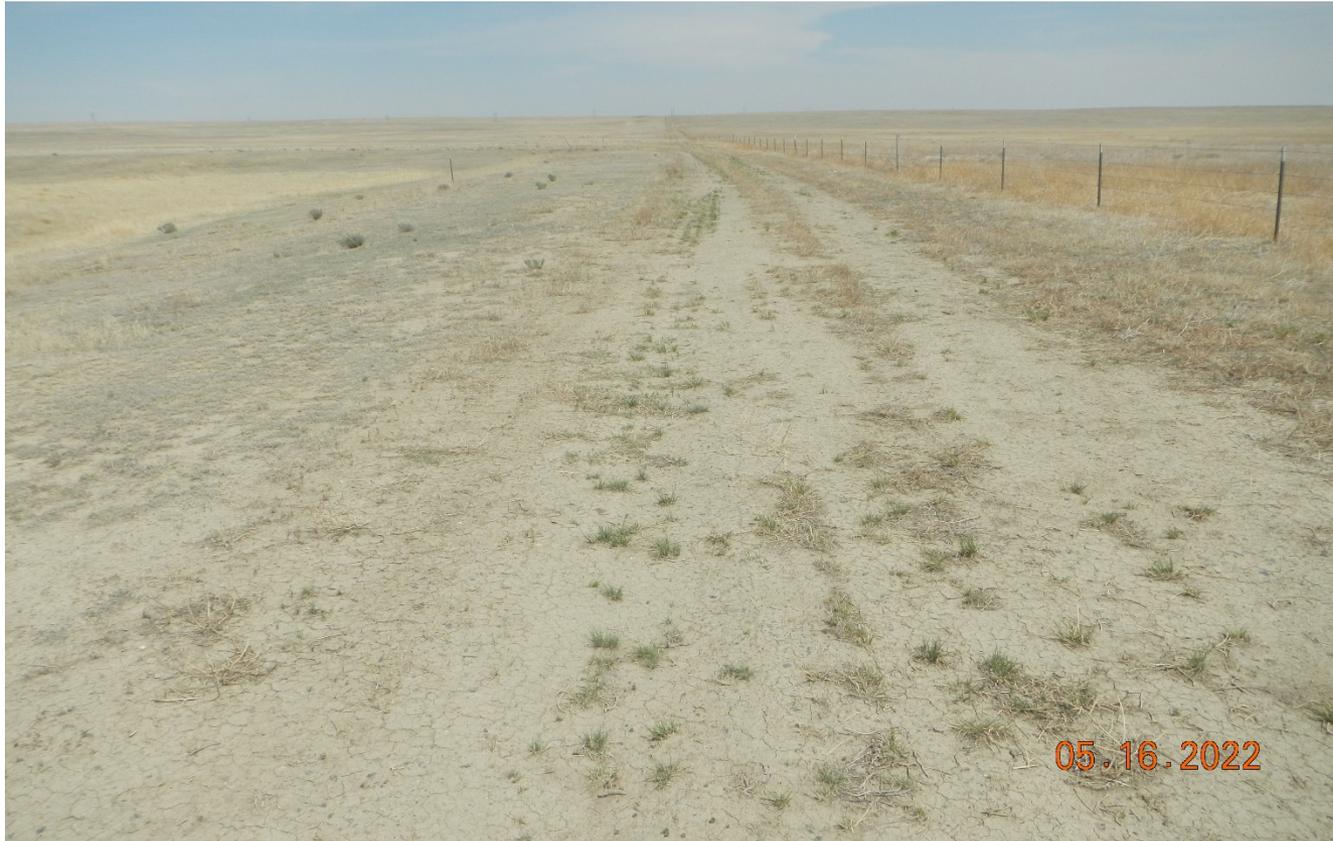
Photo 1. Facing east along the former access road. There are some establishment of vegetation however, the vegetation does not appear to be progressing.

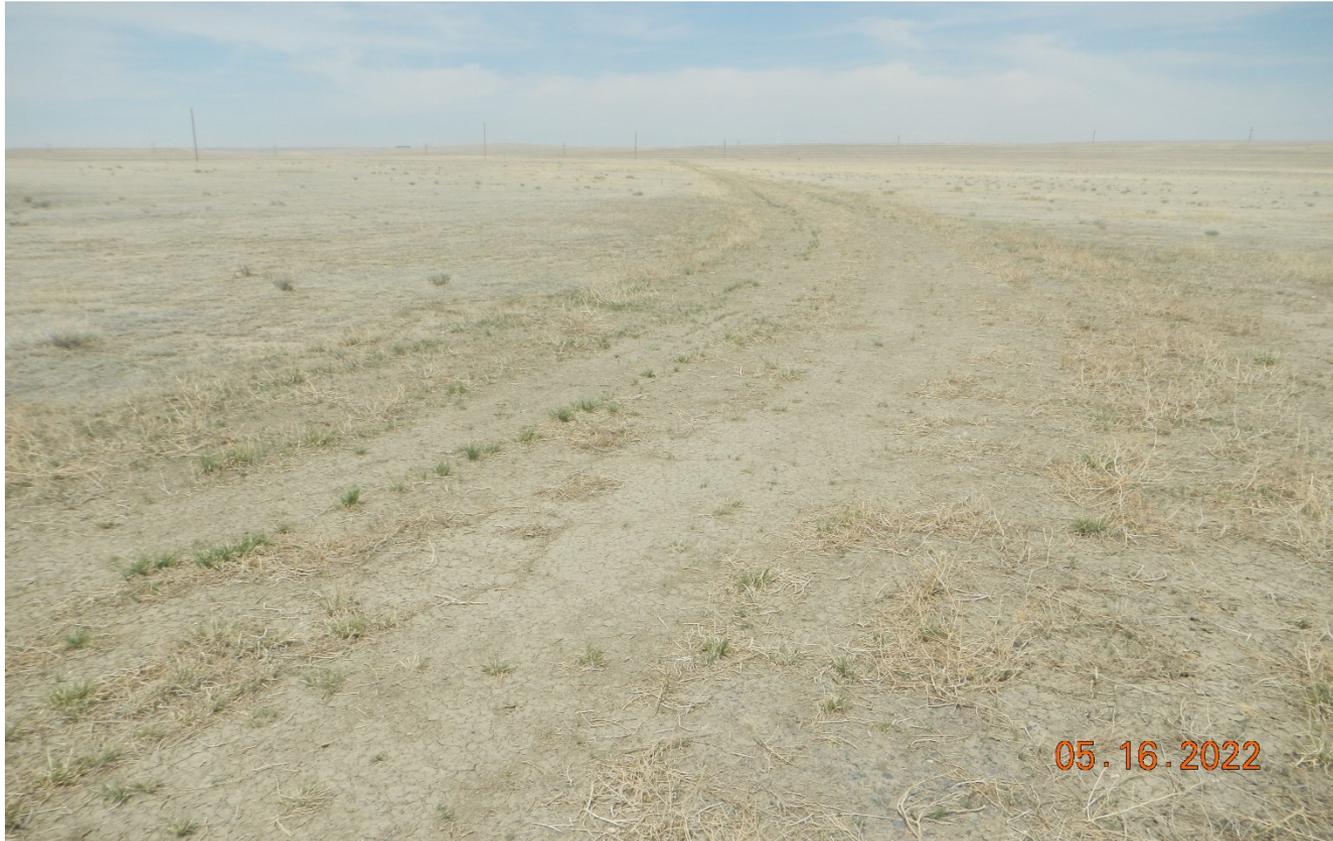
Photo 2. The former road turns to the north. There are some establishment of vegetation however, the vegetation does not appear to be progressing.

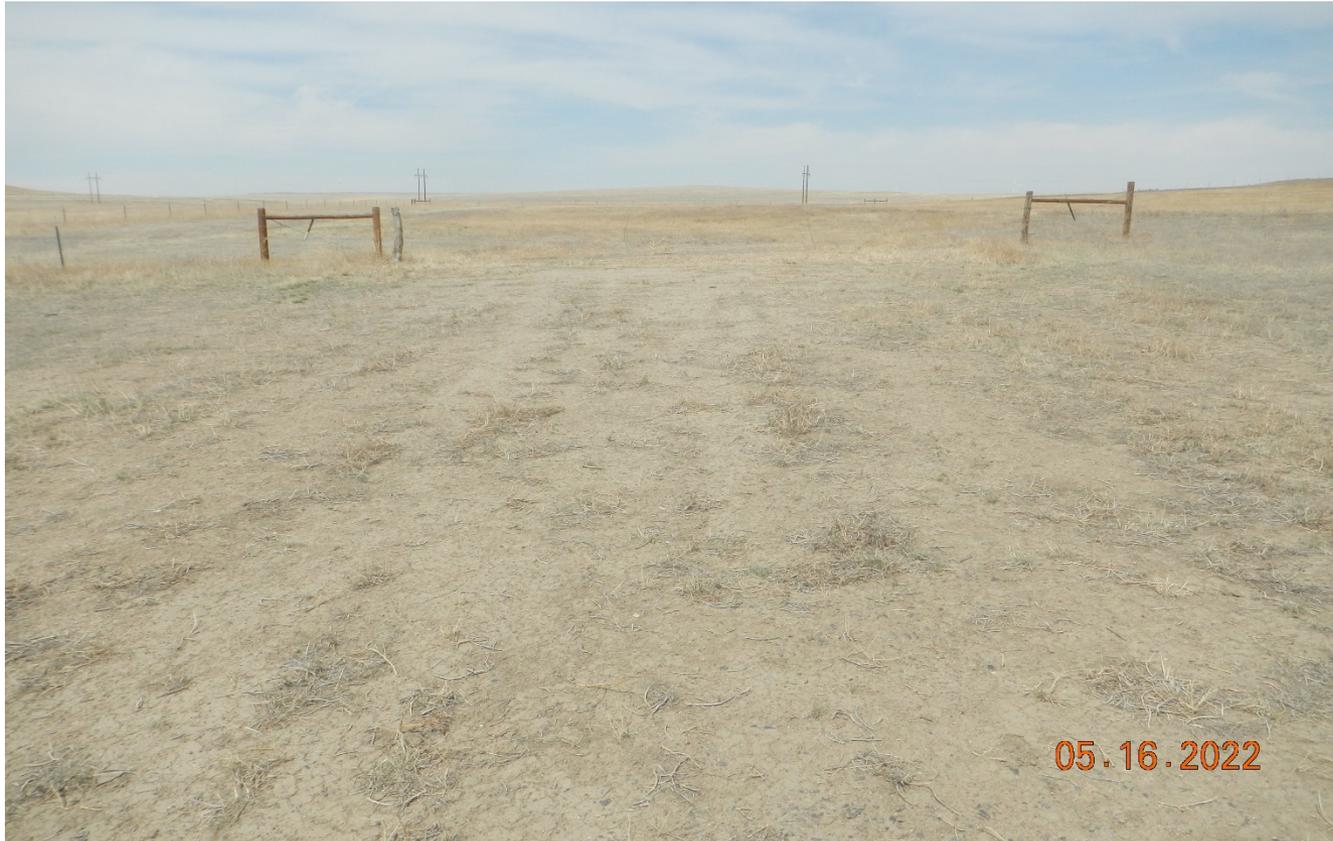
Photo 3. Facing north toward the fenced location.

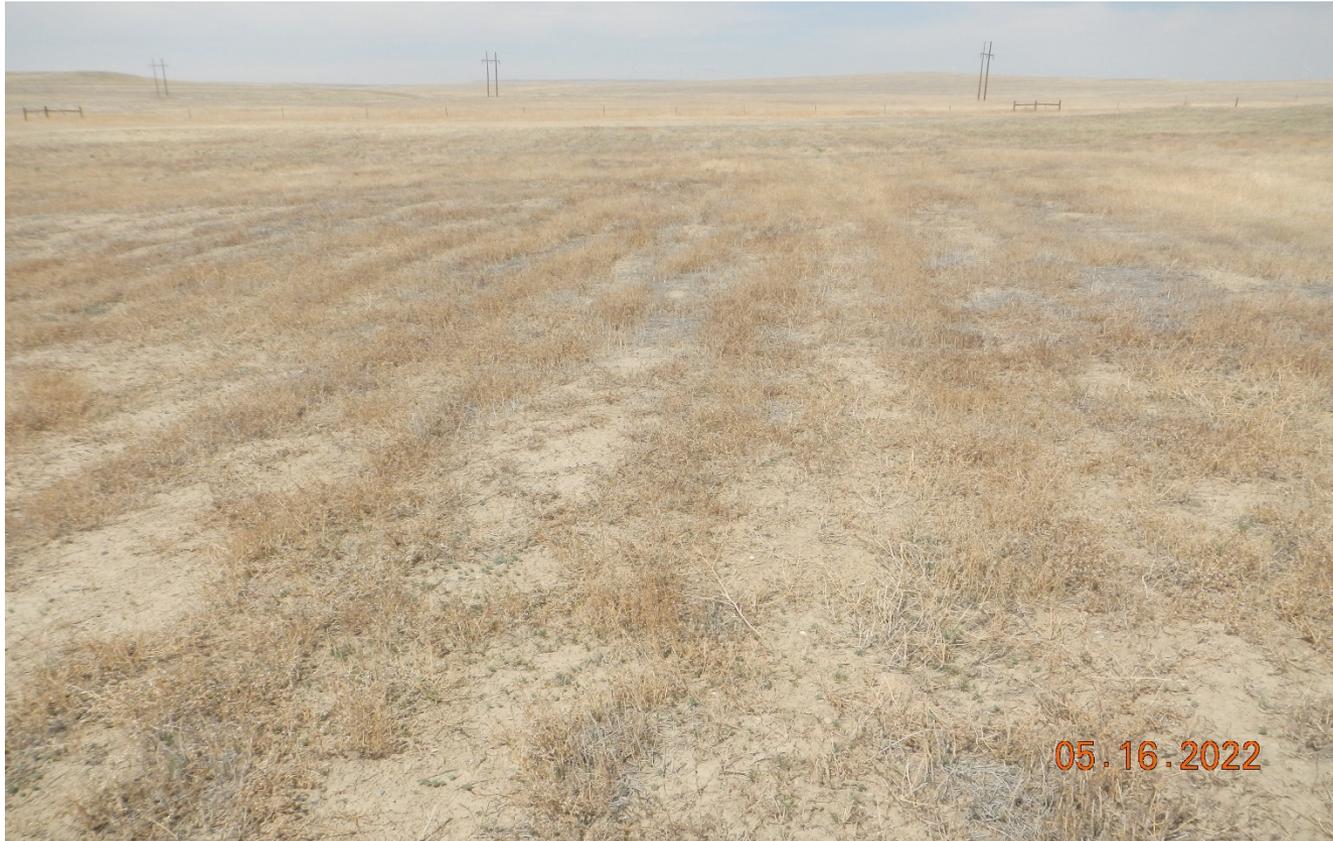
Photo 4. Center of the location facing north. The desirable vegetation does not appear to be progressing. There is mostly undesirable weeds which appear to have been mowed for control.

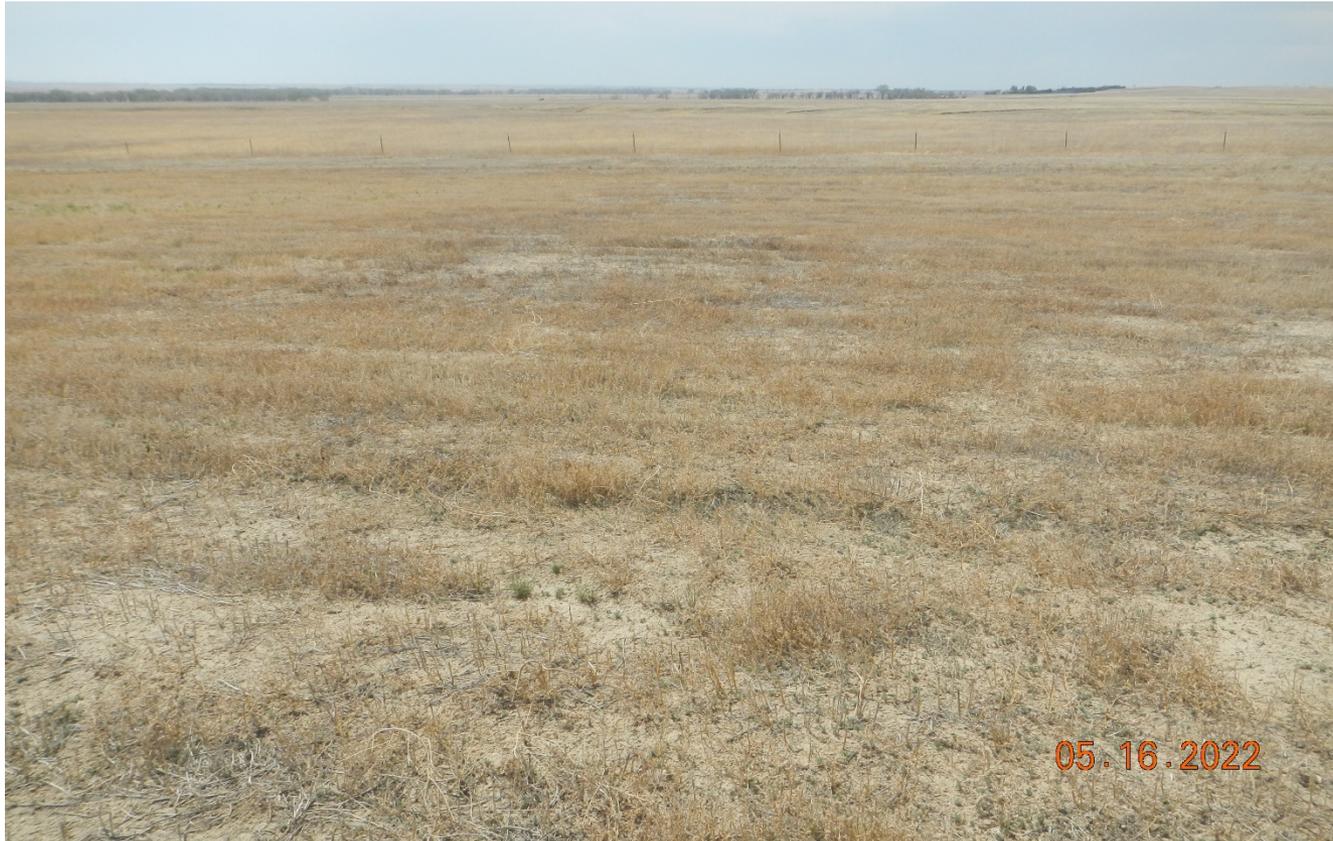
Photo 5. Center of the location facing west. The desirable vegetation does not appear to be progressing. There is mostly undesirable weeds which appear to have been mowed for control.

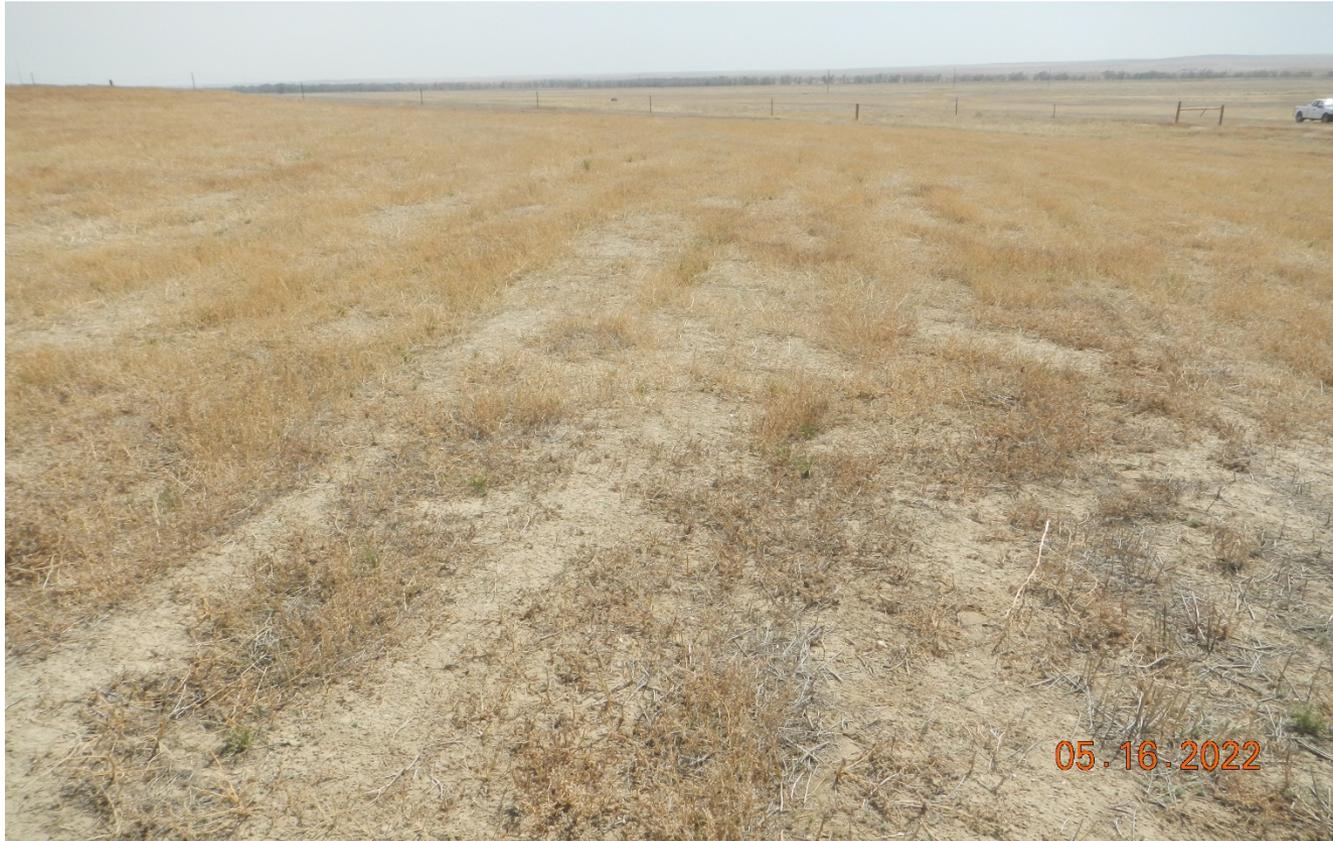
Photo 6. Center of the location facing south. The desirable vegetation does not appear to be progressing. There is mostly undesirable weeds which appear to have been mowed for control.

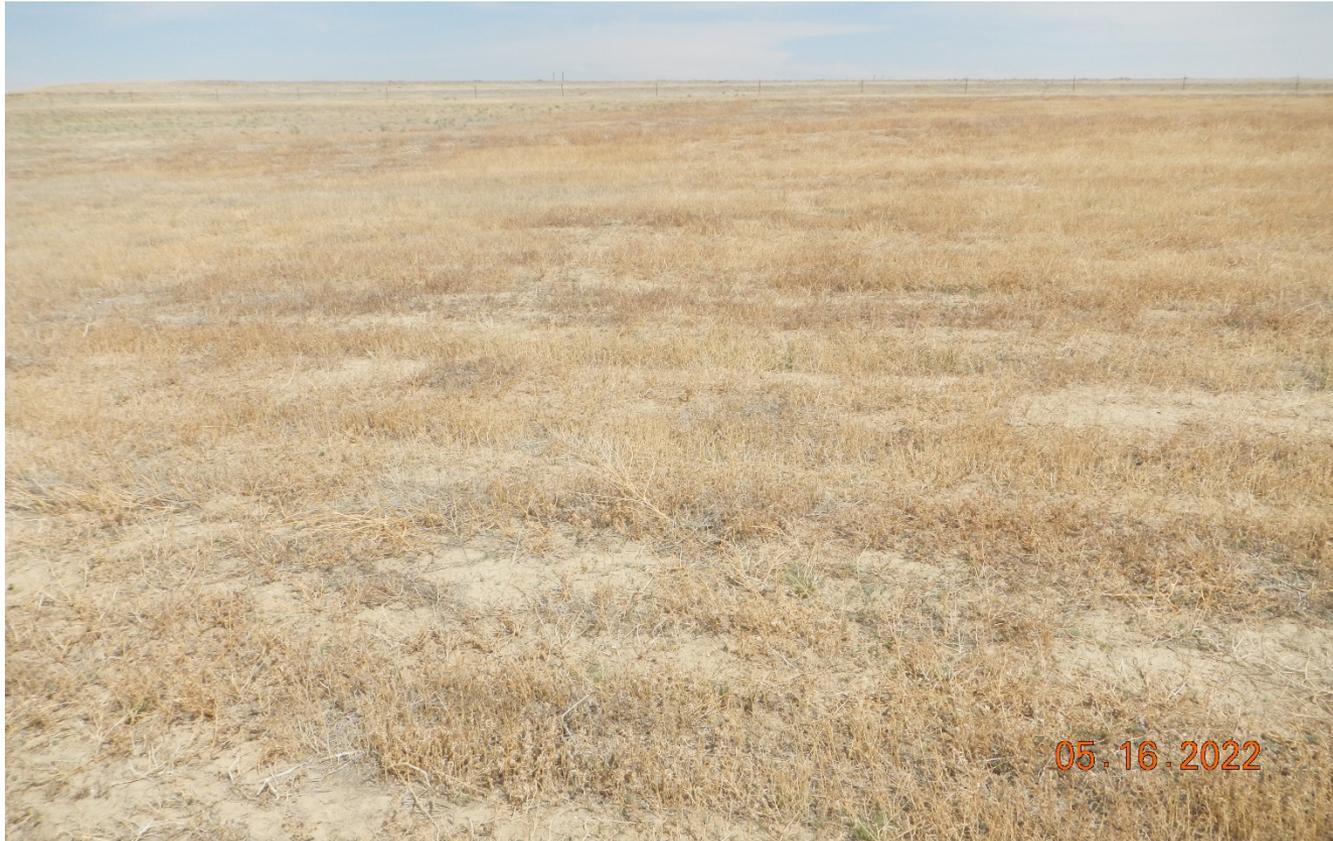
Photo 7. Center of the location facing east. The desirable vegetation does not appear to be progressing. There is mostly undesirable weeds which appear to have been mowed for control.

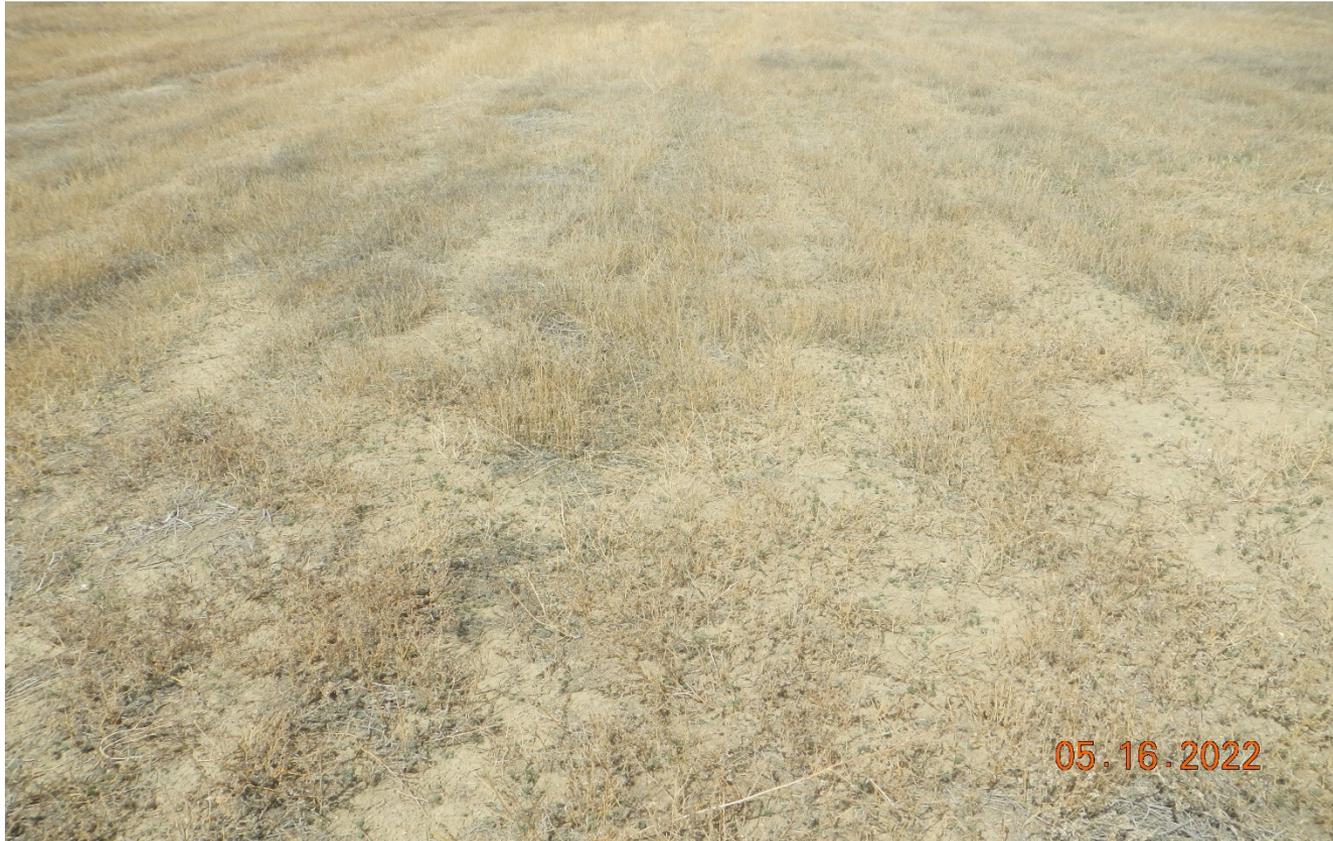
Photo 8. View of groundcover shows mostly undesirable weeds (Kochia sp.). The location will need to be reseeded and weeds controlled.

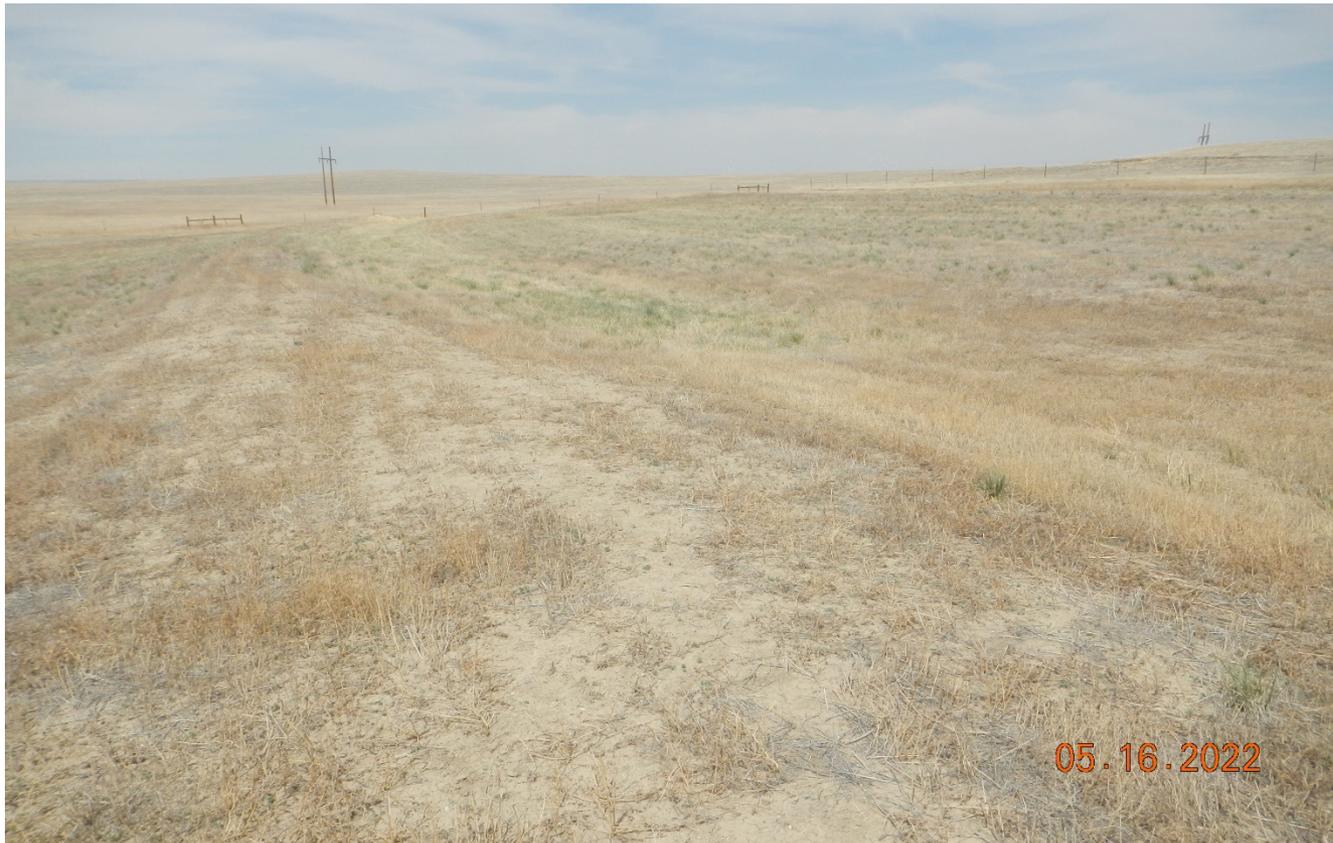
Photo 9. Facing northeast. There is some desirable vegetation in the northeast portion of the location.

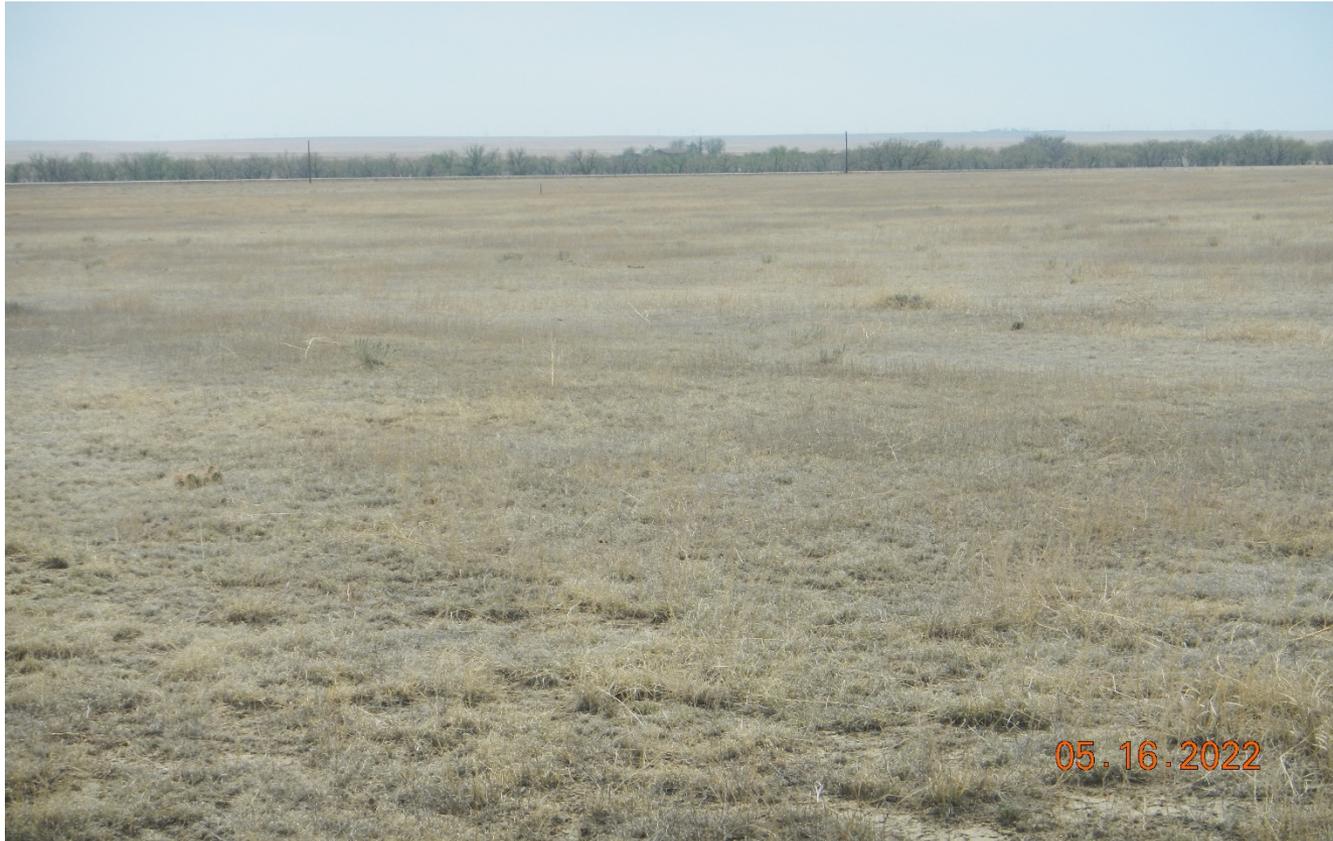
Photo 10. Facing toward the surrounding reference area consisting of Blue grama, Sand dropseed, among other species.
