Inspection Photos  
Location Name:UPRR 23 Pan Am D#1  
Location ID:319690

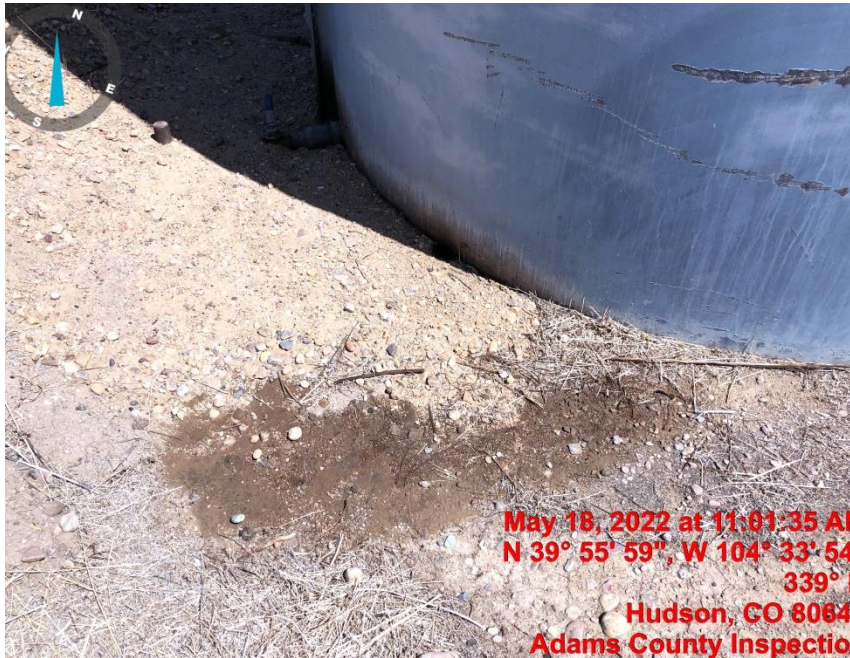
Photo#3 Stained Soil

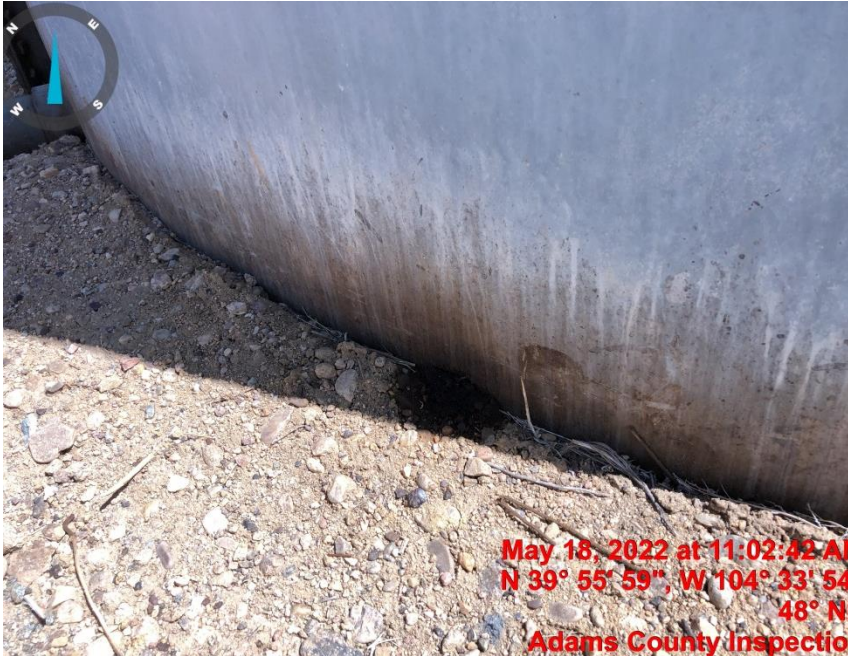
Photo#5 Potential pinhole in production tank. Stained Soil
