Inspection Photos

Location Name: CAERUS PICEANCE LLC MAGNALL-66S92W /34NWSW

Location ID: 334916

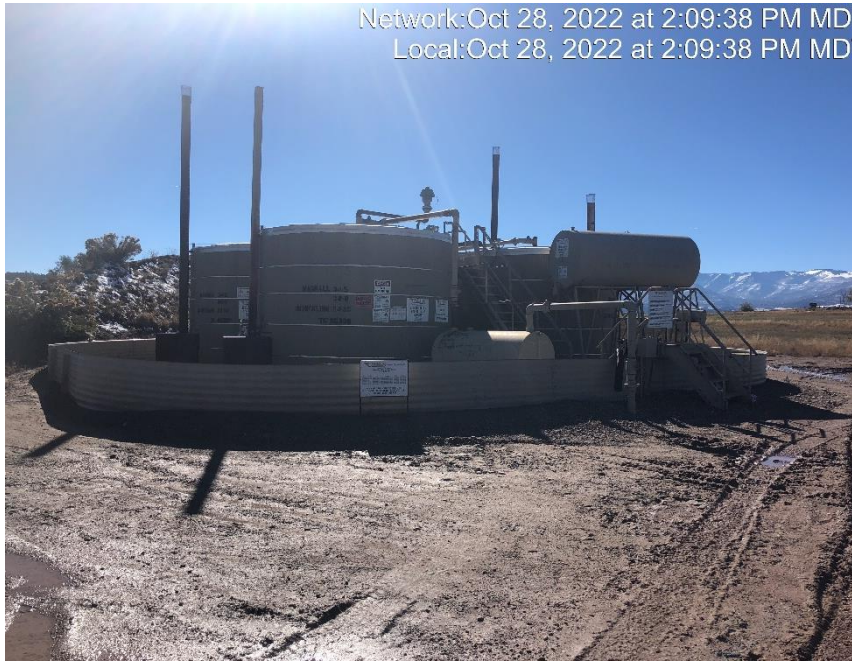
Photo #8238 From entrance to location.

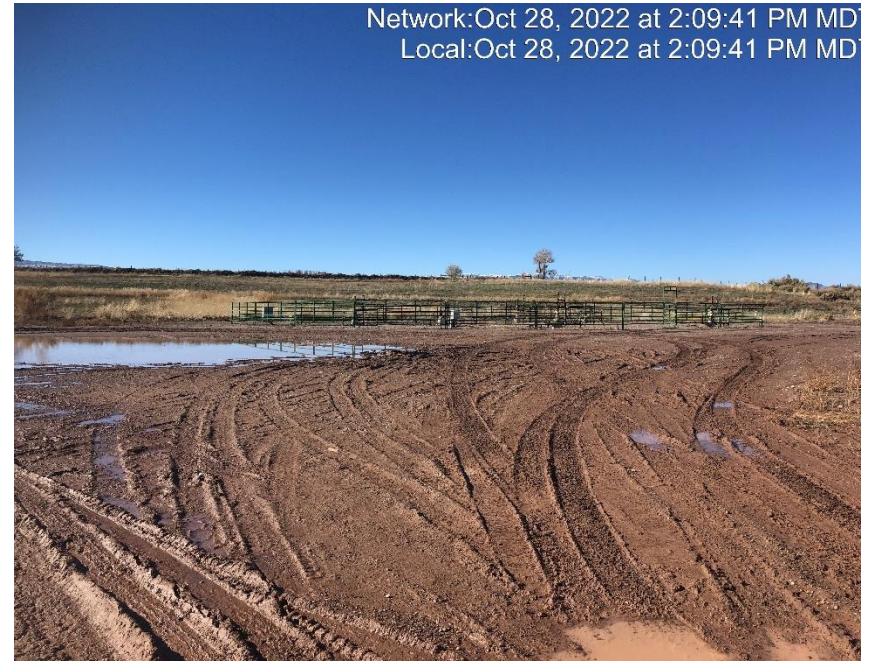
Photo #8239 From entrance to location.

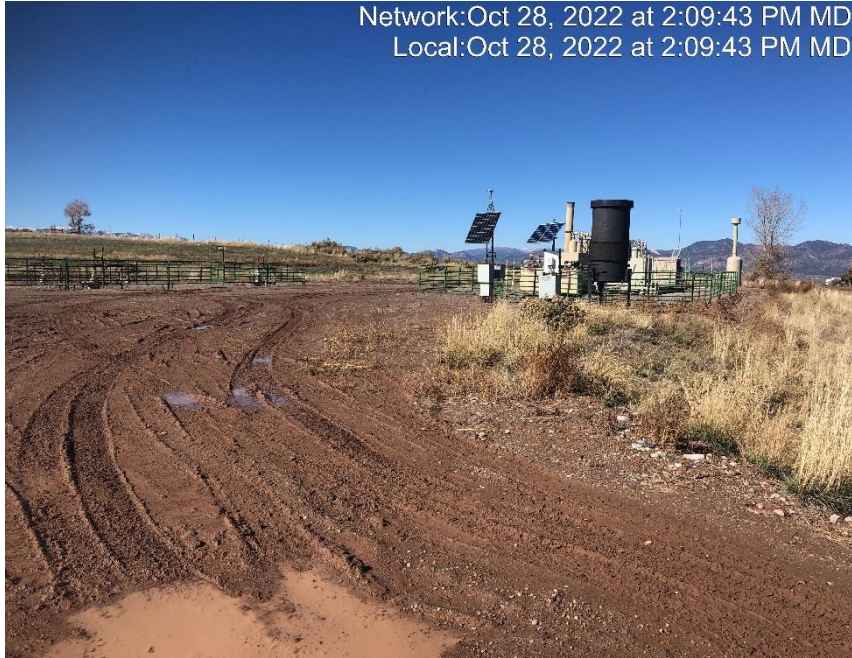
Photo #8240 From entrance to location.

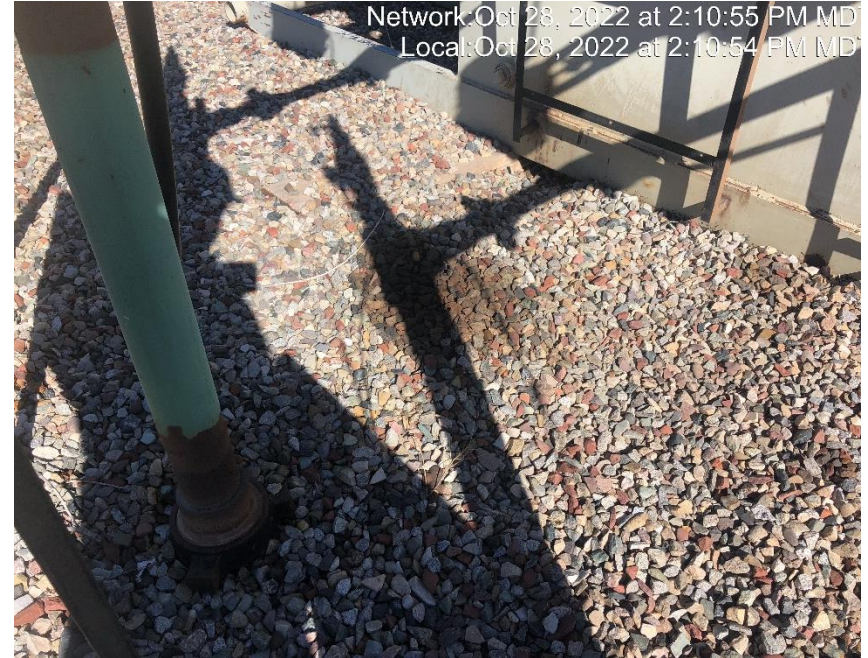
Photo #8245 Stained soils.

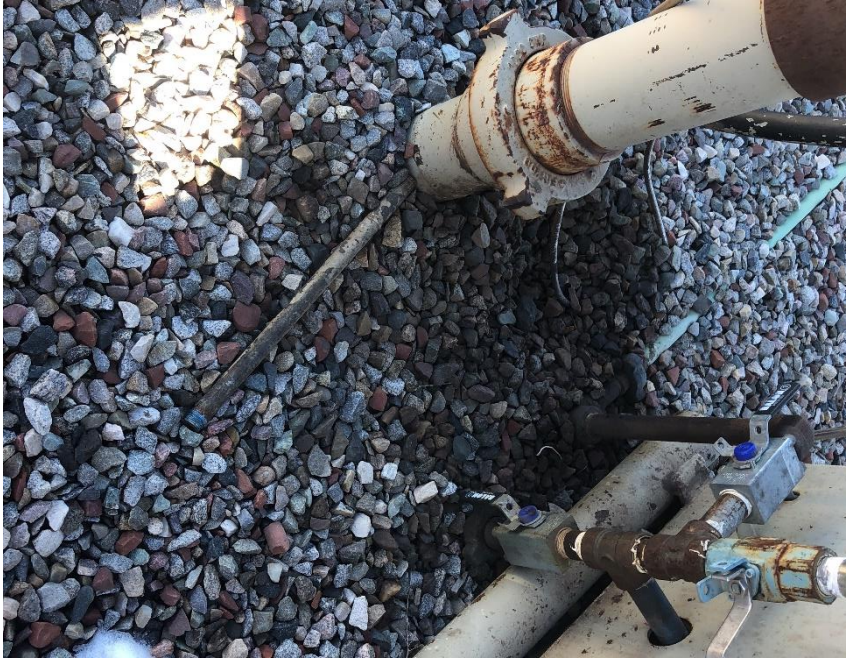
Photo #8246 Stained soils by separators.

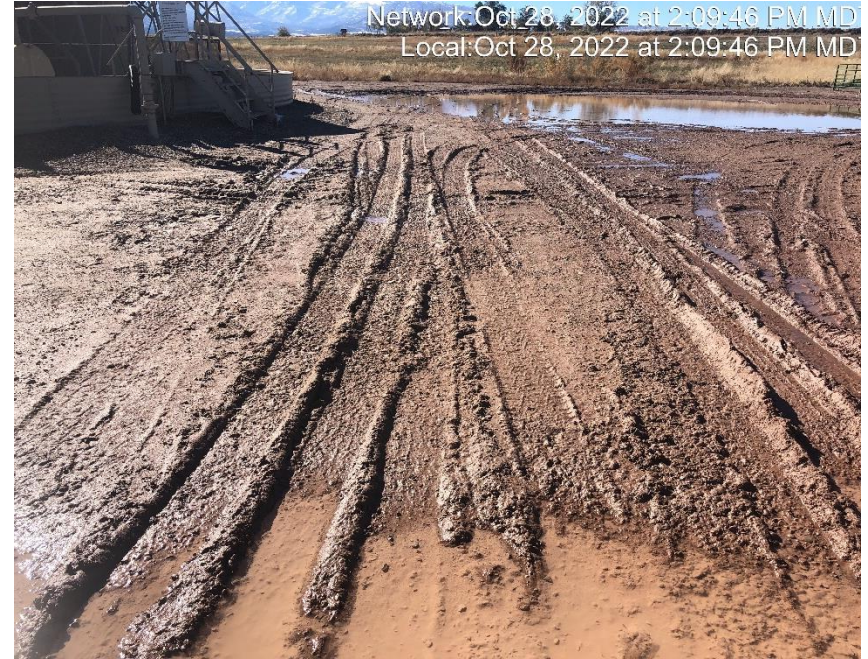
Photo #8241 Location lacks stabilization.

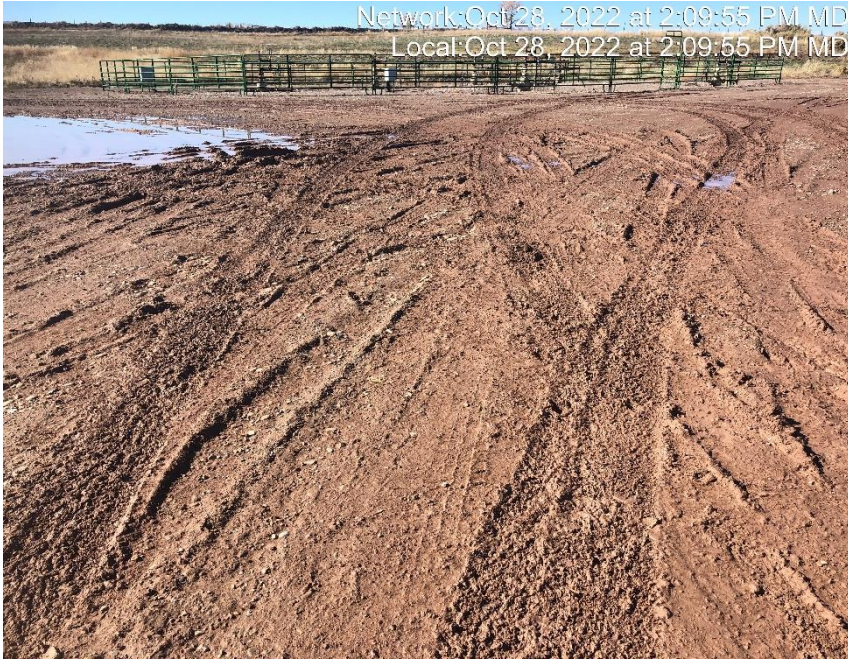
Photo #8242 From entrance to location.

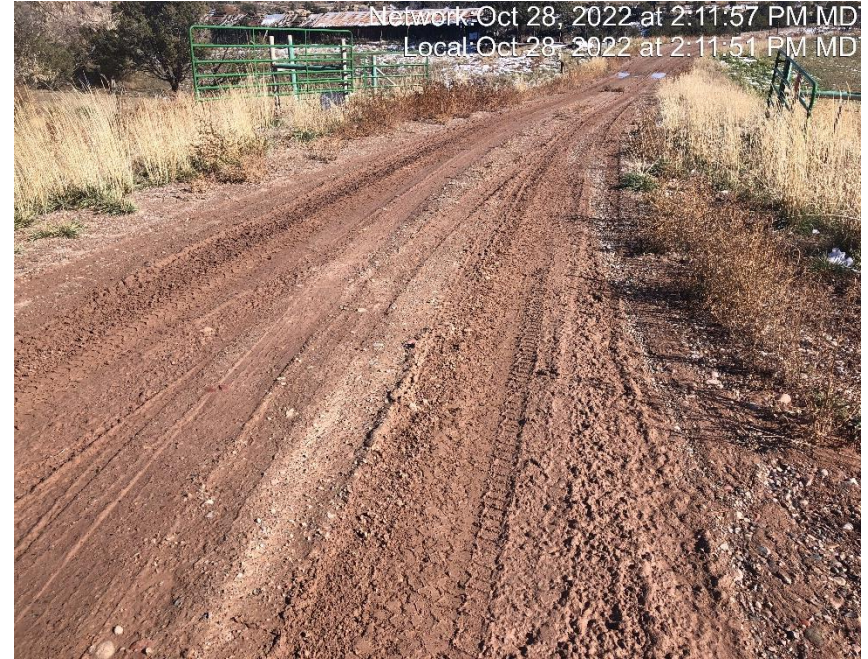
Photo #8247 Insufficient tracking control at entrance to location.
