# Inspection Photos

API: 071-07604

Operator: EVERGREEN NATURAL RESOURCES

Inspection Date: 12/12/2022

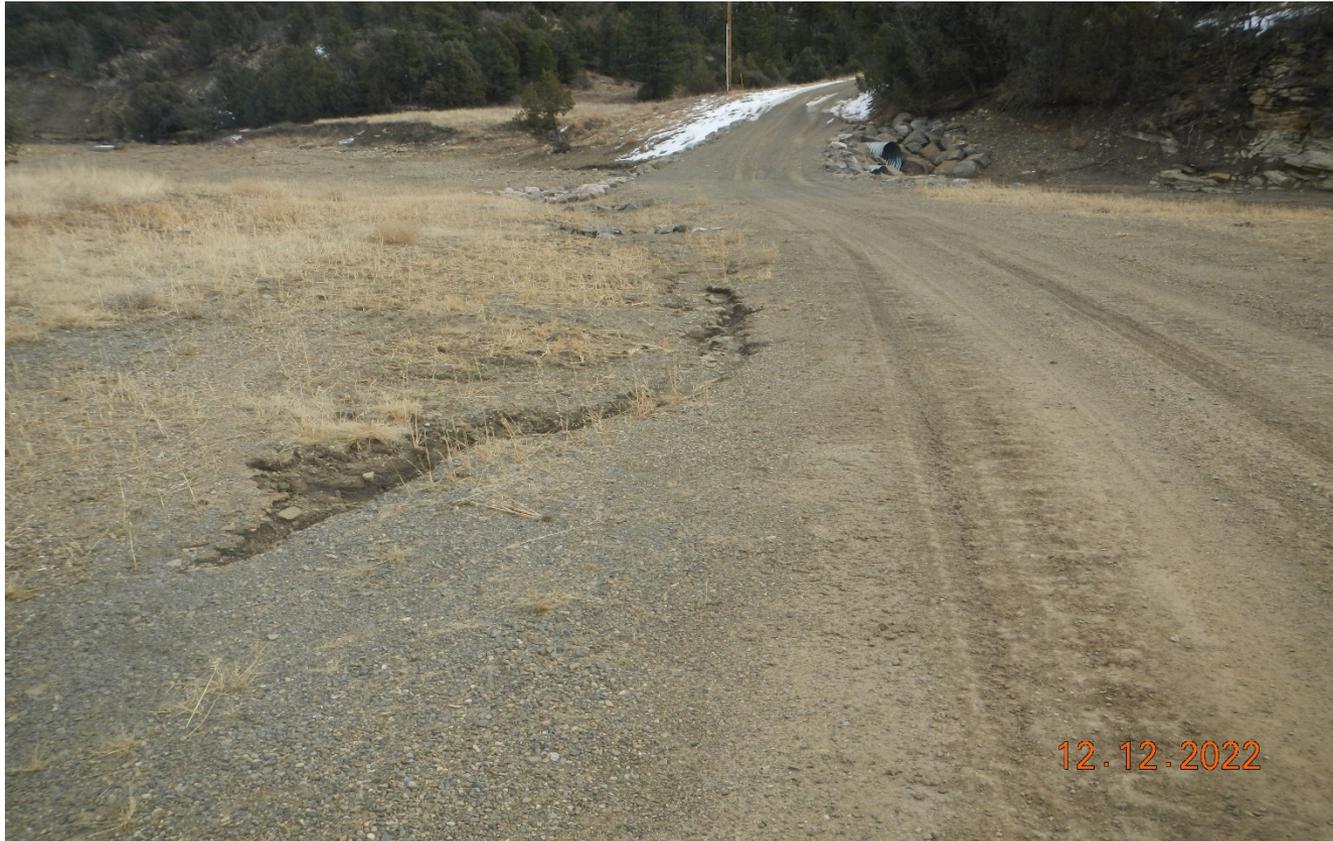
**Photo 1.** Facing east toward the access road stream crossing. There is erosion beginning to occur in this area and needs to be repaired.

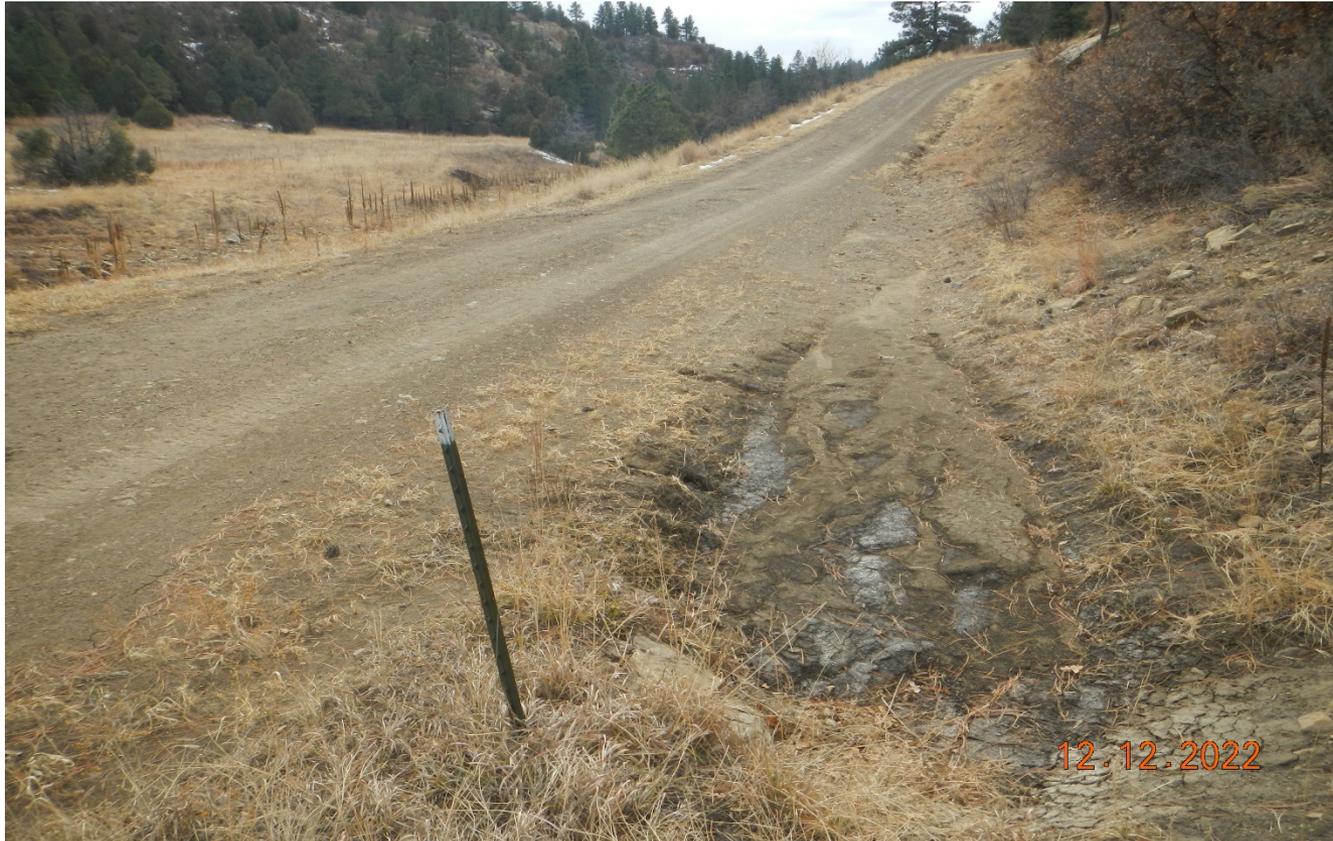
**Photo 2.** Facing southeast along the access road. This culvert along the access road has filled back in with sediment and needs to be cleaned out.

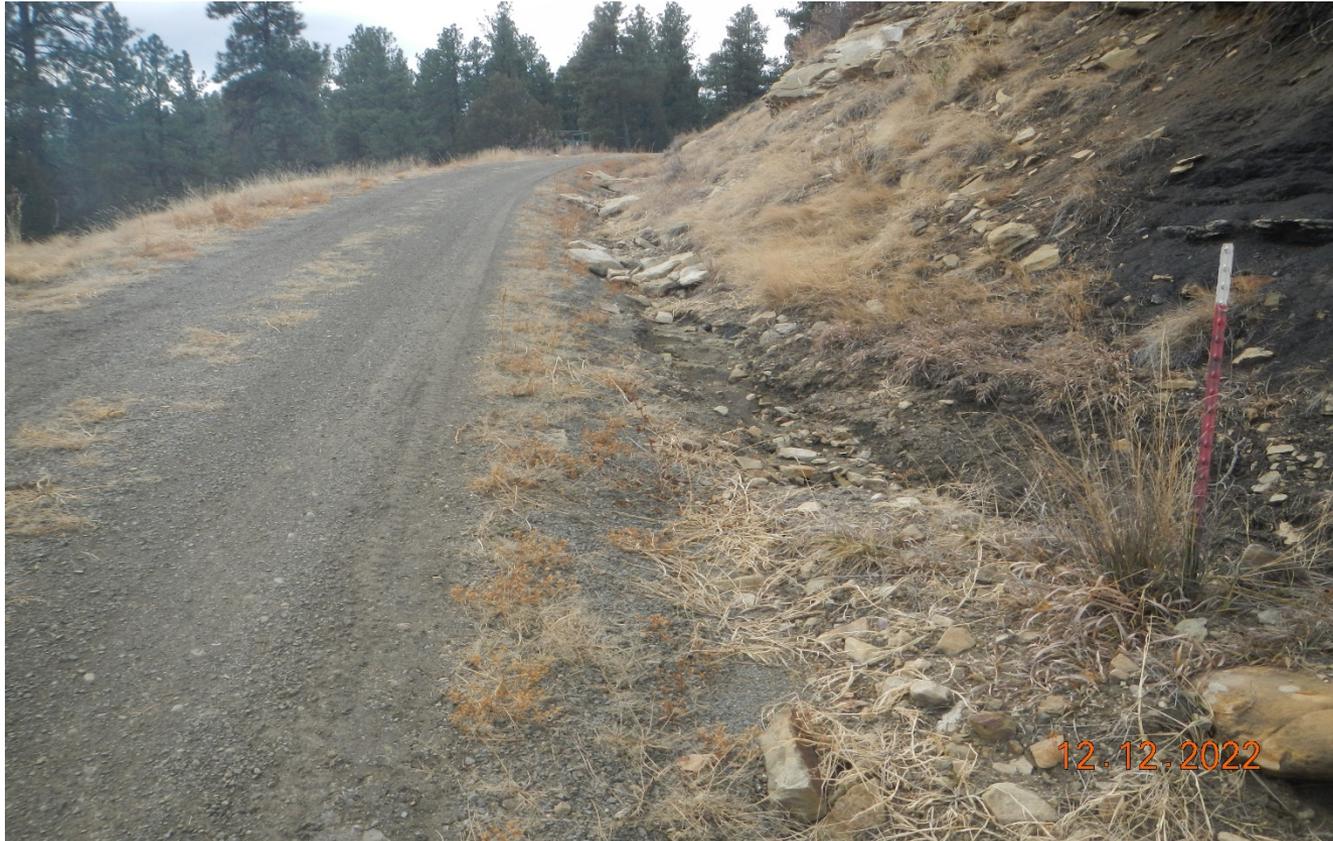
**Photo 4.** Facing south along the access road. Other culverts along the road have been cleaned out and maintained.

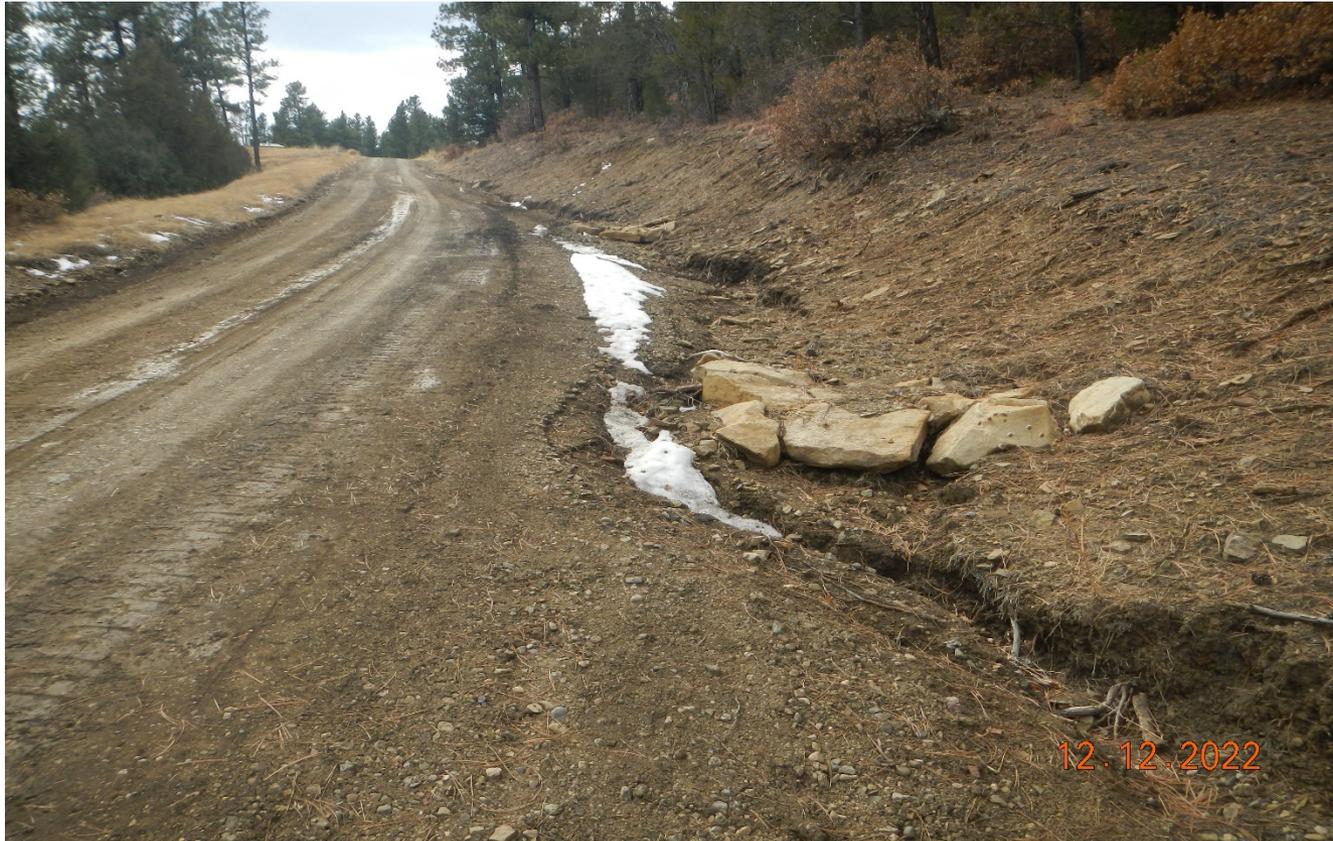
**Photo 4.** There was repairs made since previous inspection however erosion is occurring around the rock check dams. BMP maintenance is needed and additional BMP's should be installed.

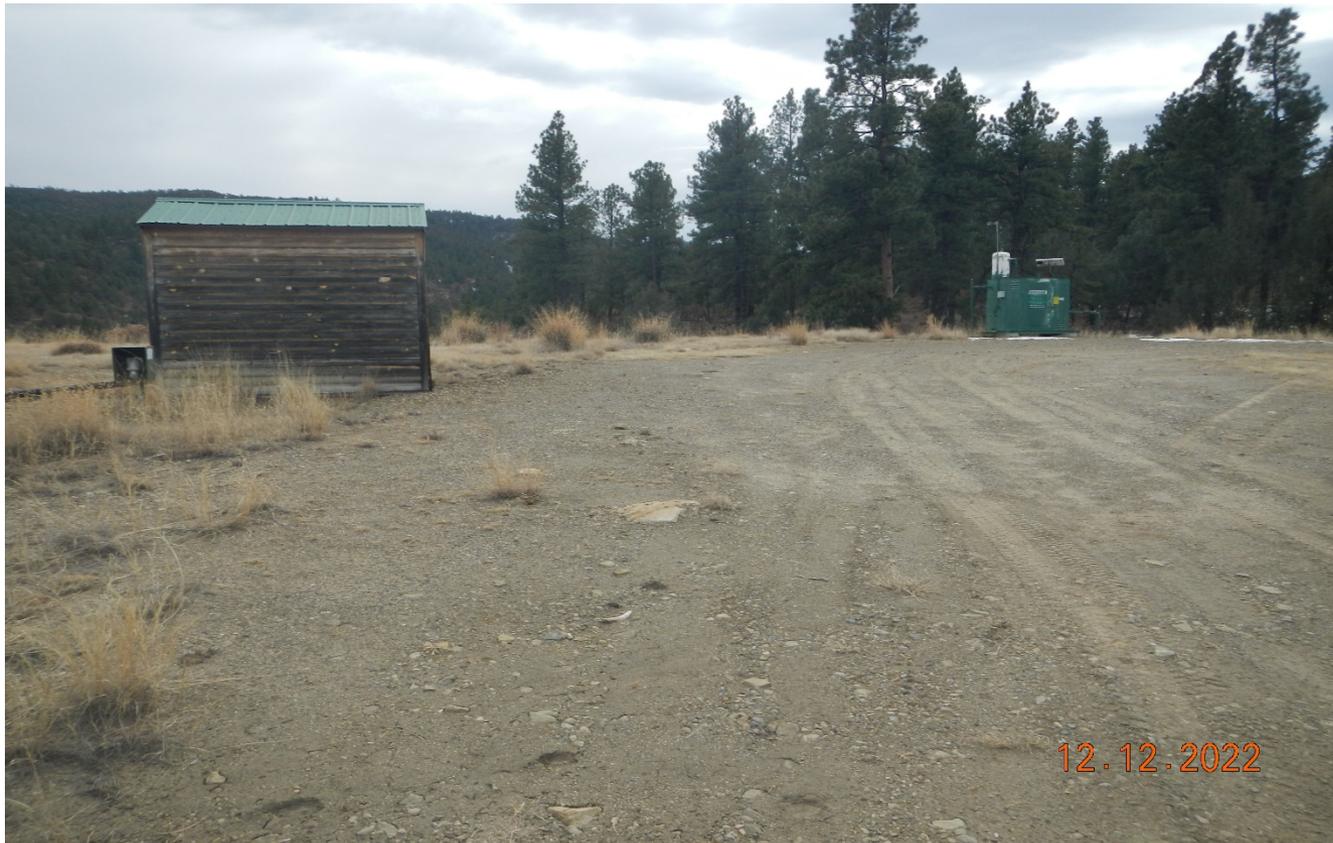
**Photo 5.** Facing south toward the well site.
